**APPENDIX Z**  
**p,p'-DDE IN SEDIMENT, 2009 VERSUS 2013**

**Table 1 - p,p-DDE in 0-8 cm Sediment Layer – 2009 vs. 2013**  
**First MNR Report**  
**Palos Verdes Shelf (OU 5 of the Montrose Chemical Corp. Superfund Site)**  
**Los Angeles County, California**

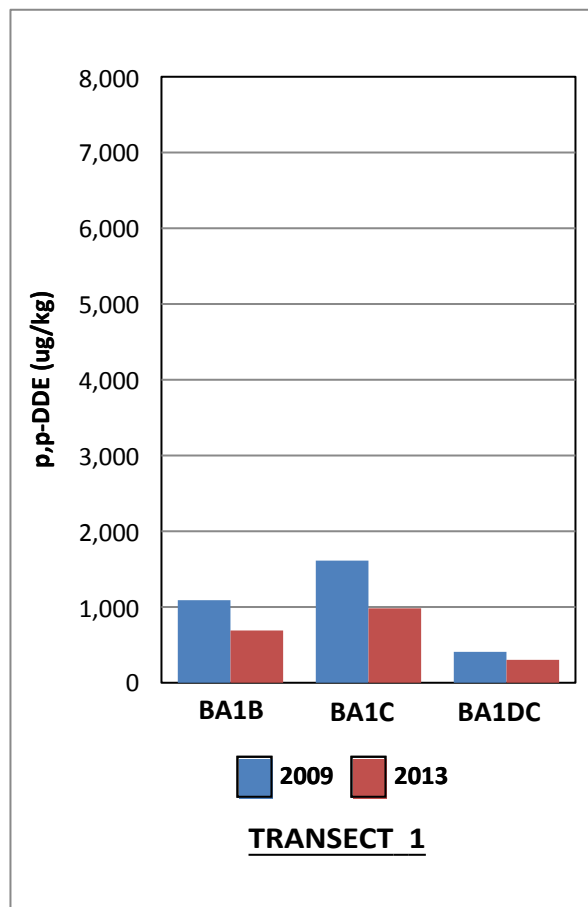
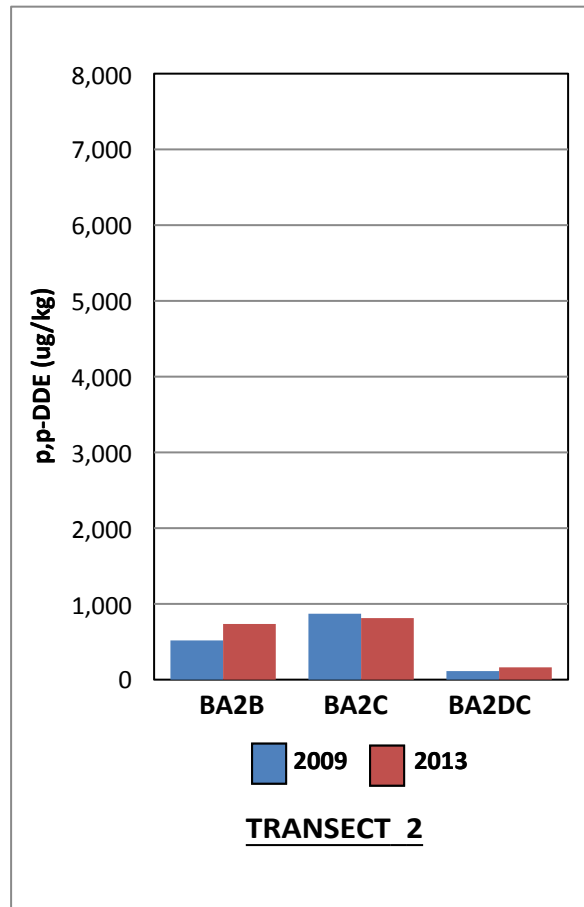
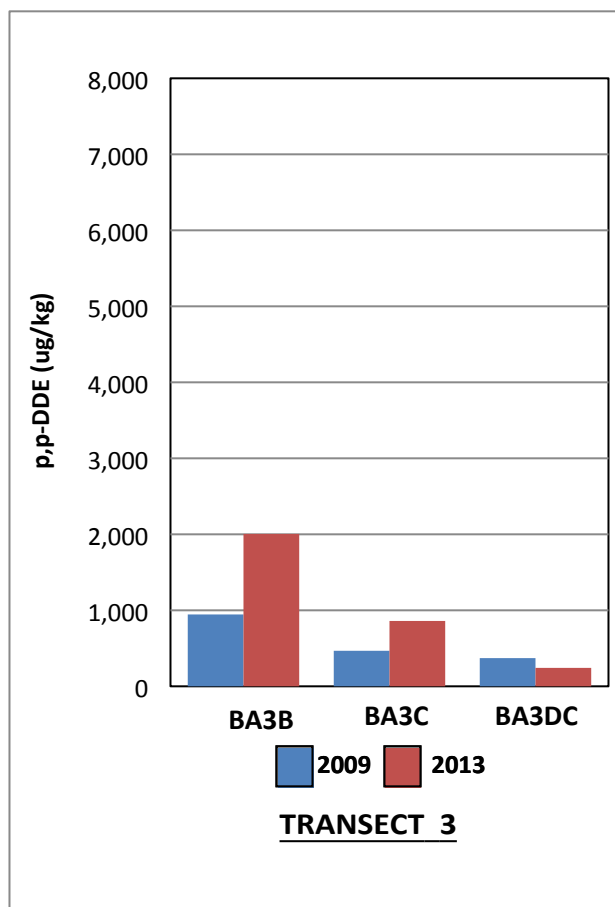
1. Nominal water column depths at sediment core locations were as follows: B - 150 m; C - 60 m; DC - 40 m.

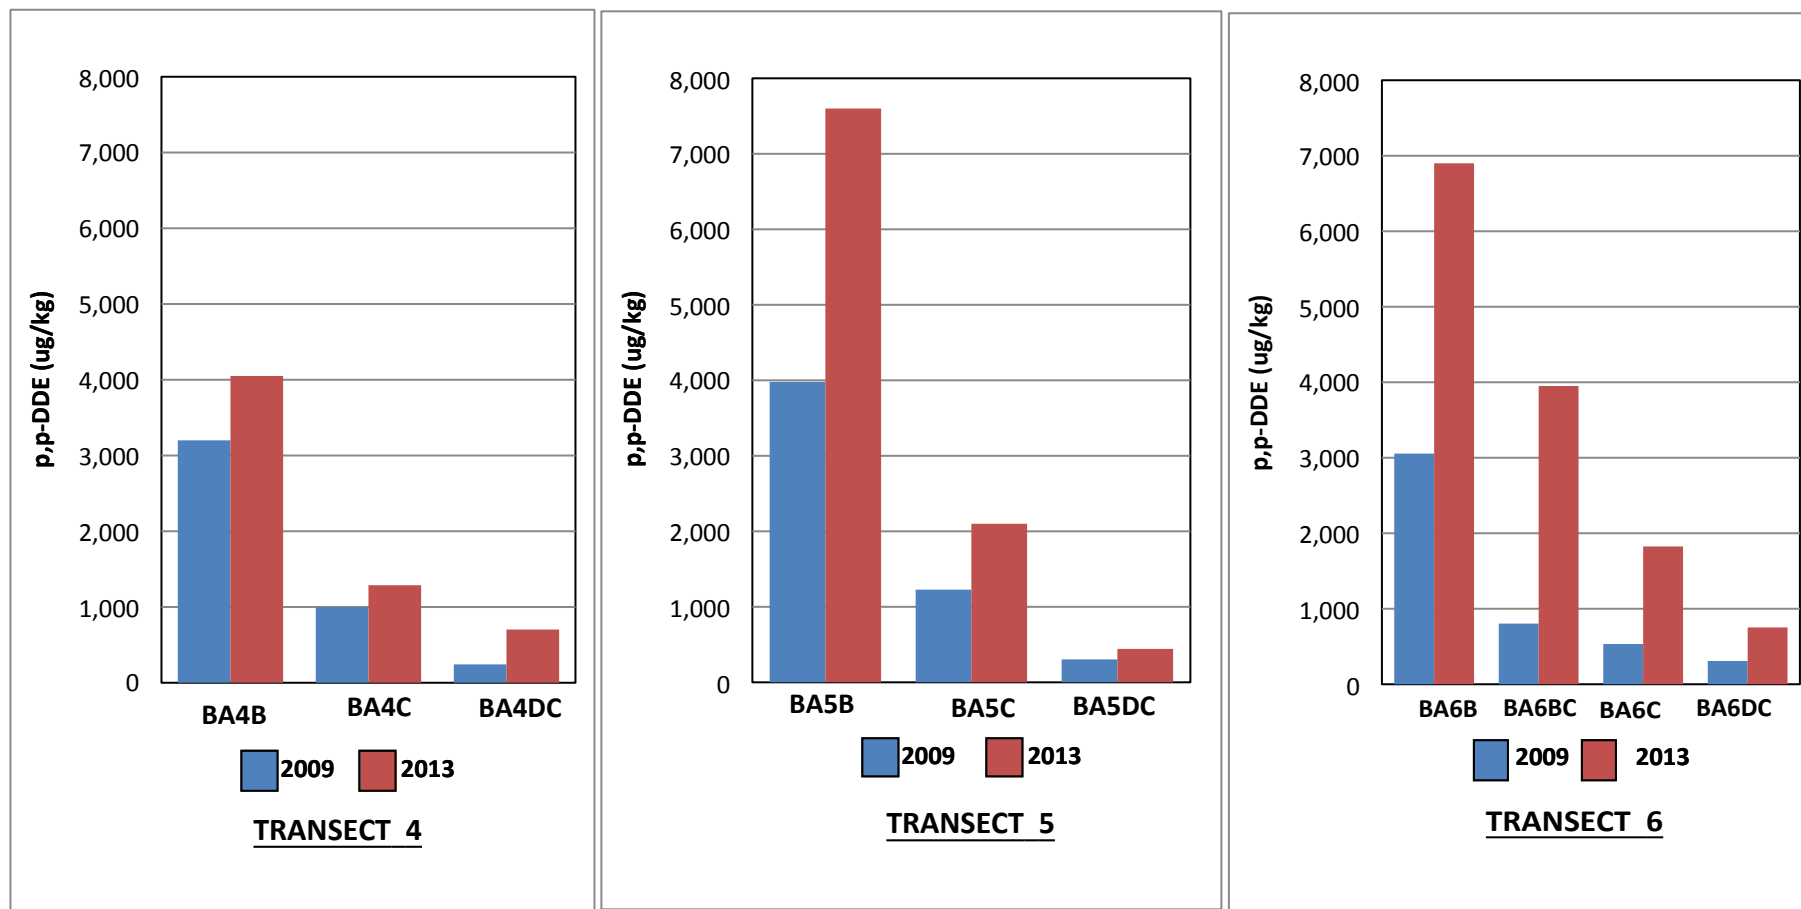
**Table 2 - p,p-DDE in 0-8 cm Sediment Layer – 2009 vs. 2013**  
**First MNR Report**  
**Palos Verdes Shelf (OU 5 of the Montrose Chemical Corp. Superfund Site)**  
**Los Angeles County, California**

1. Nominal water column depths at sediment core locations were as follows: B - 150 m; BC - 95 m; C - 60 m; DC - 40 m.

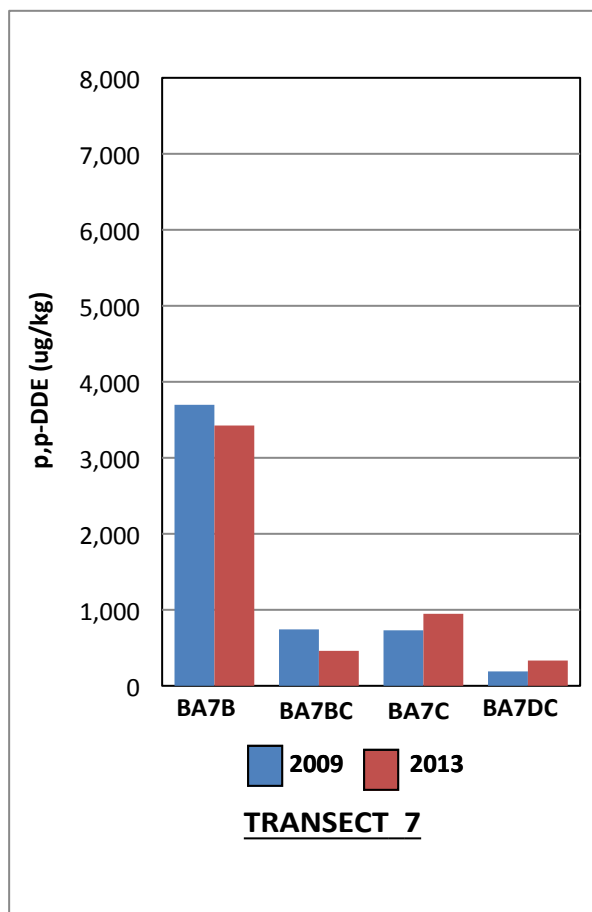
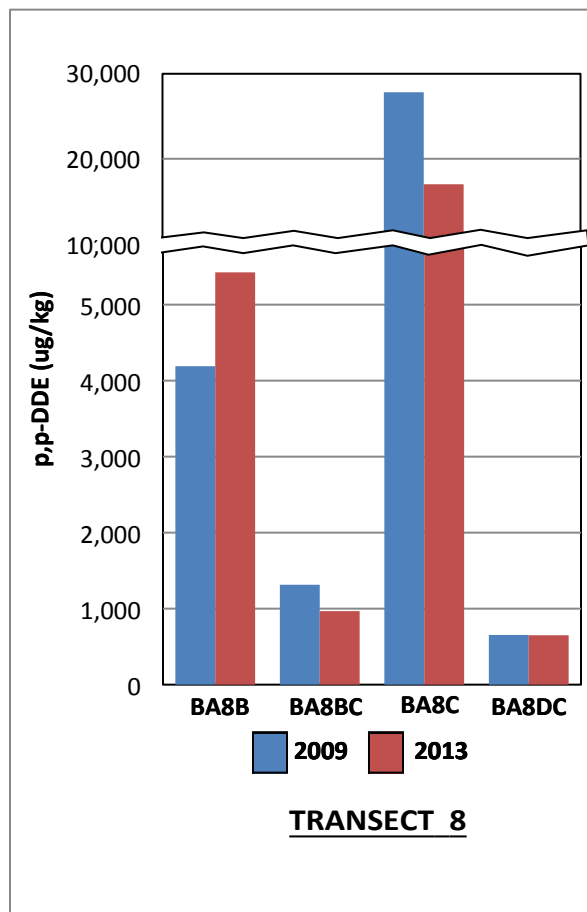
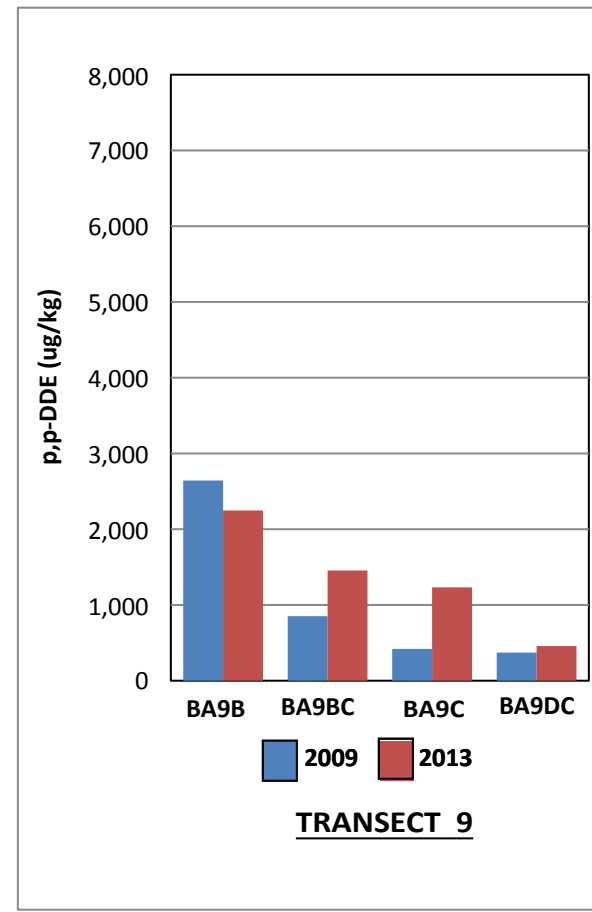
**Table 3 - p,p-DDE in 0-8 cm Sediment Layer – 2009 vs. 2013**  
**First MNR Report**  
**Palos Verdes Shelf (OU 5 of the Montrose Chemical Corp. Superfund Site)**  
**Los Angeles County, California**

1. Nominal water column depths at sediment core locations were as follows: B - 150 m; BC - 95 m; C - 60 m; DC - 40 m.

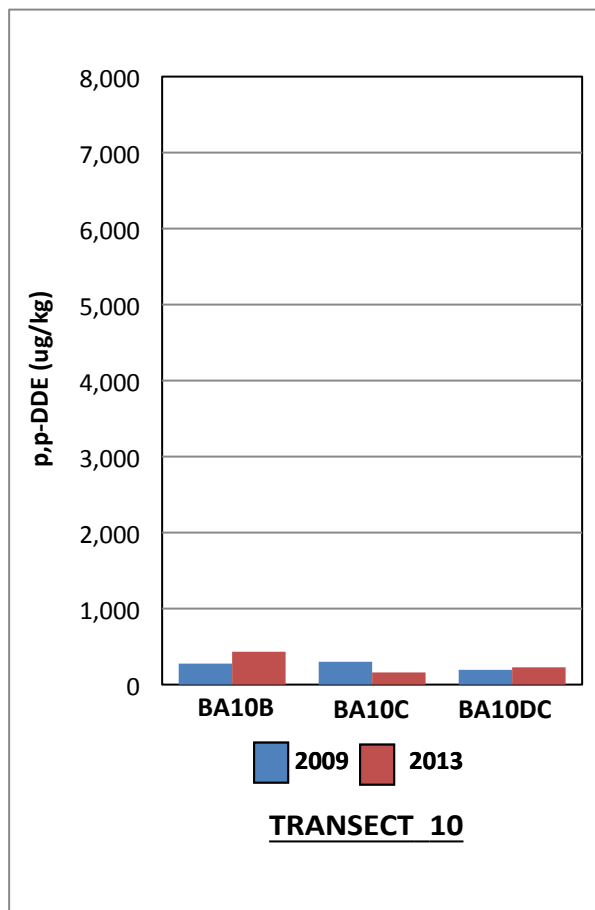
**Table 4 - p,p-DDE in 0-8 cm Sediment Layer – 2009 vs. 2013**  
**First MNR Report**  
**Palos Verdes Shelf (OU 5 of the Montrose Chemical Corp. Superfund Site)**  
**Los Angeles County, California**

1. Nominal water column depths at sediment core locations were as follows: B - 150 m; C - 60 m; DC - 40 m.
