First MNR Report
Palos Verdes Shelf
Los Angeles County, California

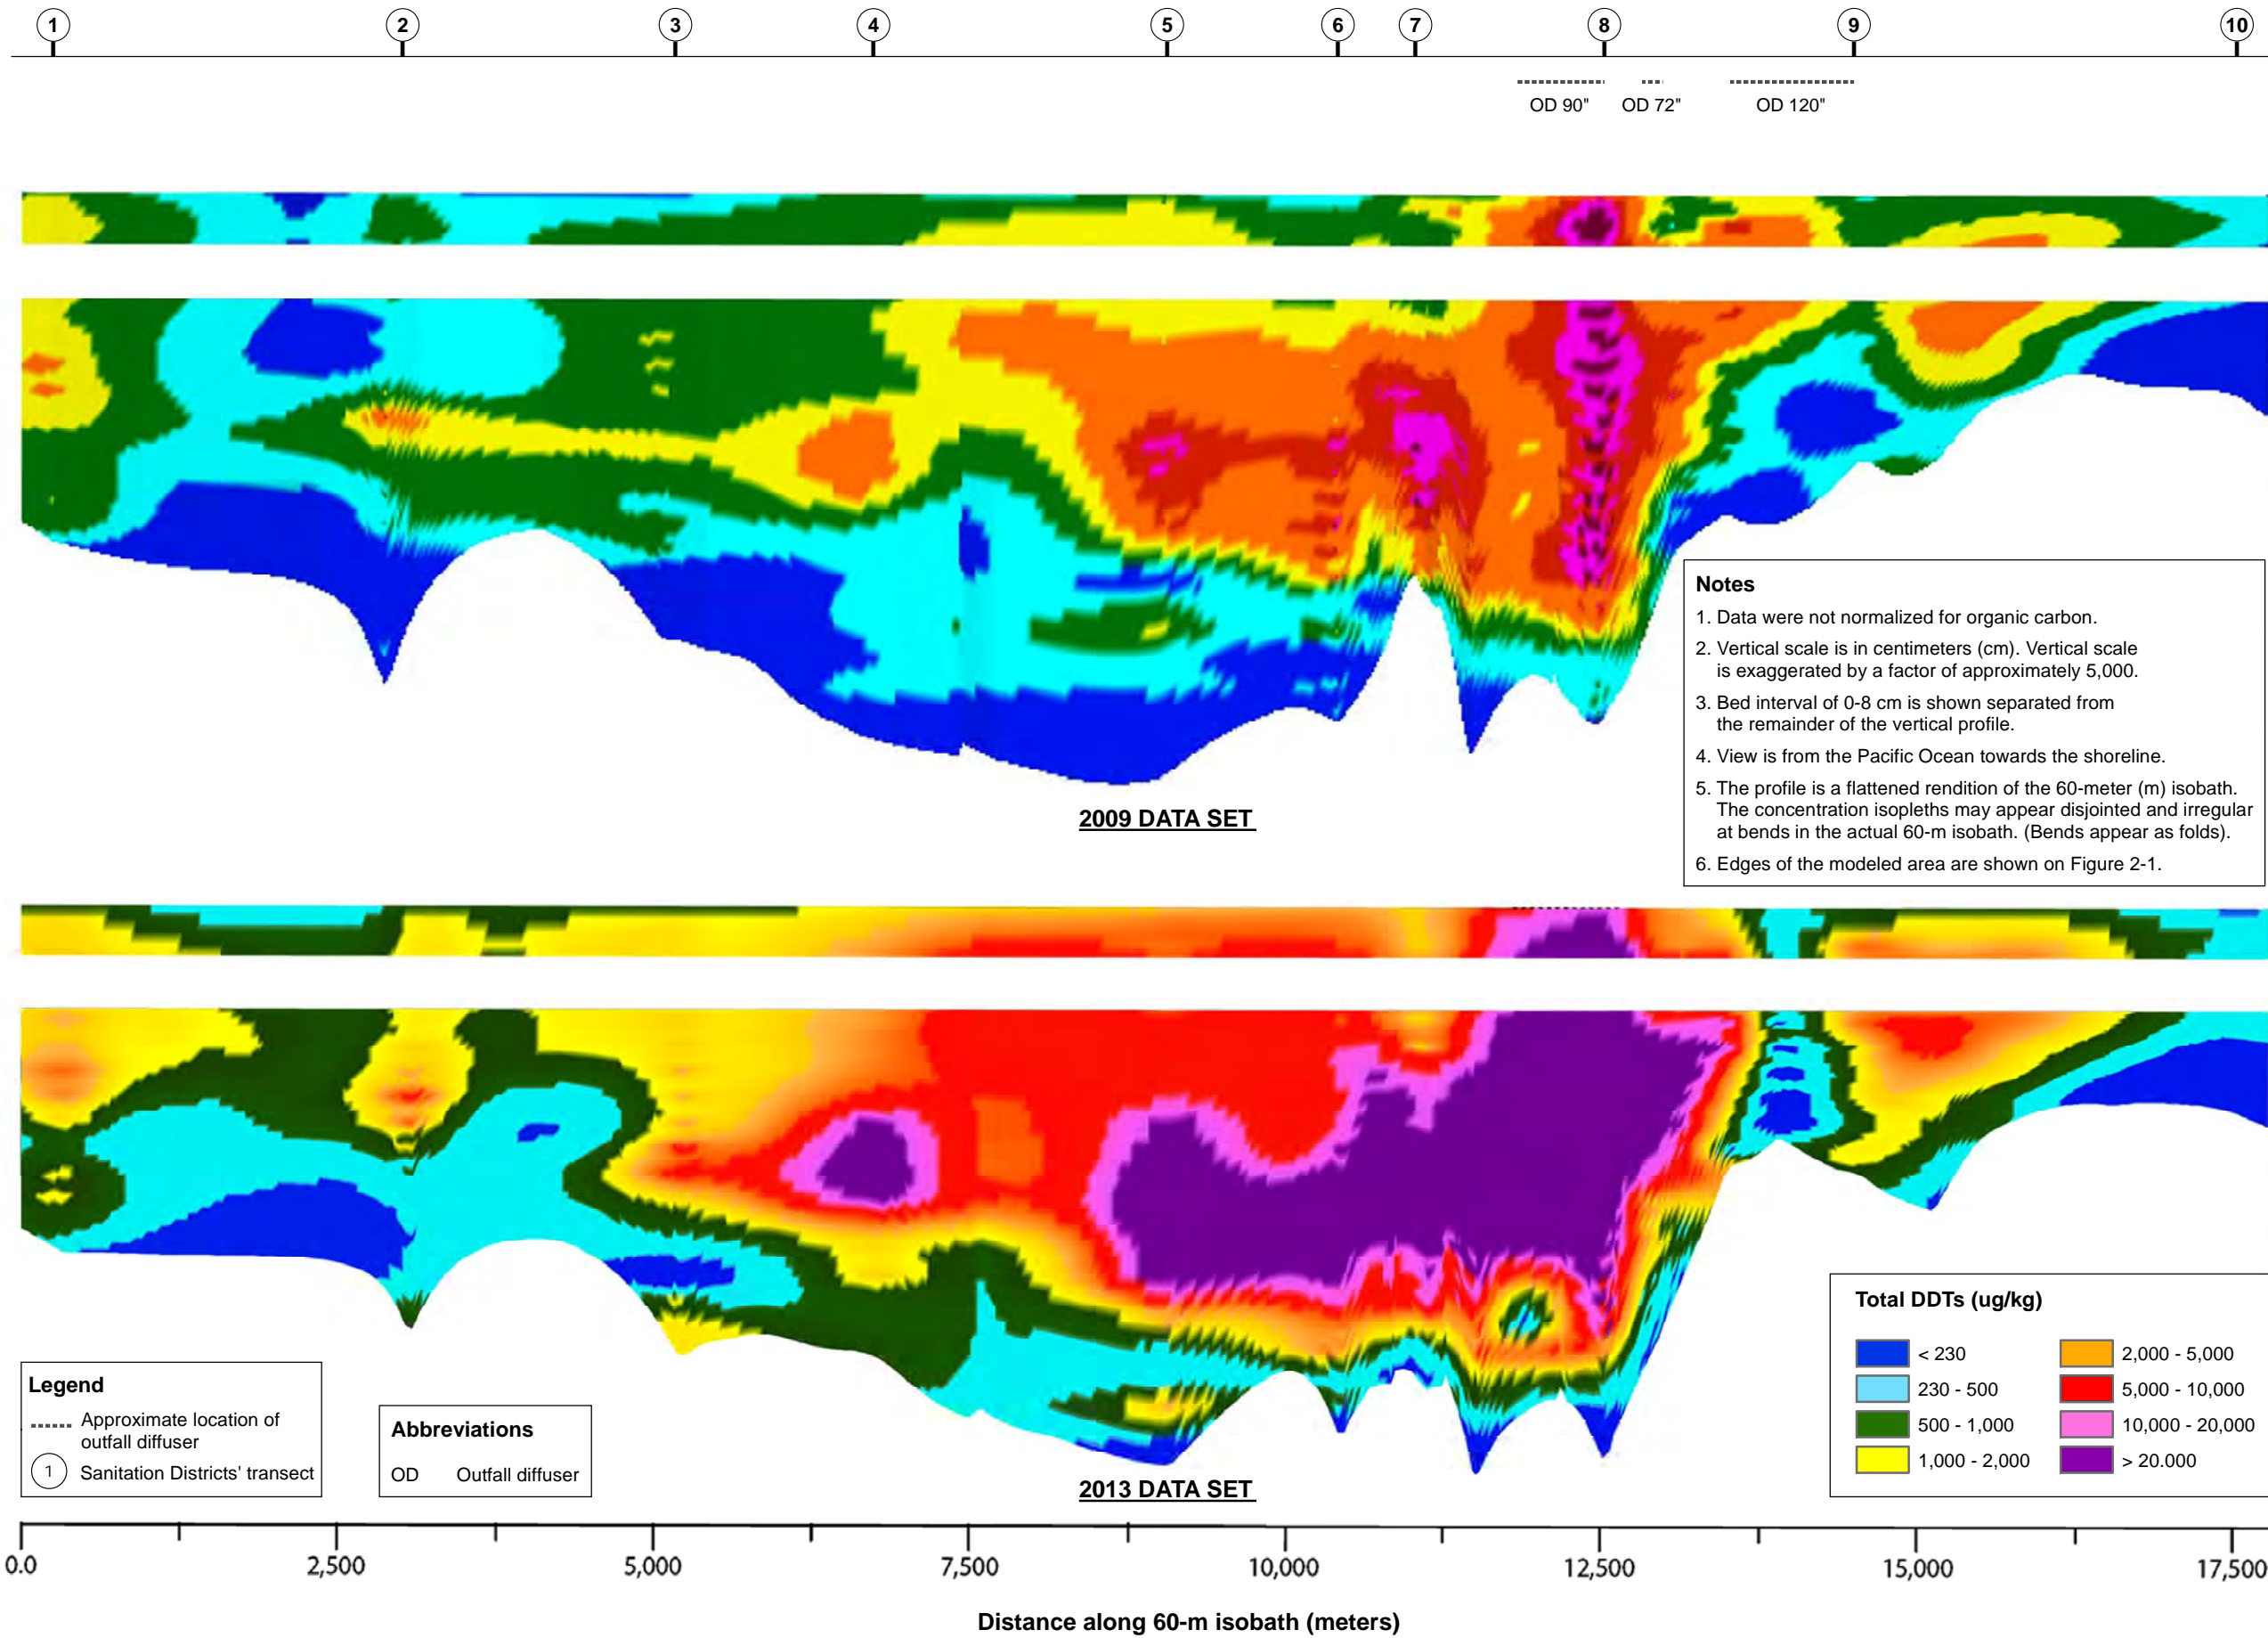
FIGURE 3-2
Vertical Profiles:
Total DDTs in Sediment
