**APPENDIX X**  
**VERTICAL PROFILES OF SEDIMENT BED – BD AND COCS**

## **APPENDIX X.1 – VERTICAL PROFILES – SHELF-WIDE CORES**

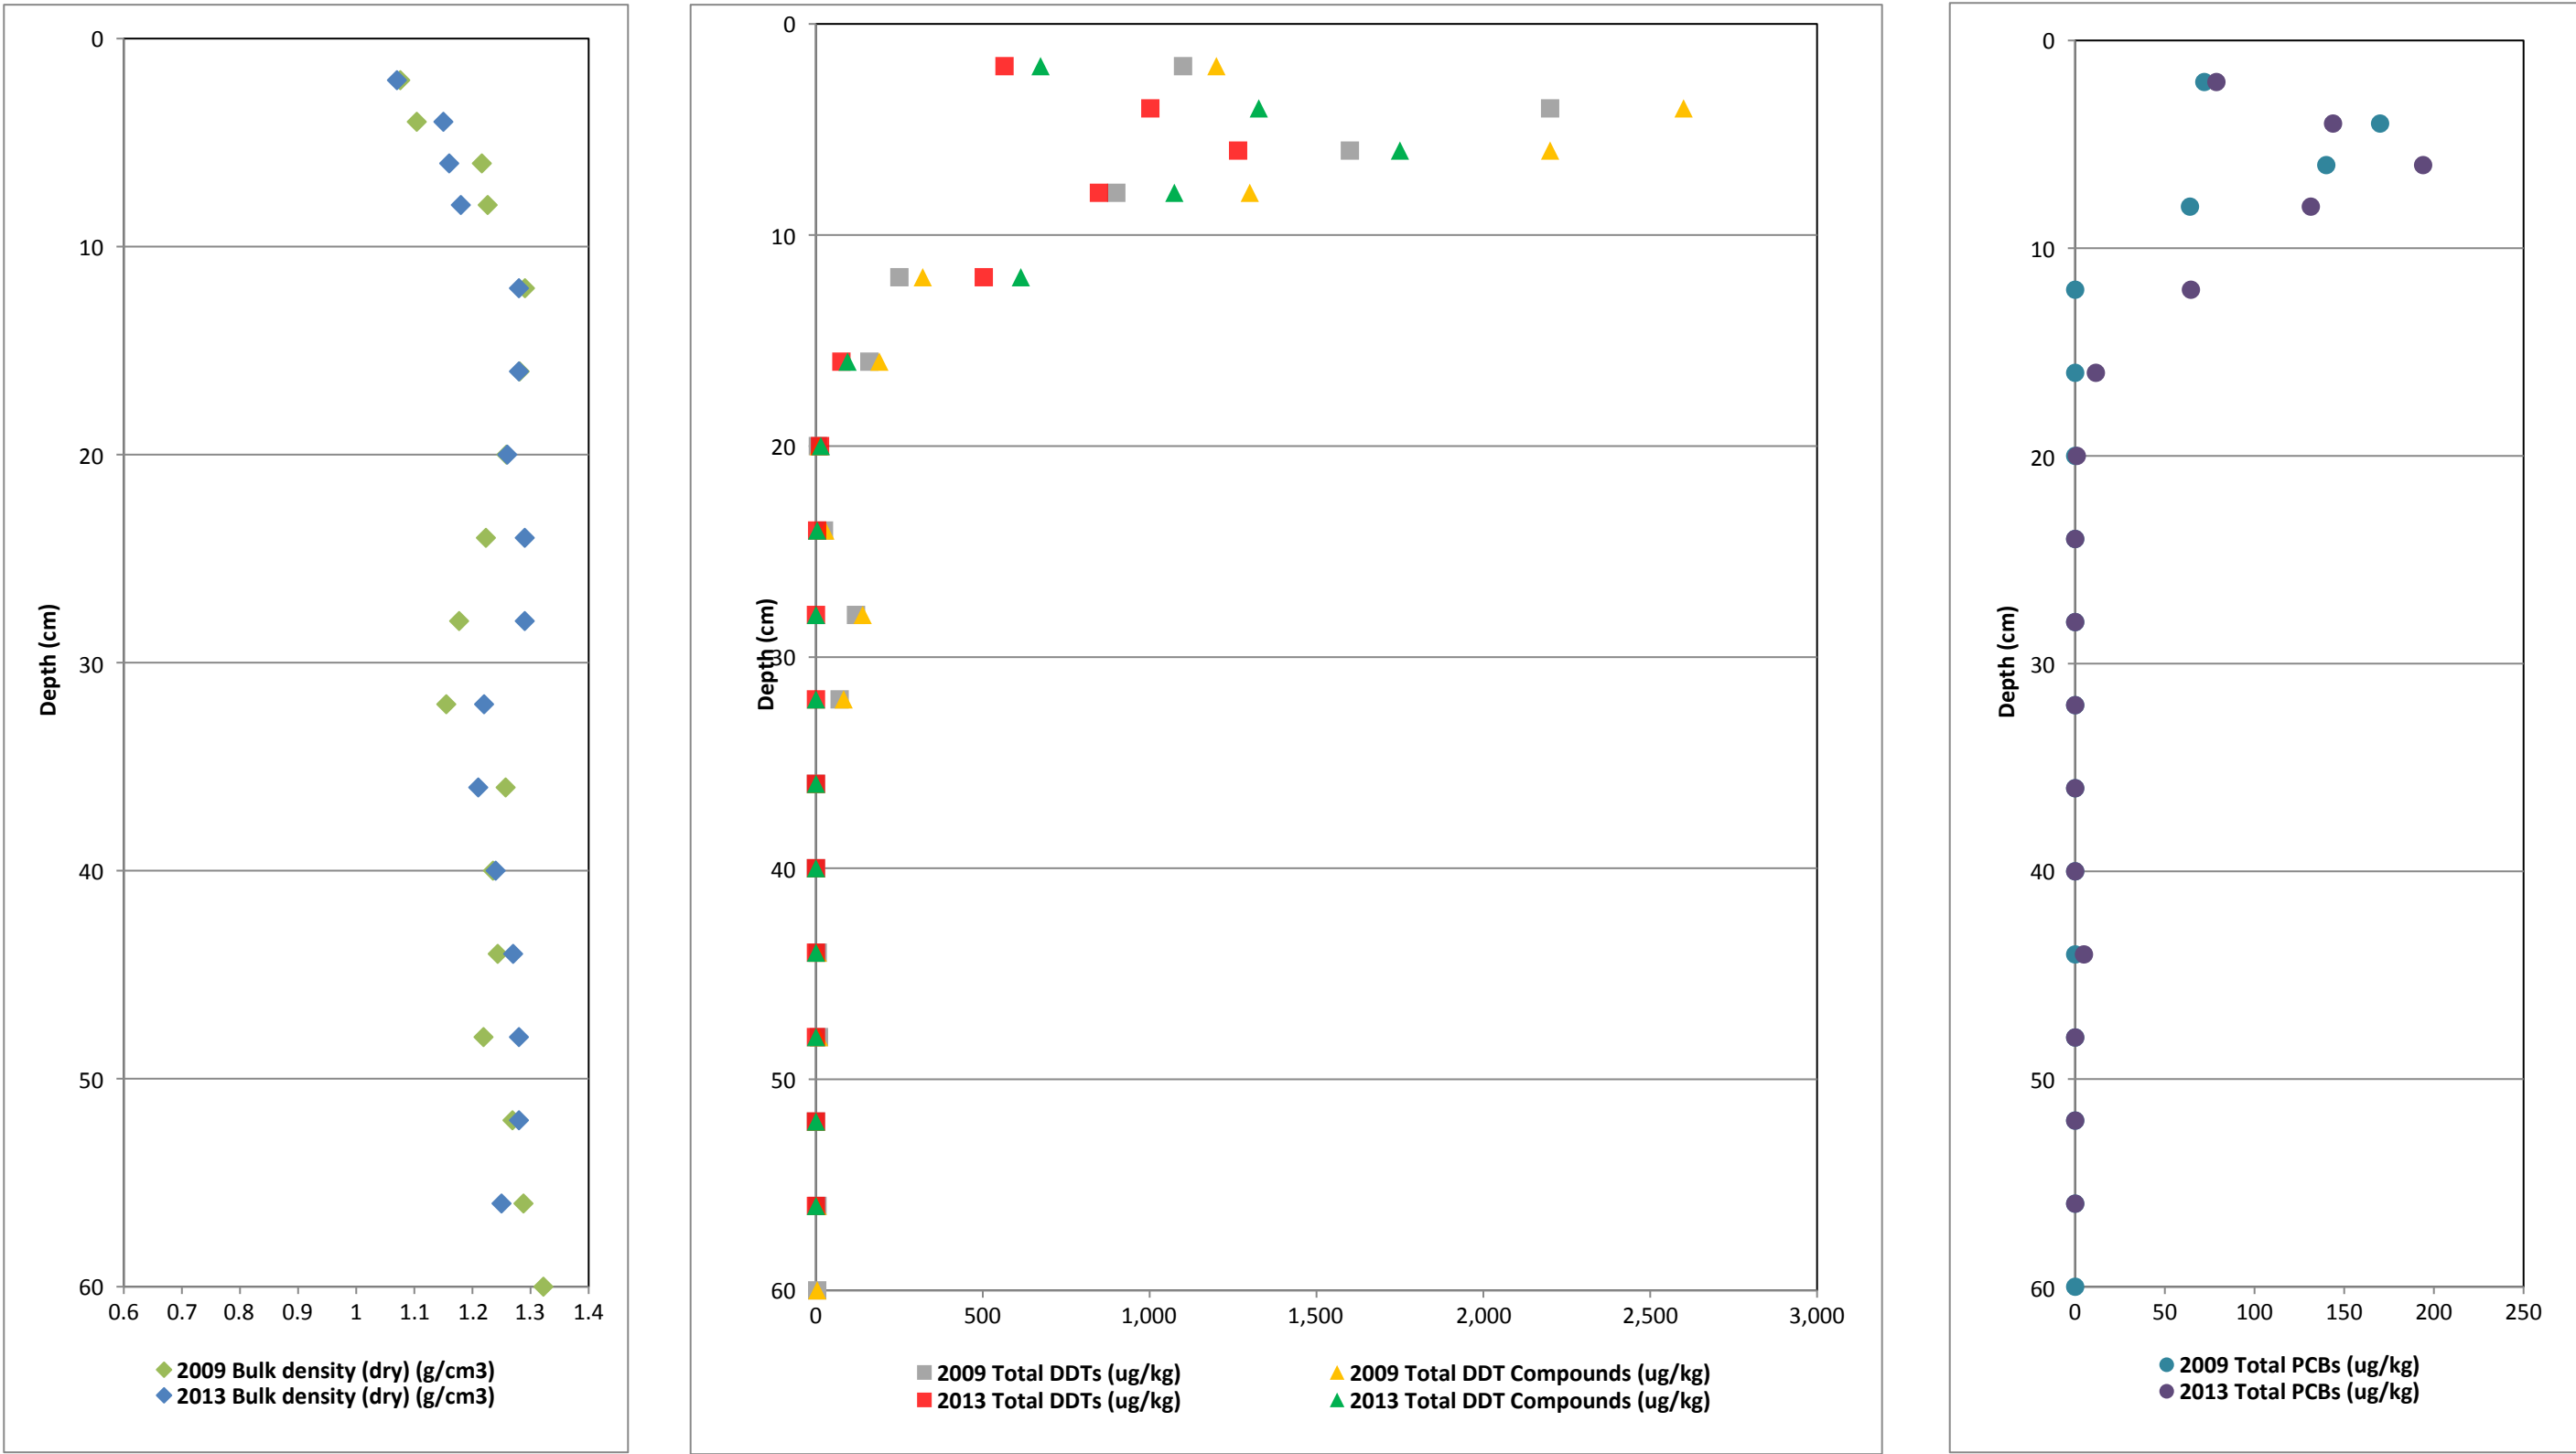
Figure 1. Vertical Profiles of Bulk Density, Total DDTs, and Total DDT Compounds for Core BA1B  
First MNR Report  
Palos Verdes Shelf (OU 5 of the Montrose Chemical Corp. Superfund Site)  
Los Angeles County, California

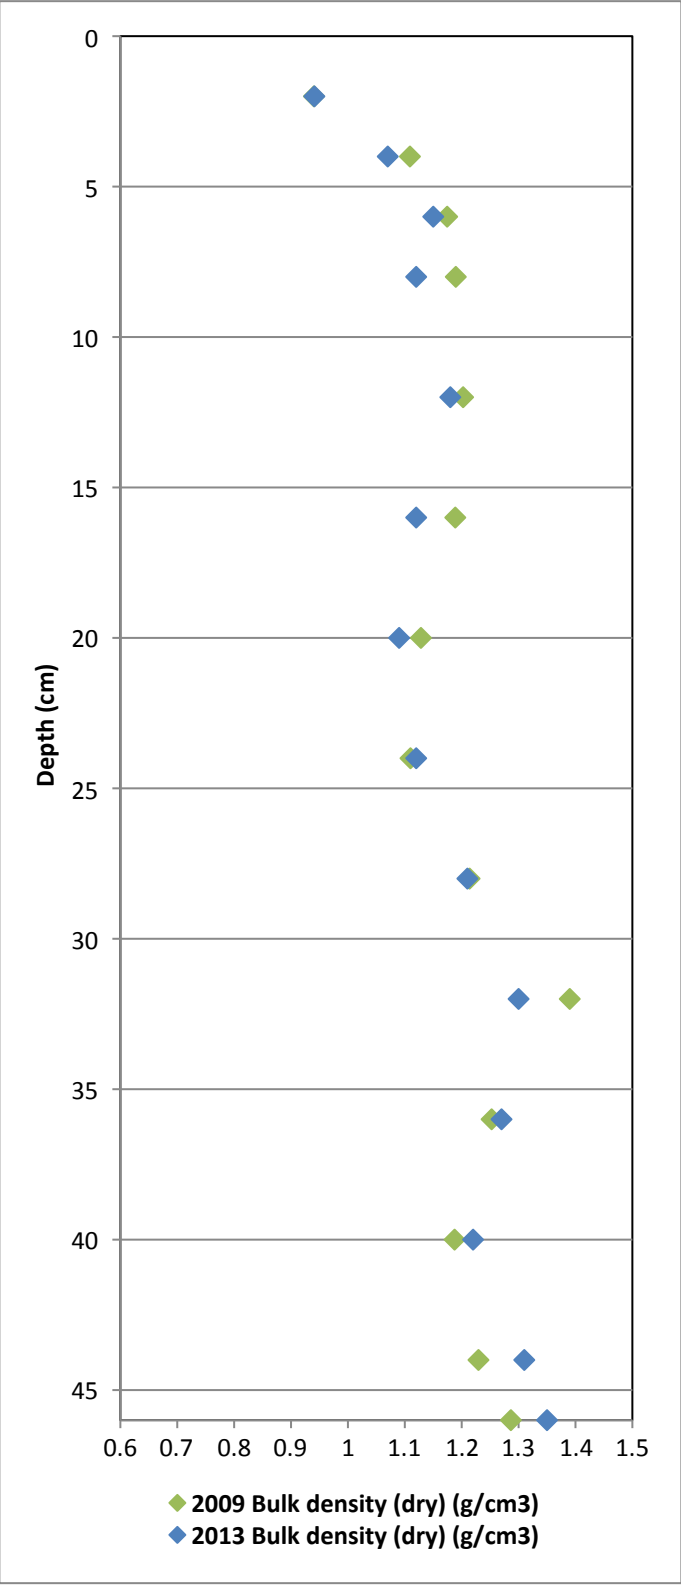
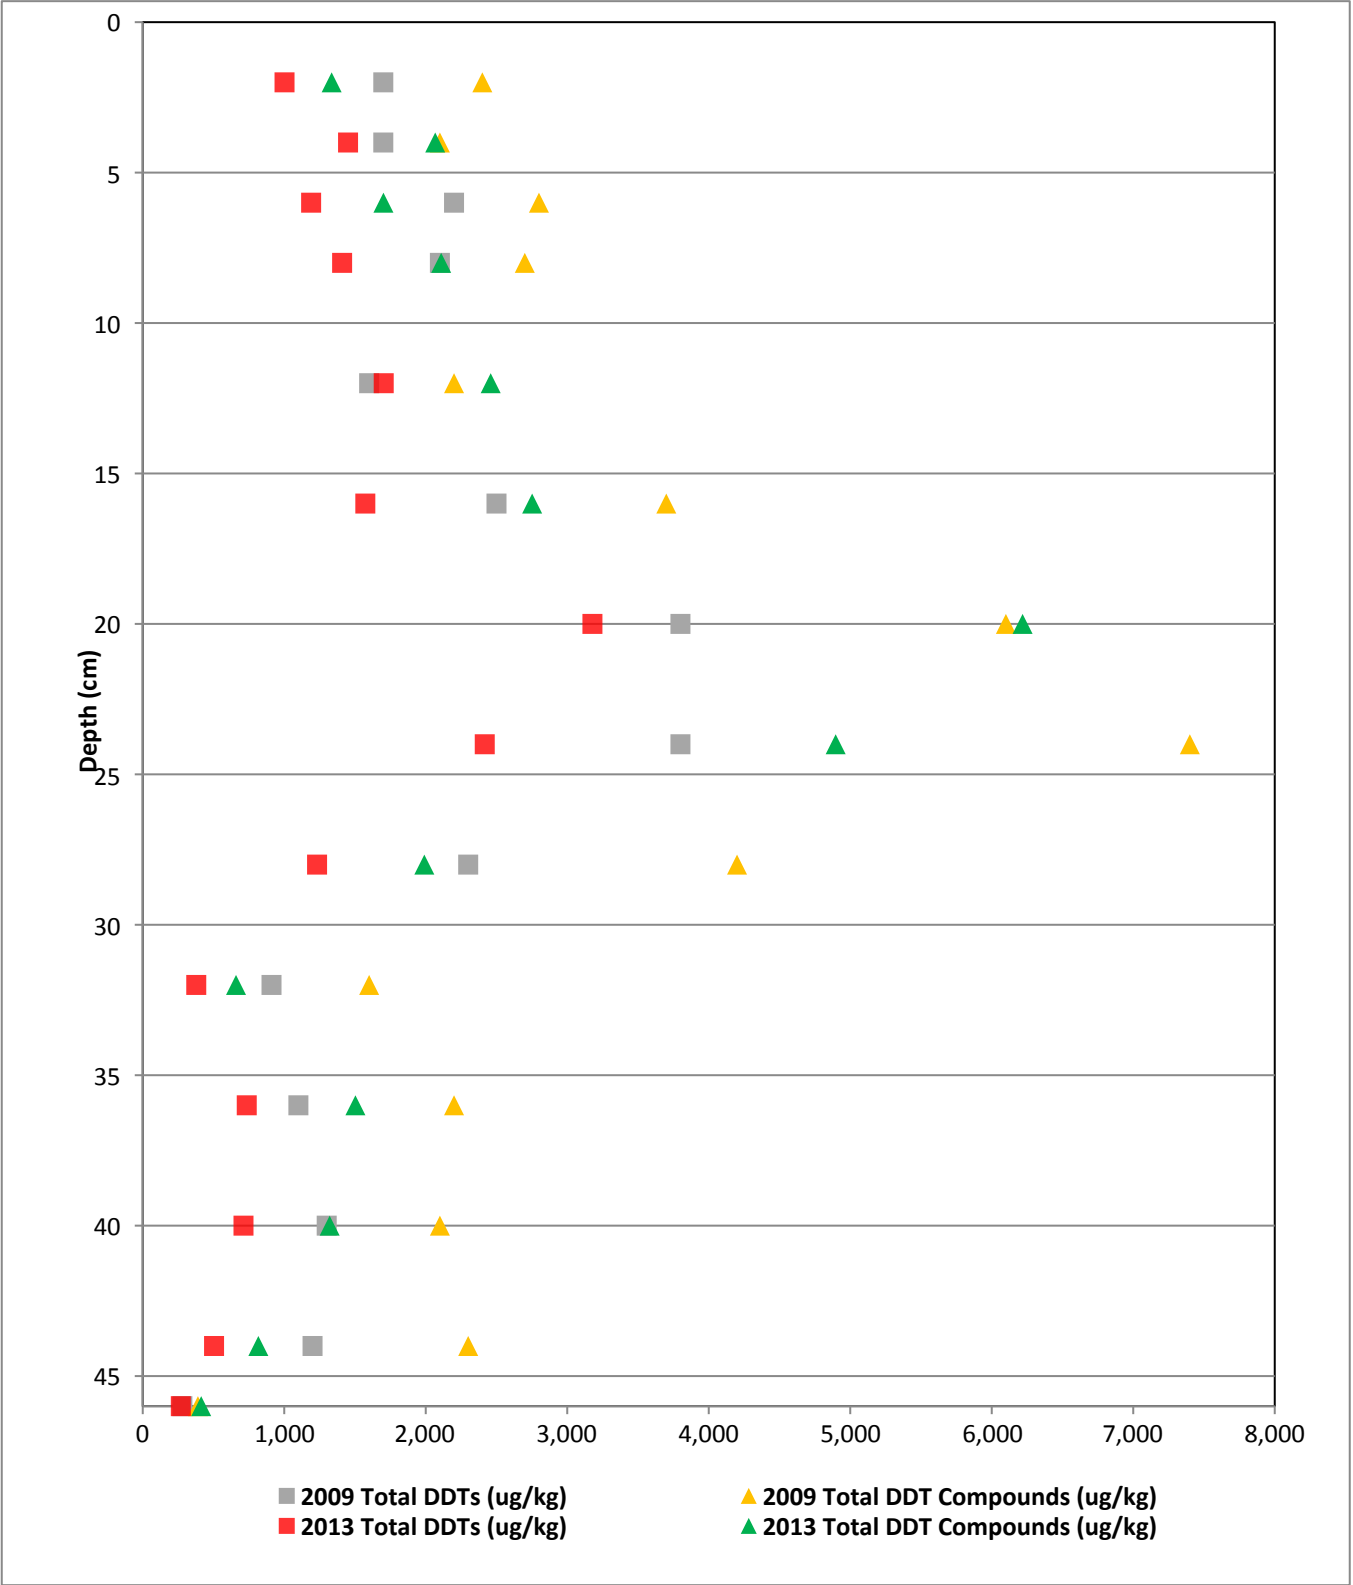
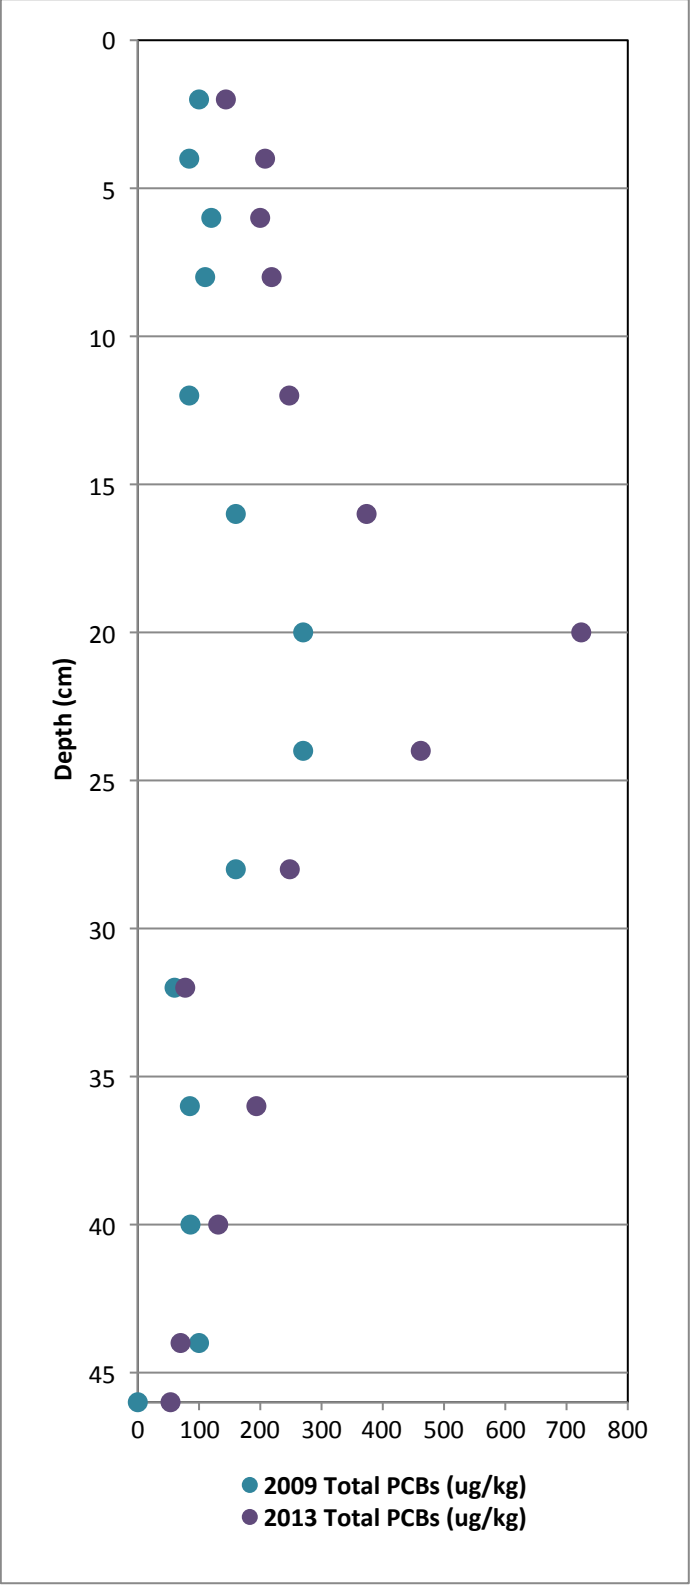
Figure 2. Vertical Profiles of Bulk Density and COCs for Core BA1C  
First MNR Report  
Palos Verdes Shelf (OU 5 of the Montrose Chemical Corp. Superfund Site)  
Los Angeles County, California

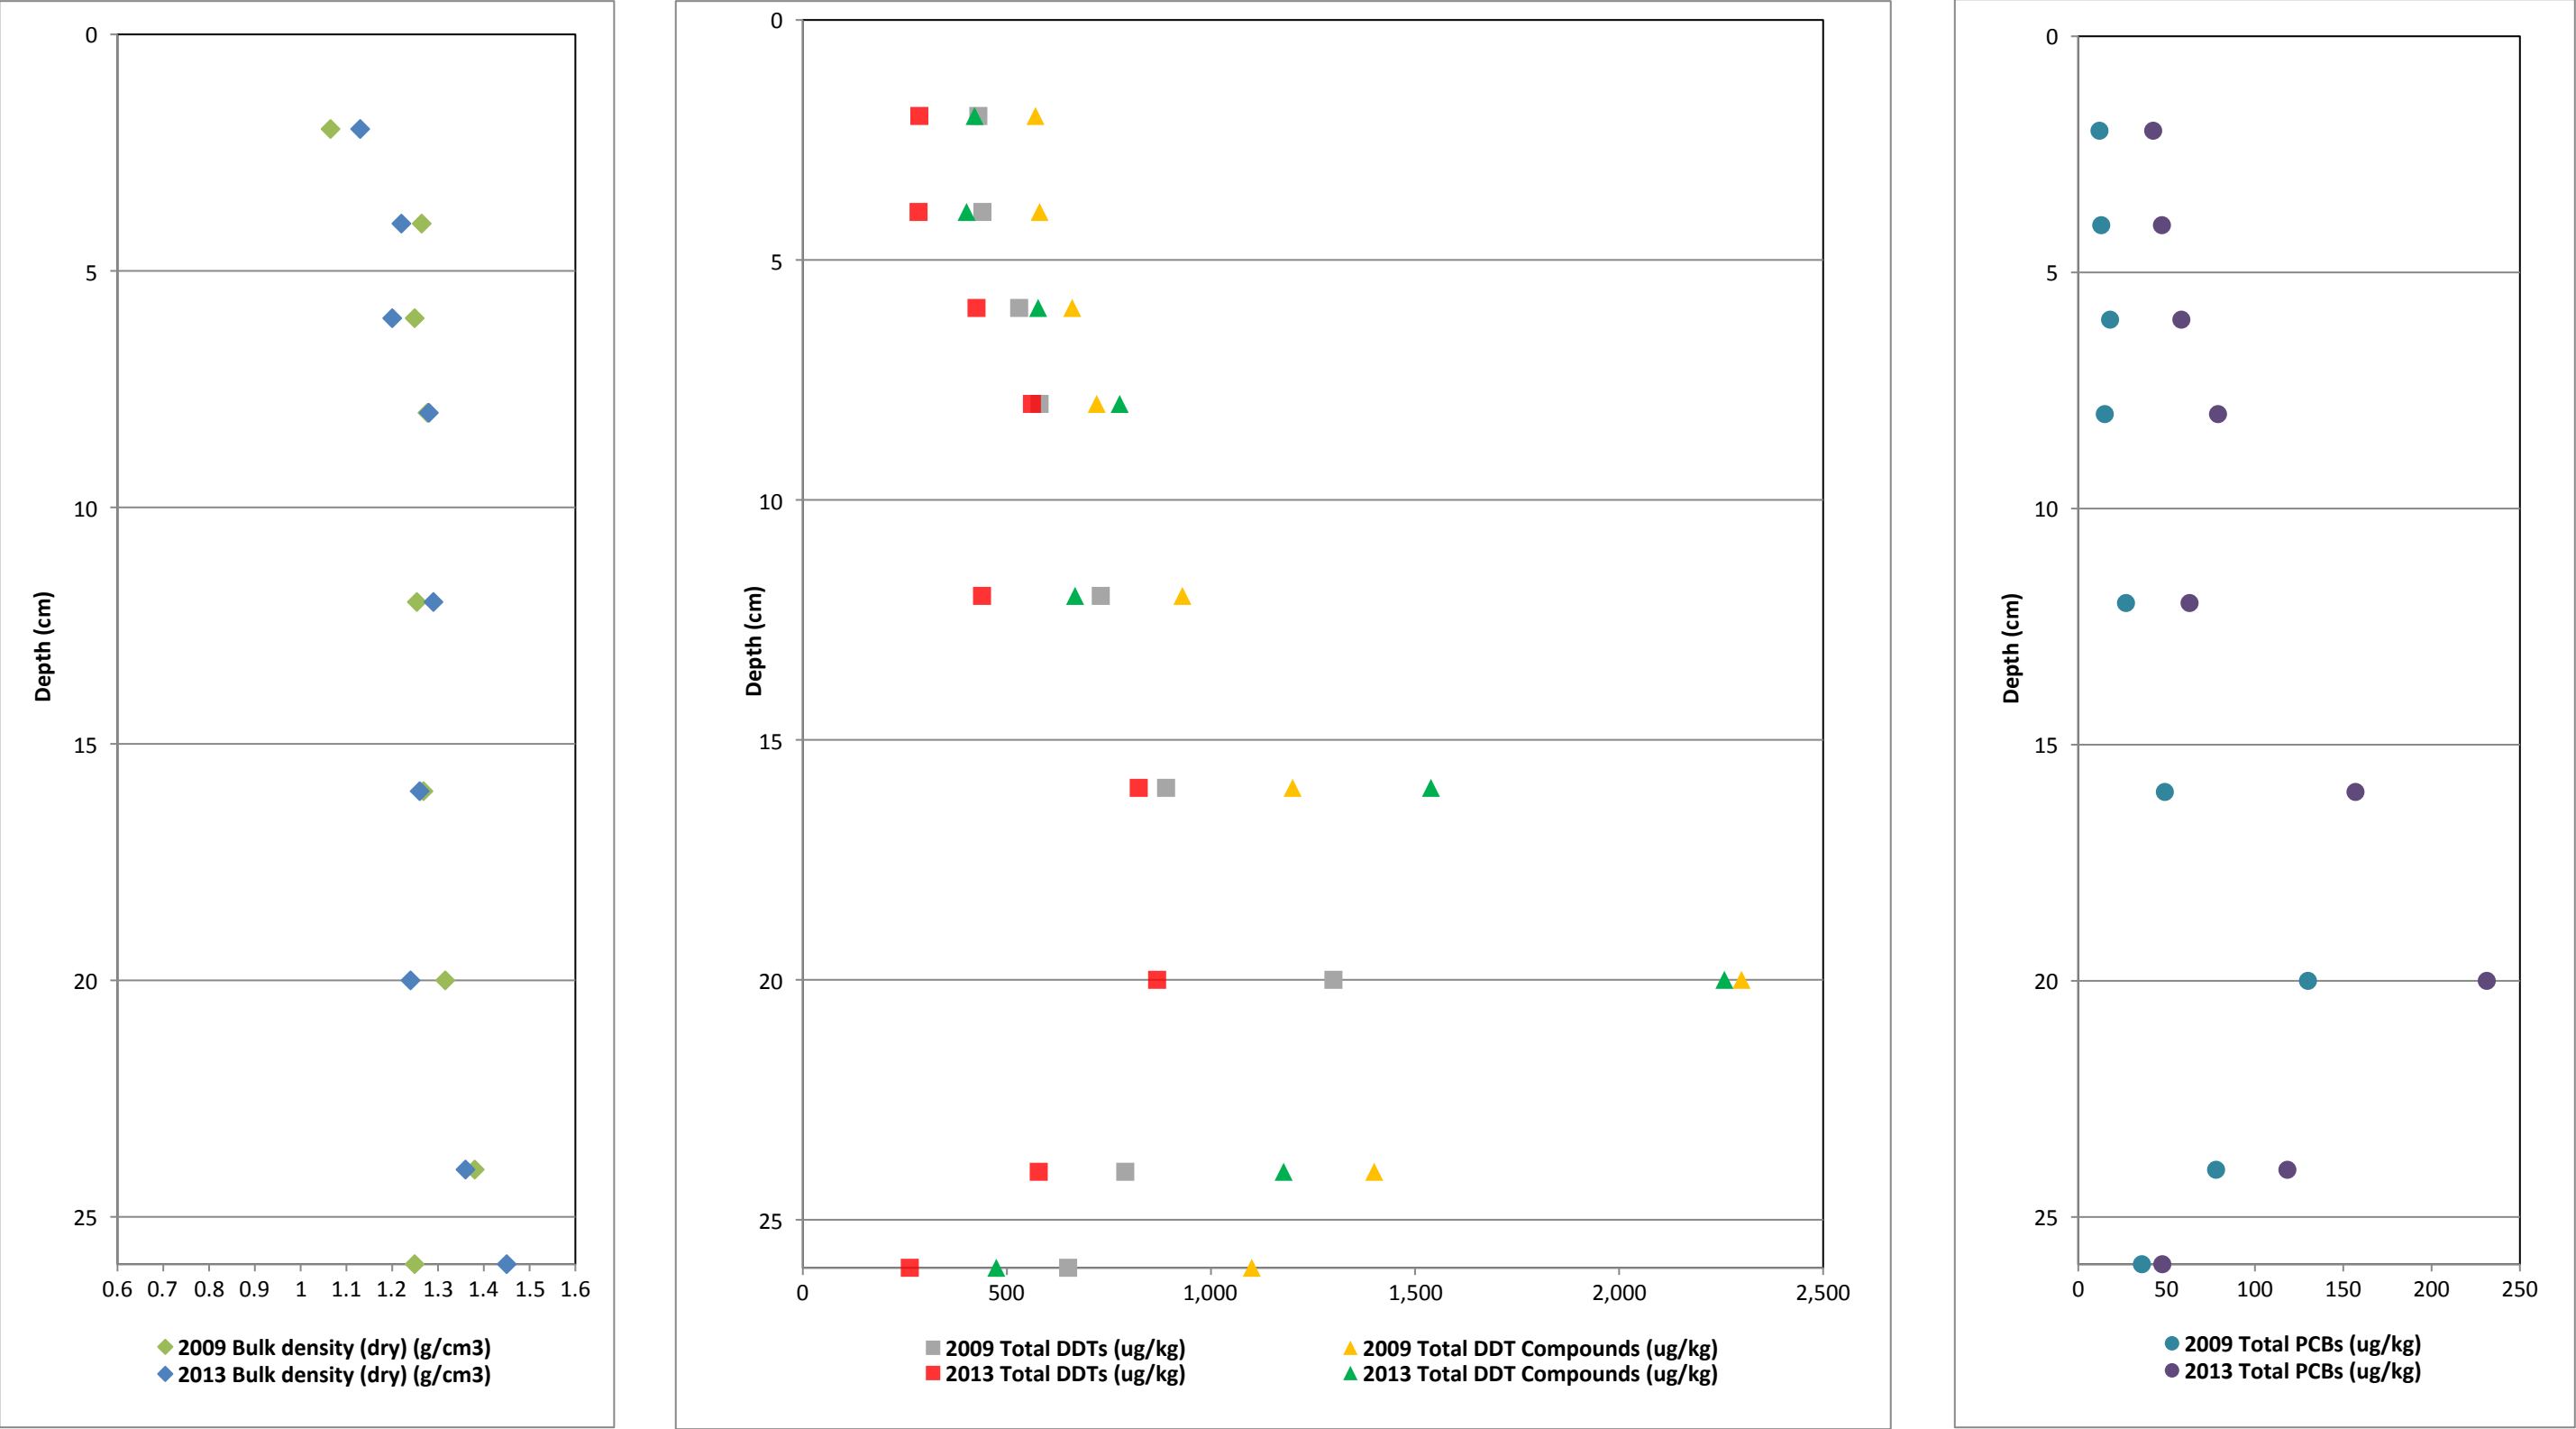
Figure 3. Vertical Profiles of Bulk Density and COCs for Core BA1DC  
First MNR Report  
Palos Verdes Shelf (OU 5 of the Montrose Chemical Corp. Superfund Site)  
Los Angeles County, California

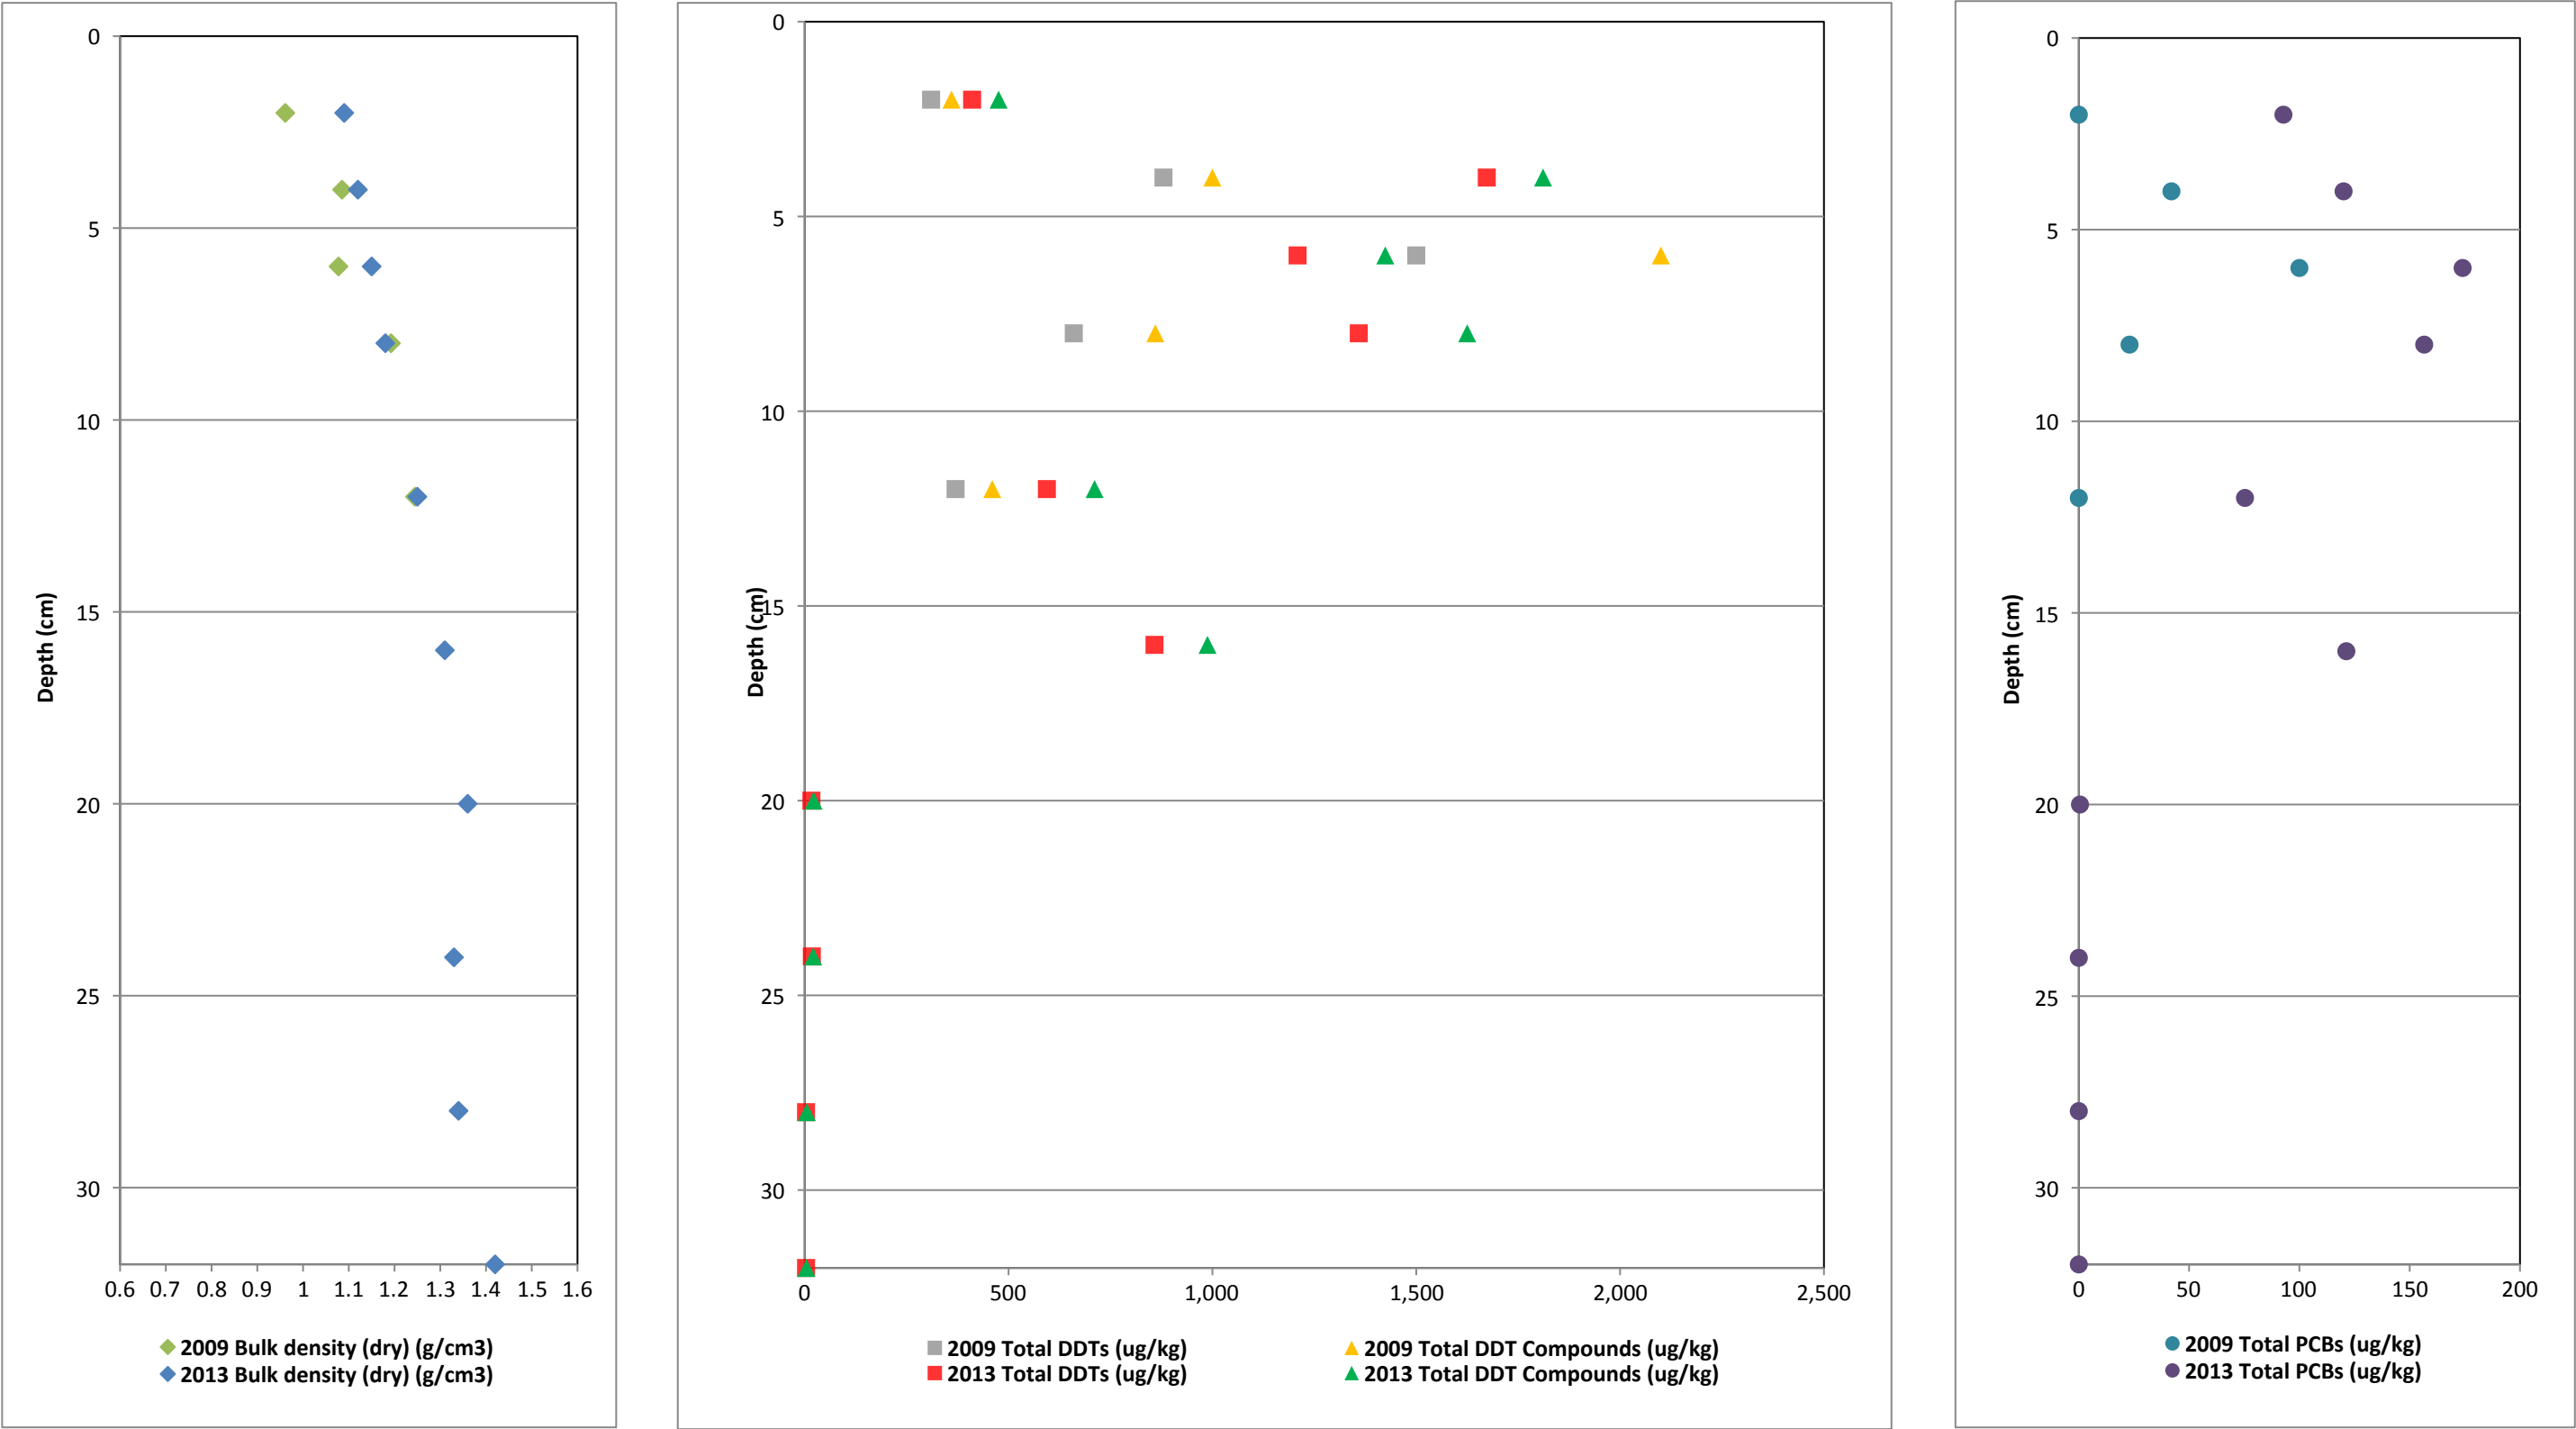
Figure 4. Vertical Profiles of Bulk Density and COCs for Core BA2B  
First MNR Report  
Palos Verdes Shelf (OU 5 of the Montrose Chemical Corp. Superfund Site)  
Los Angeles County, California

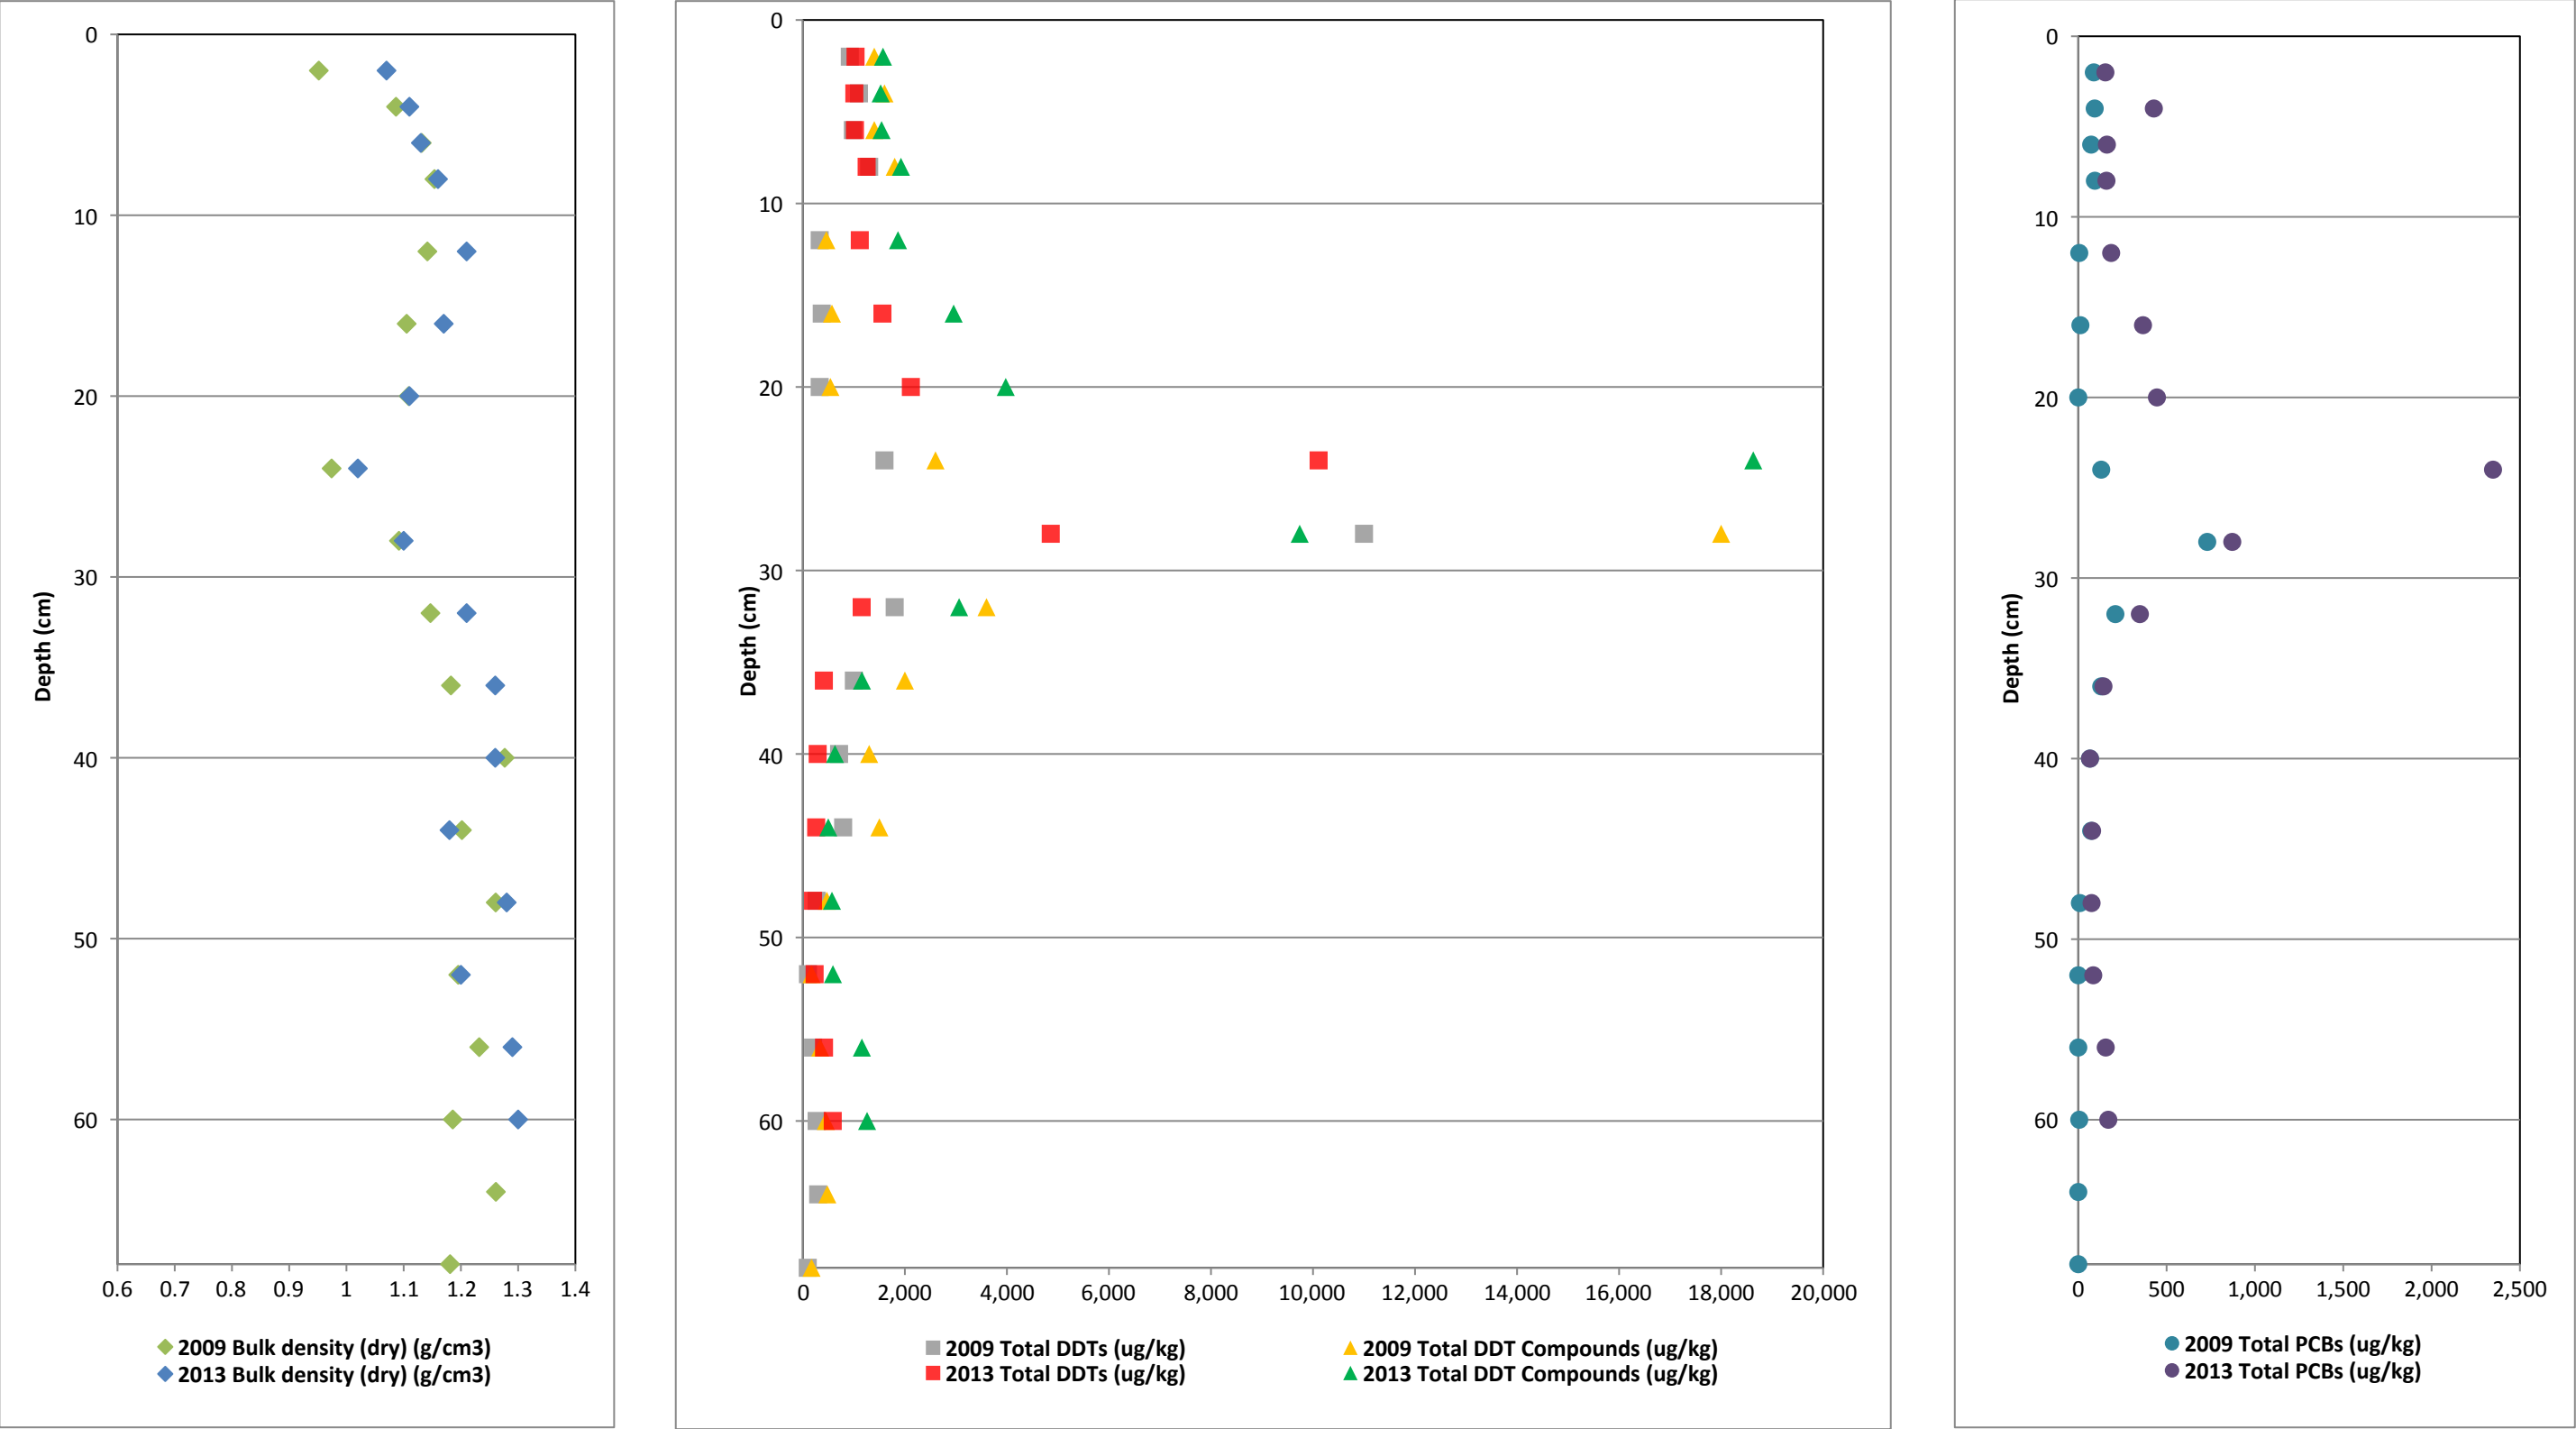
Figure 5. Vertical Profiles of Bulk Density and COCs for Core BA2C  
First MNR Report  
Palos Verdes Shelf (OU 5 of the Montrose Chemical Corp. Superfund Site)  
Los Angeles County, California
