**APPENDIX X**  
**VERTICAL PROFILES OF SEDIMENT BED – BD AND COCS**

## **APPENDIX X.1 – VERTICAL PROFILES – SHELF-WIDE CORES**

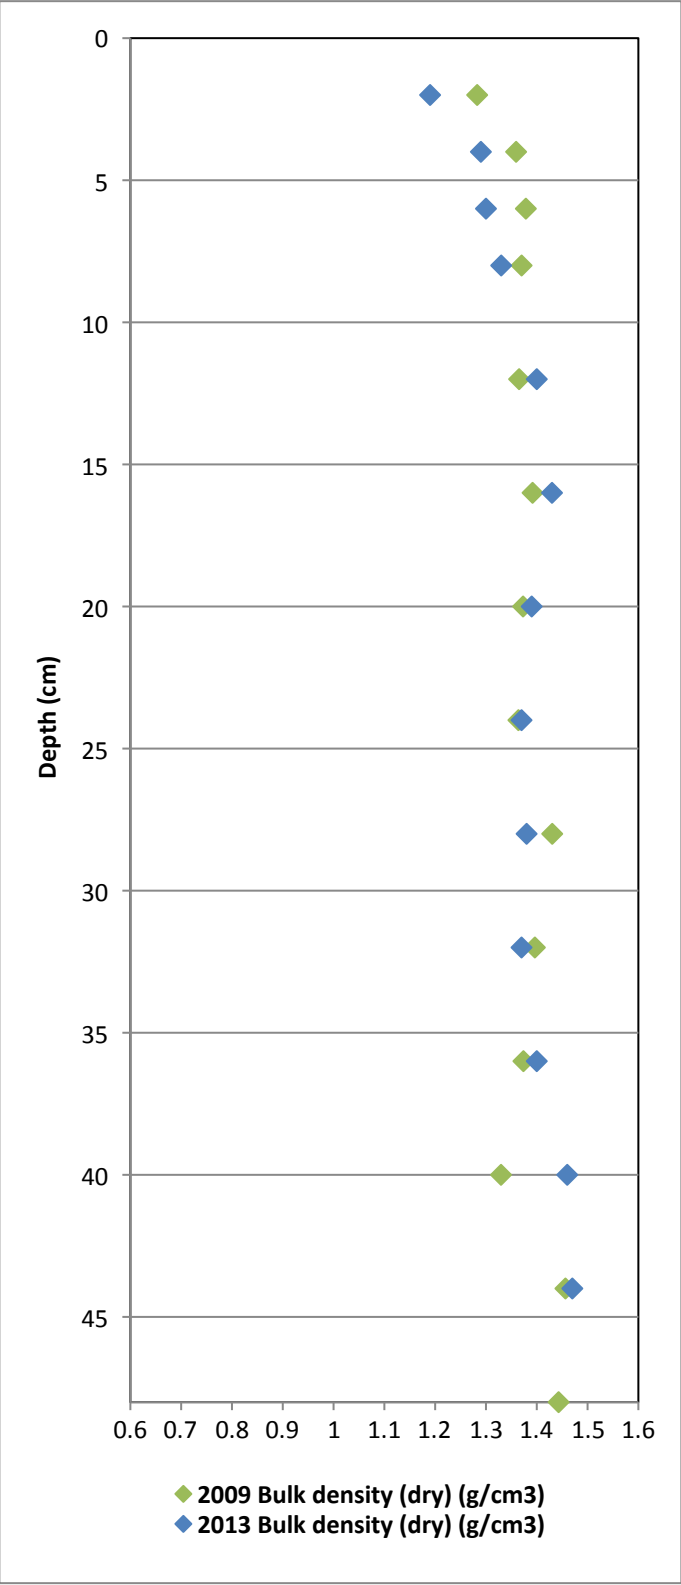
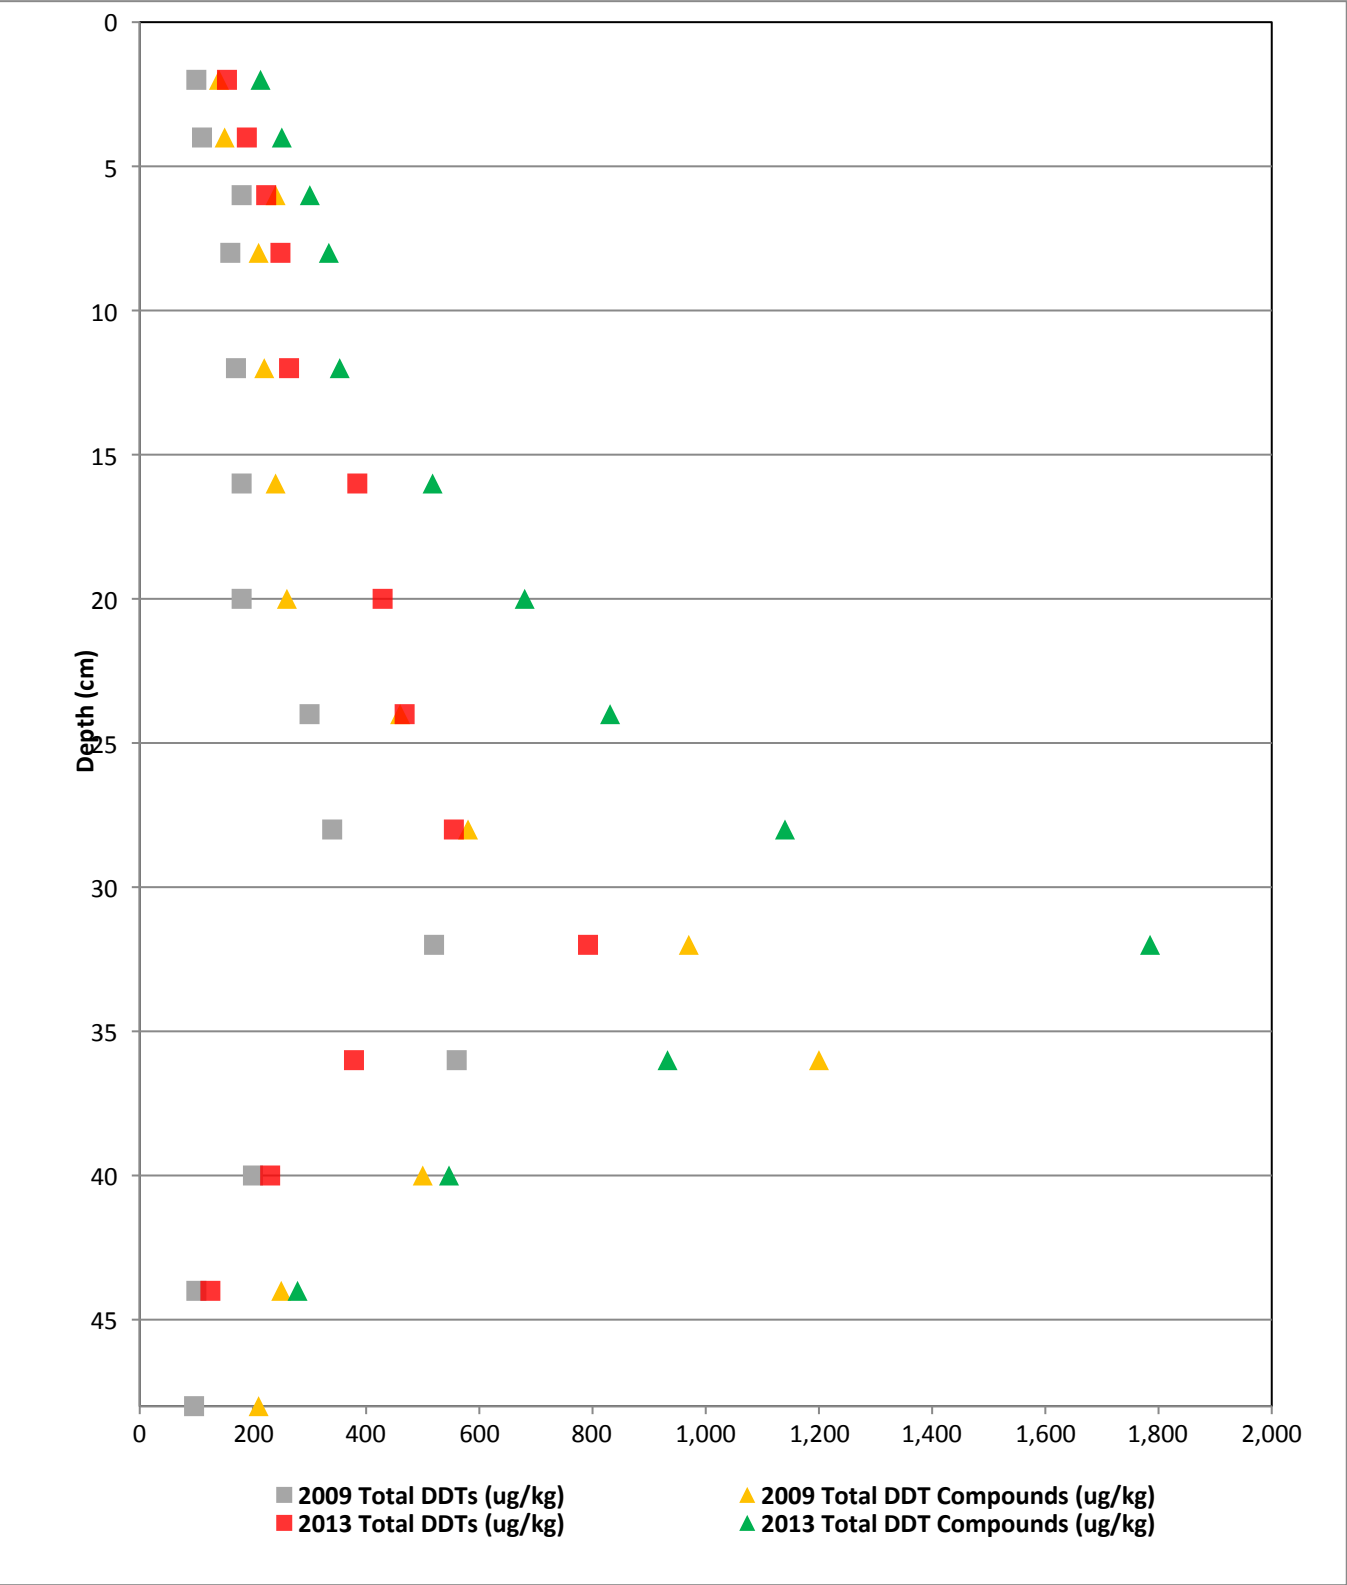
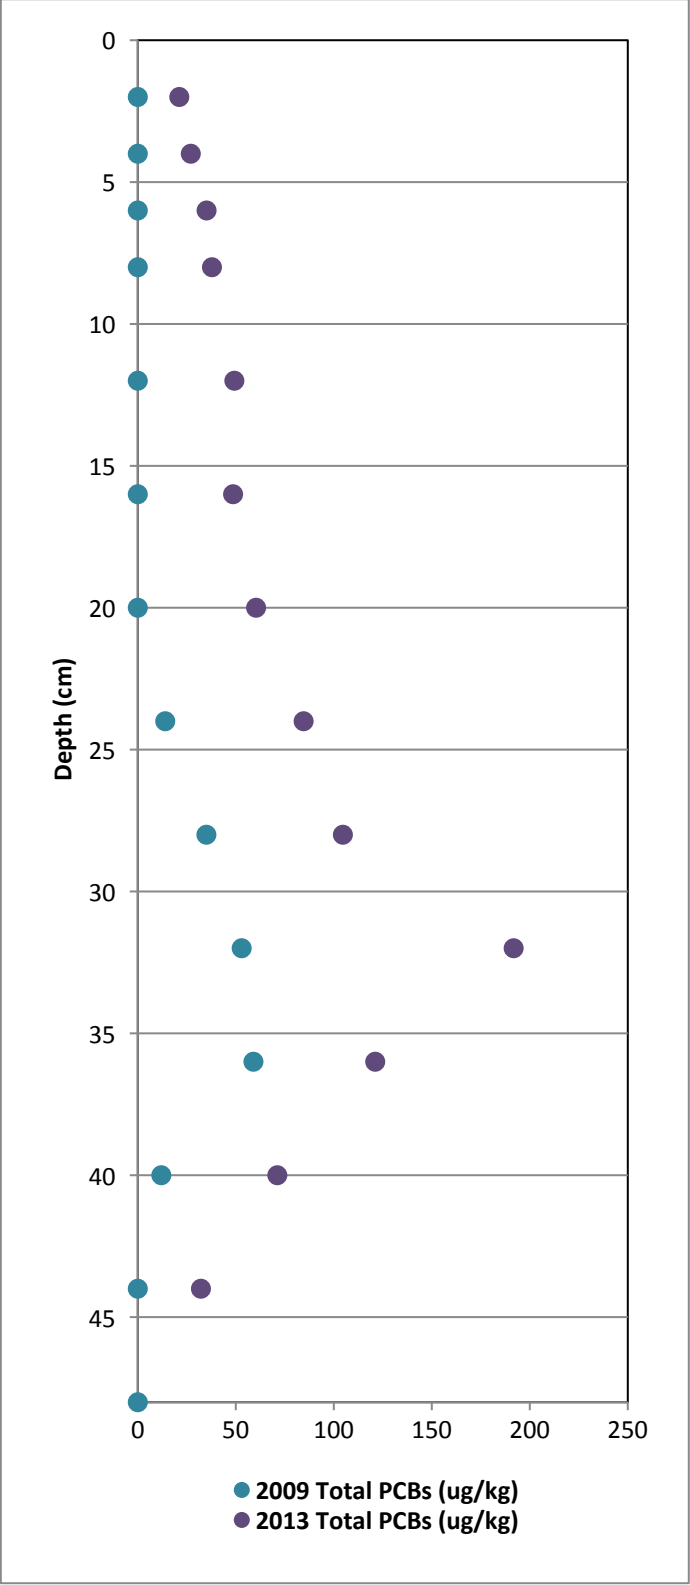
Figure 6. Vertical Profiles of Bulk Density and COCs for Core BA2DC  
First MNR Report  
Palos Verdes Shelf (OU 5 of the Montrose Chemical Corp. Superfund Site)  
Los Angeles County, California

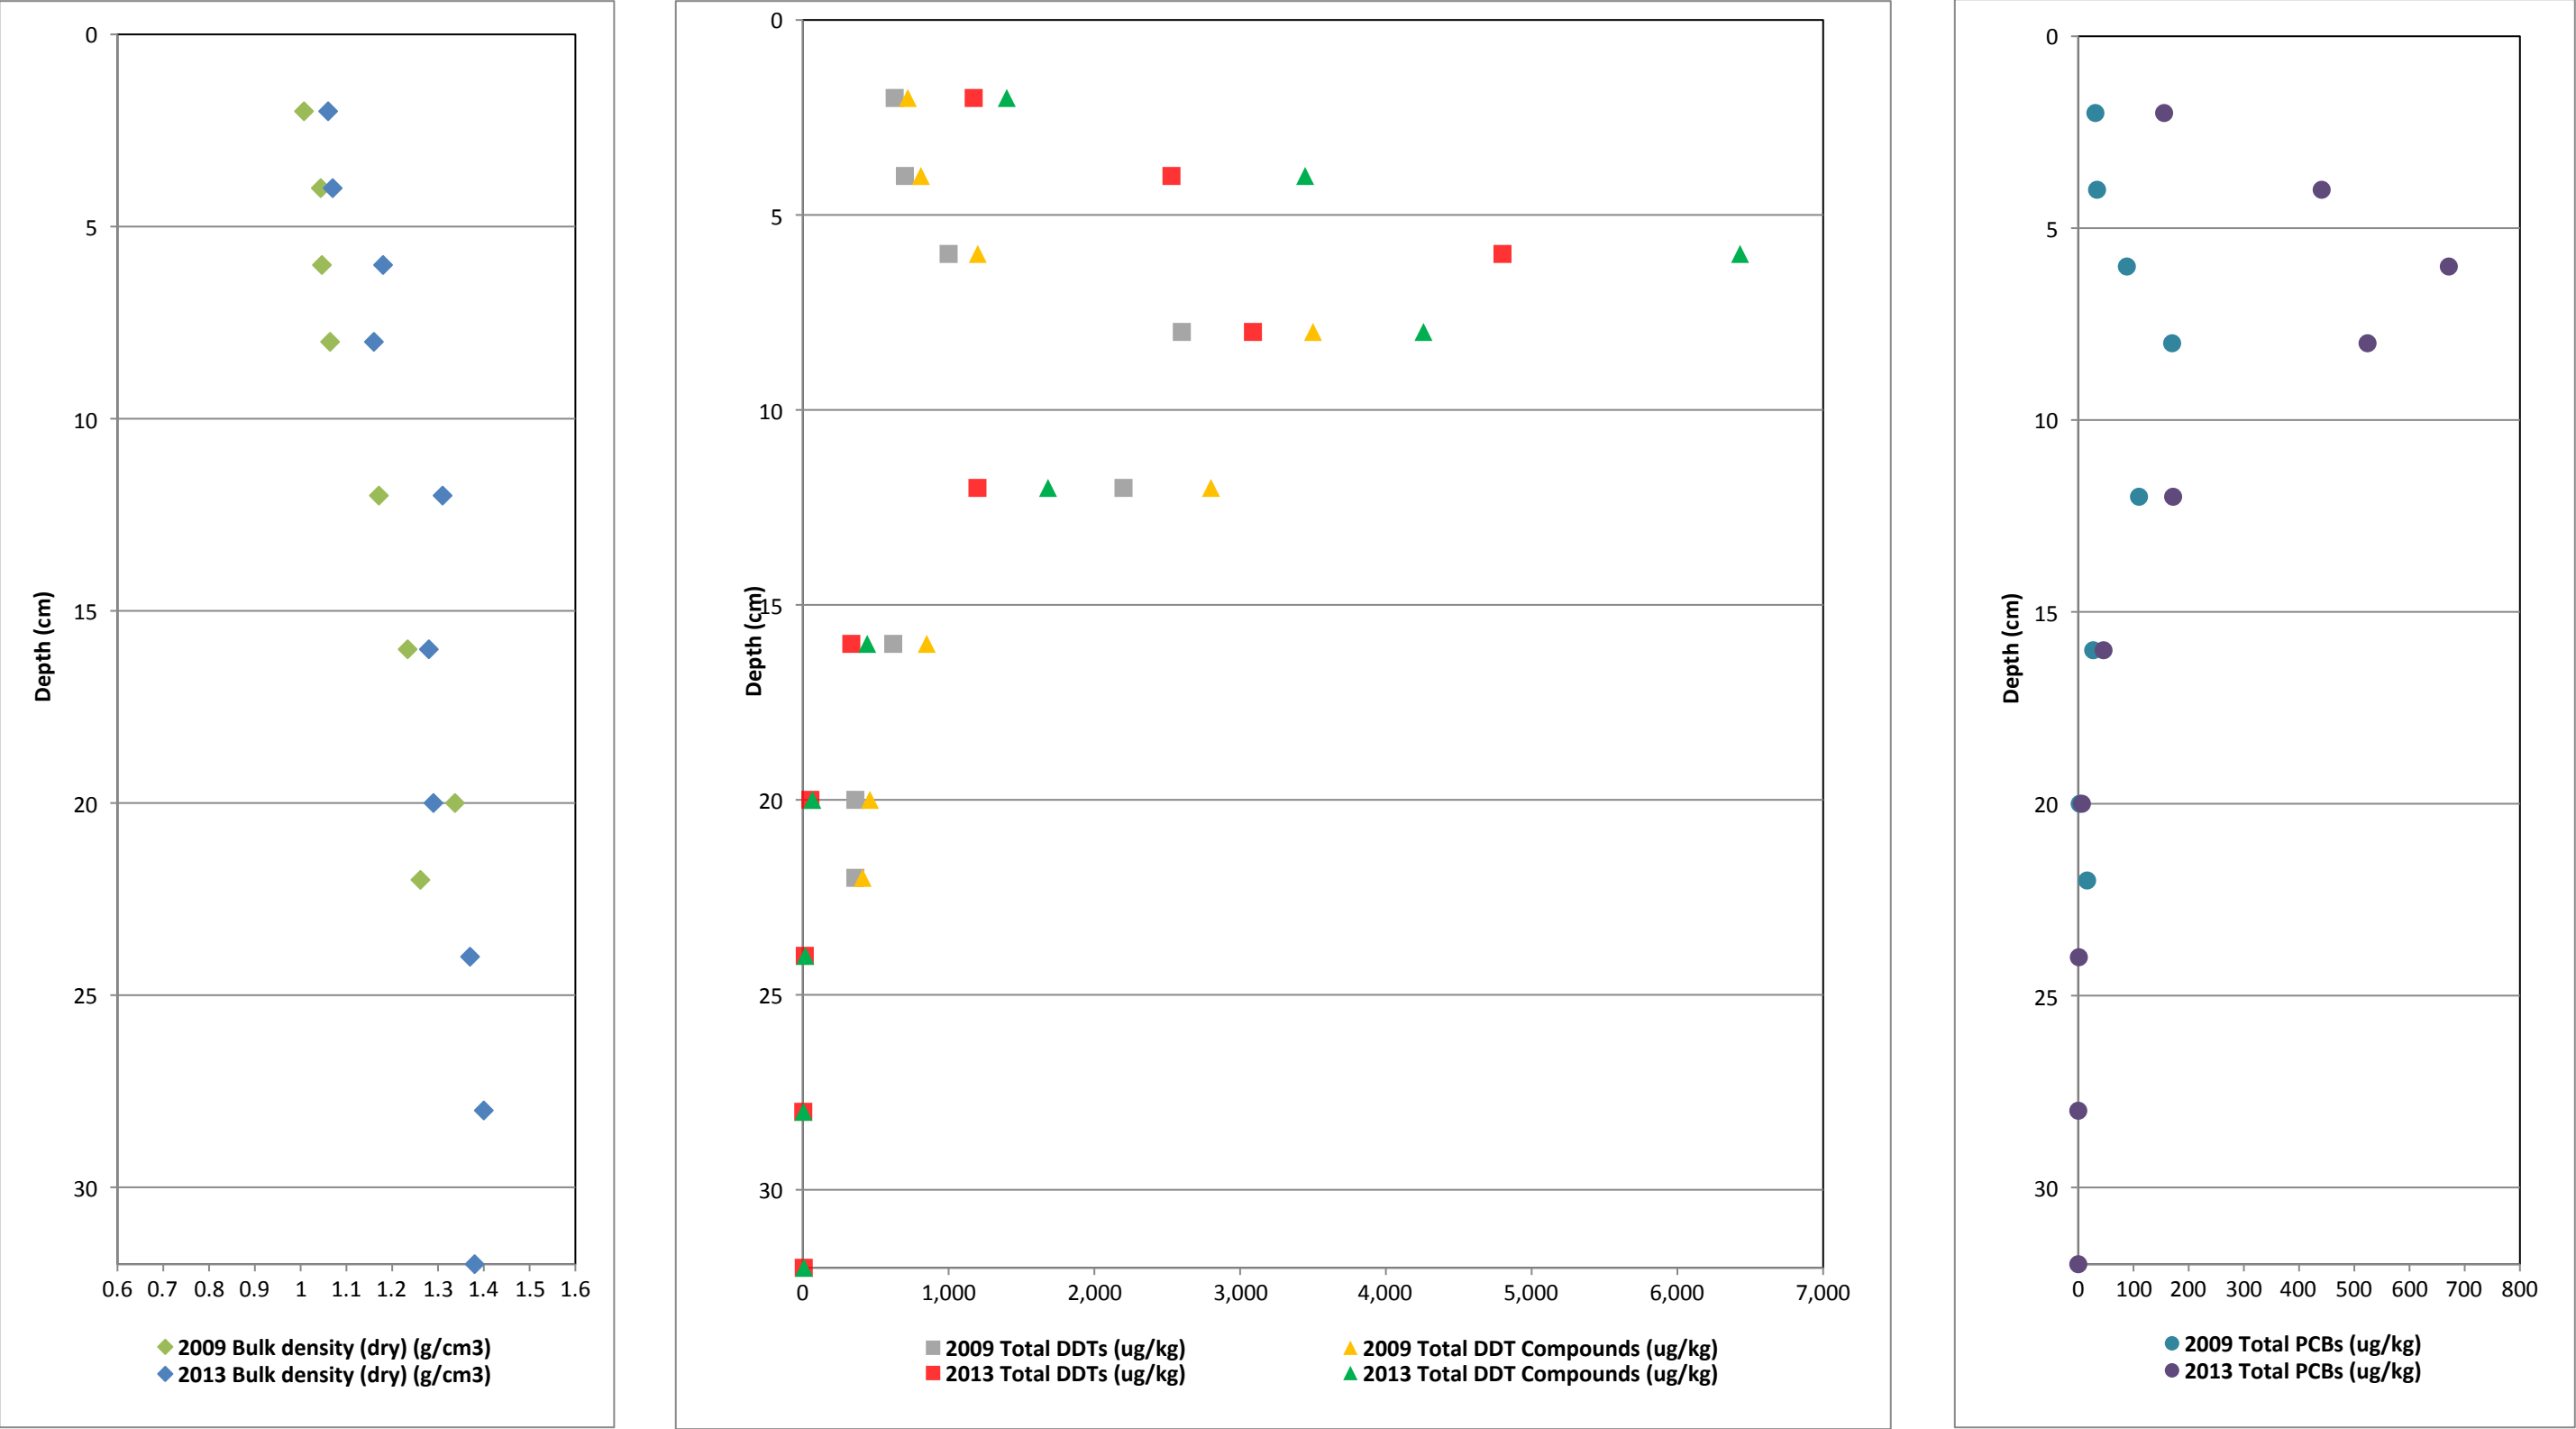
Figure 7. Vertical Profiles of Bulk Density and COCs for Core BA3B  
First MNR Report  
Palos Verdes Shelf (OU 5 of the Montrose Chemical Corp. Superfund Site)  
Los Angeles County, California

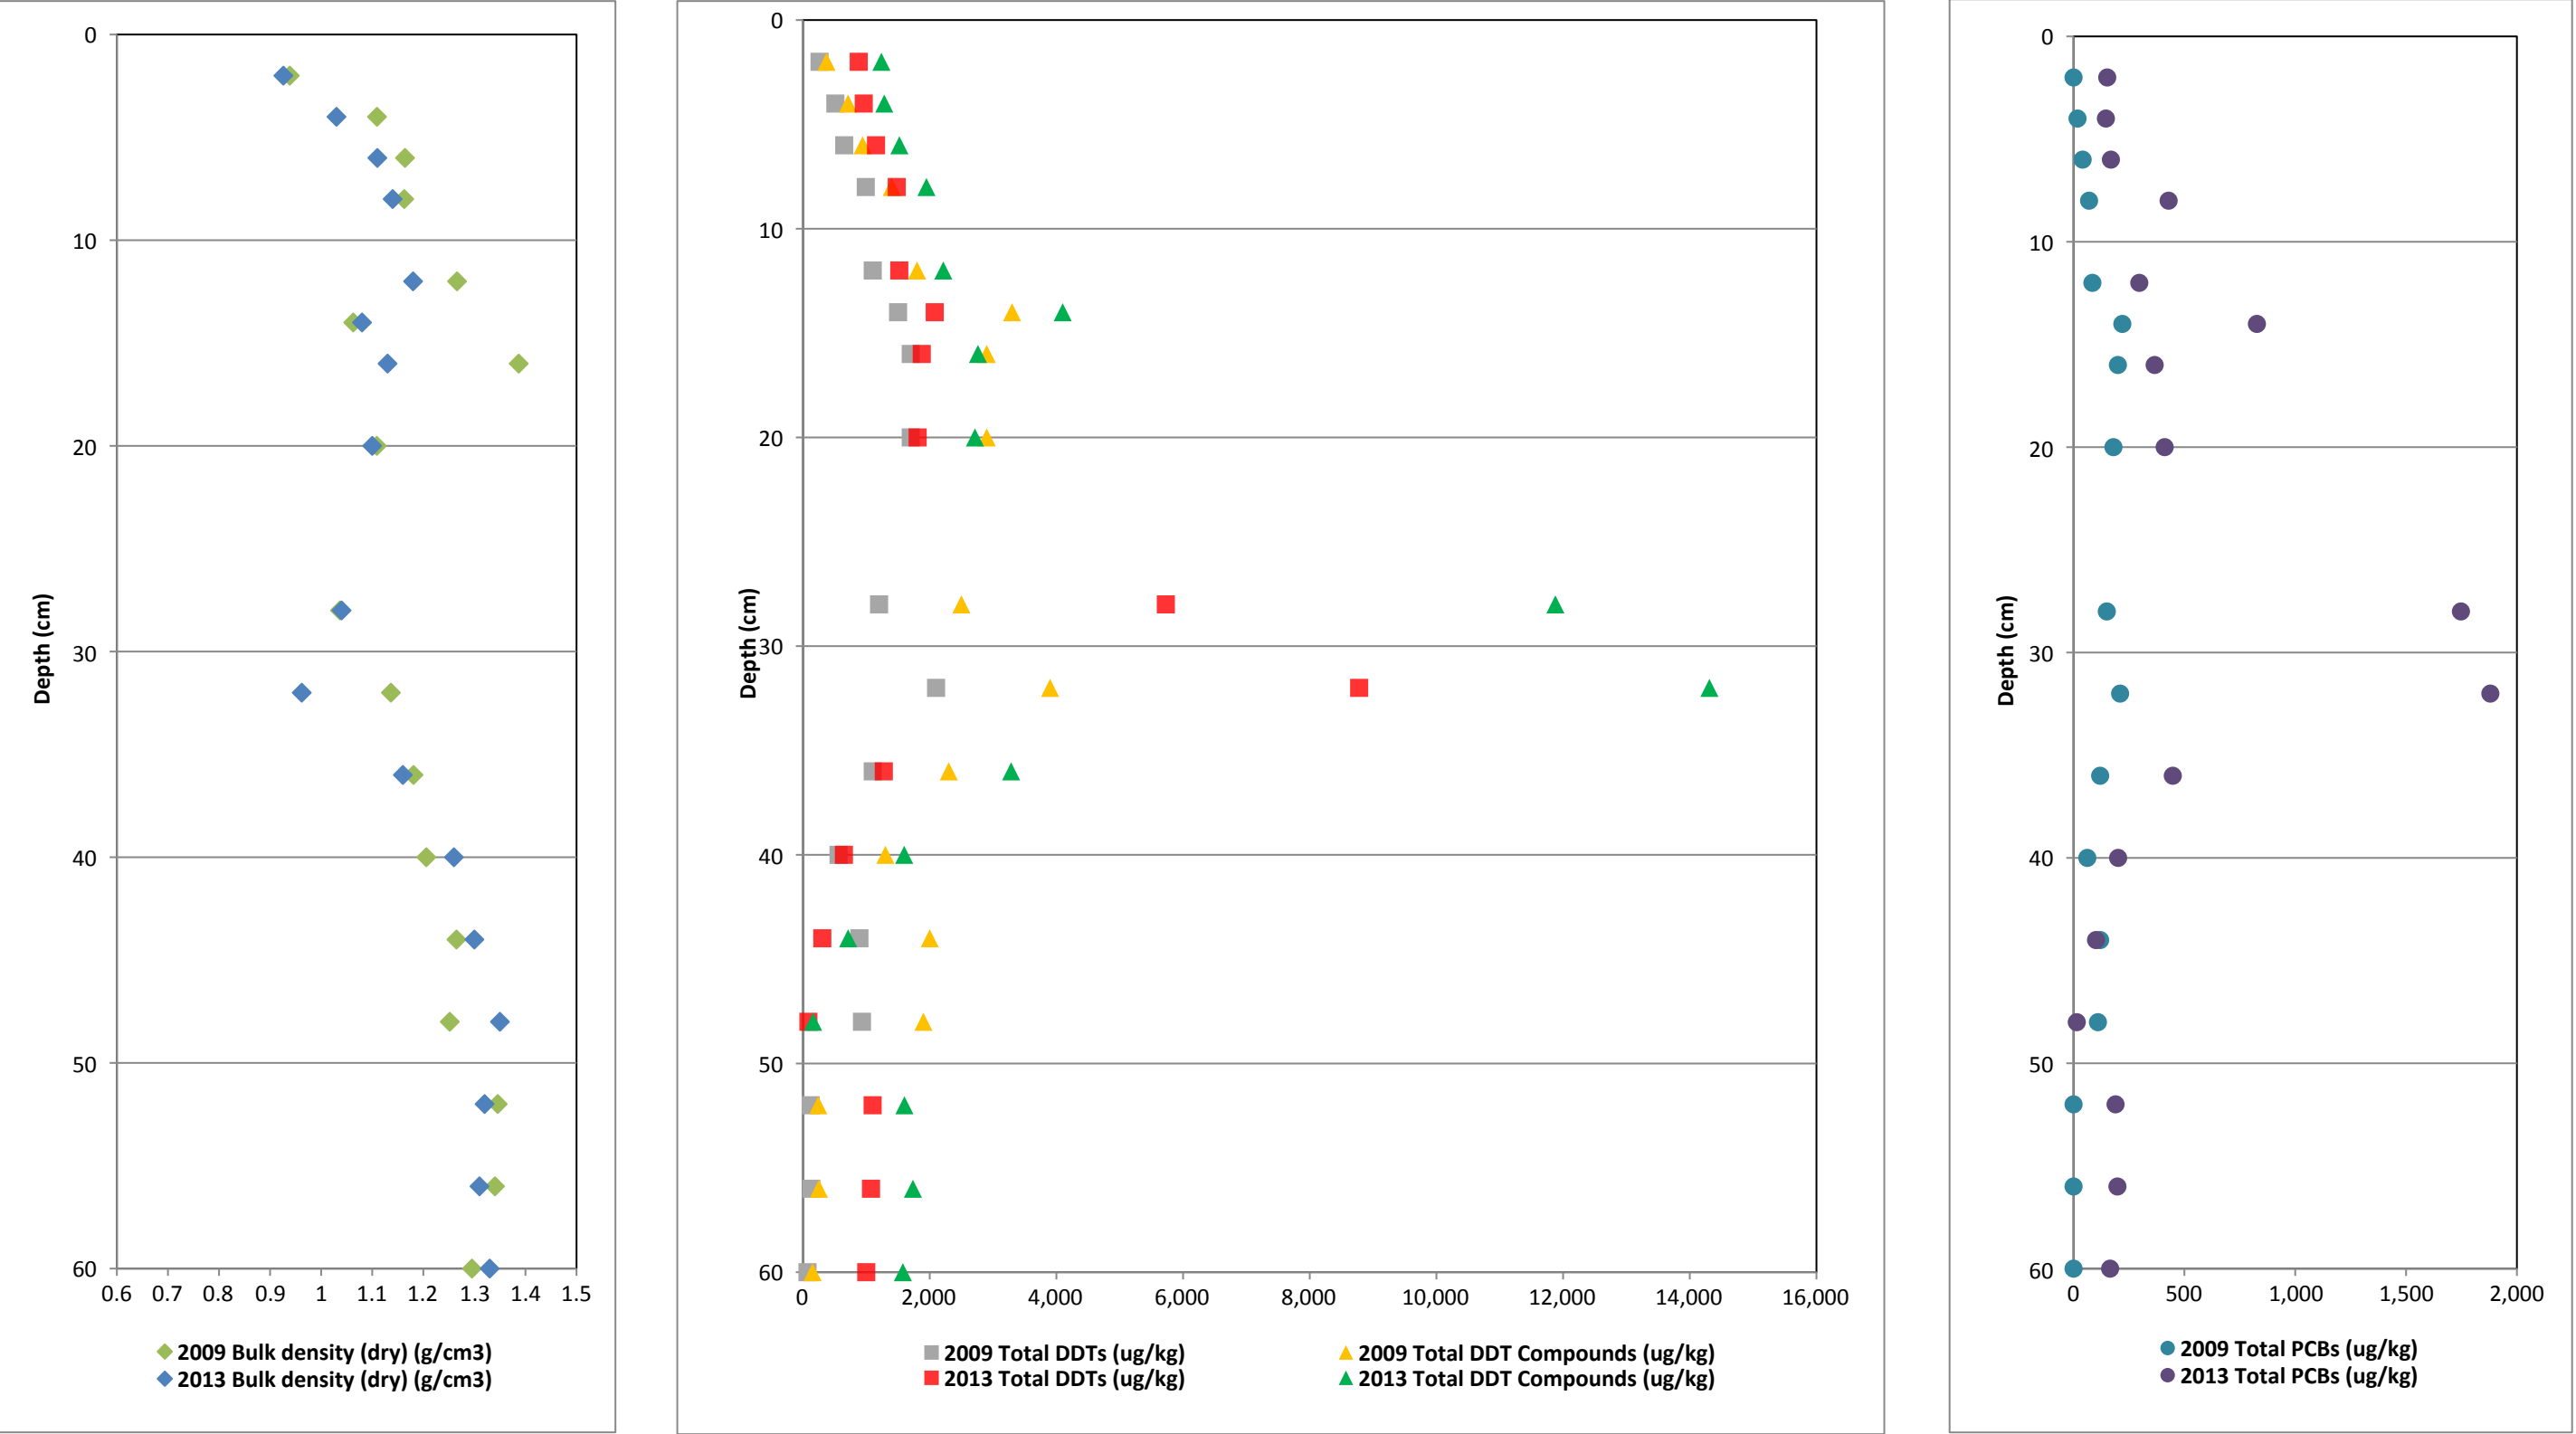
Figure 8. Vertical Profiles of Bulk Density and COCs for Core BA3C  
First MNR Report  
Palos Verdes Shelf (OU 5 of the Montrose Chemical Corp. Superfund Site)  
Los Angeles County, California

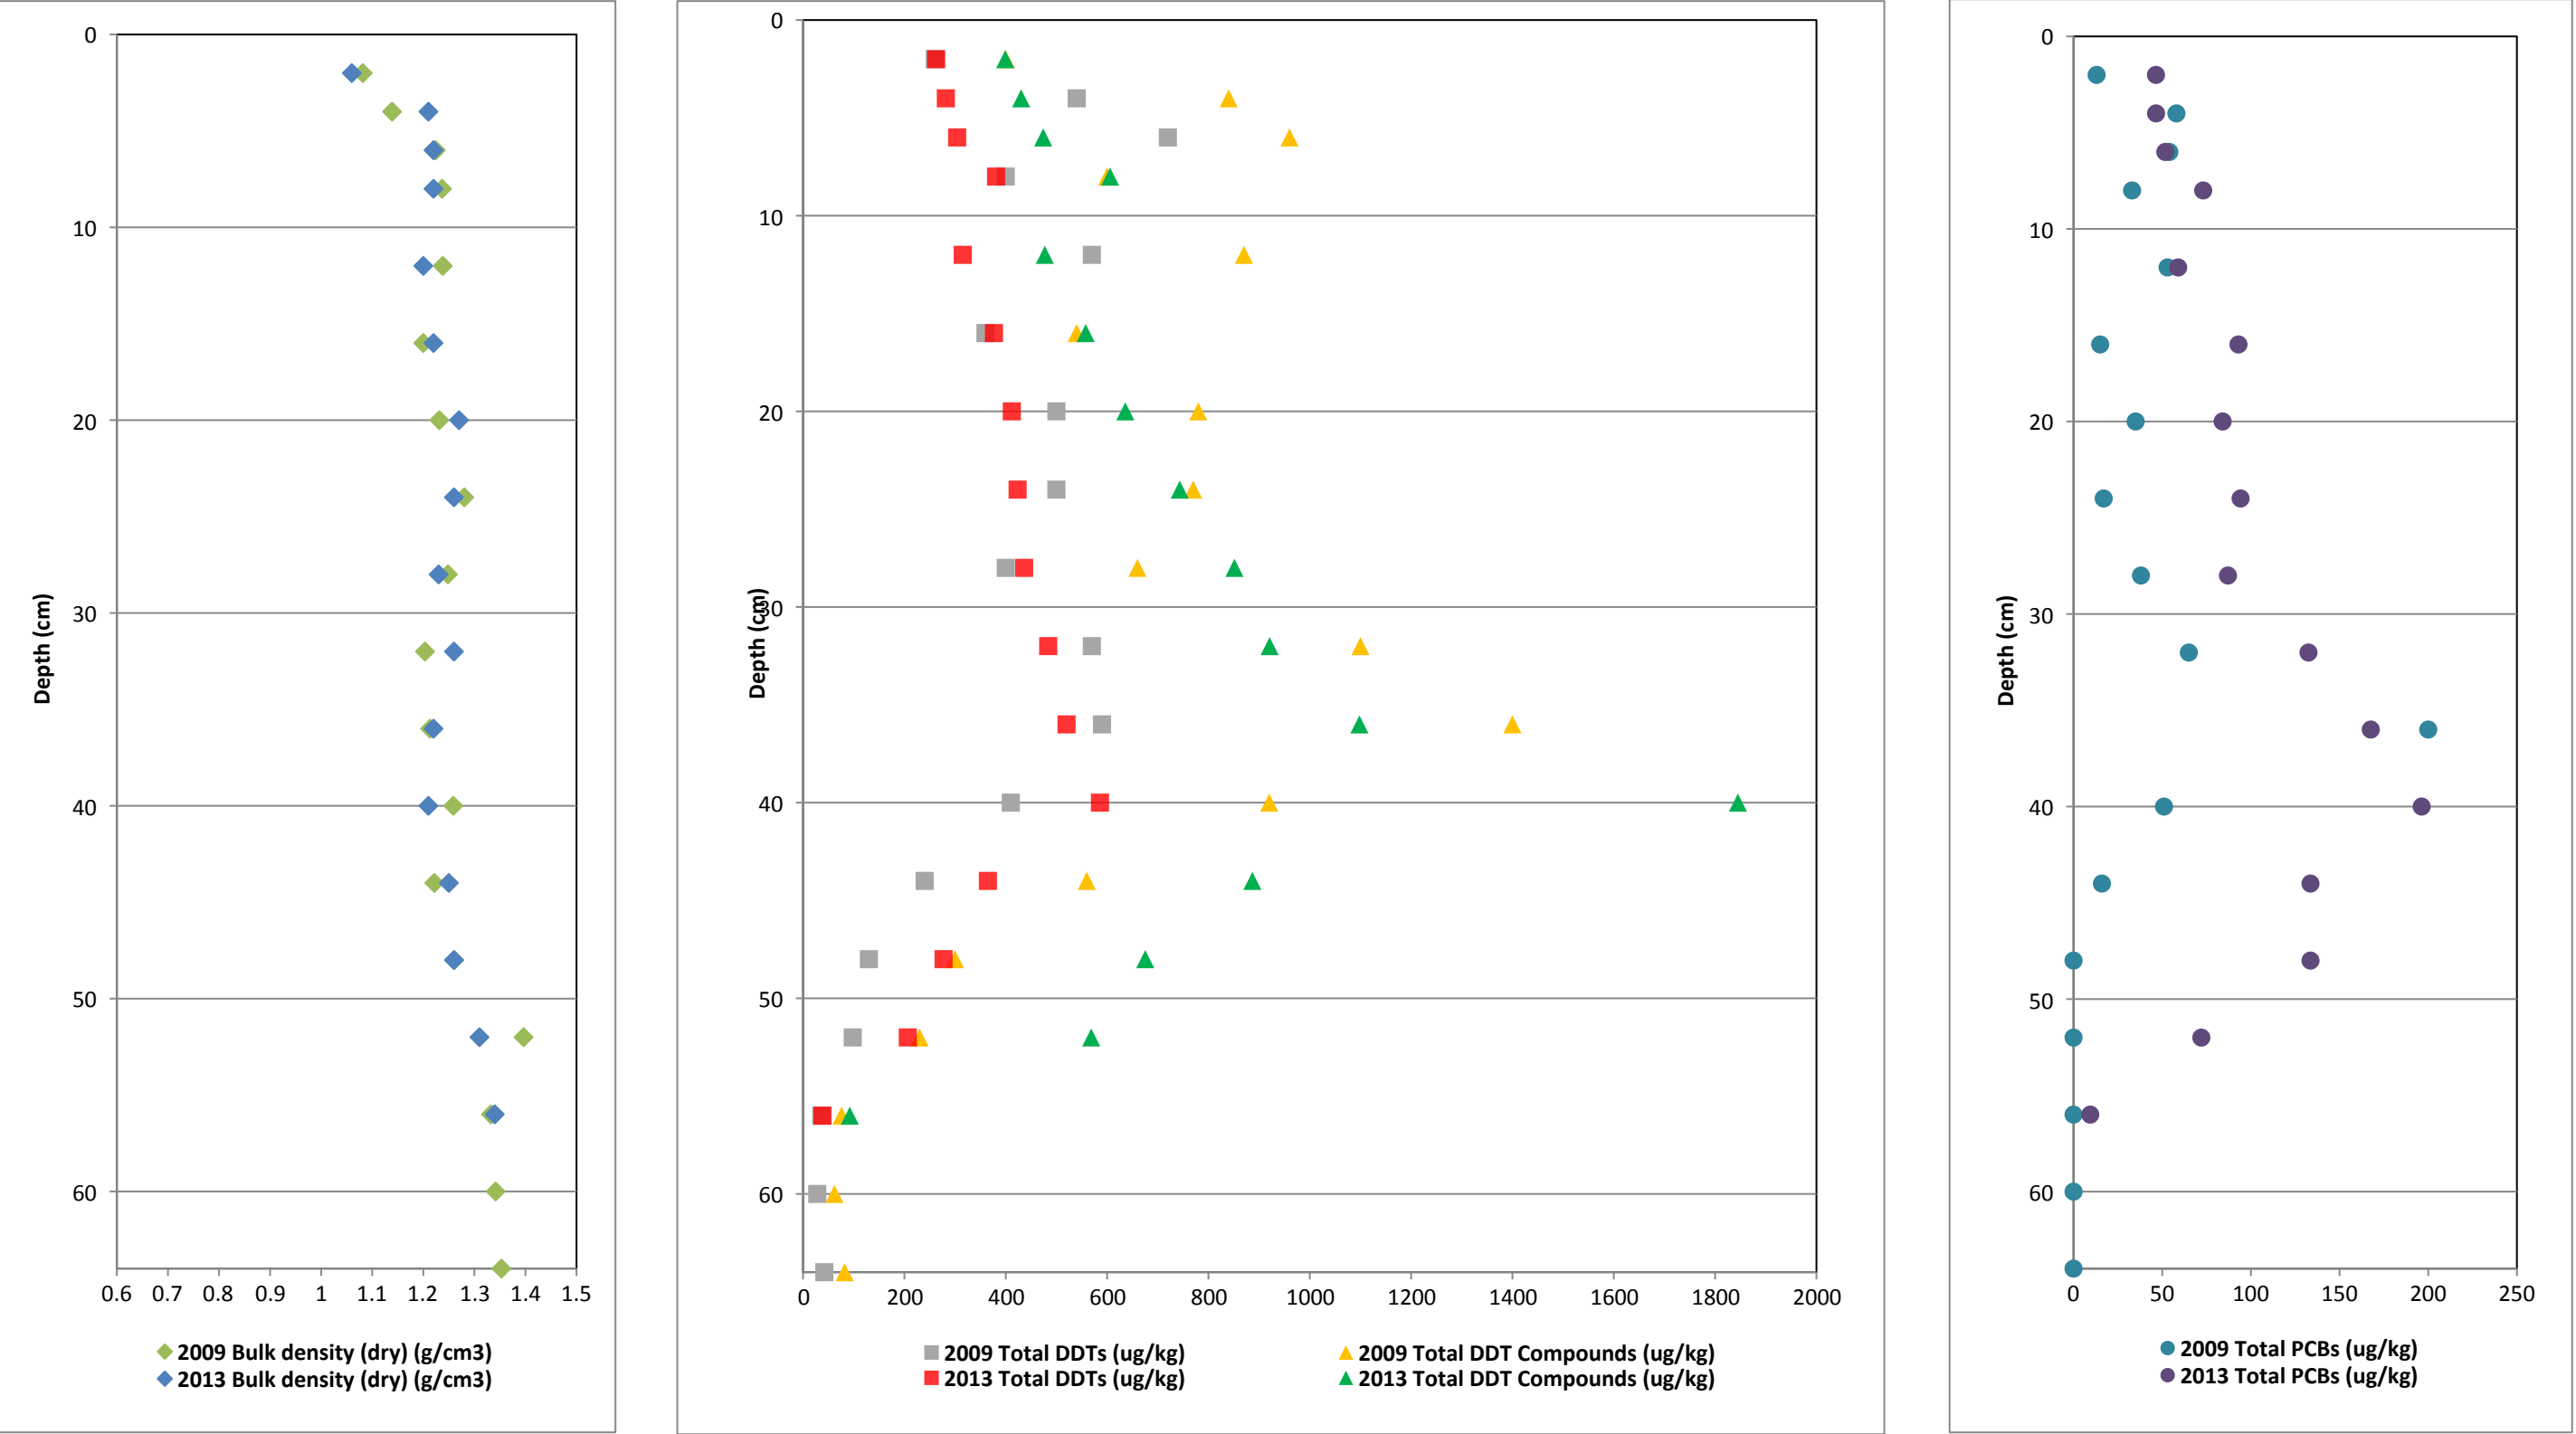
Figure 9. Vertical Profiles of Bulk Density and COCs for Core BA3DC  
First MNR Report  
Palos Verdes Shelf (OU 5 of the Montrose Chemical Corp. Superfund Site)  
Los Angeles County, California

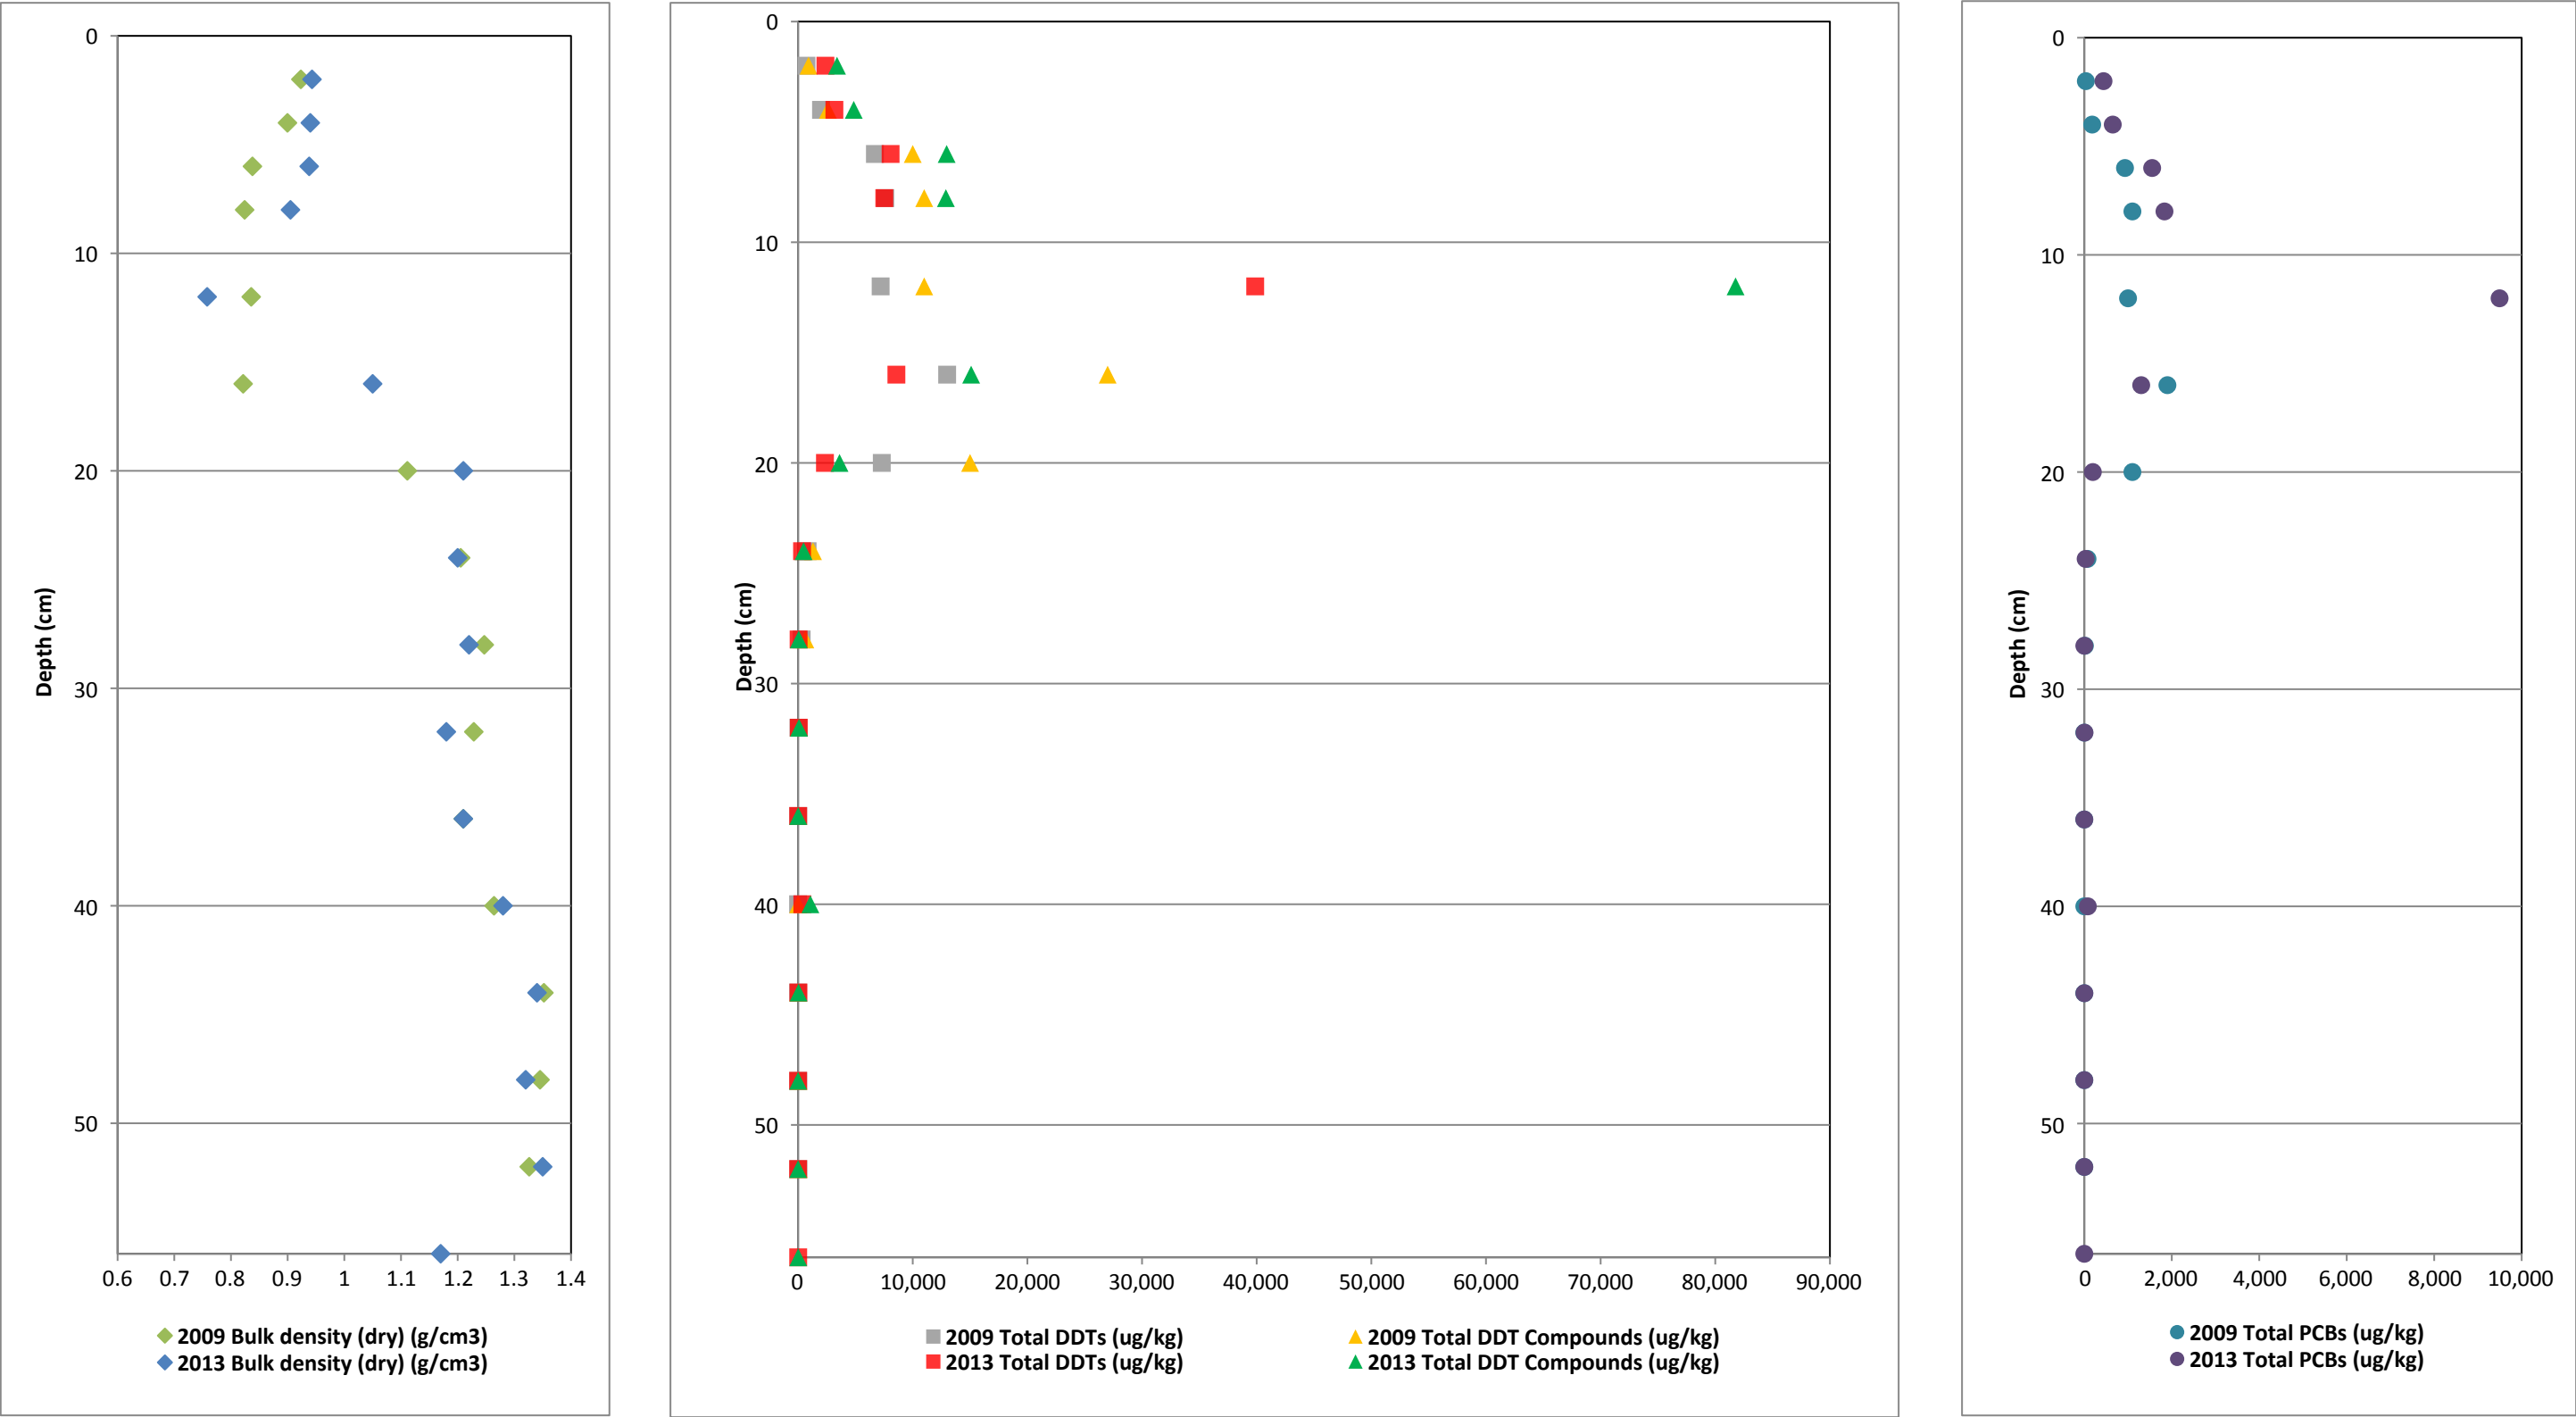
Figure 10. Vertical Profiles of Bulk Density and COCs for Core BA4B  
First MNR Report  
Palos Verdes Shelf (OU 5 of the Montrose Chemical Corp. Superfund Site)  
Los Angeles County, California

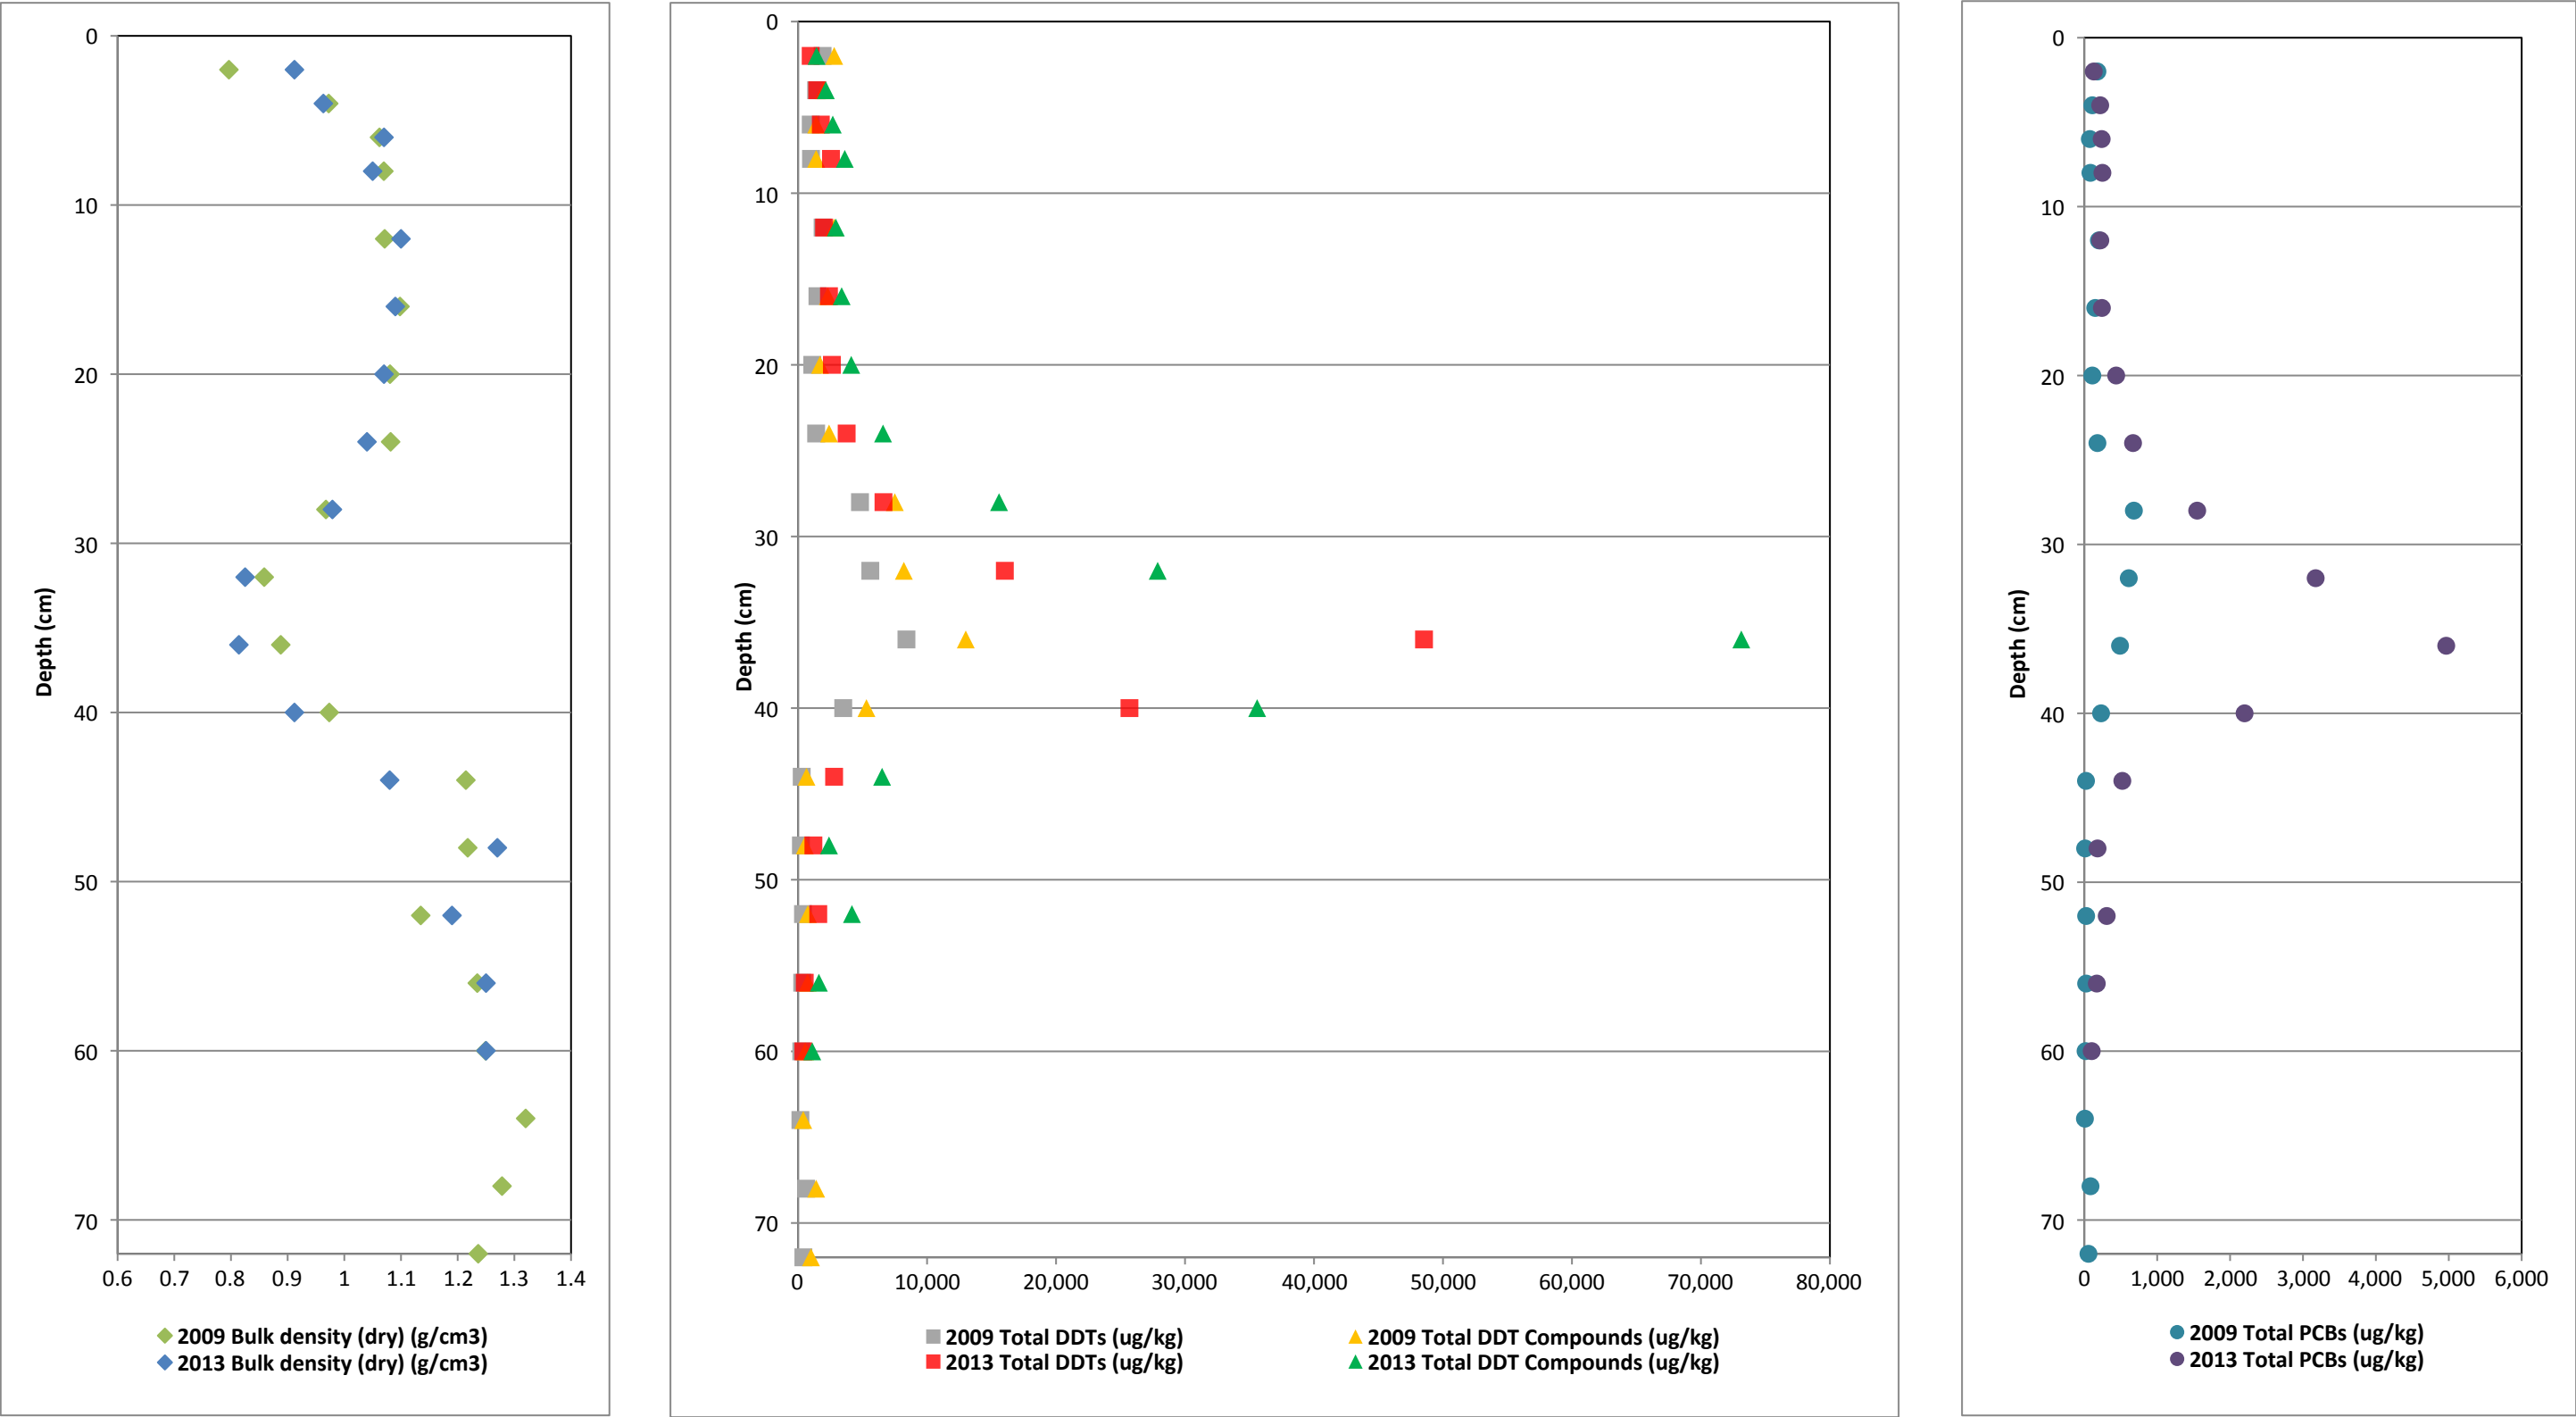
Figure 11. Vertical Profiles of Bulk Density and COCs for Core BA4C  
First MNR Report  
Palos Verdes Shelf (OU 5 of the Montrose Chemical Corp. Superfund Site)  
Los Angeles County, California
