**APPENDIX X**  
**VERTICAL PROFILES OF SEDIMENT BED – BD AND COCS**

## **APPENDIX X.1 – VERTICAL PROFILES – SHELF-WIDE CORES**

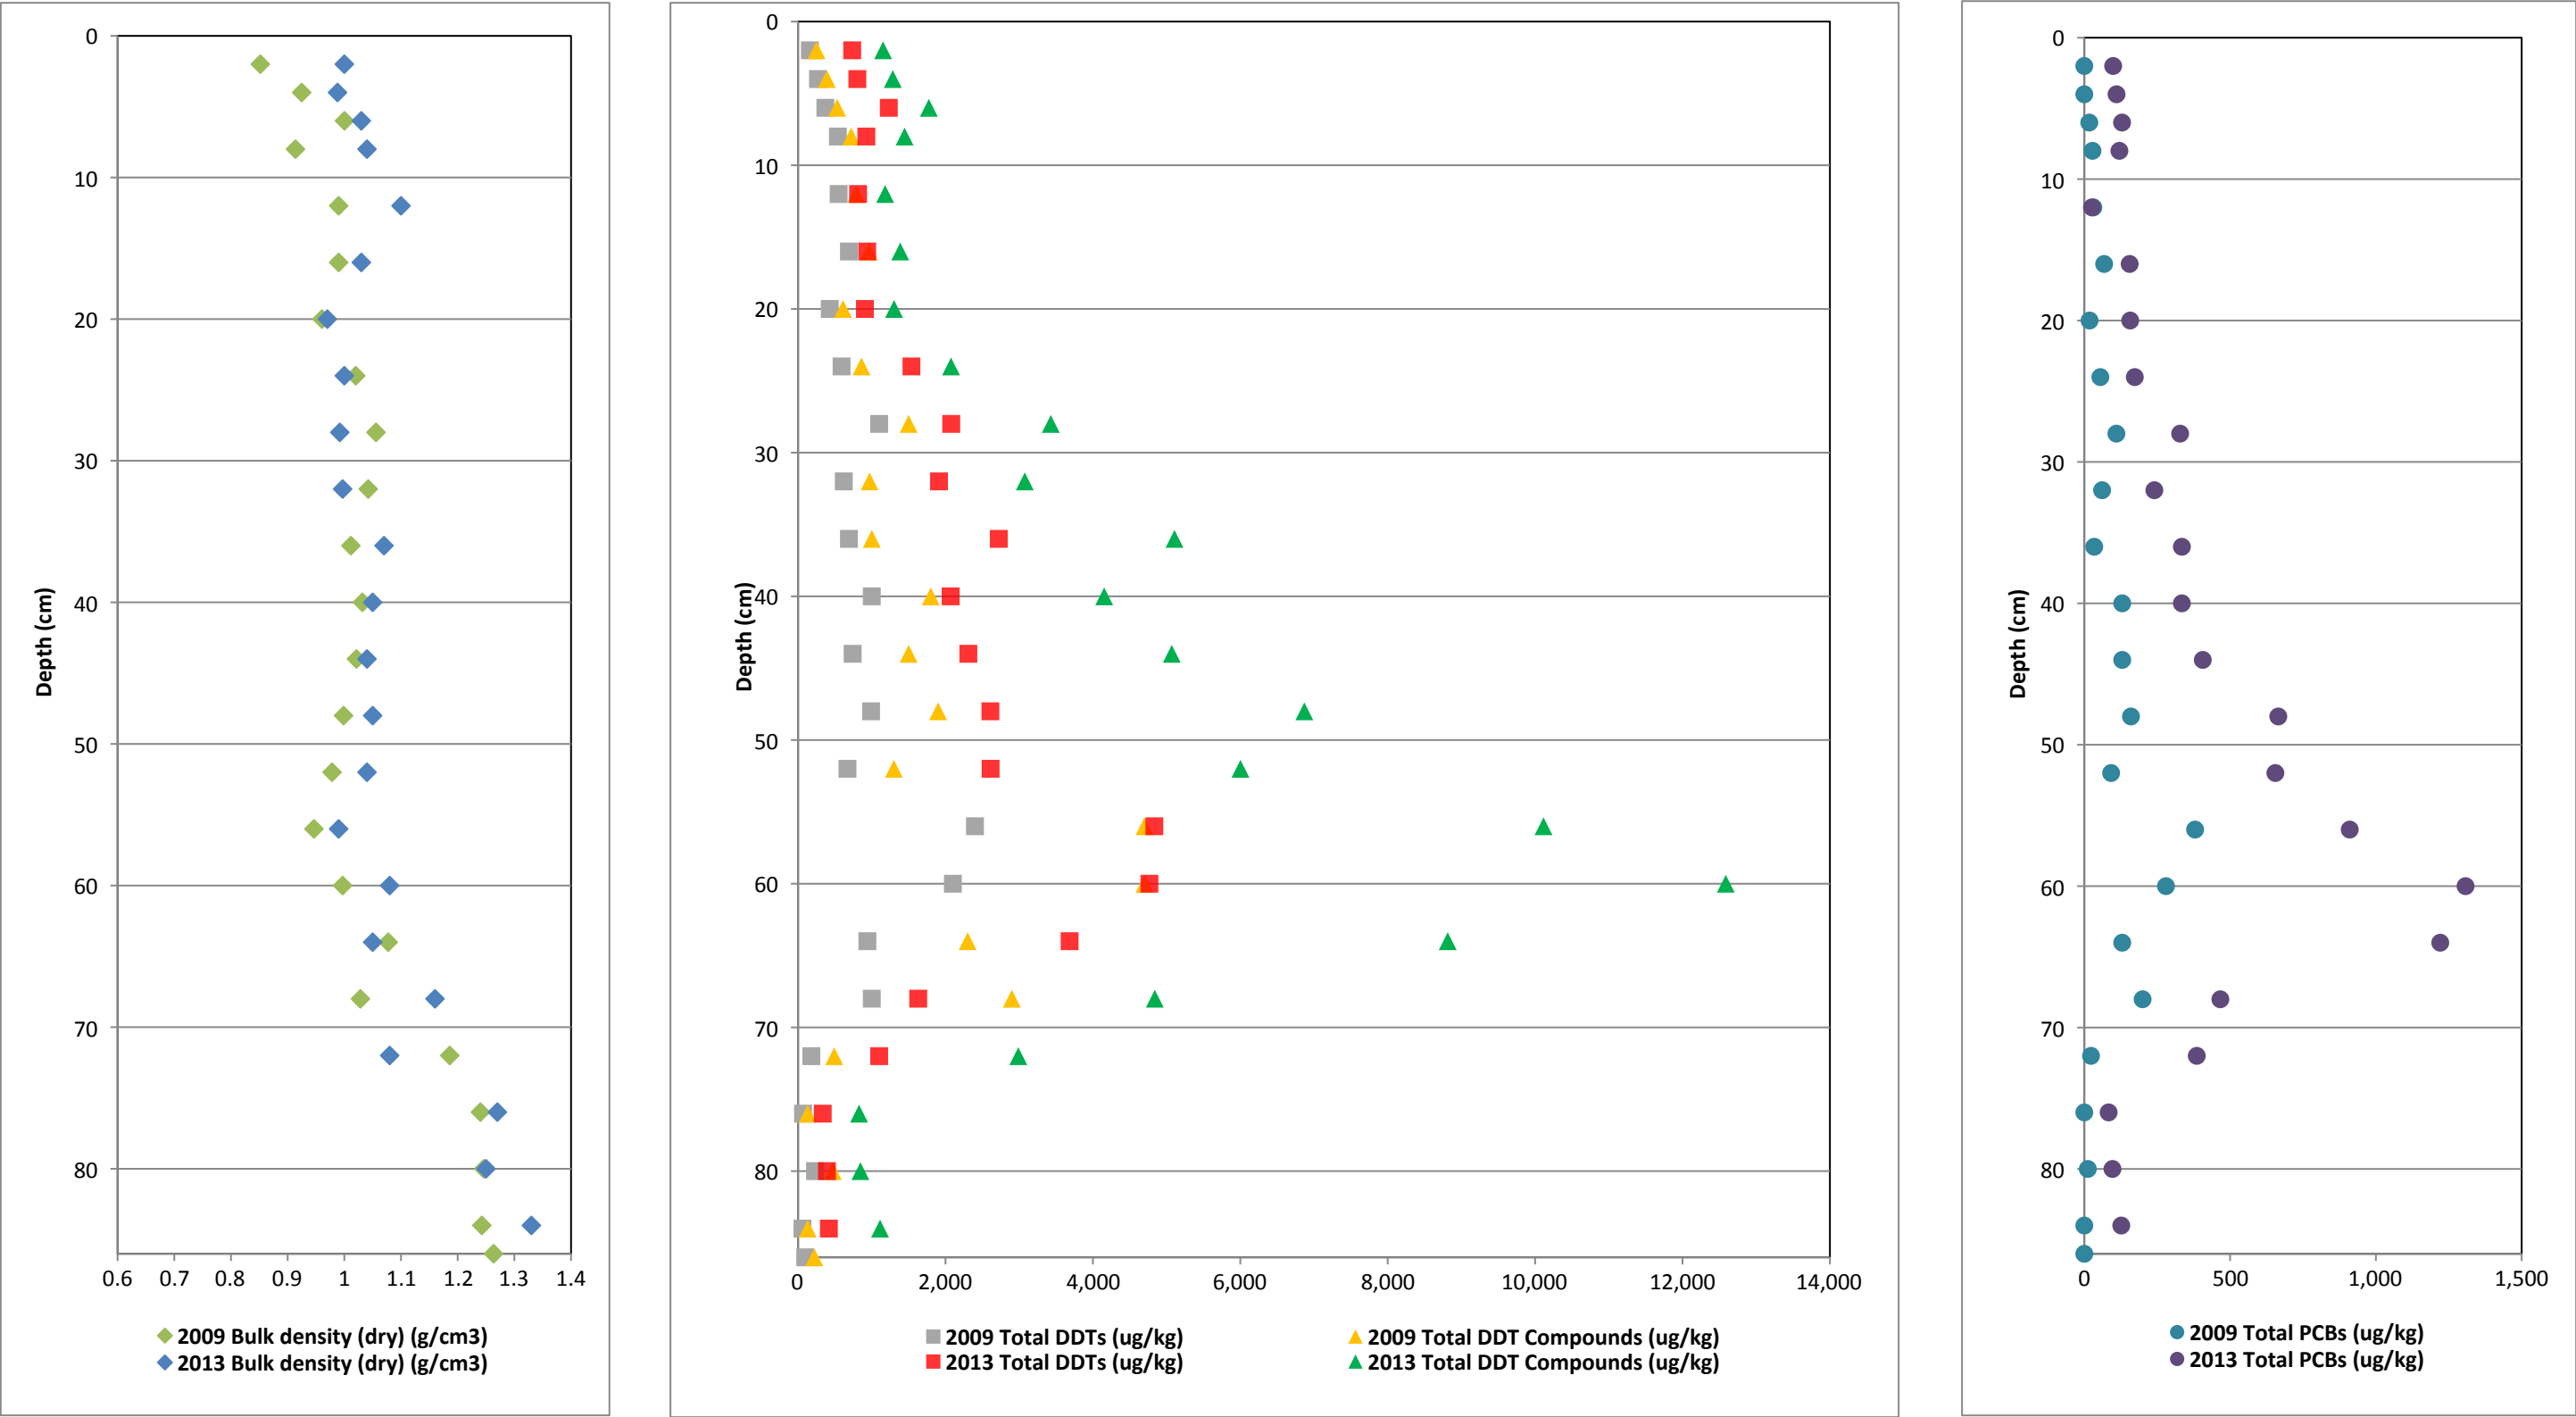
Figure 12. Vertical Profiles of Bulk Density and COCs for Core BA4DC  
First MNR Report  
Palos Verdes Shelf (OU 5 of the Montrose Chemical Corp. Superfund Site)  
Los Angeles County, California

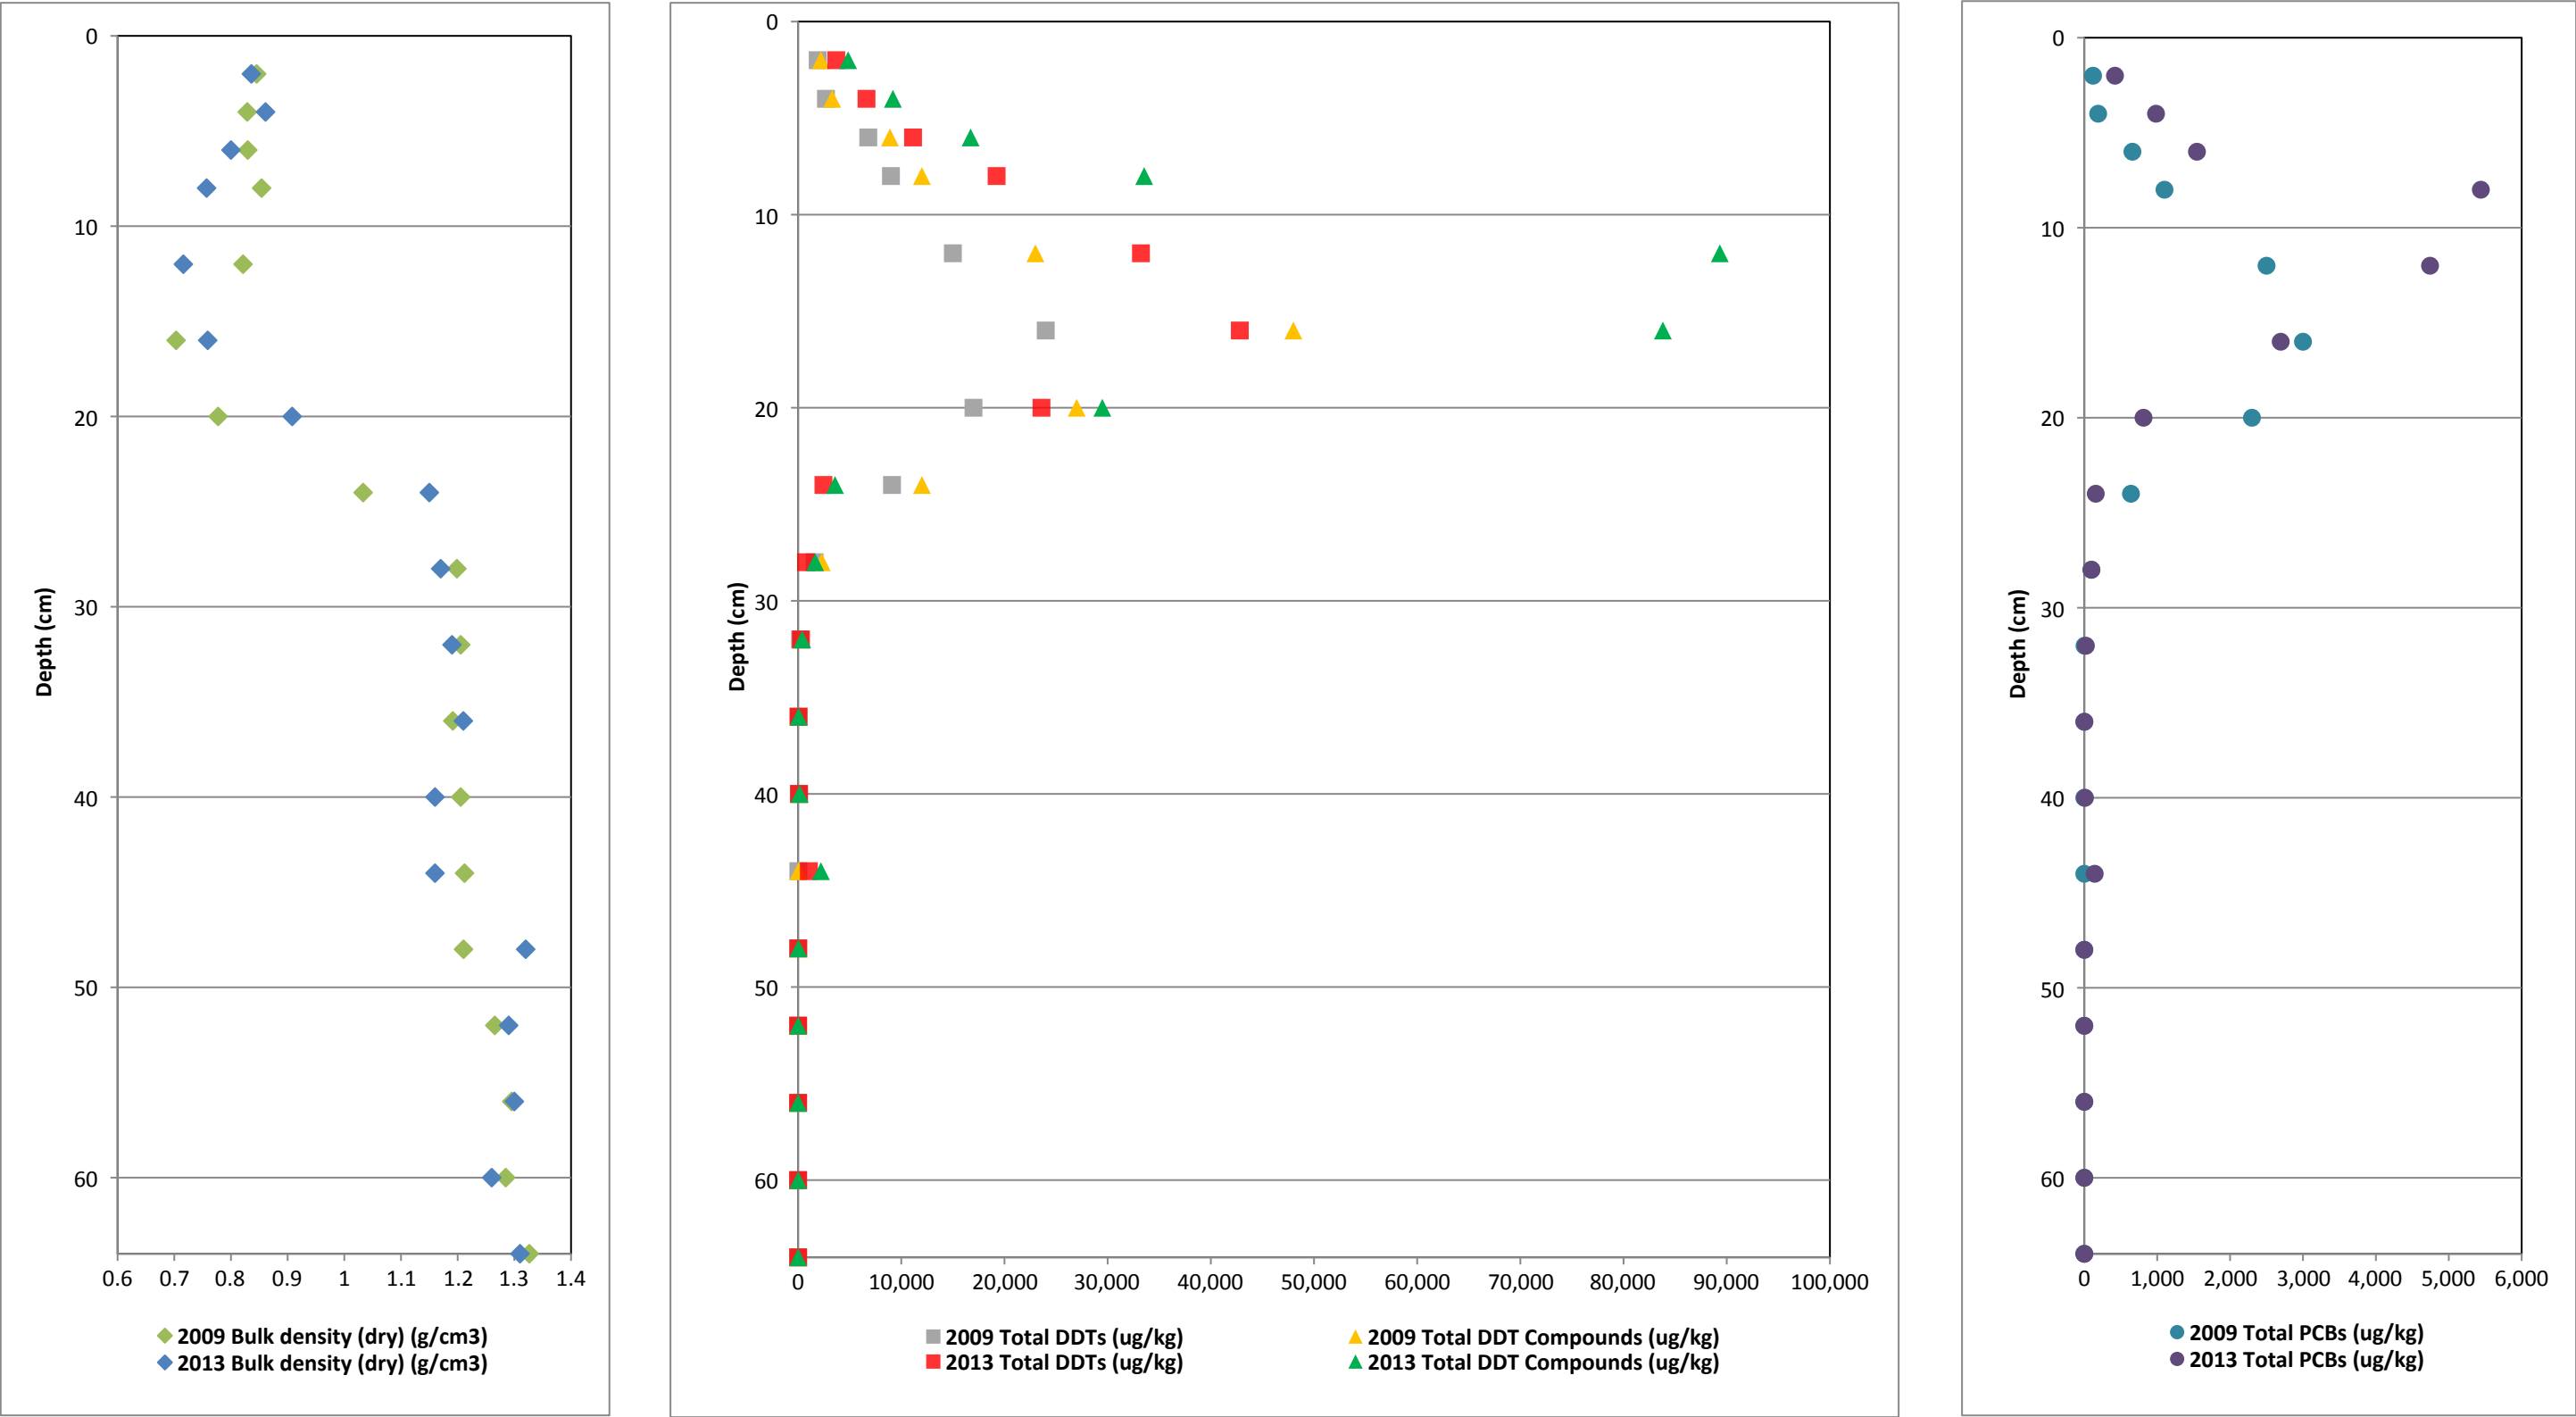
Figure 13. Vertical Profiles of Bulk Density and COCs for Core BA5B  
First MNR Report  
Palos Verdes Shelf (OU 5 of the Montrose Chemical Corp. Superfund Site)  
Los Angeles County, California

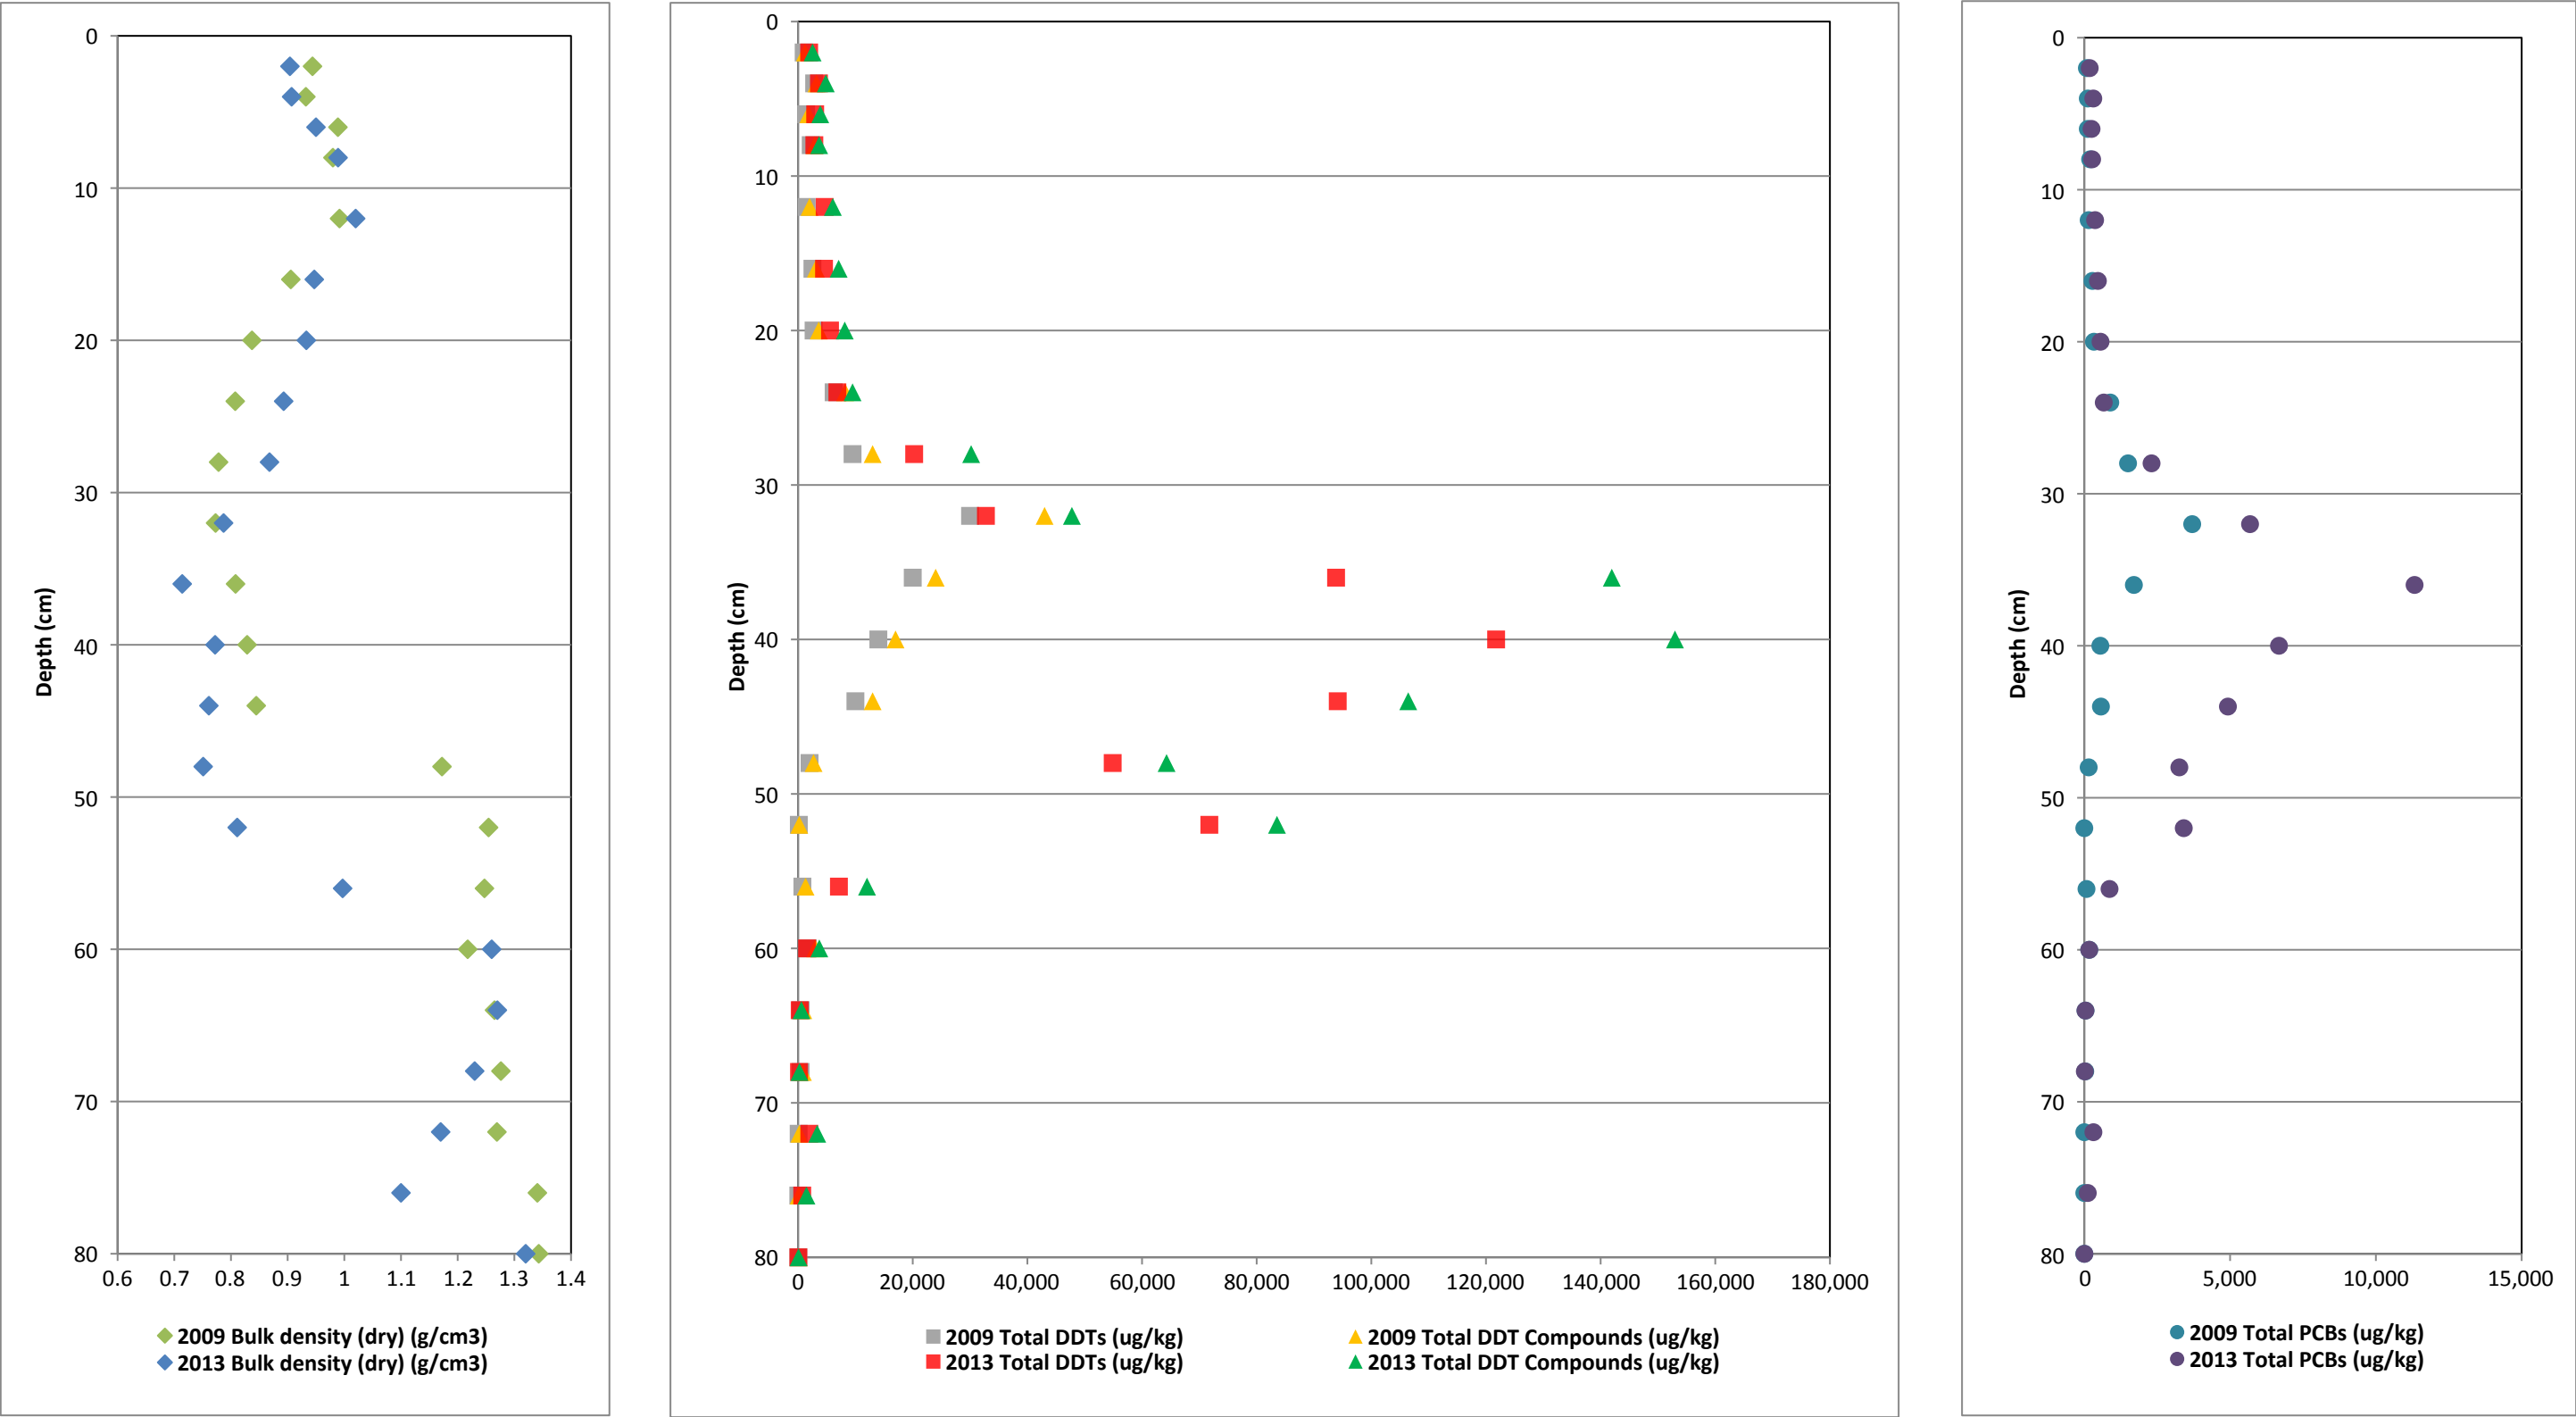
Figure 14. Vertical Profiles of Bulk Density and COCs for Core BA5C  
First MNR Report  
Palos Verdes Shelf (OU 5 of the Montrose Chemical Corp. Superfund Site)  
Los Angeles County, California

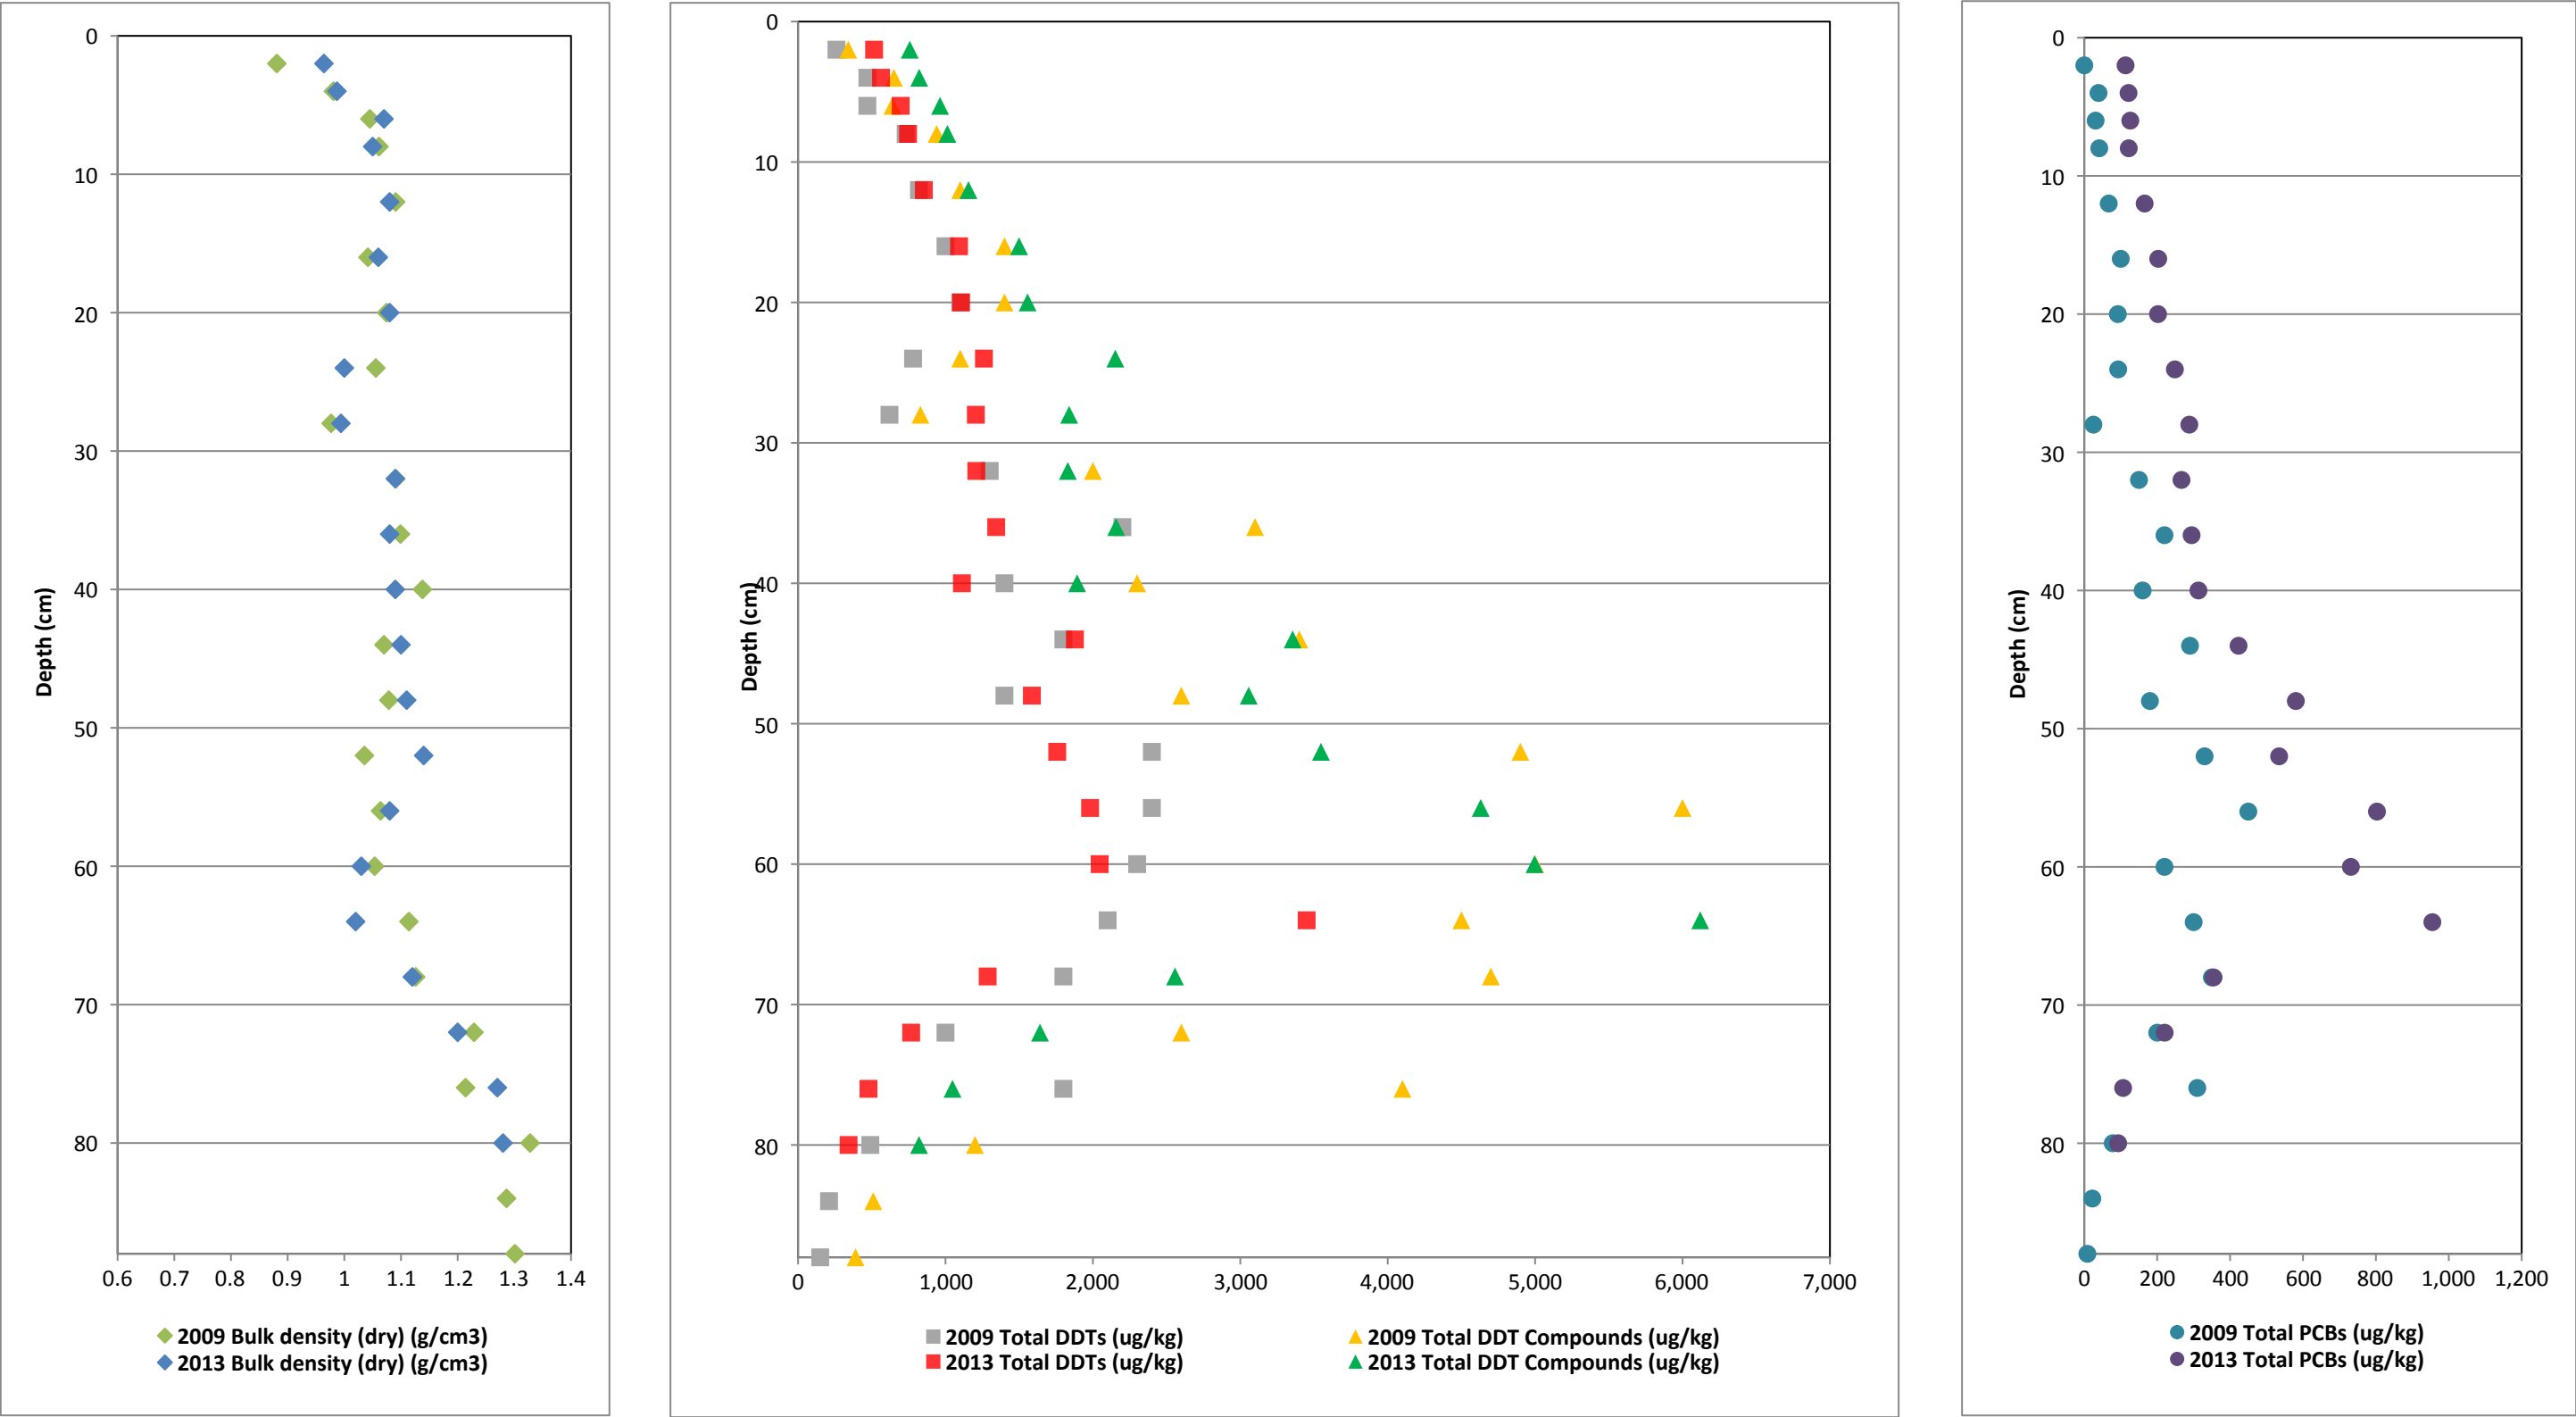
Figure 15. Vertical Profiles of Bulk Density and COCs for Core BA5DC  
First MNR Report  
Palos Verdes Shelf (OU 5 of the Montrose Chemical Corp. Superfund Site)  
Los Angeles County, California

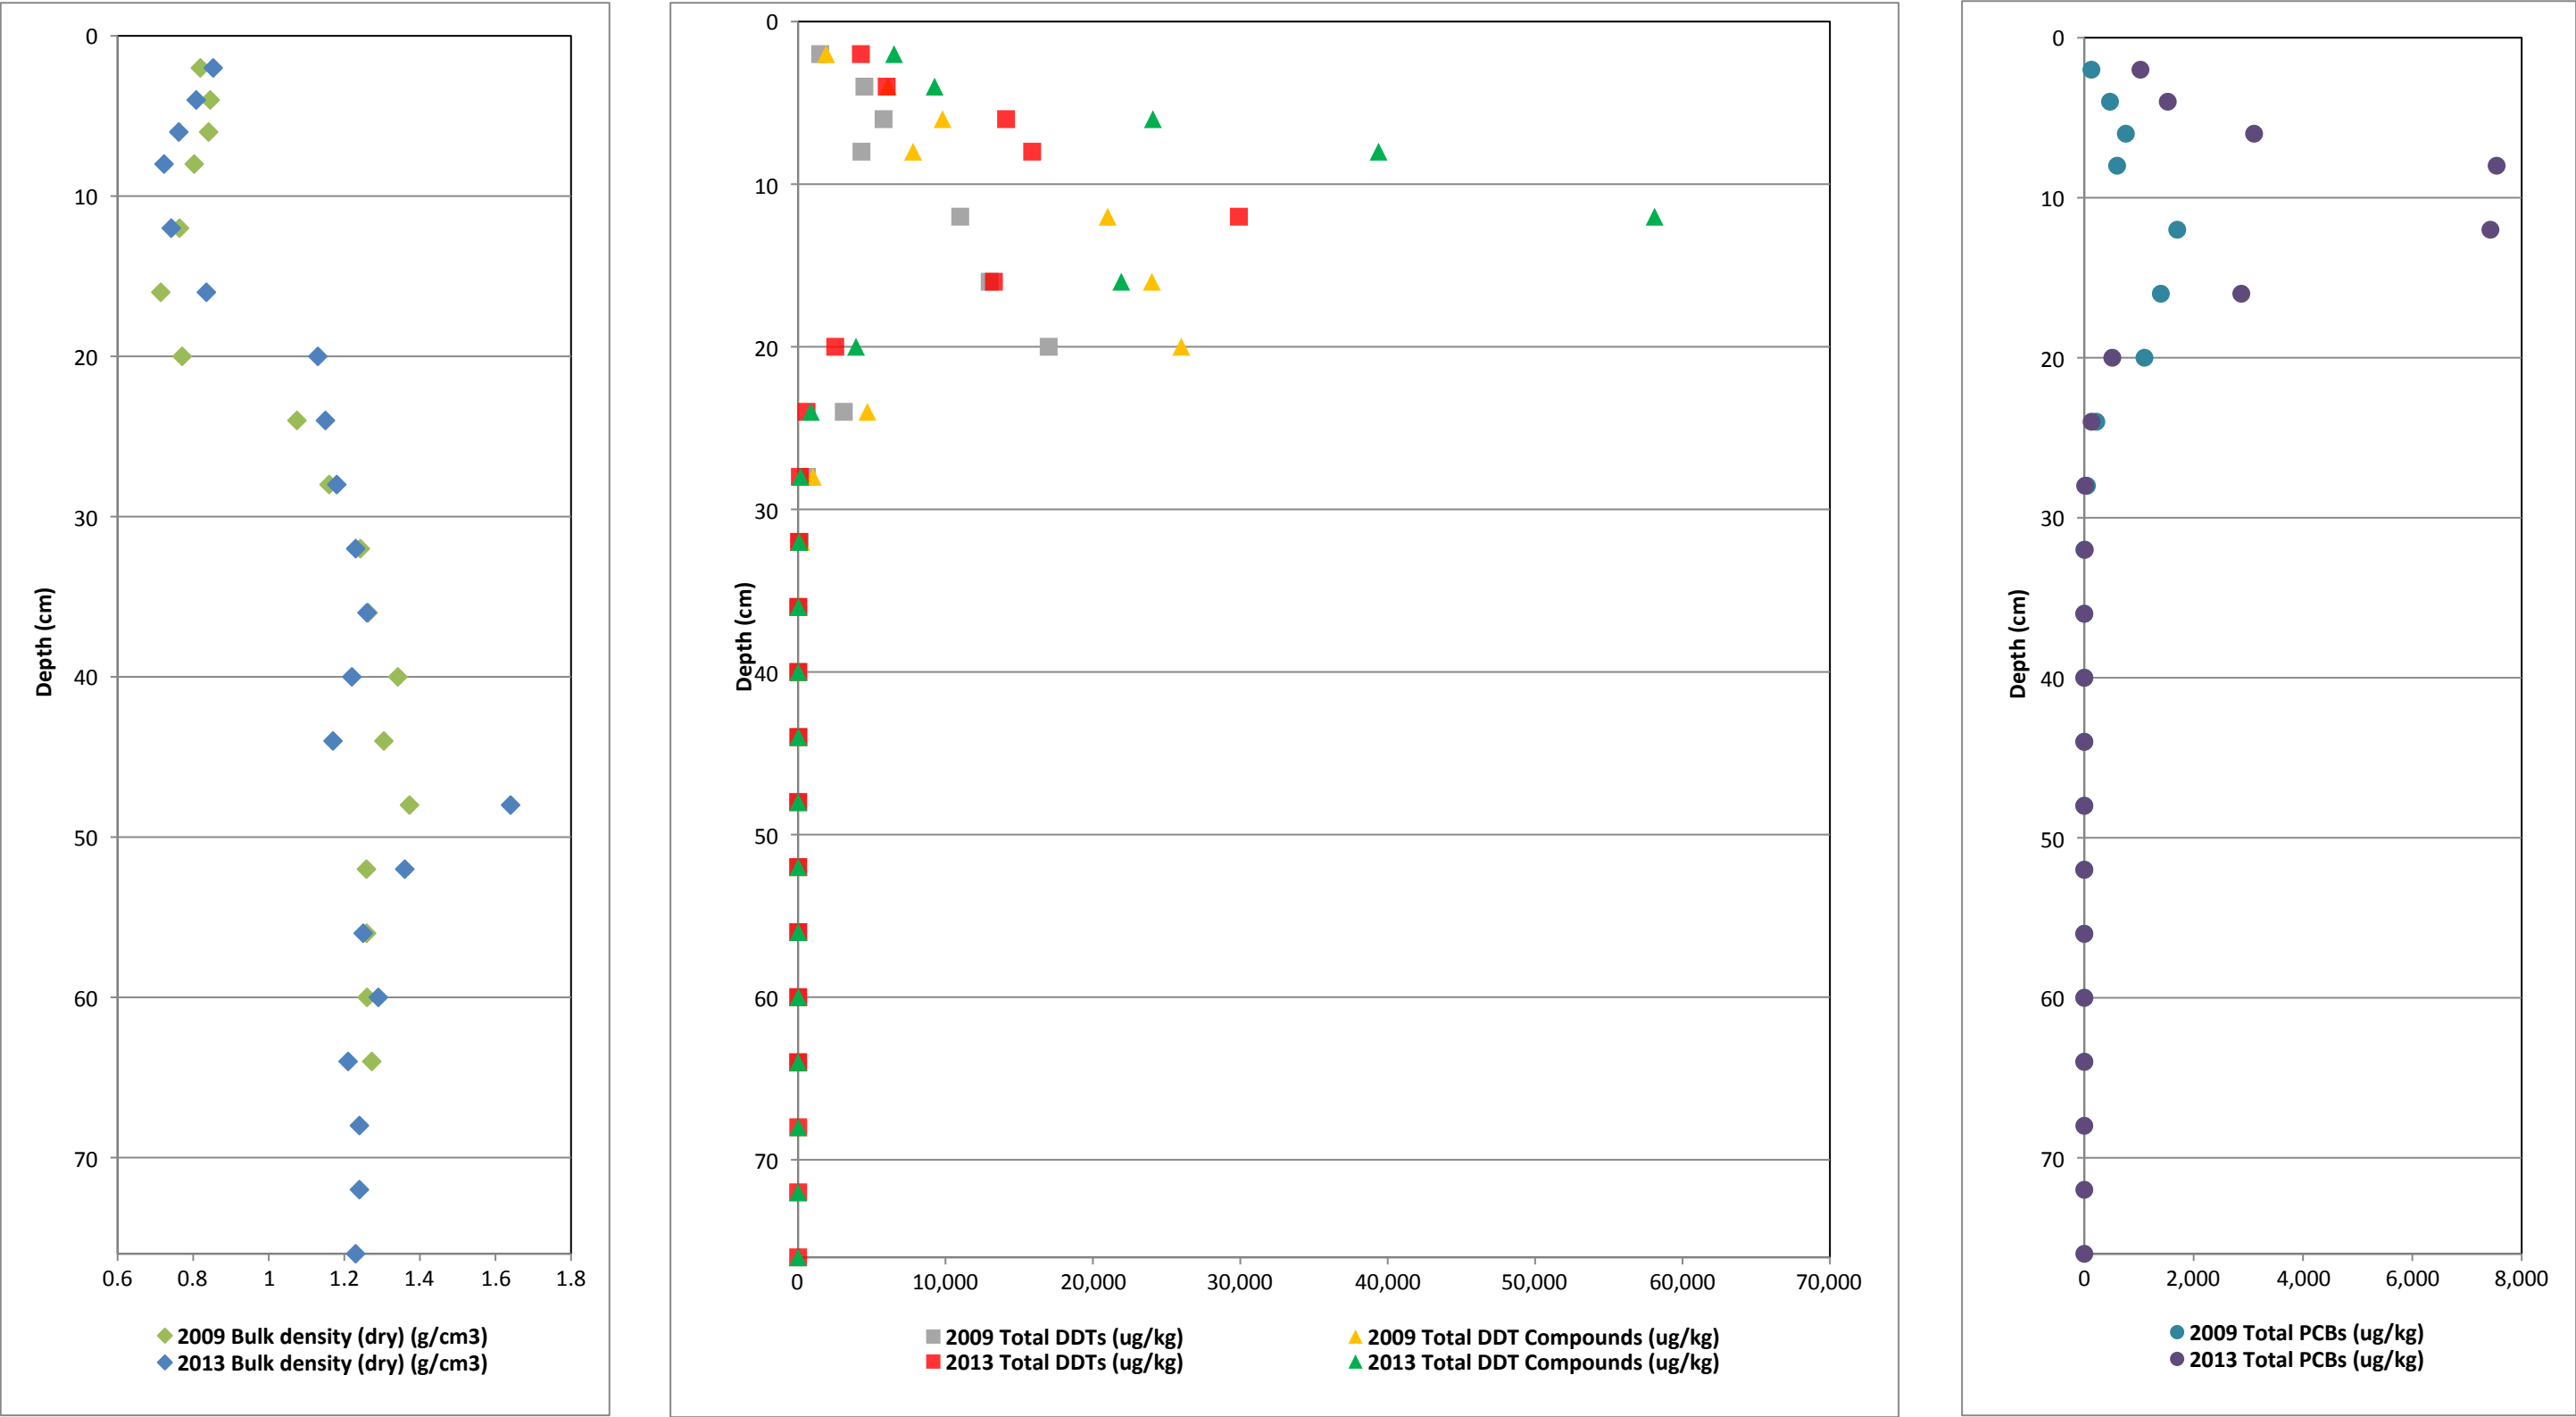
Figure 16. Vertical Profiles of Bulk Density and COCs for Core BA6B  
First MNR Report  
Palos Verdes Shelf (OU 5 of the Montrose Chemical Corp. Superfund Site)  
Los Angeles County, California

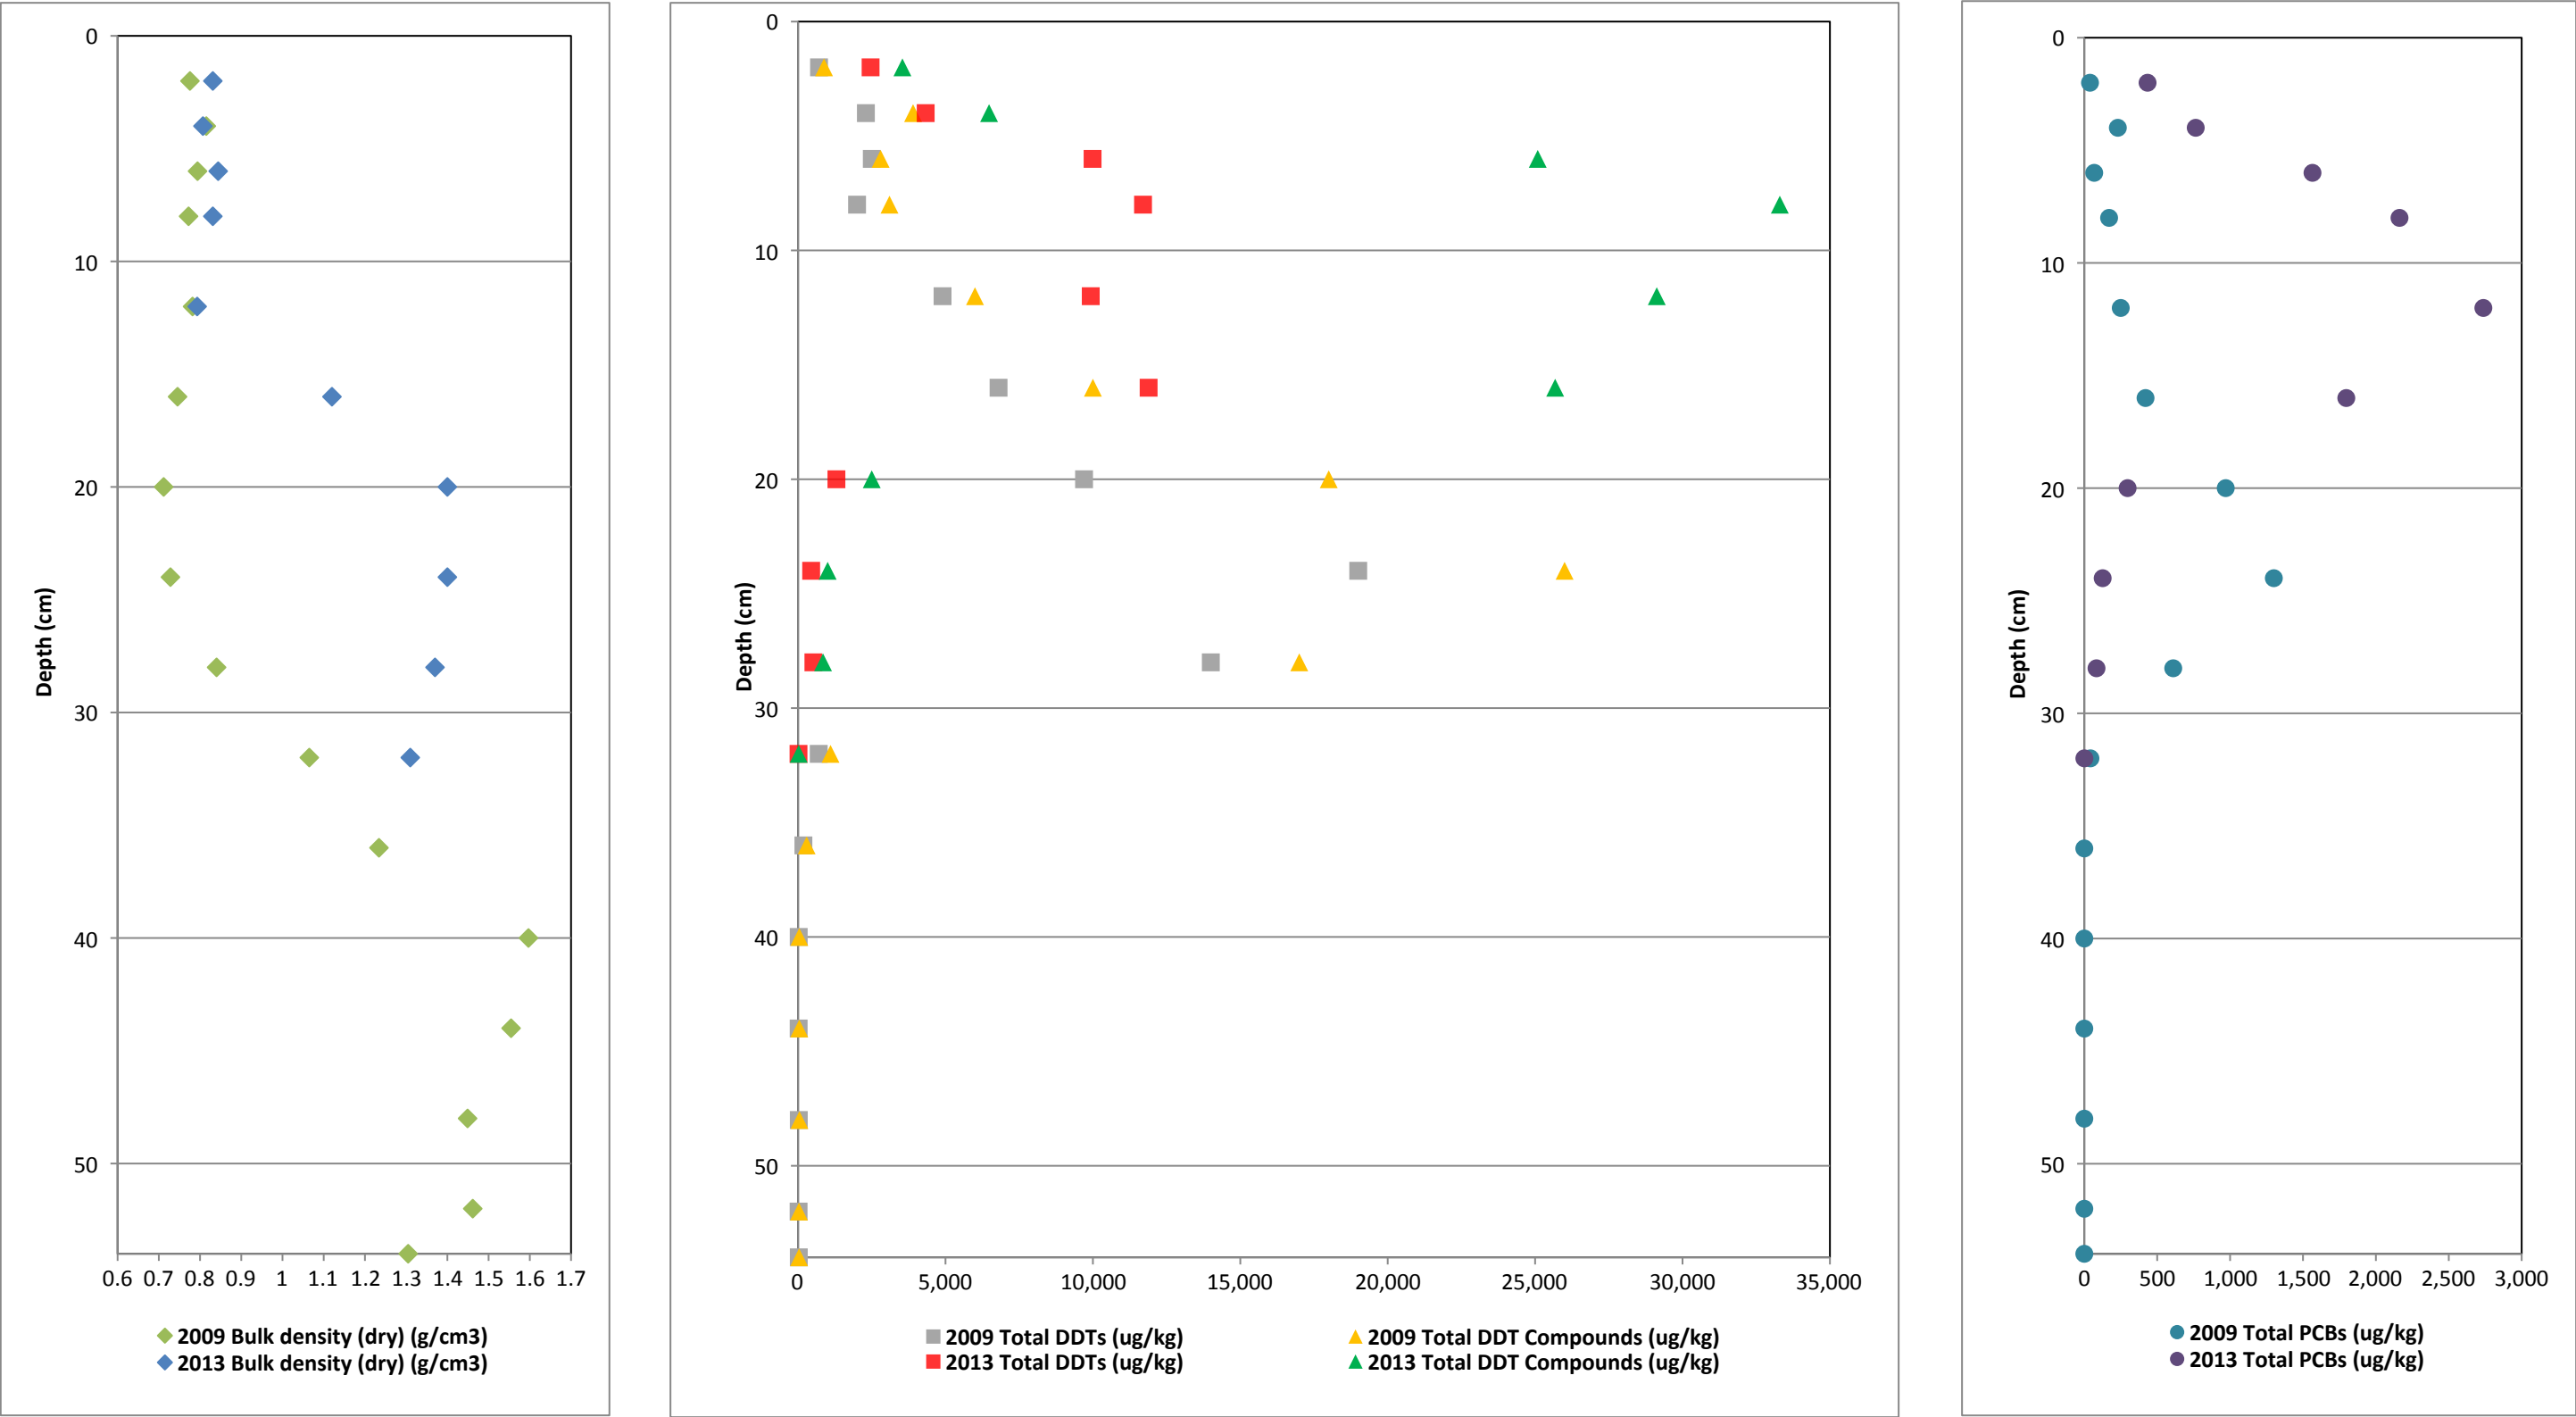
Figure 17. Vertical Profiles of Bulk Density and COCs for Core BA6BC  
First MNR Report  
Palos Verdes Shelf (OU 5 of the Montrose Chemical Corp. Superfund Site)  
Los Angeles County, California
