**APPENDIX X**  
**VERTICAL PROFILES OF SEDIMENT BED – BD AND COCS**

## **APPENDIX X.1 – VERTICAL PROFILES – SHELF-WIDE CORES**

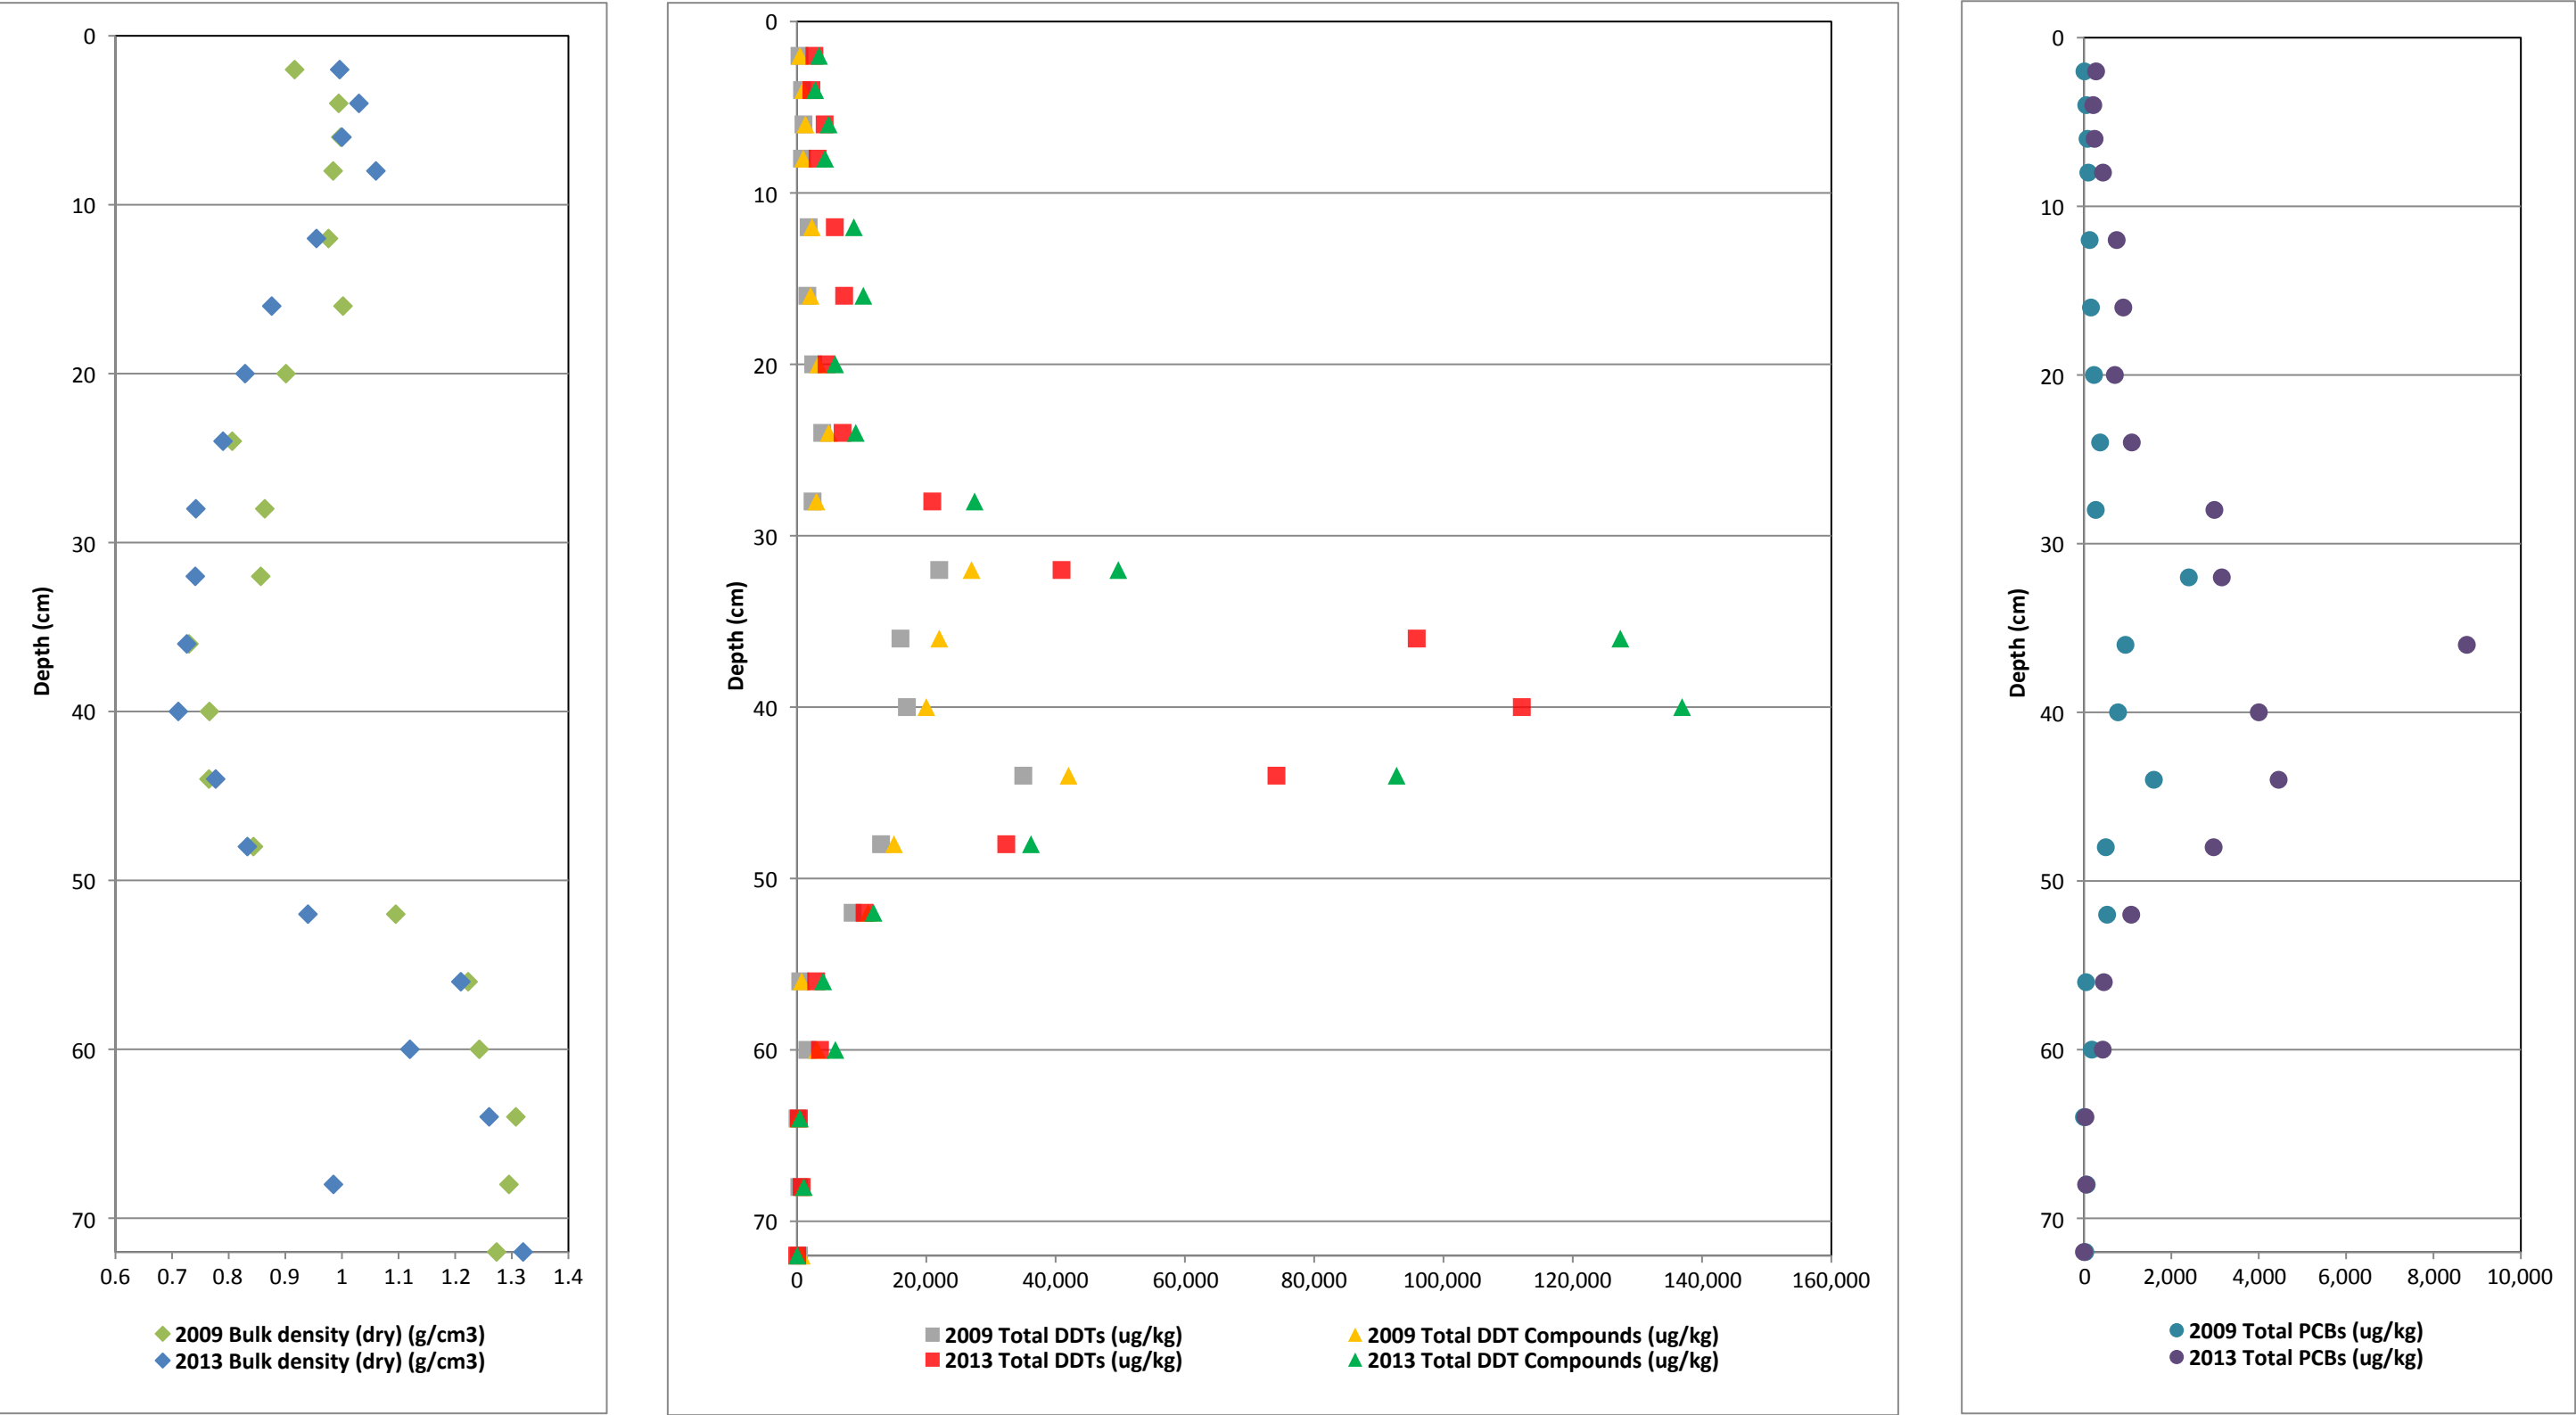
Figure 18. Vertical Profiles of Bulk Density and COCs for Core BA6C  
First MNR Report  
Palos Verdes Shelf (OU 5 of the Montrose Chemical Corp. Superfund Site)  
Los Angeles County, California

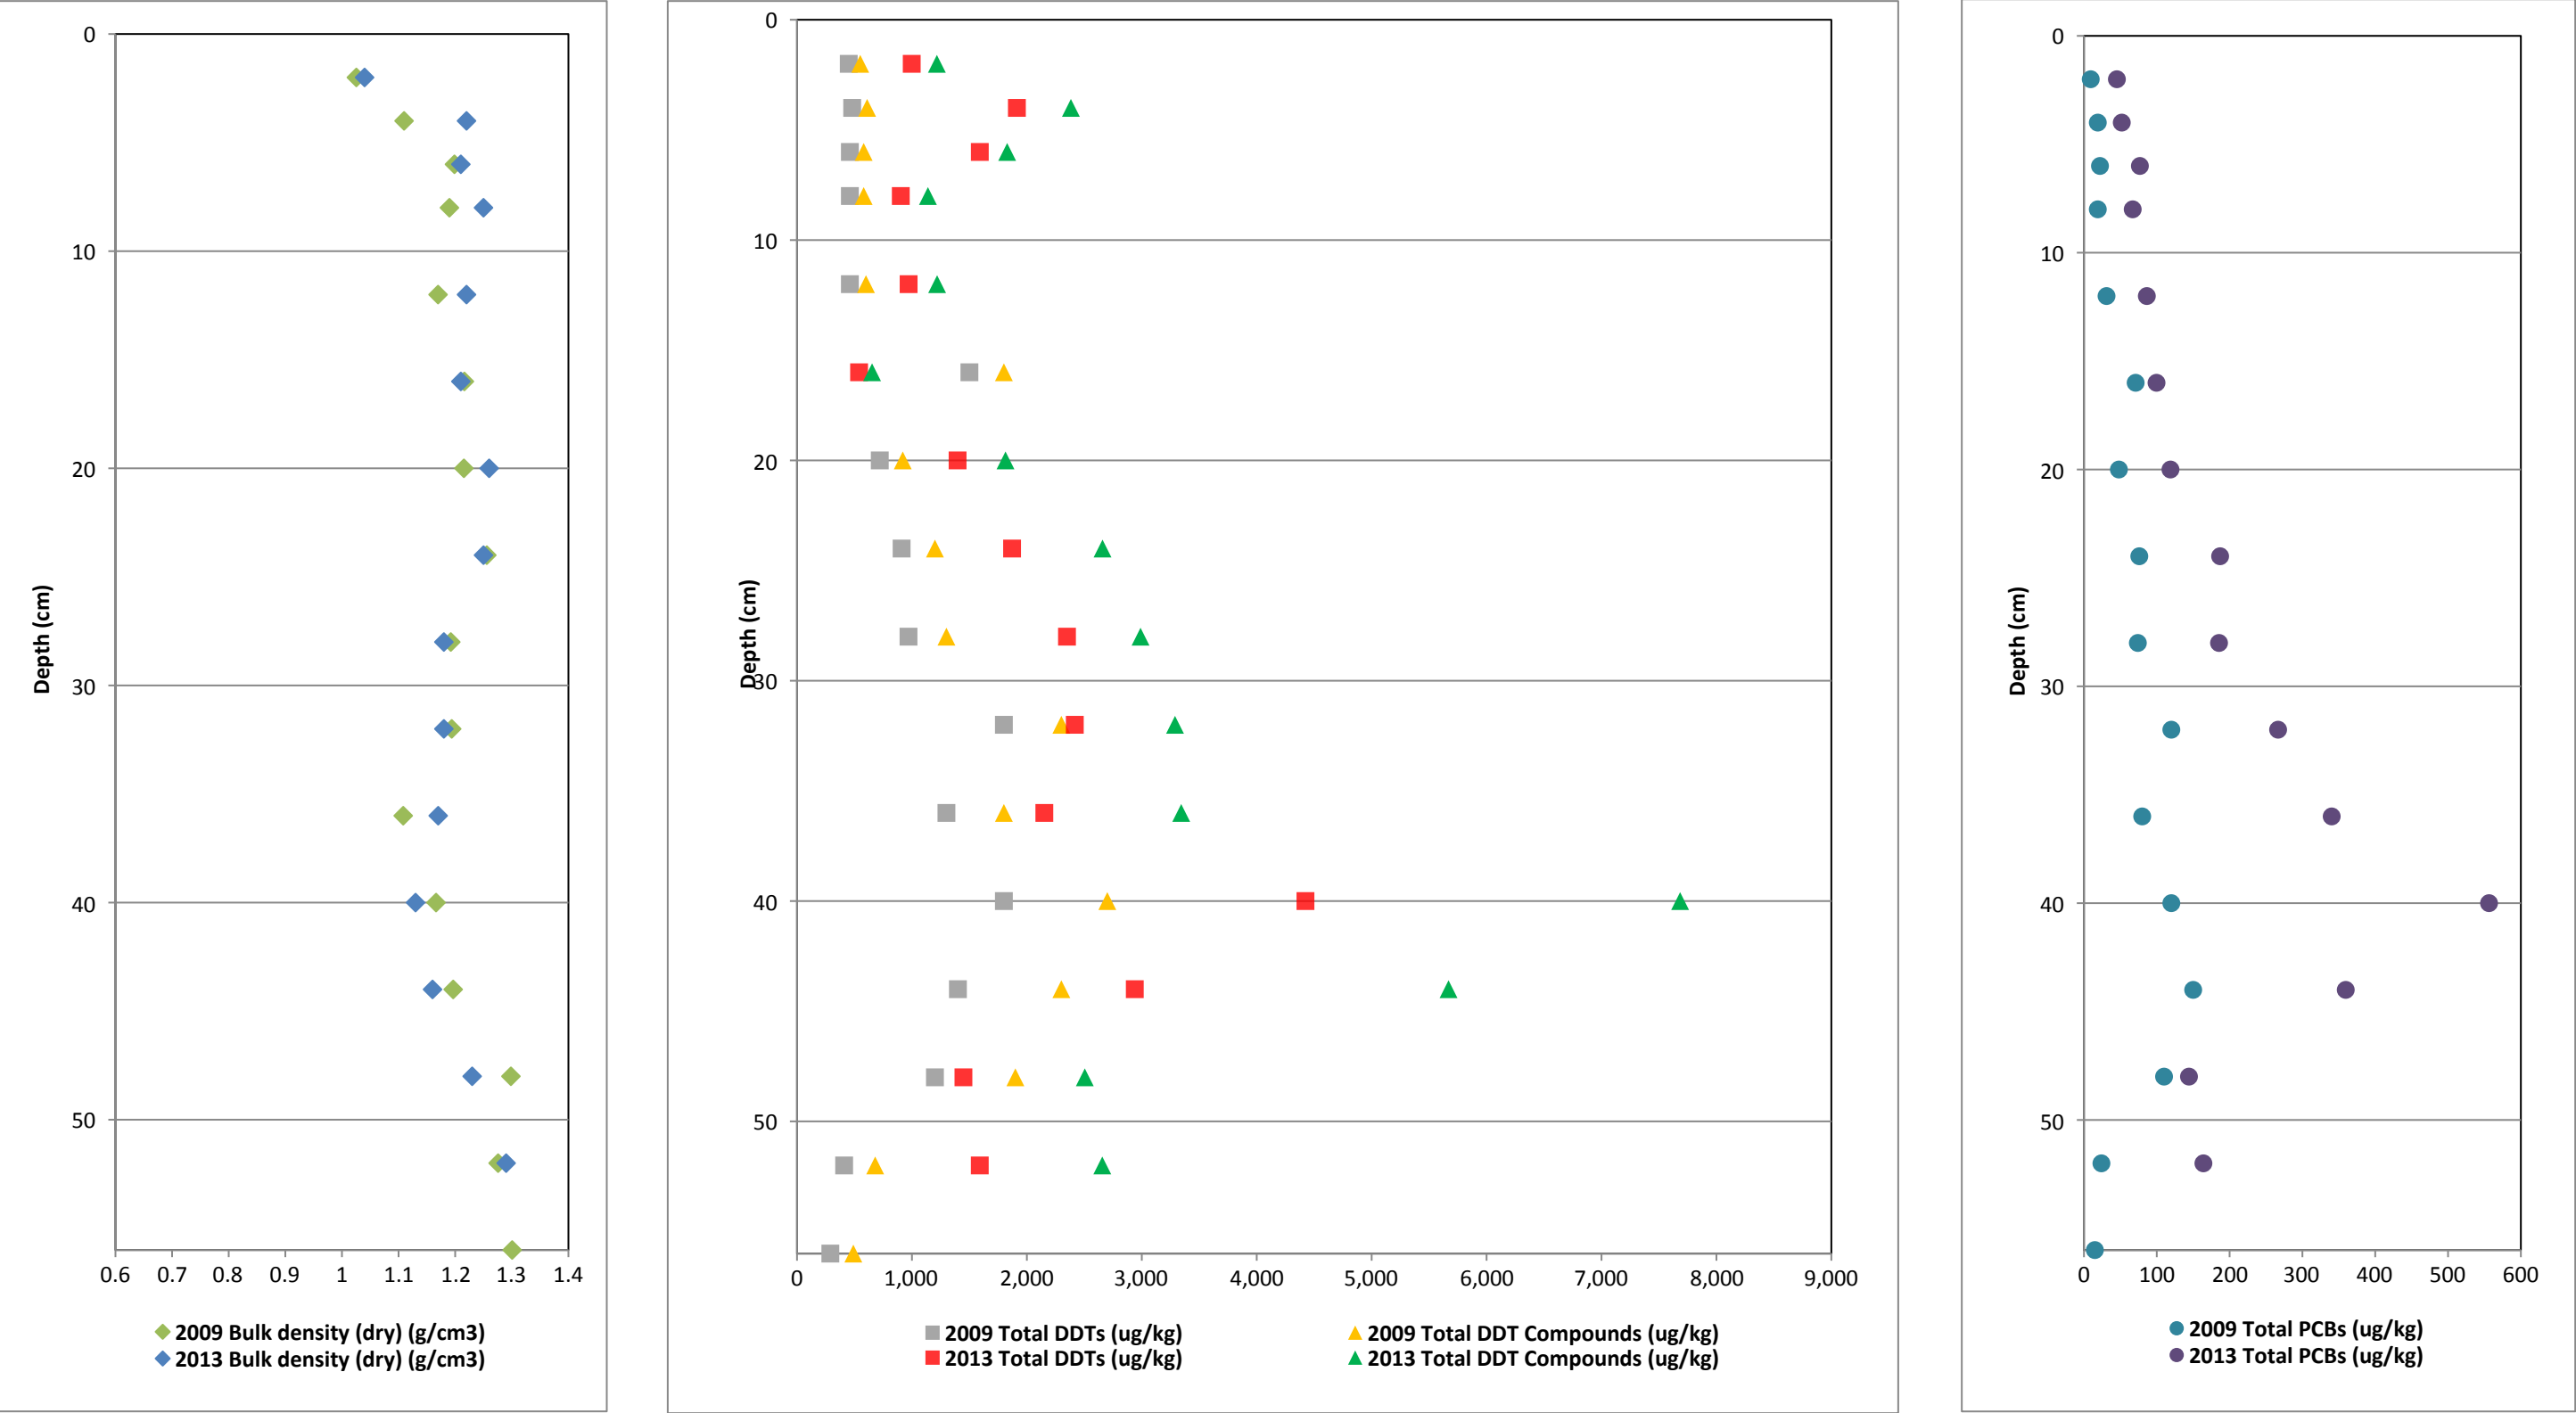
Figure 19. Vertical Profiles of Bulk Density and COCs for Core BA6DC  
First MNR Report  
Palos Verdes Shelf (OU 5 of the Montrose Chemical Corp. Superfund Site)  
Los Angeles County, California

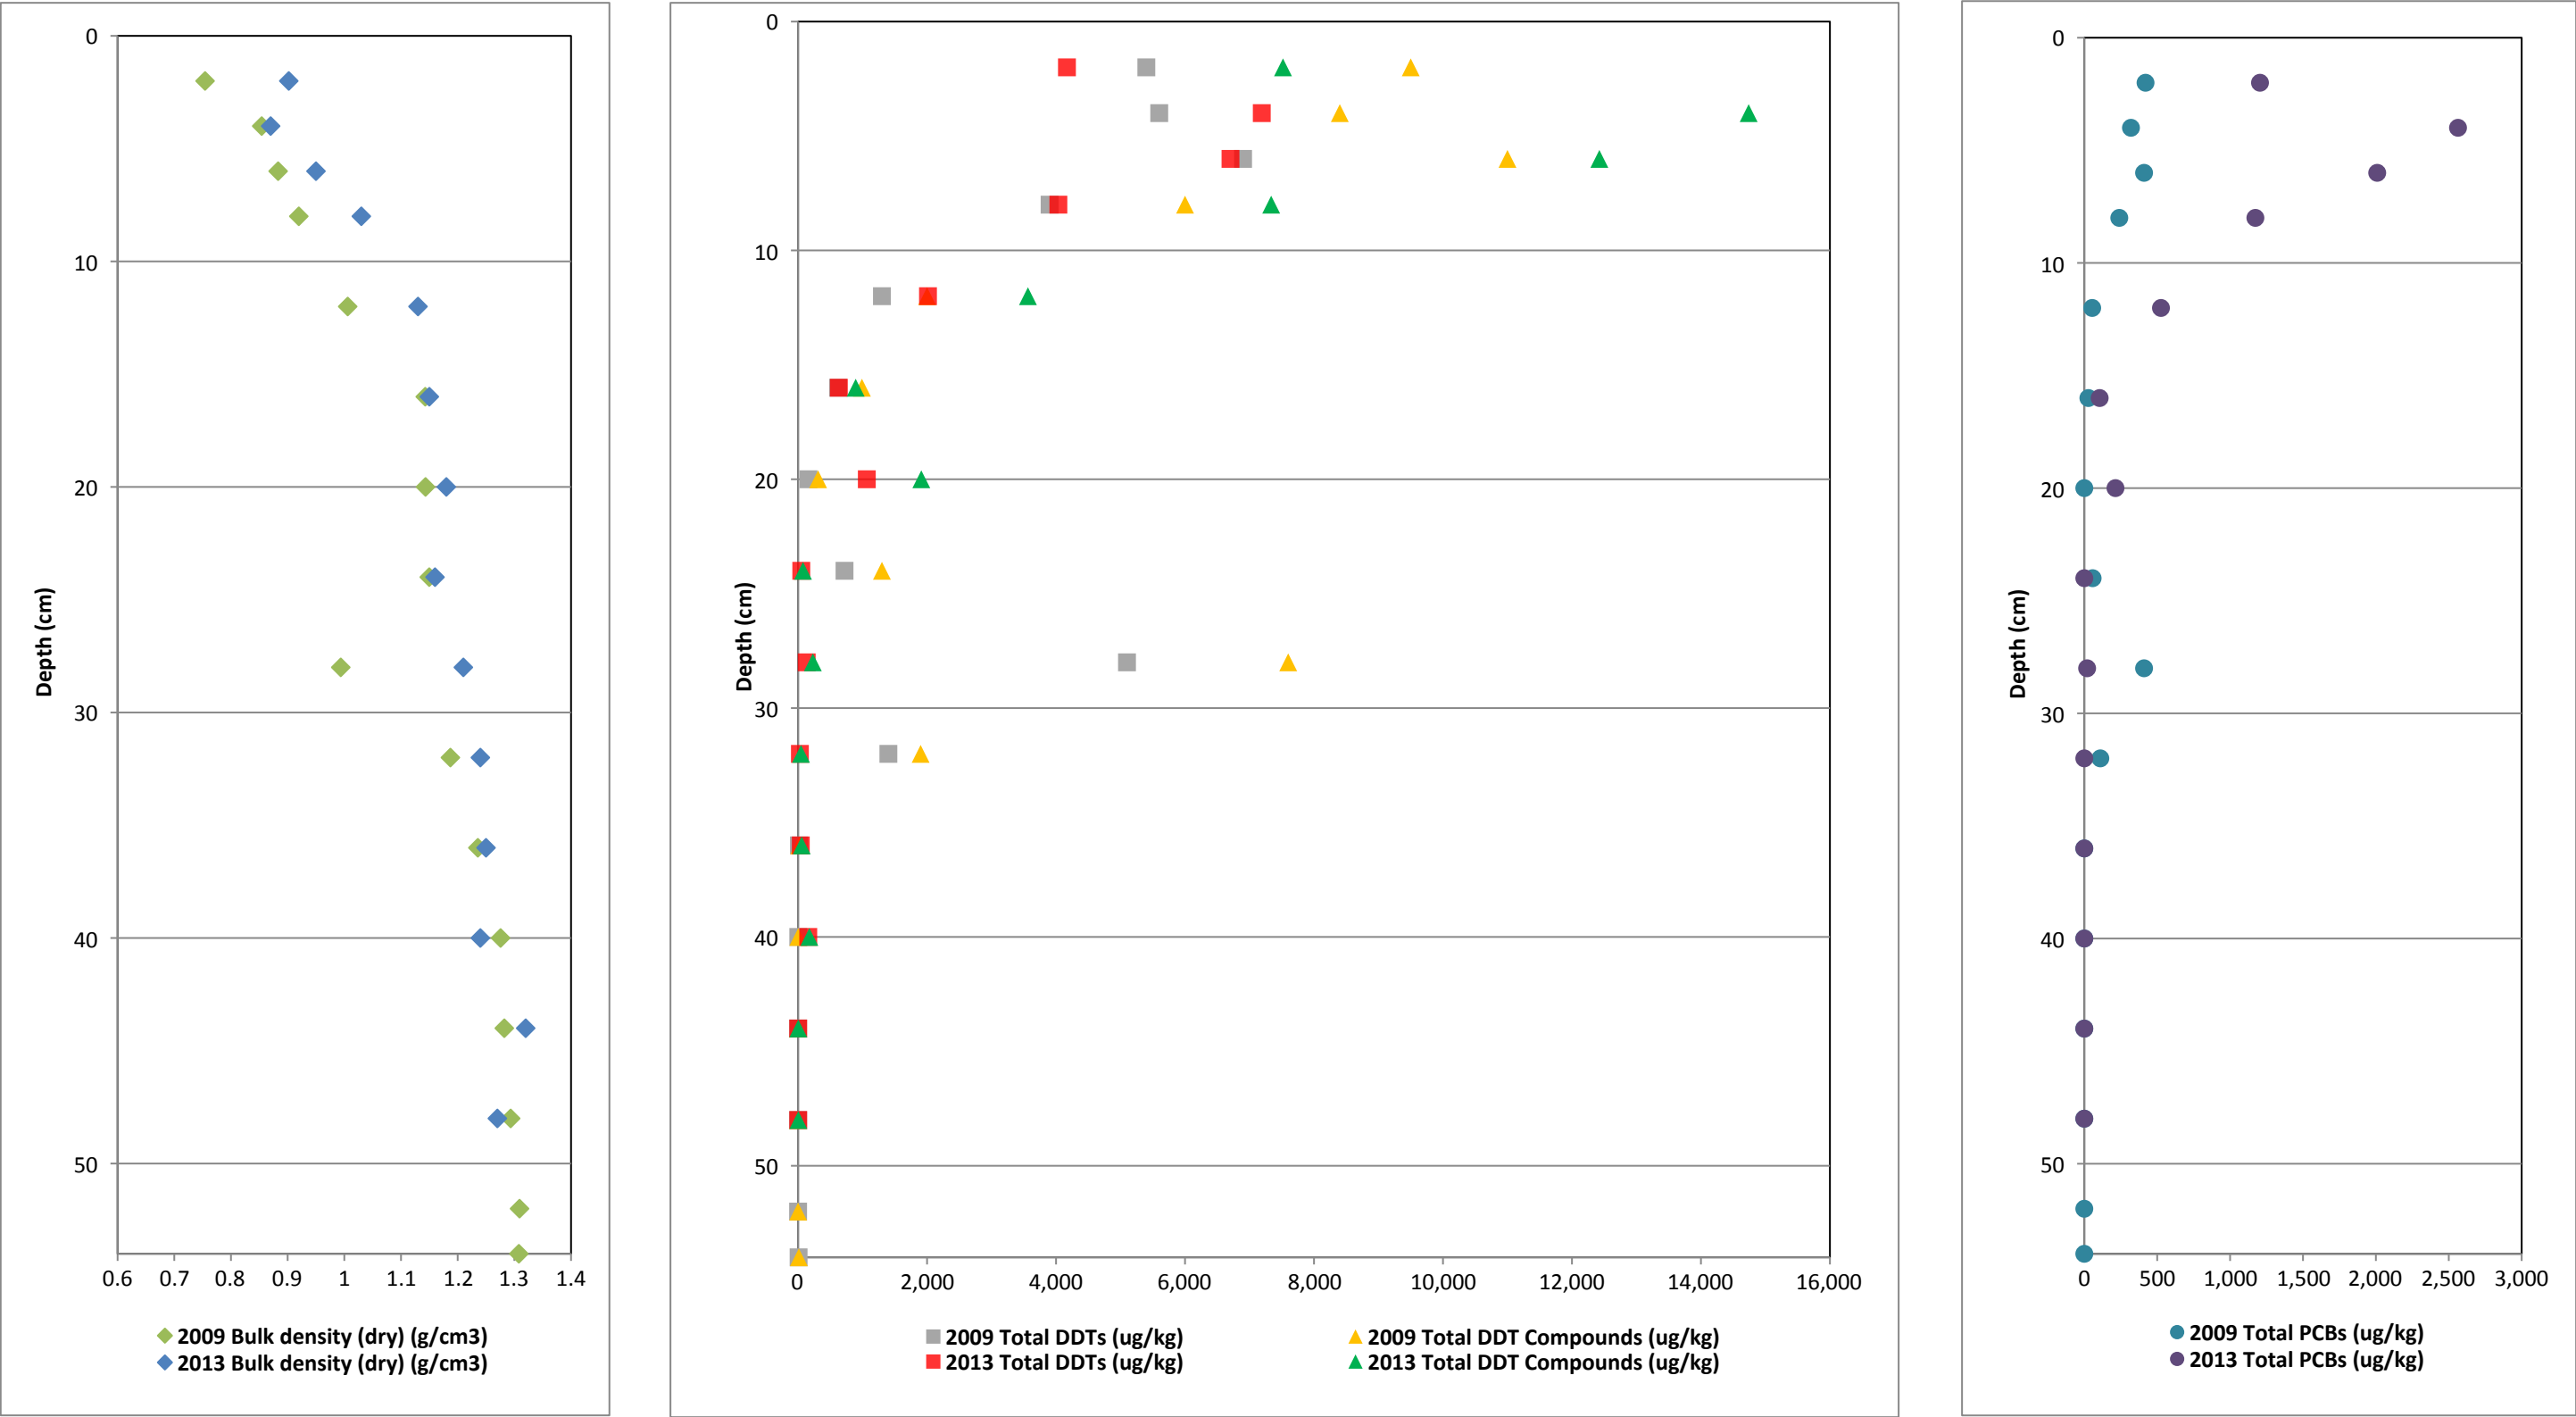
Figure 20. Vertical Profiles of Bulk Density and COCs for Core BA7B  
First MNR Report  
Palos Verdes Shelf (OU 5 of the Montrose Chemical Corp. Superfund Site)  
Los Angeles County, California

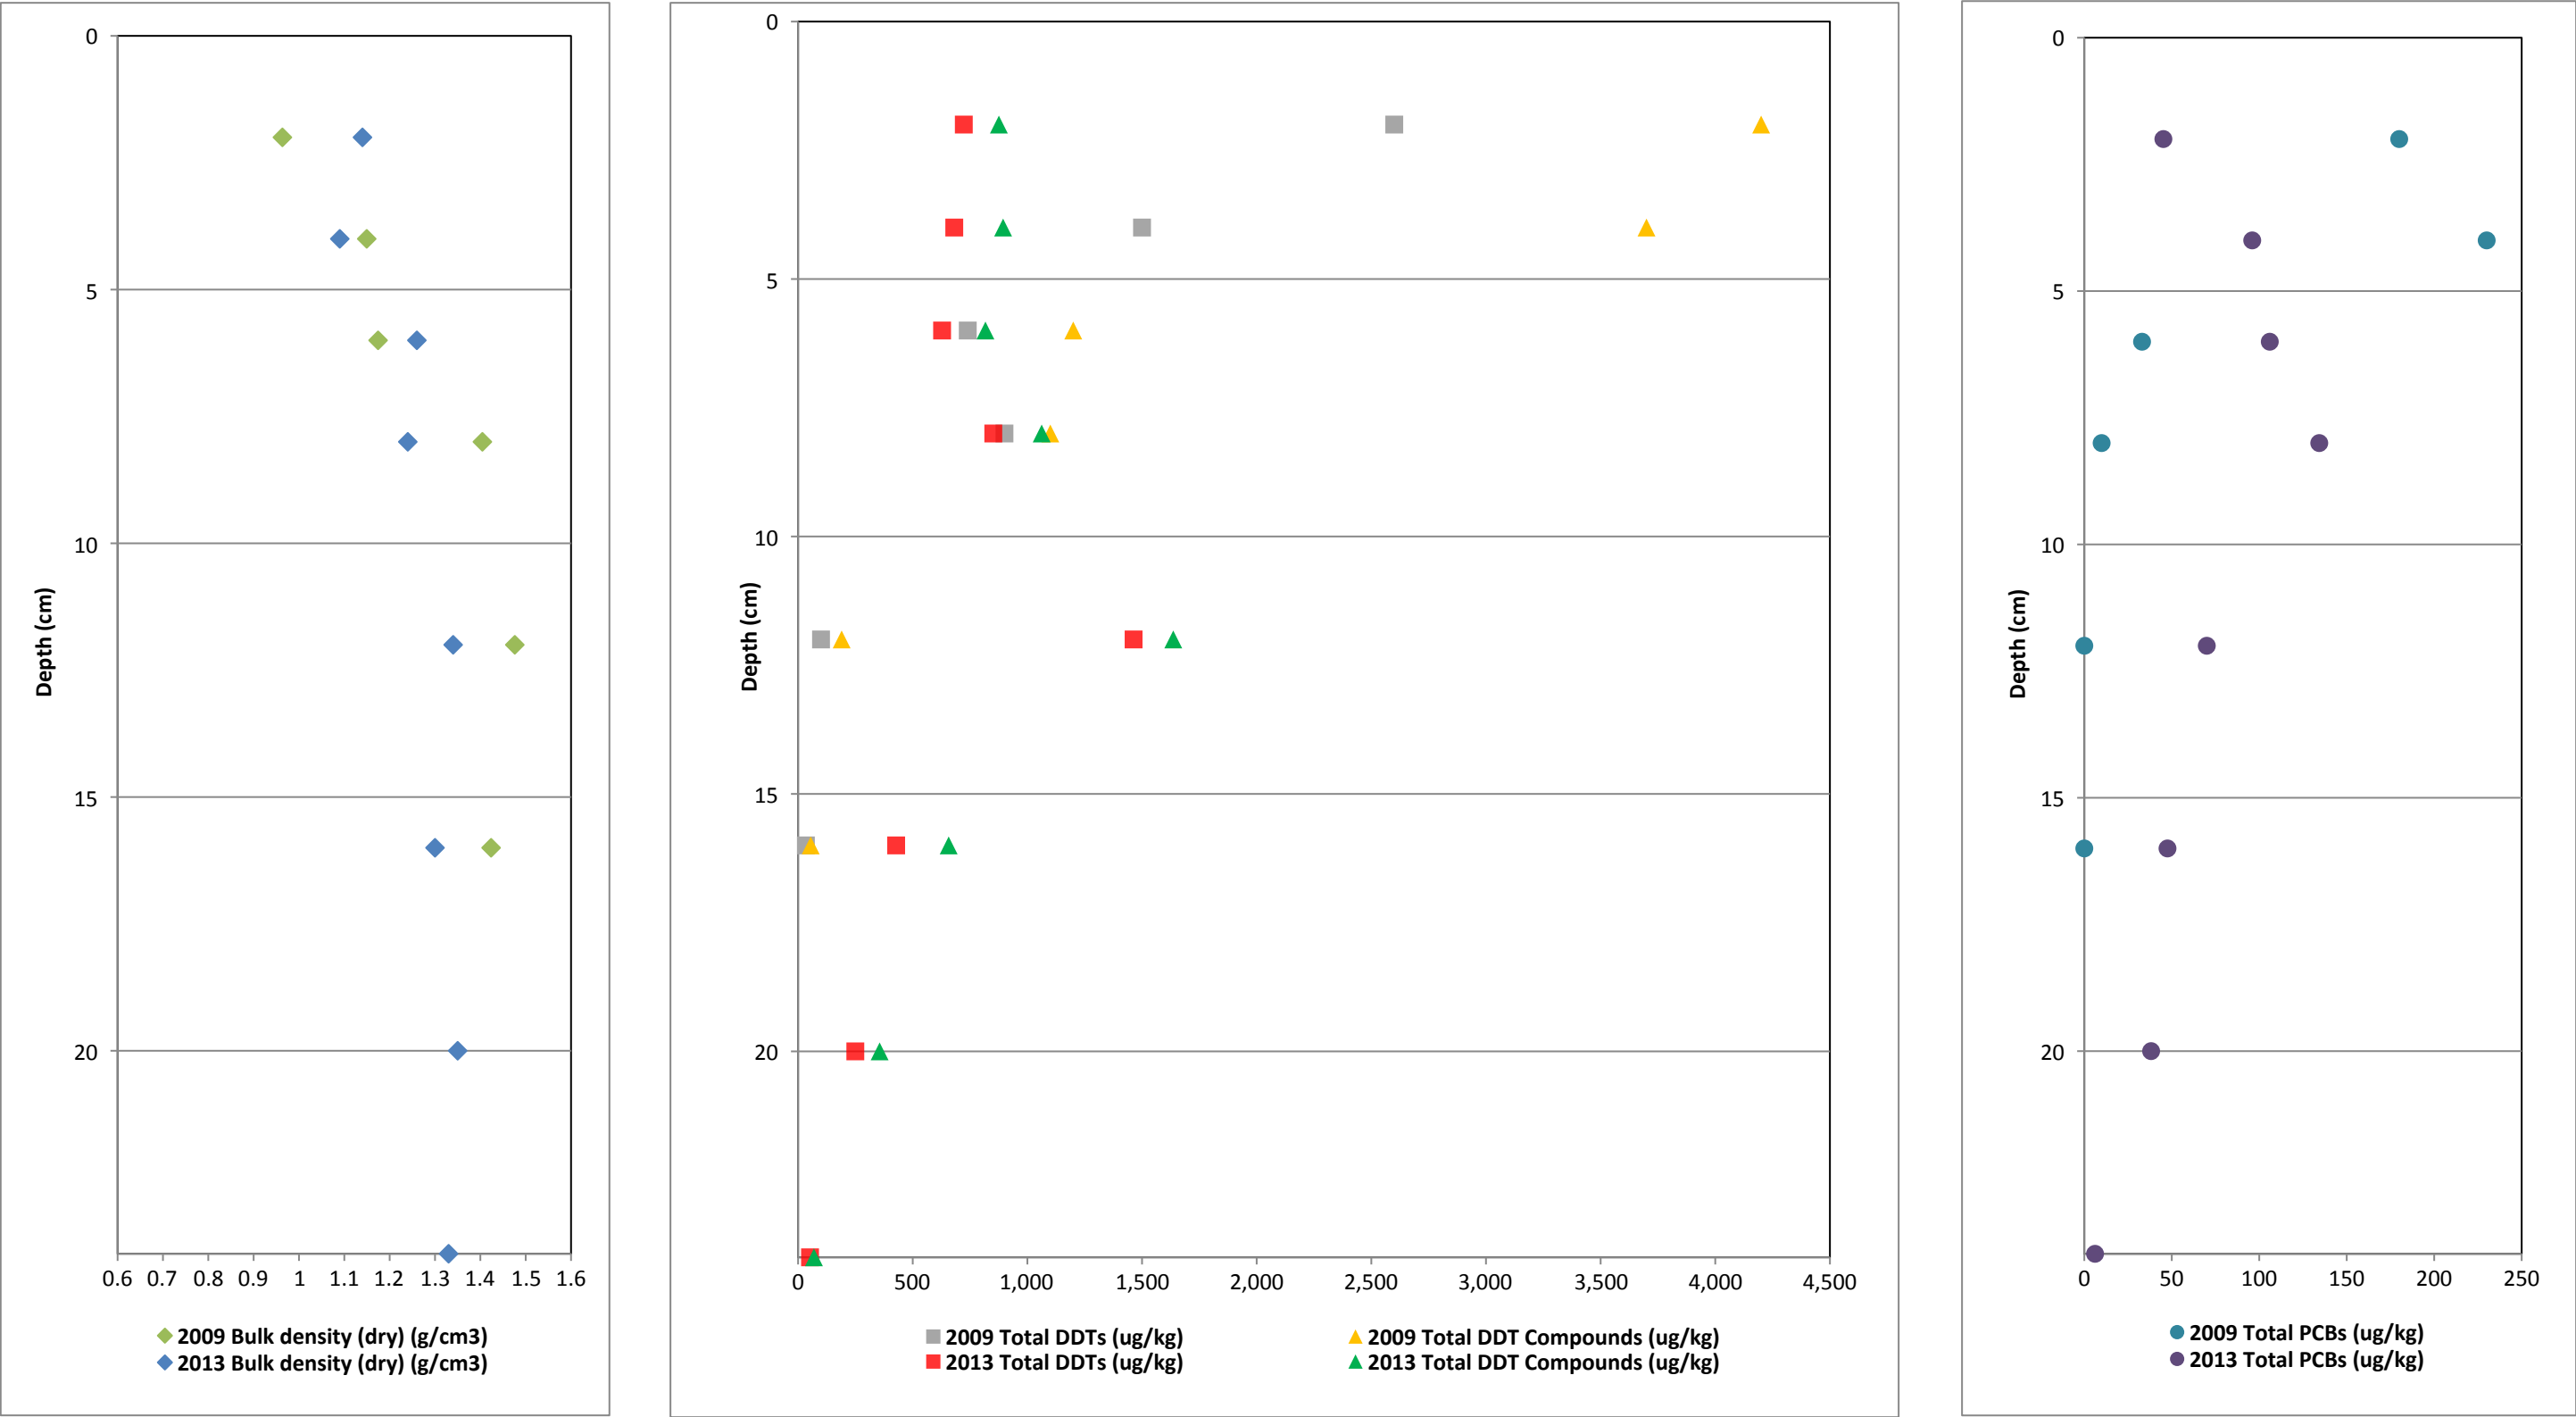
Figure 21. Vertical Profiles of Bulk Density and COCs for Core BA7BC  
First MNR Report  
Palos Verdes Shelf (OU 5 of the Montrose Chemical Corp. Superfund Site)  
Los Angeles County, California

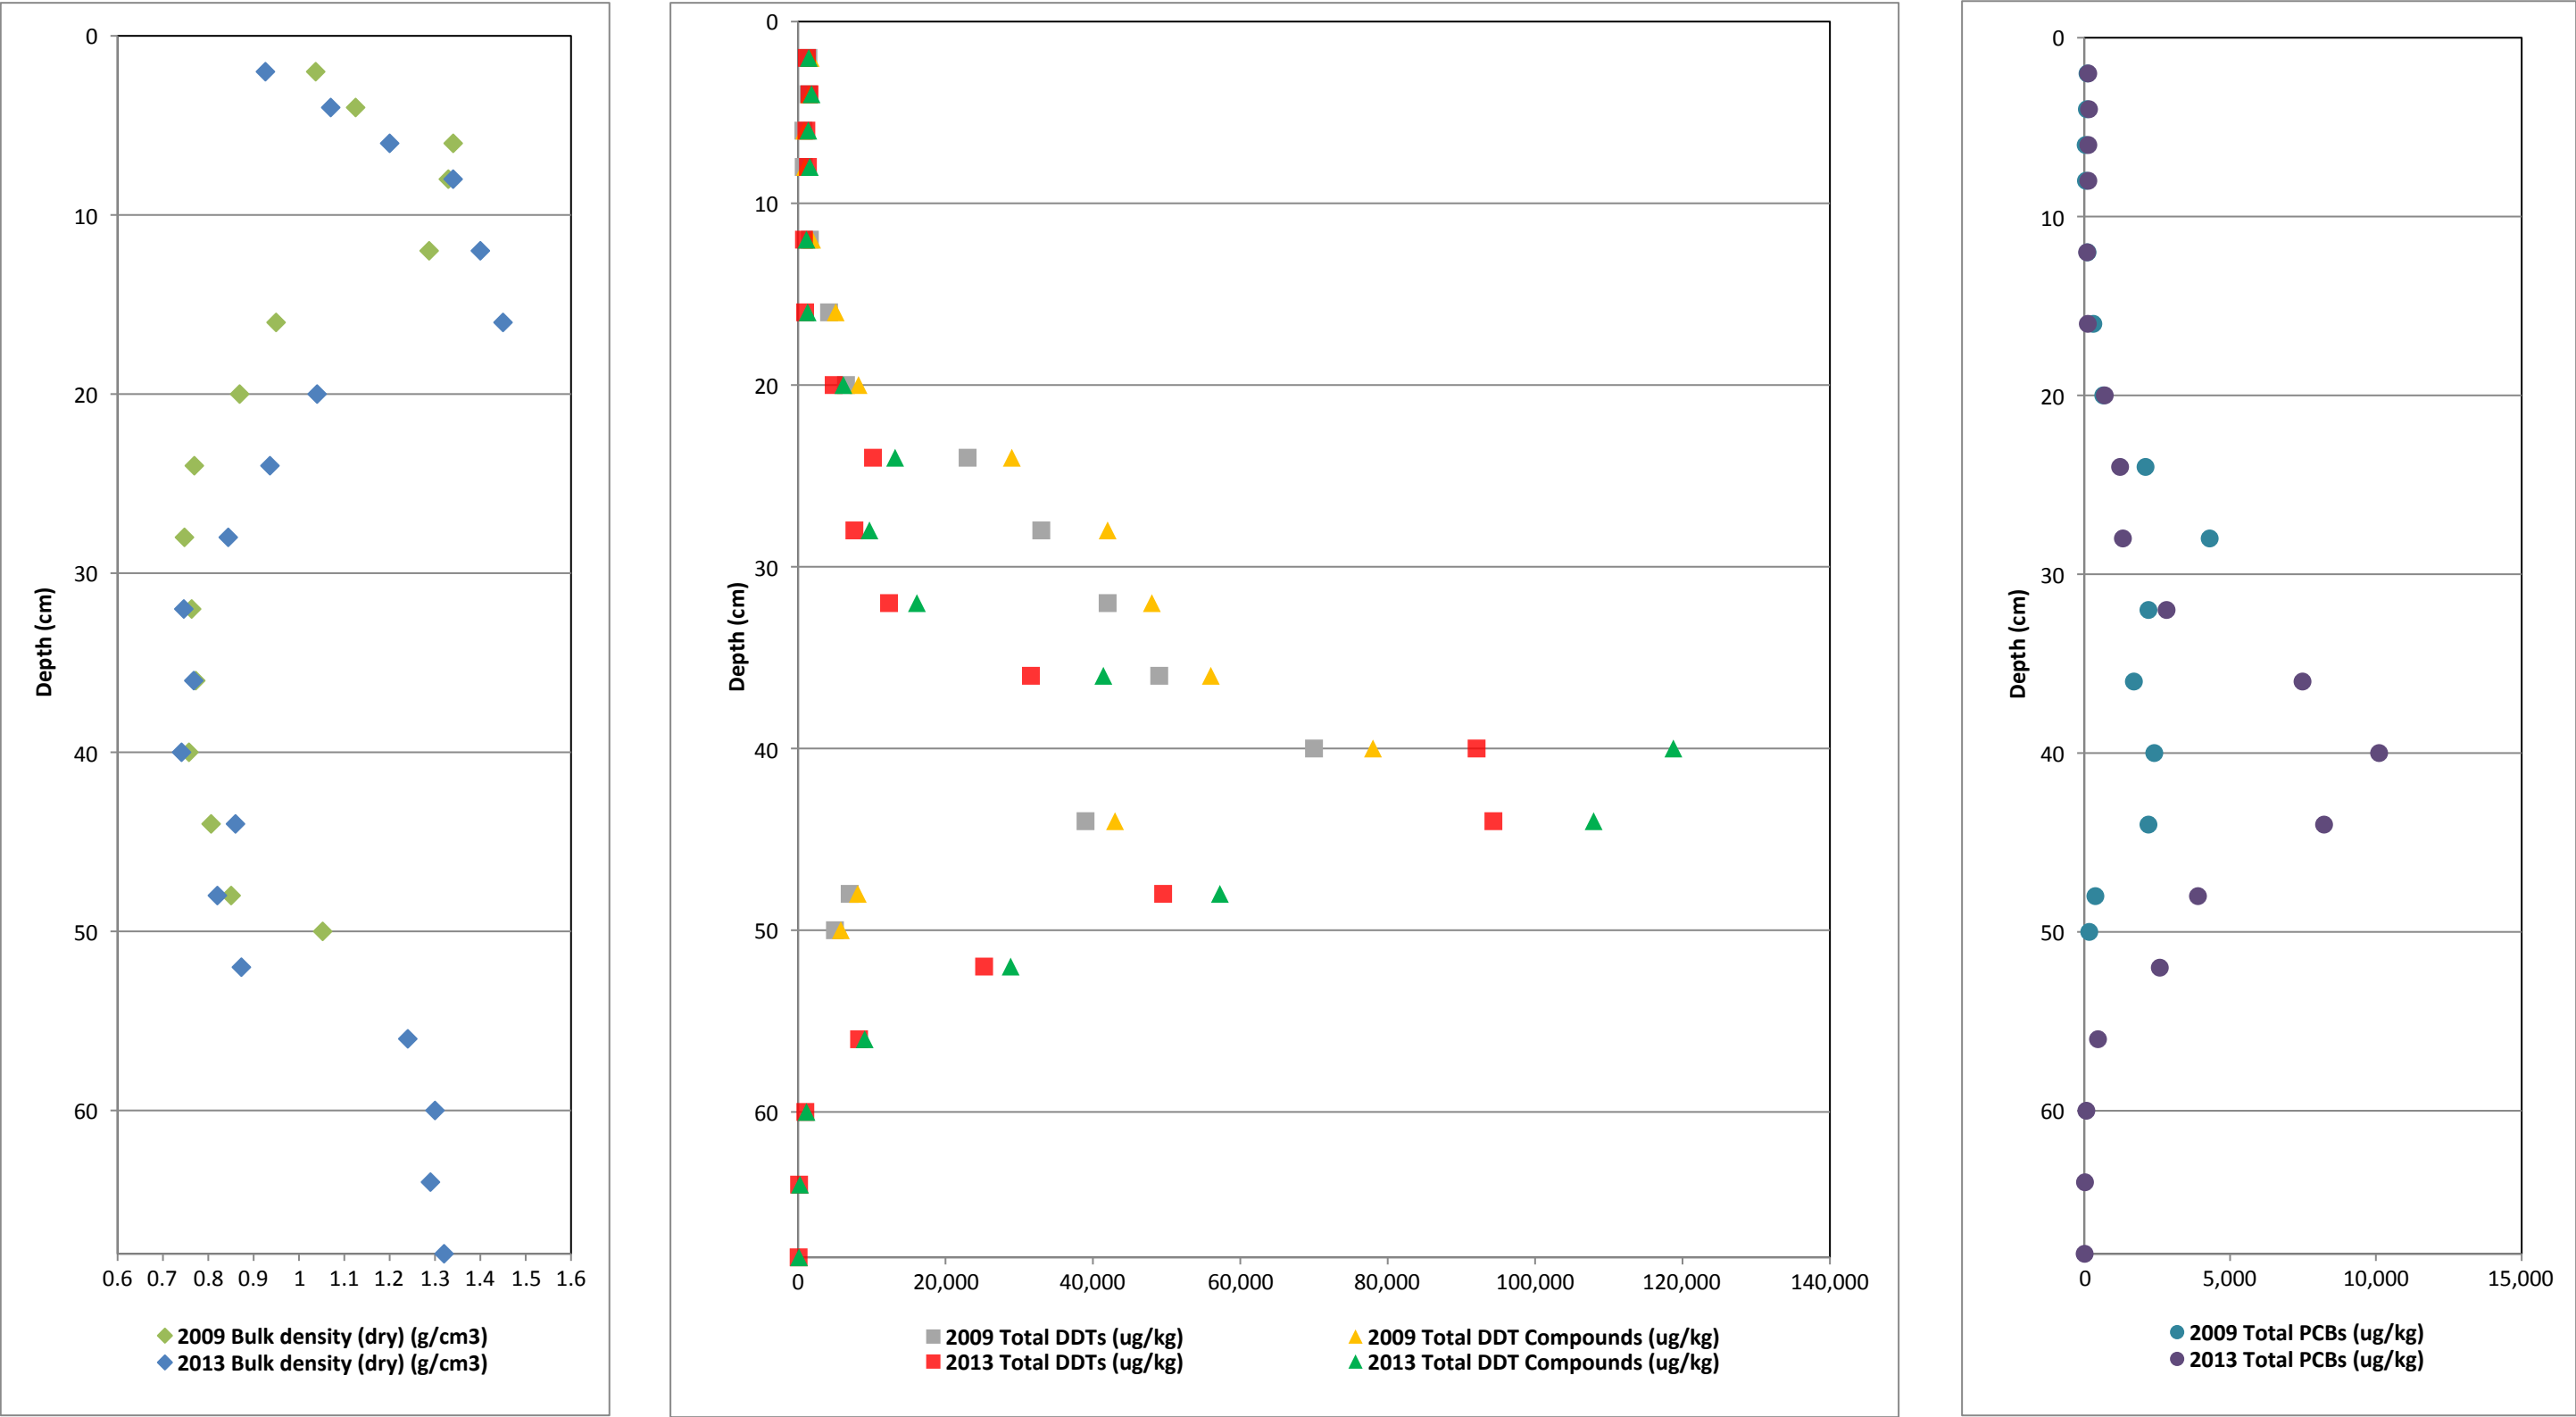
Figure 22. Vertical Profiles of Bulk Density and COCs for Core BA7C  
First MNR Report  
Palos Verdes Shelf (OU 5 of the Montrose Chemical Corp. Superfund Site)  
Los Angeles County, California

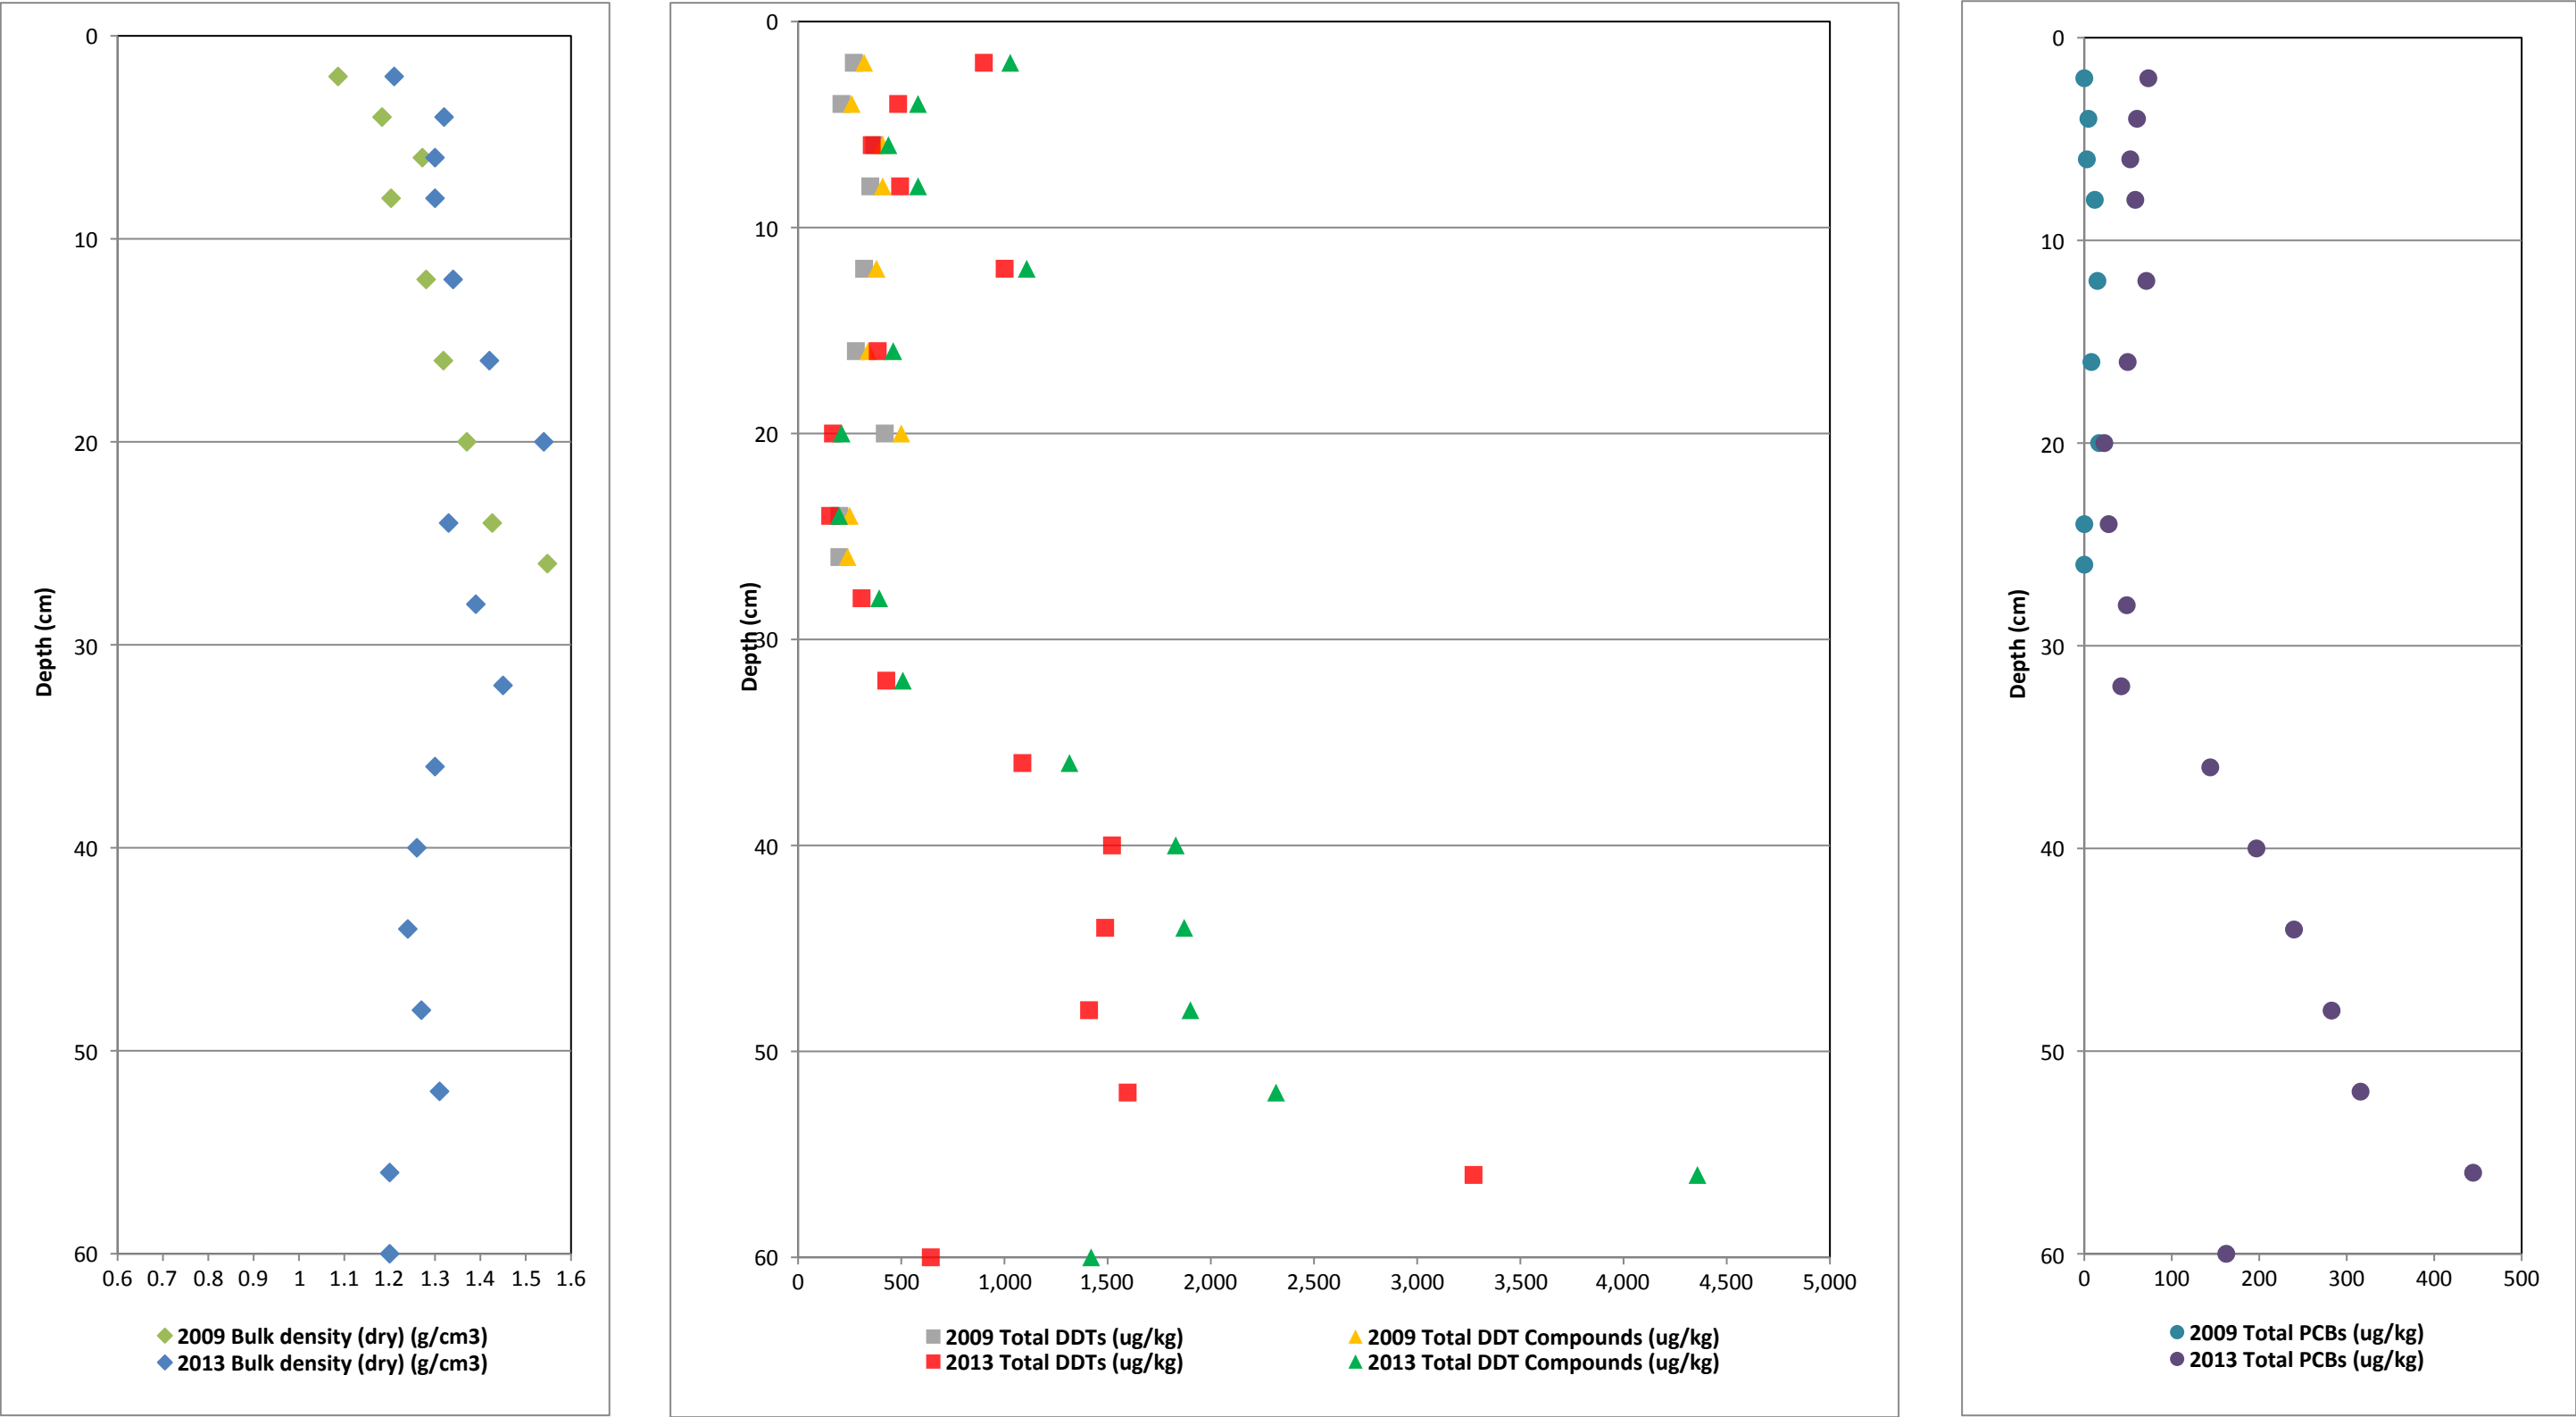
Figure 23. Vertical Profiles of Bulk Density and COCs for Core BA7DC  
First MNR Report  
Palos Verdes Shelf (OU 5 of the Montrose Chemical Corp. Superfund Site)  
Los Angeles County, California
