**APPENDIX X**  
**VERTICAL PROFILES OF SEDIMENT BED – BD AND COCS**

## **APPENDIX X.1 – VERTICAL PROFILES – SHELF-WIDE CORES**

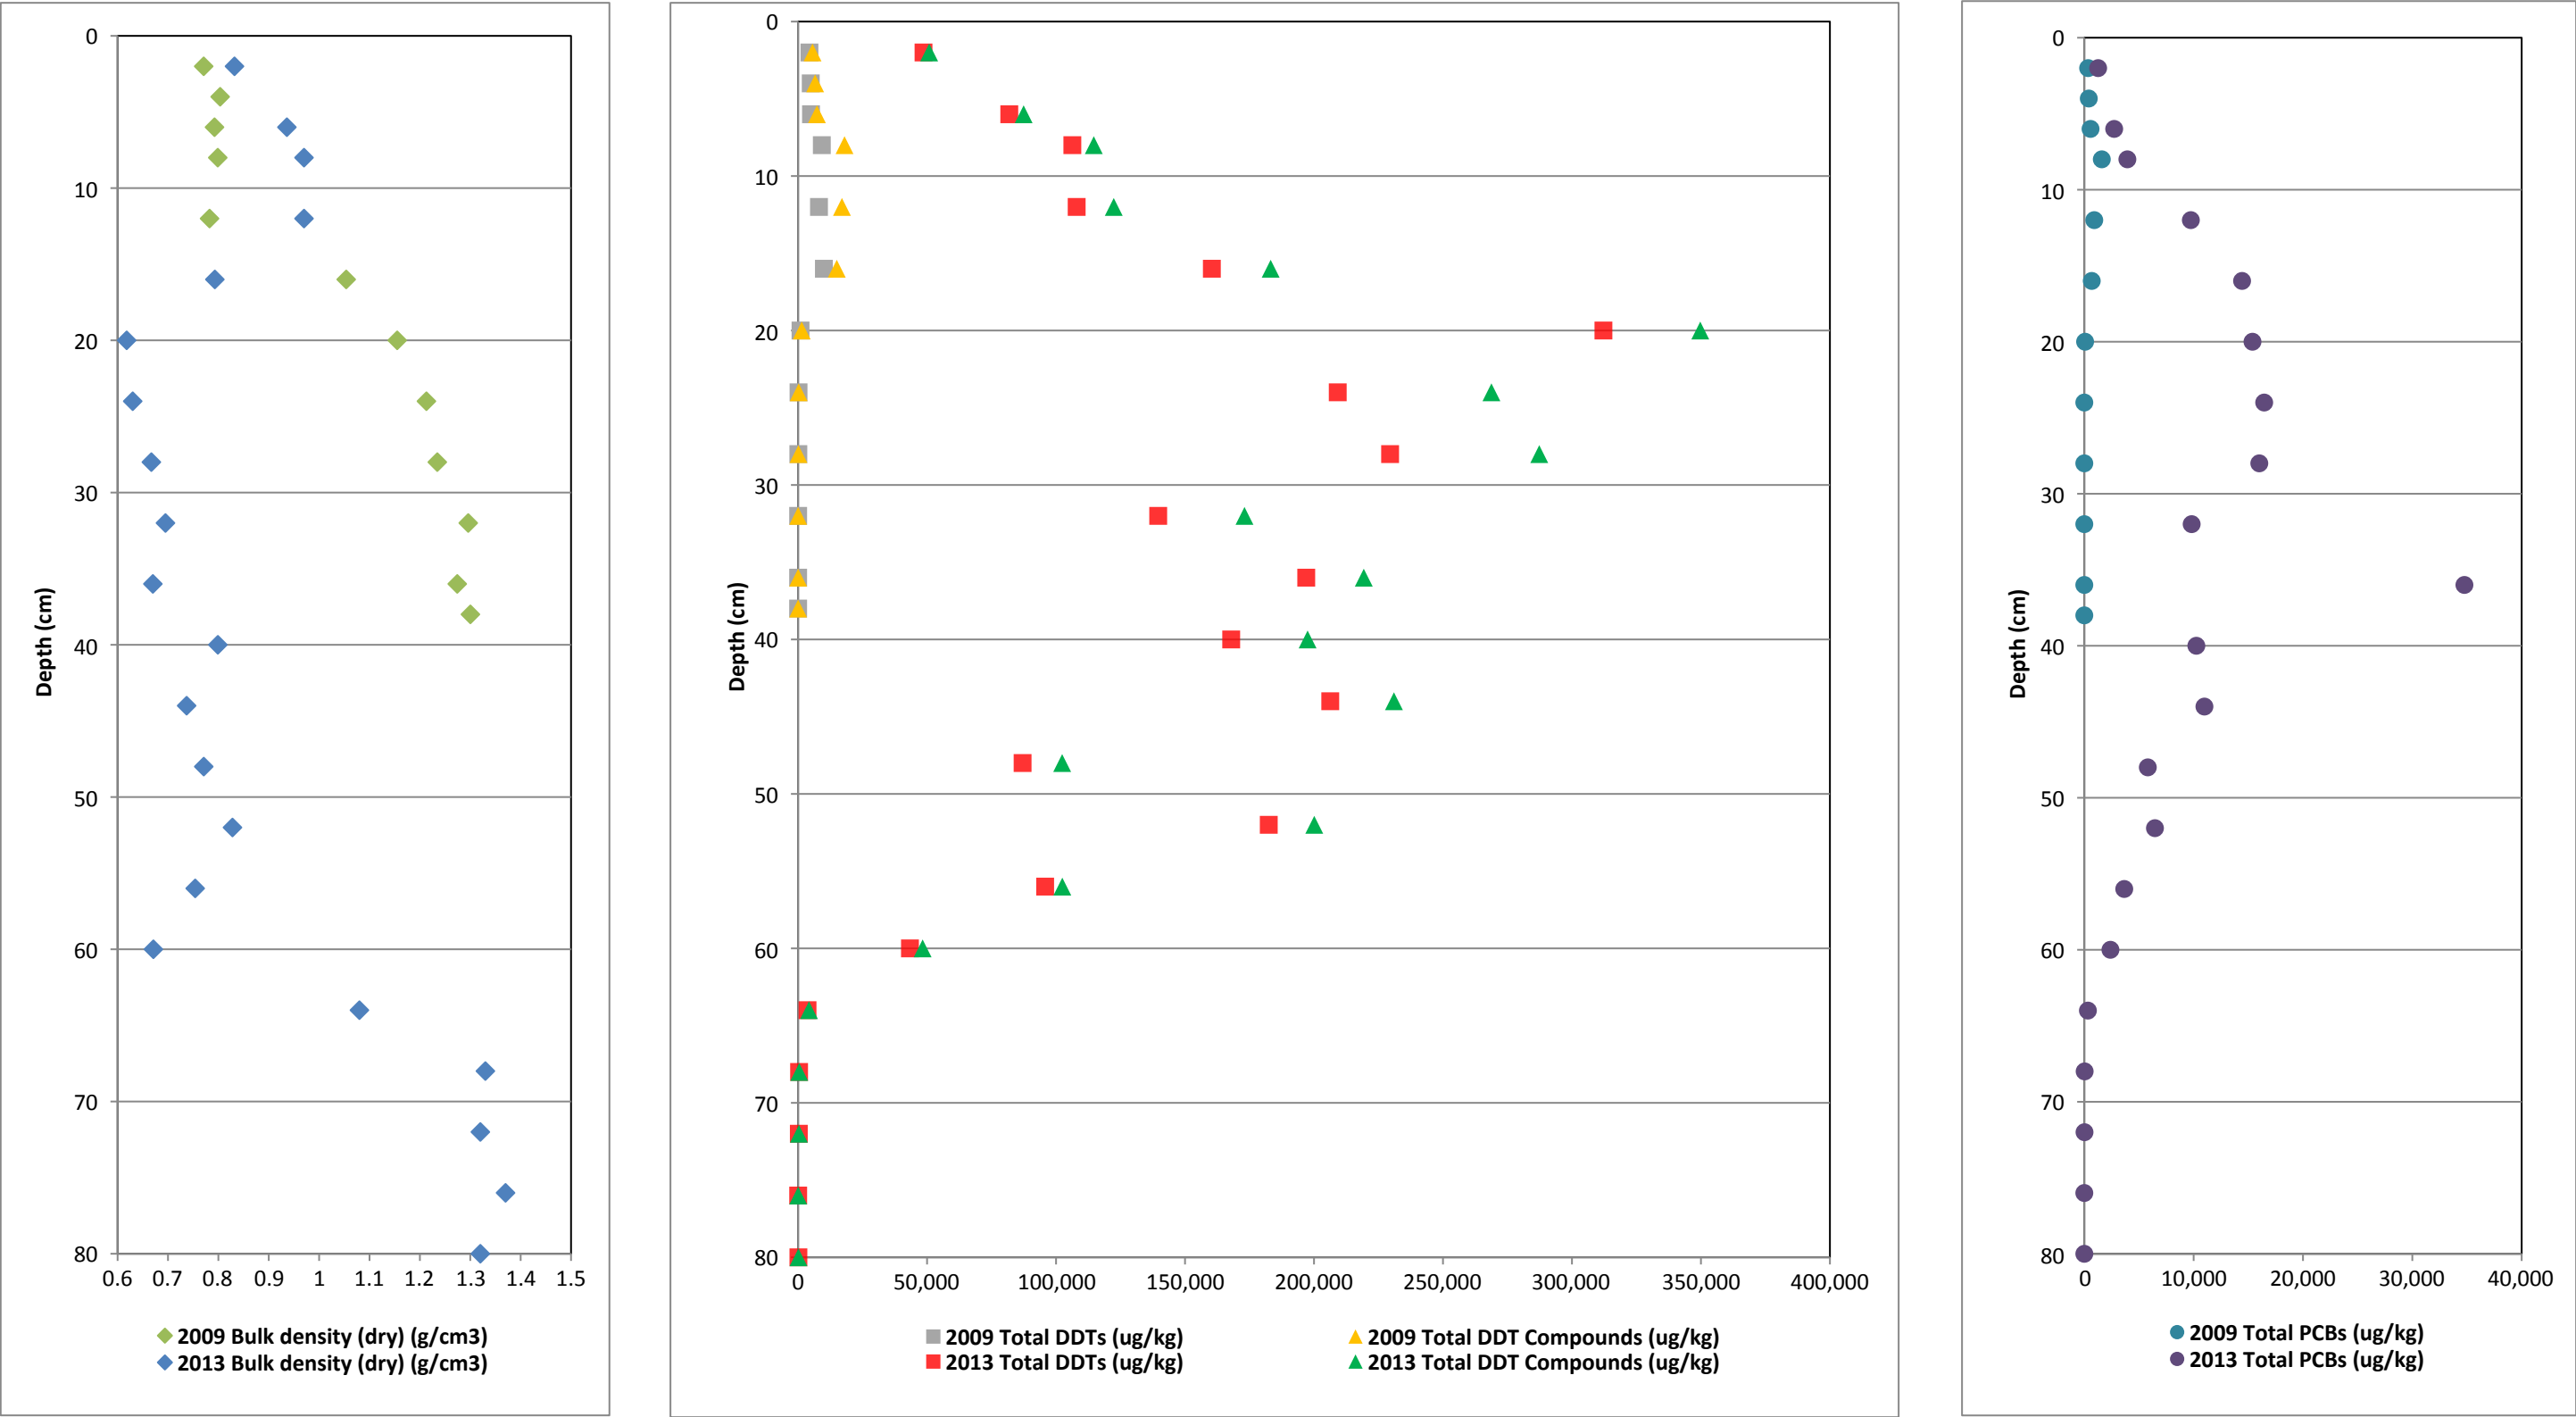
Figure 24. Vertical Profiles of Bulk Density and COCs for Core BA8B  
First MNR Report  
Palos Verdes Shelf (OU 5 of the Montrose Chemical Corp. Superfund Site)  
Los Angeles County, California

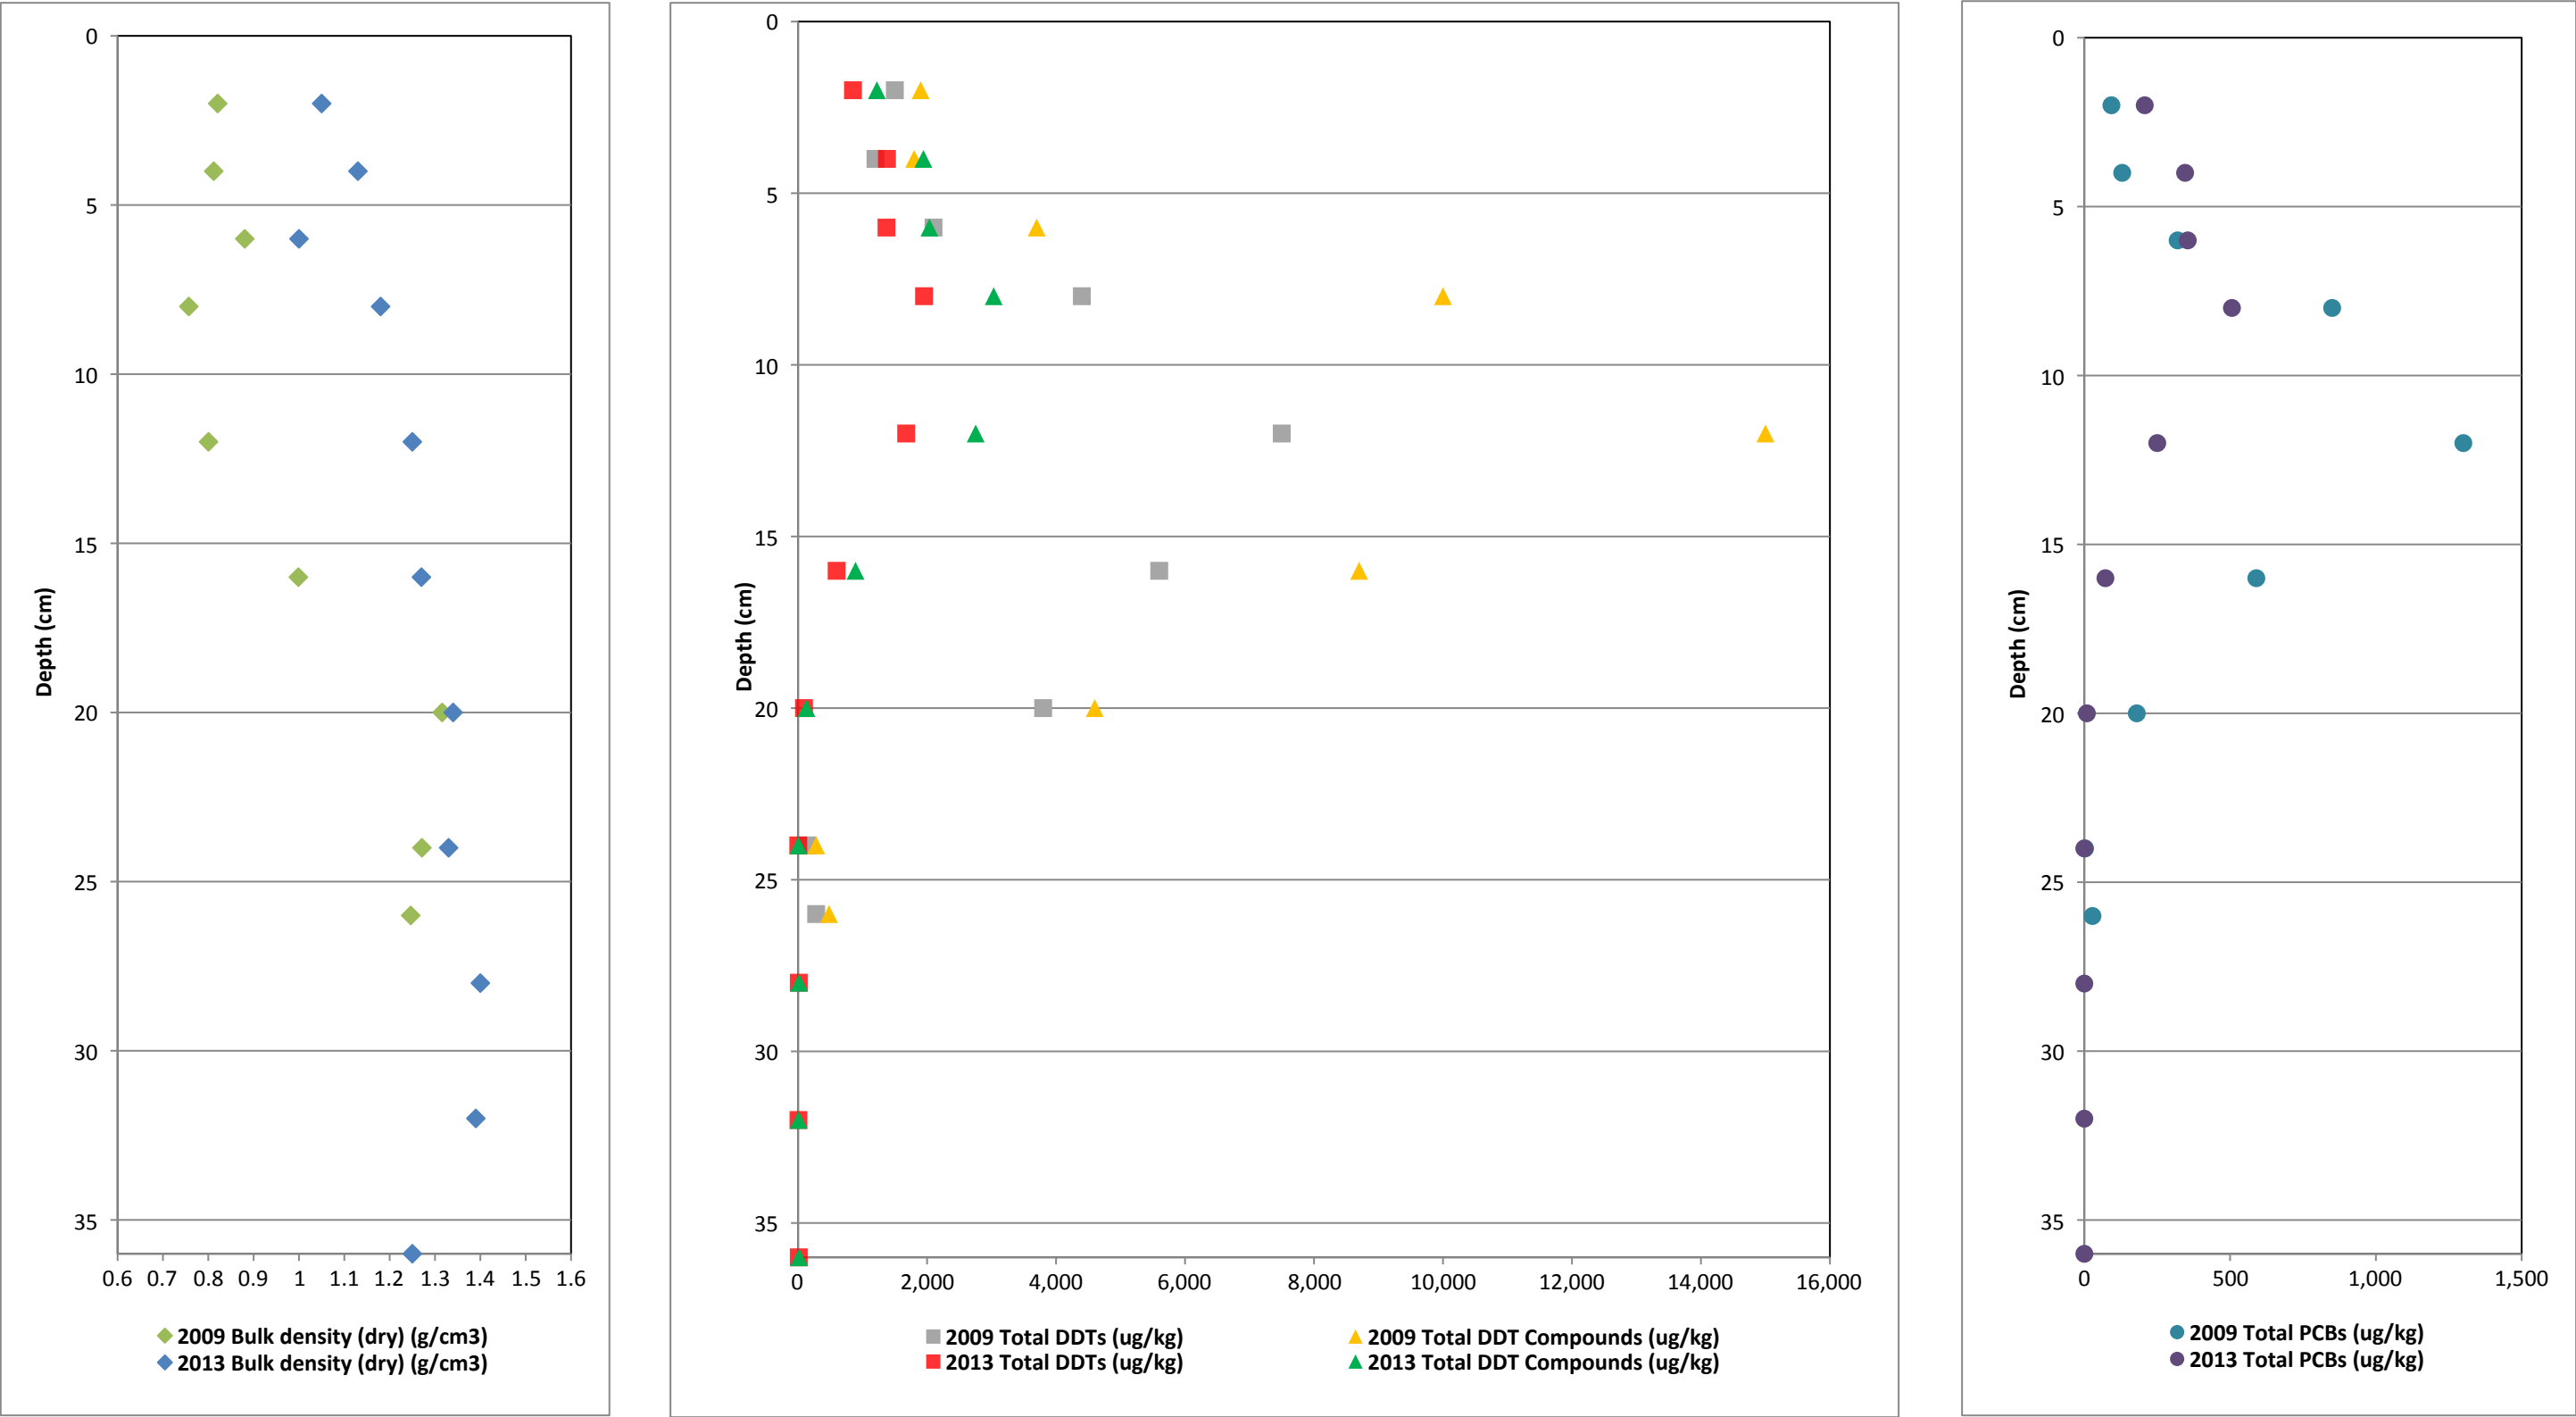
Figure 25. Vertical Profiles of Bulk Density and COCs for Core BA8BC  
First MNR Report  
Palos Verdes Shelf (OU 5 of the Montrose Chemical Corp. Superfund Site)  
Los Angeles County, California

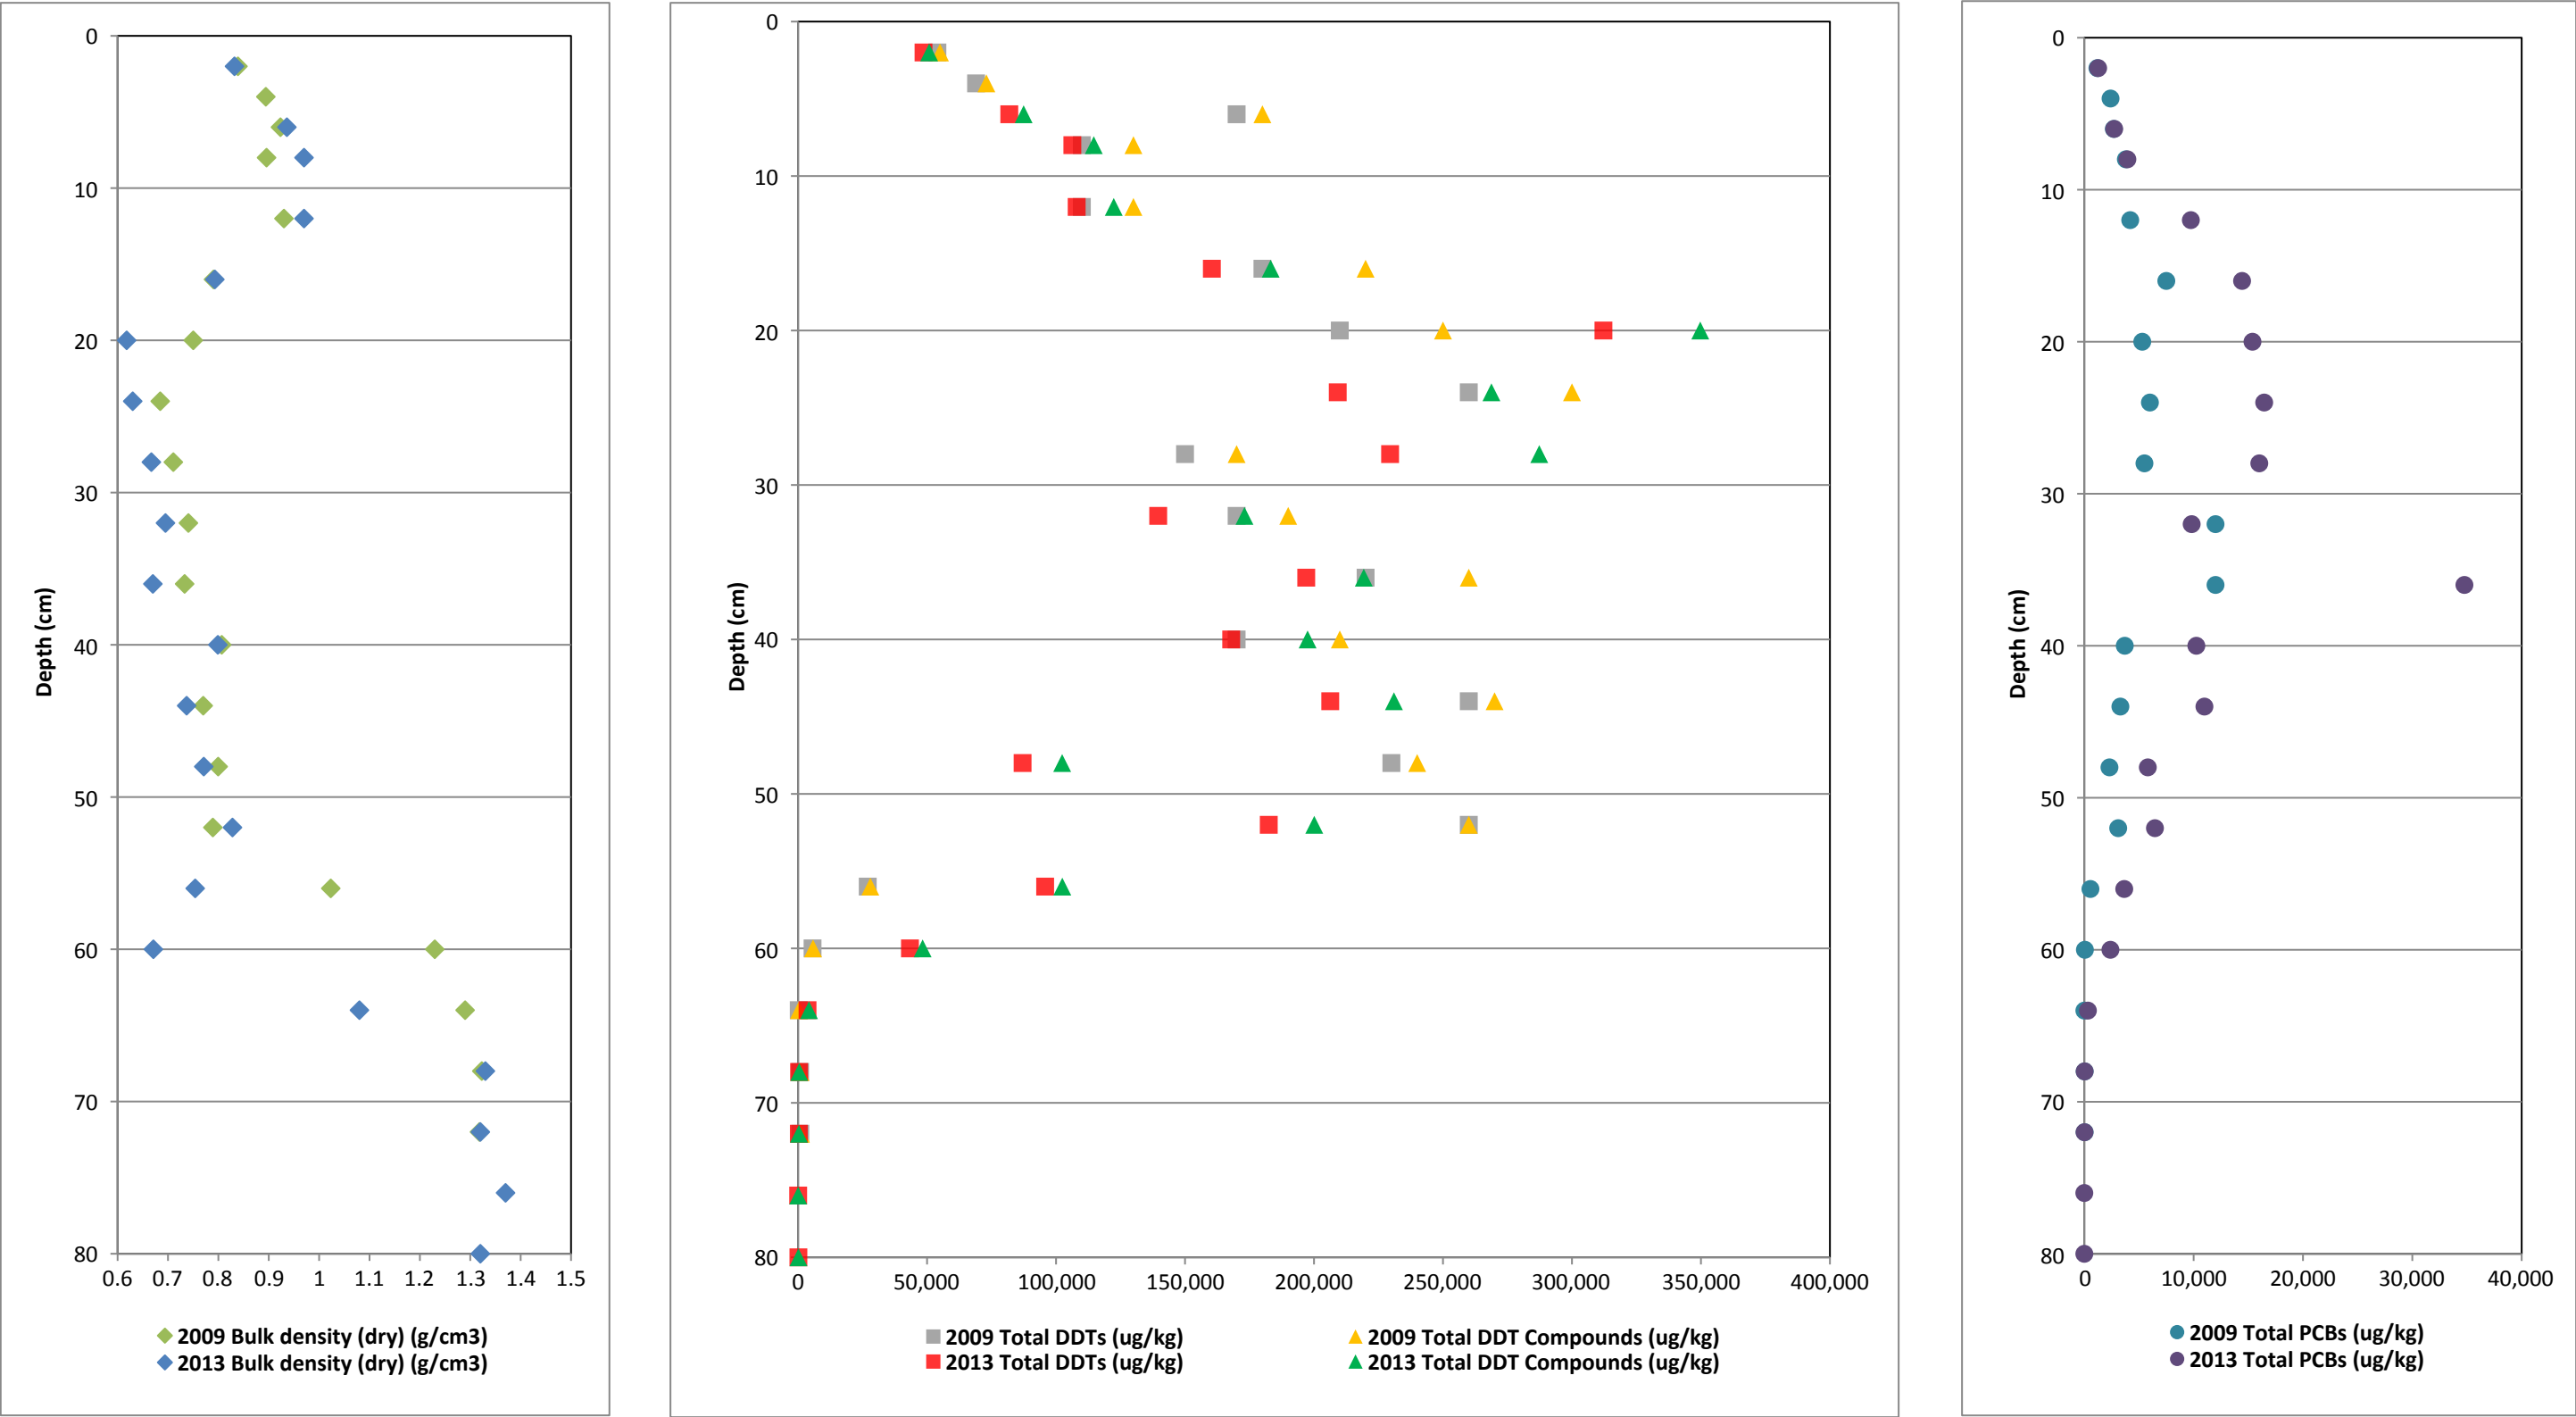
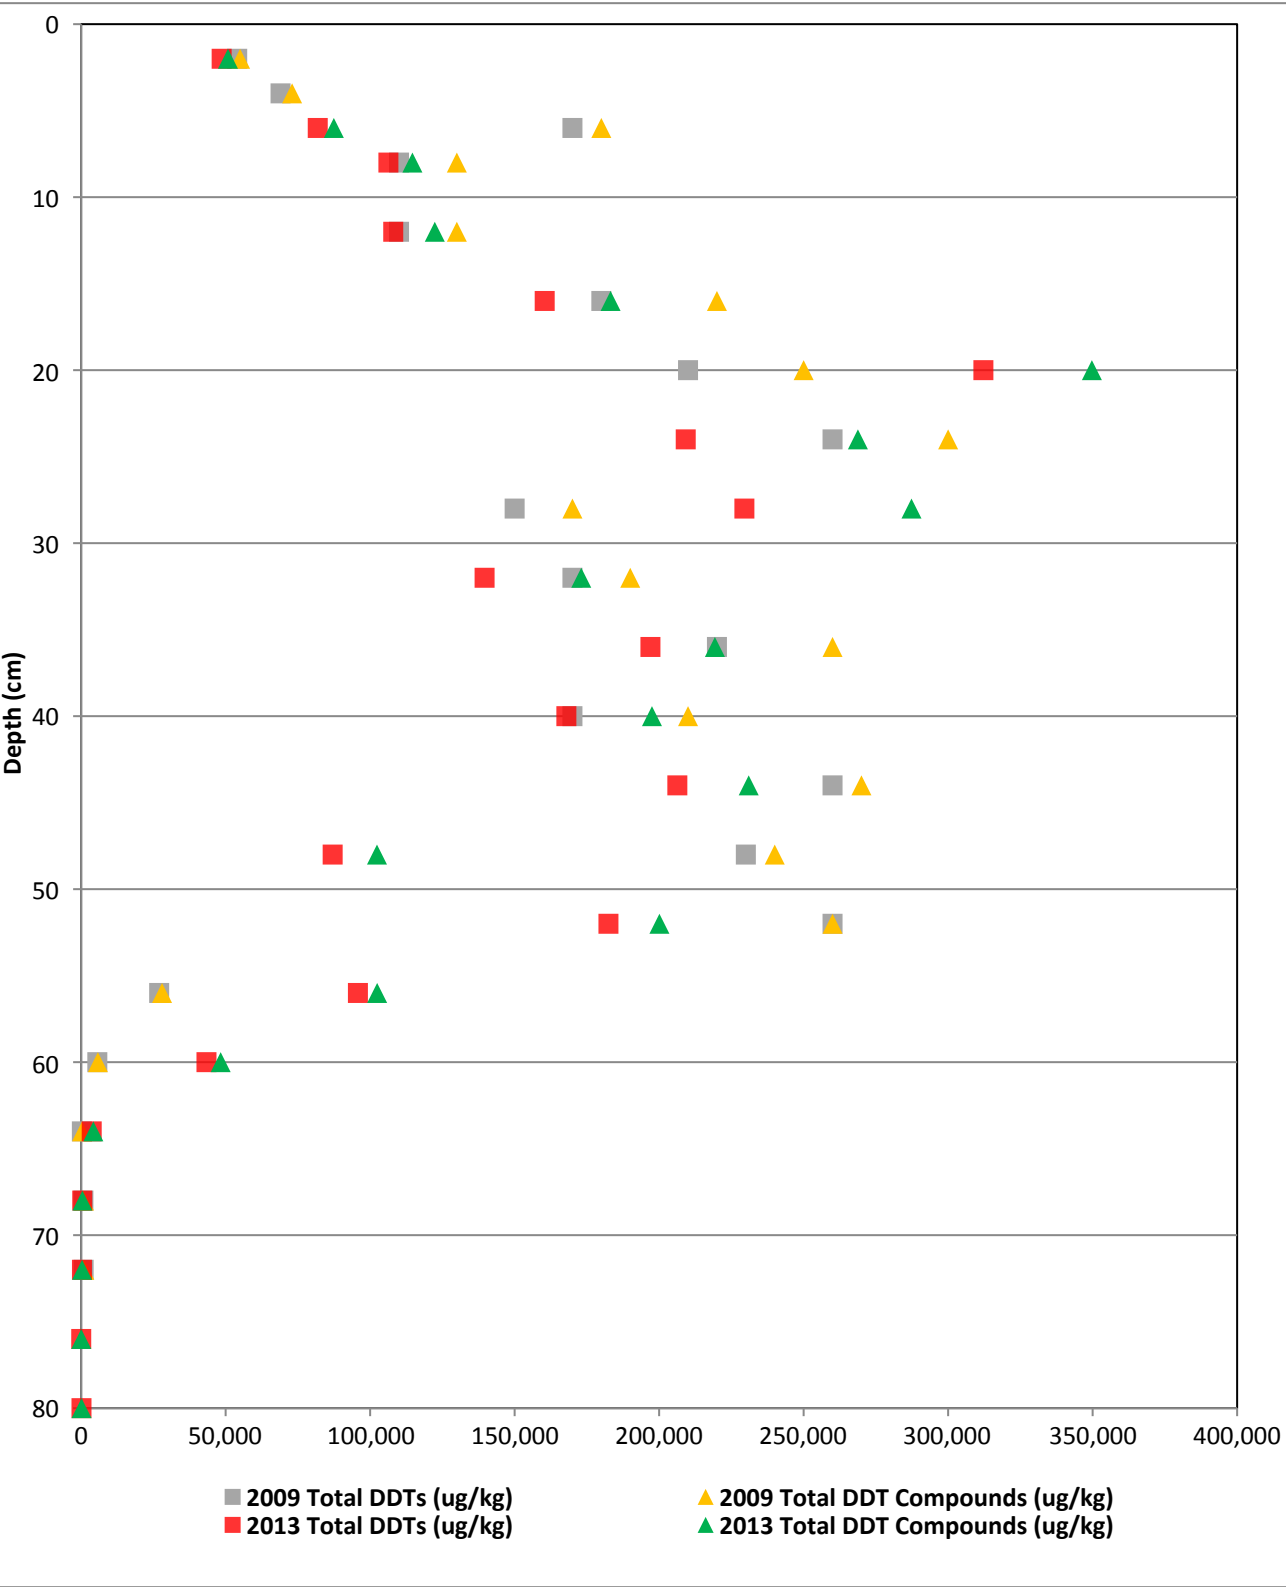
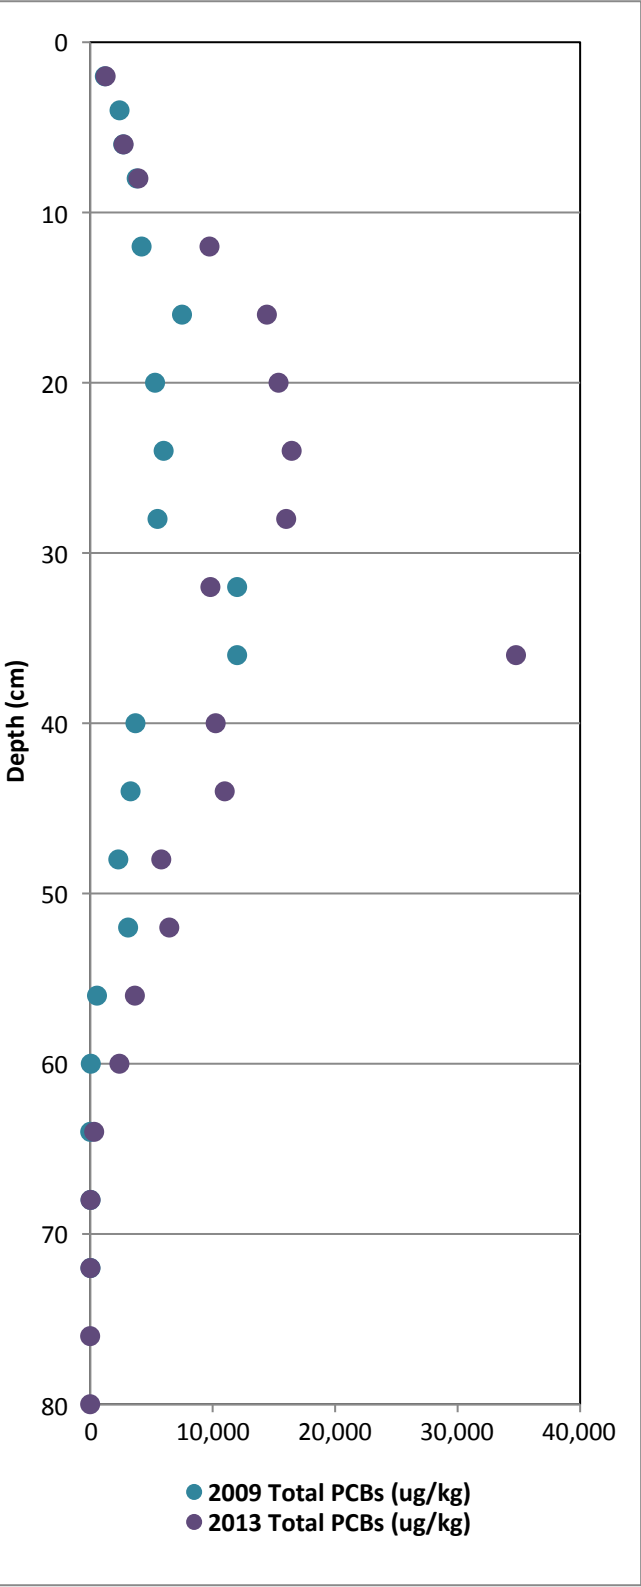
Figure 26. Vertical Profiles of Bulk Density and COCs for Core BA8C  
First MNR Report  
Palos Verdes Shelf (OU 5 of the Montrose Chemical Corp. Superfund Site)  
Los Angeles County, California

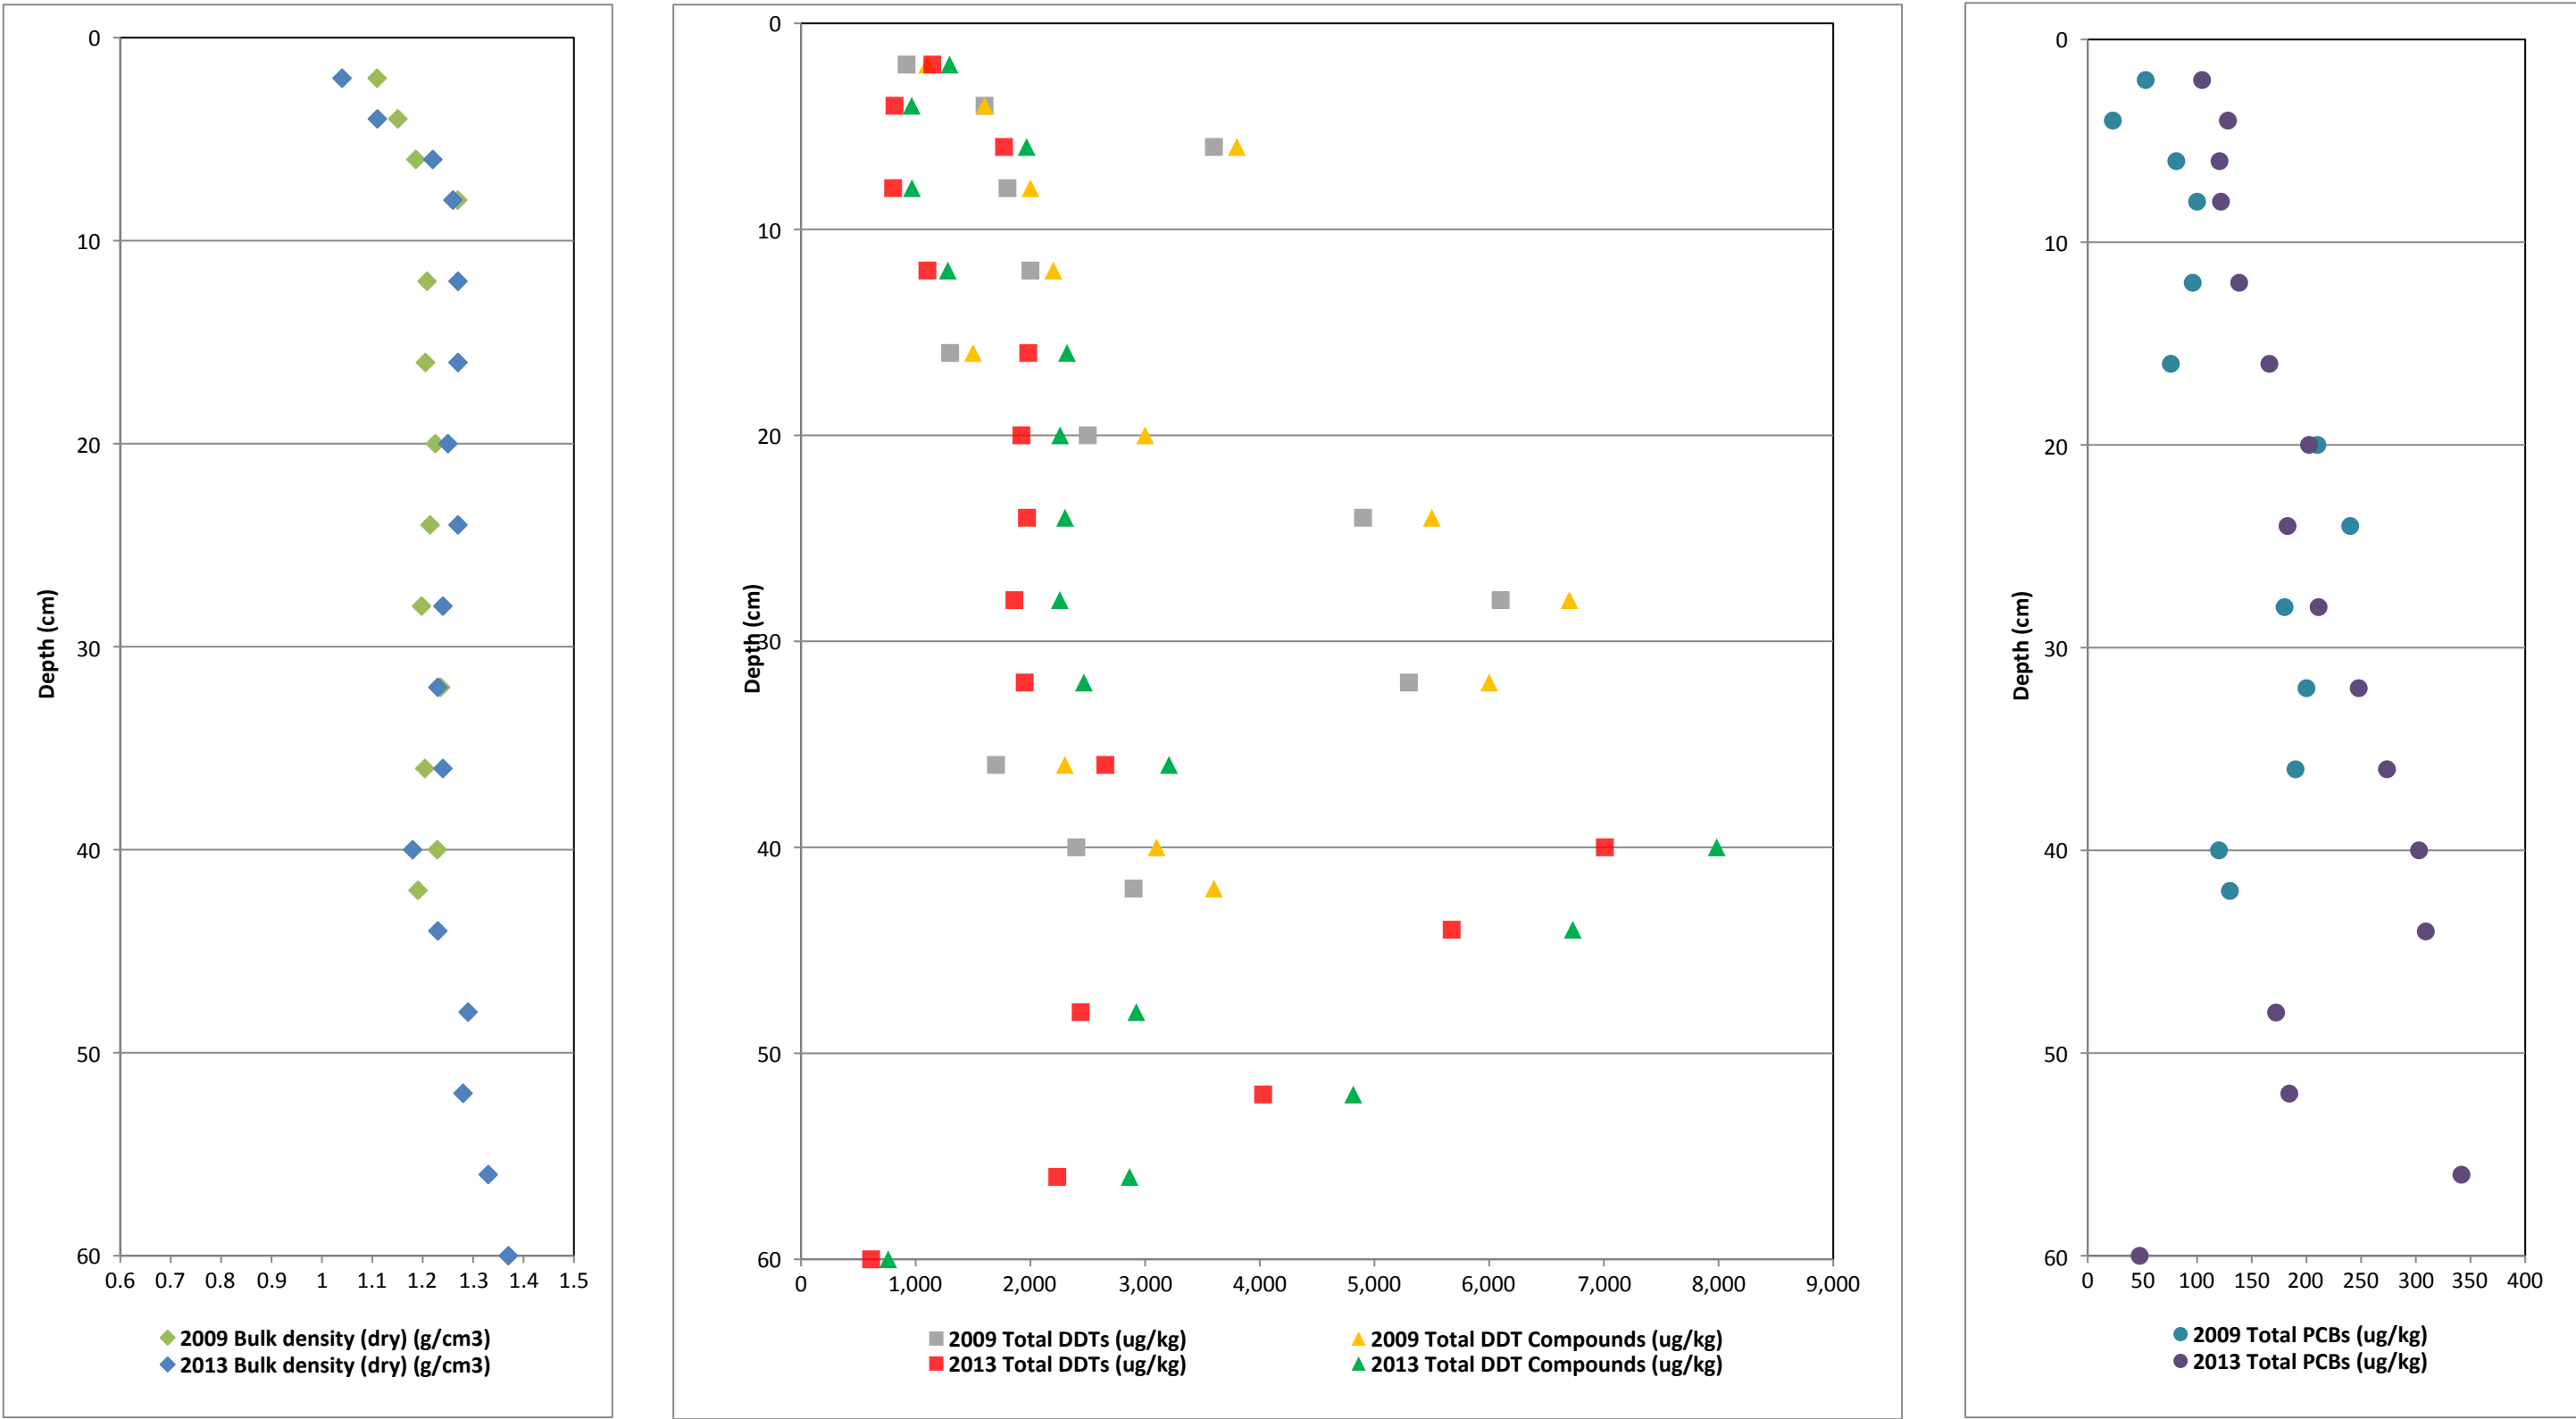
Figure 27. Vertical Profiles of Bulk Density and COCs for Core BA8DC  
First MNR Report  
Palos Verdes Shelf (OU 5 of the Montrose Chemical Corp. Superfund Site)  
Los Angeles County, California

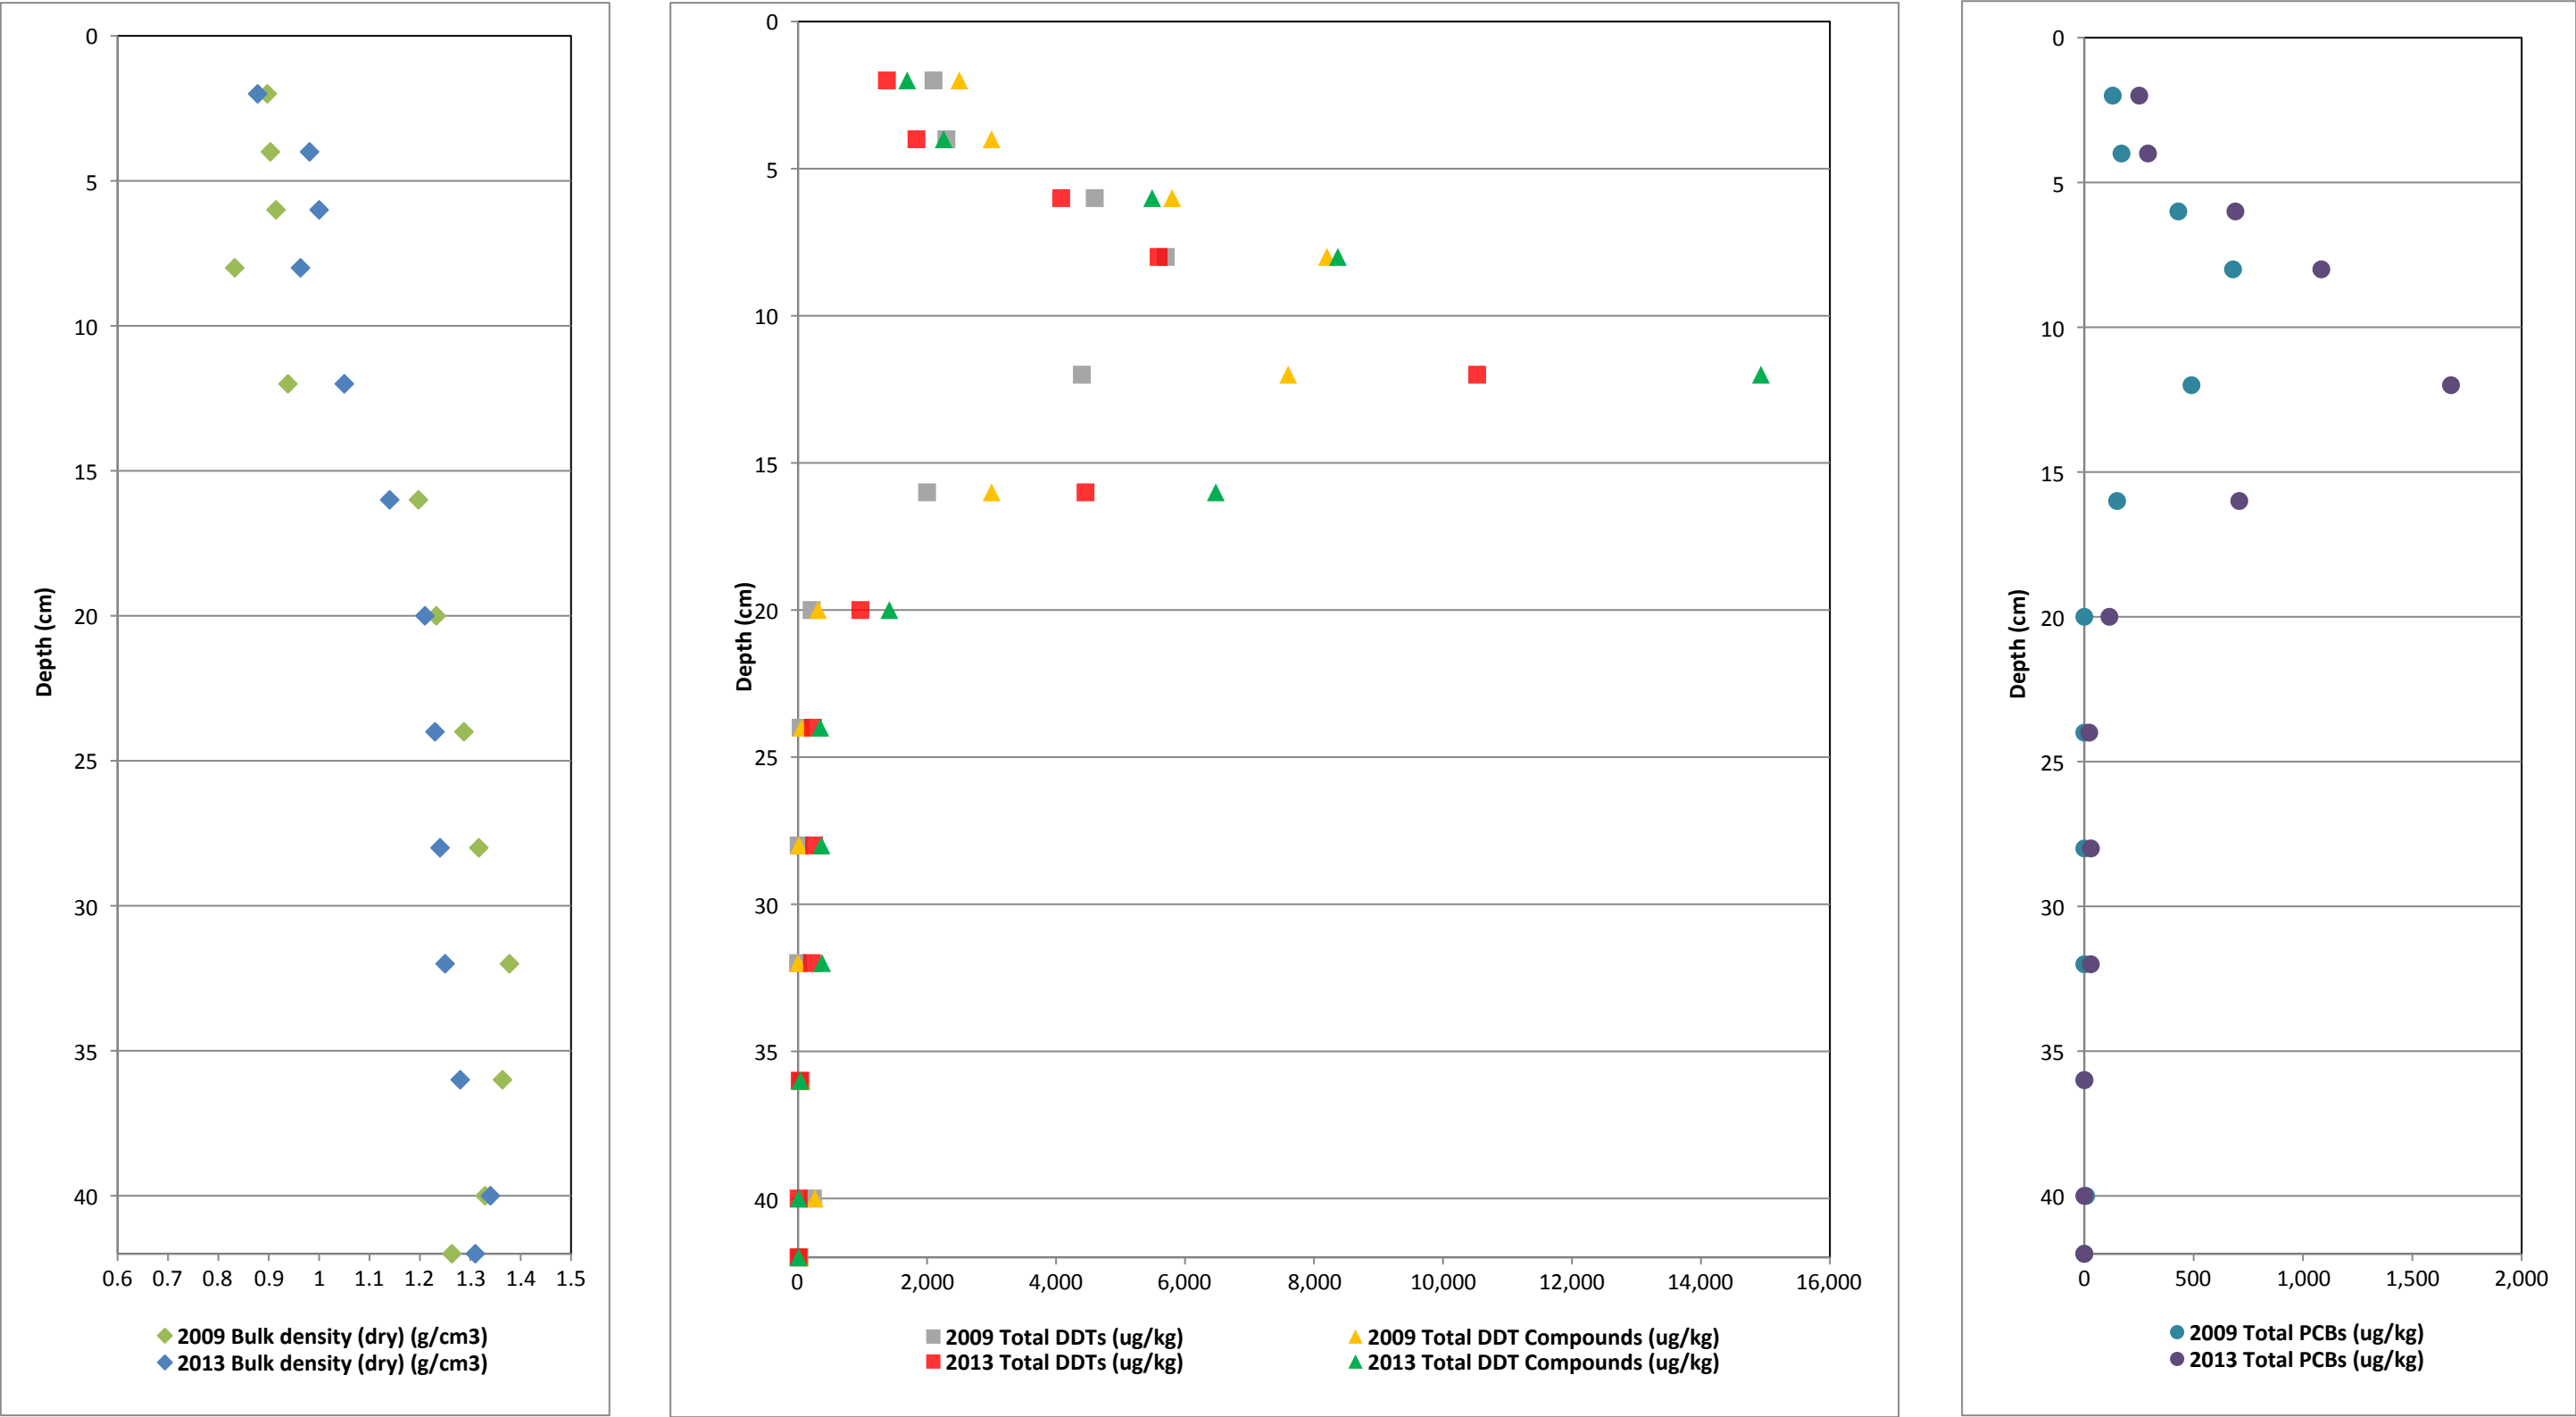
Figure 28. Vertical Profiles of Bulk Density and COCs for Core BA9B  
First MNR Report  
Palos Verdes Shelf (OU 5 of the Montrose Chemical Corp. Superfund Site)  
Los Angeles County, California
