**APPENDIX X**  
**VERTICAL PROFILES OF SEDIMENT BED – BD AND COCS**

## **APPENDIX X.1 – VERTICAL PROFILES – SHELF-WIDE CORES**

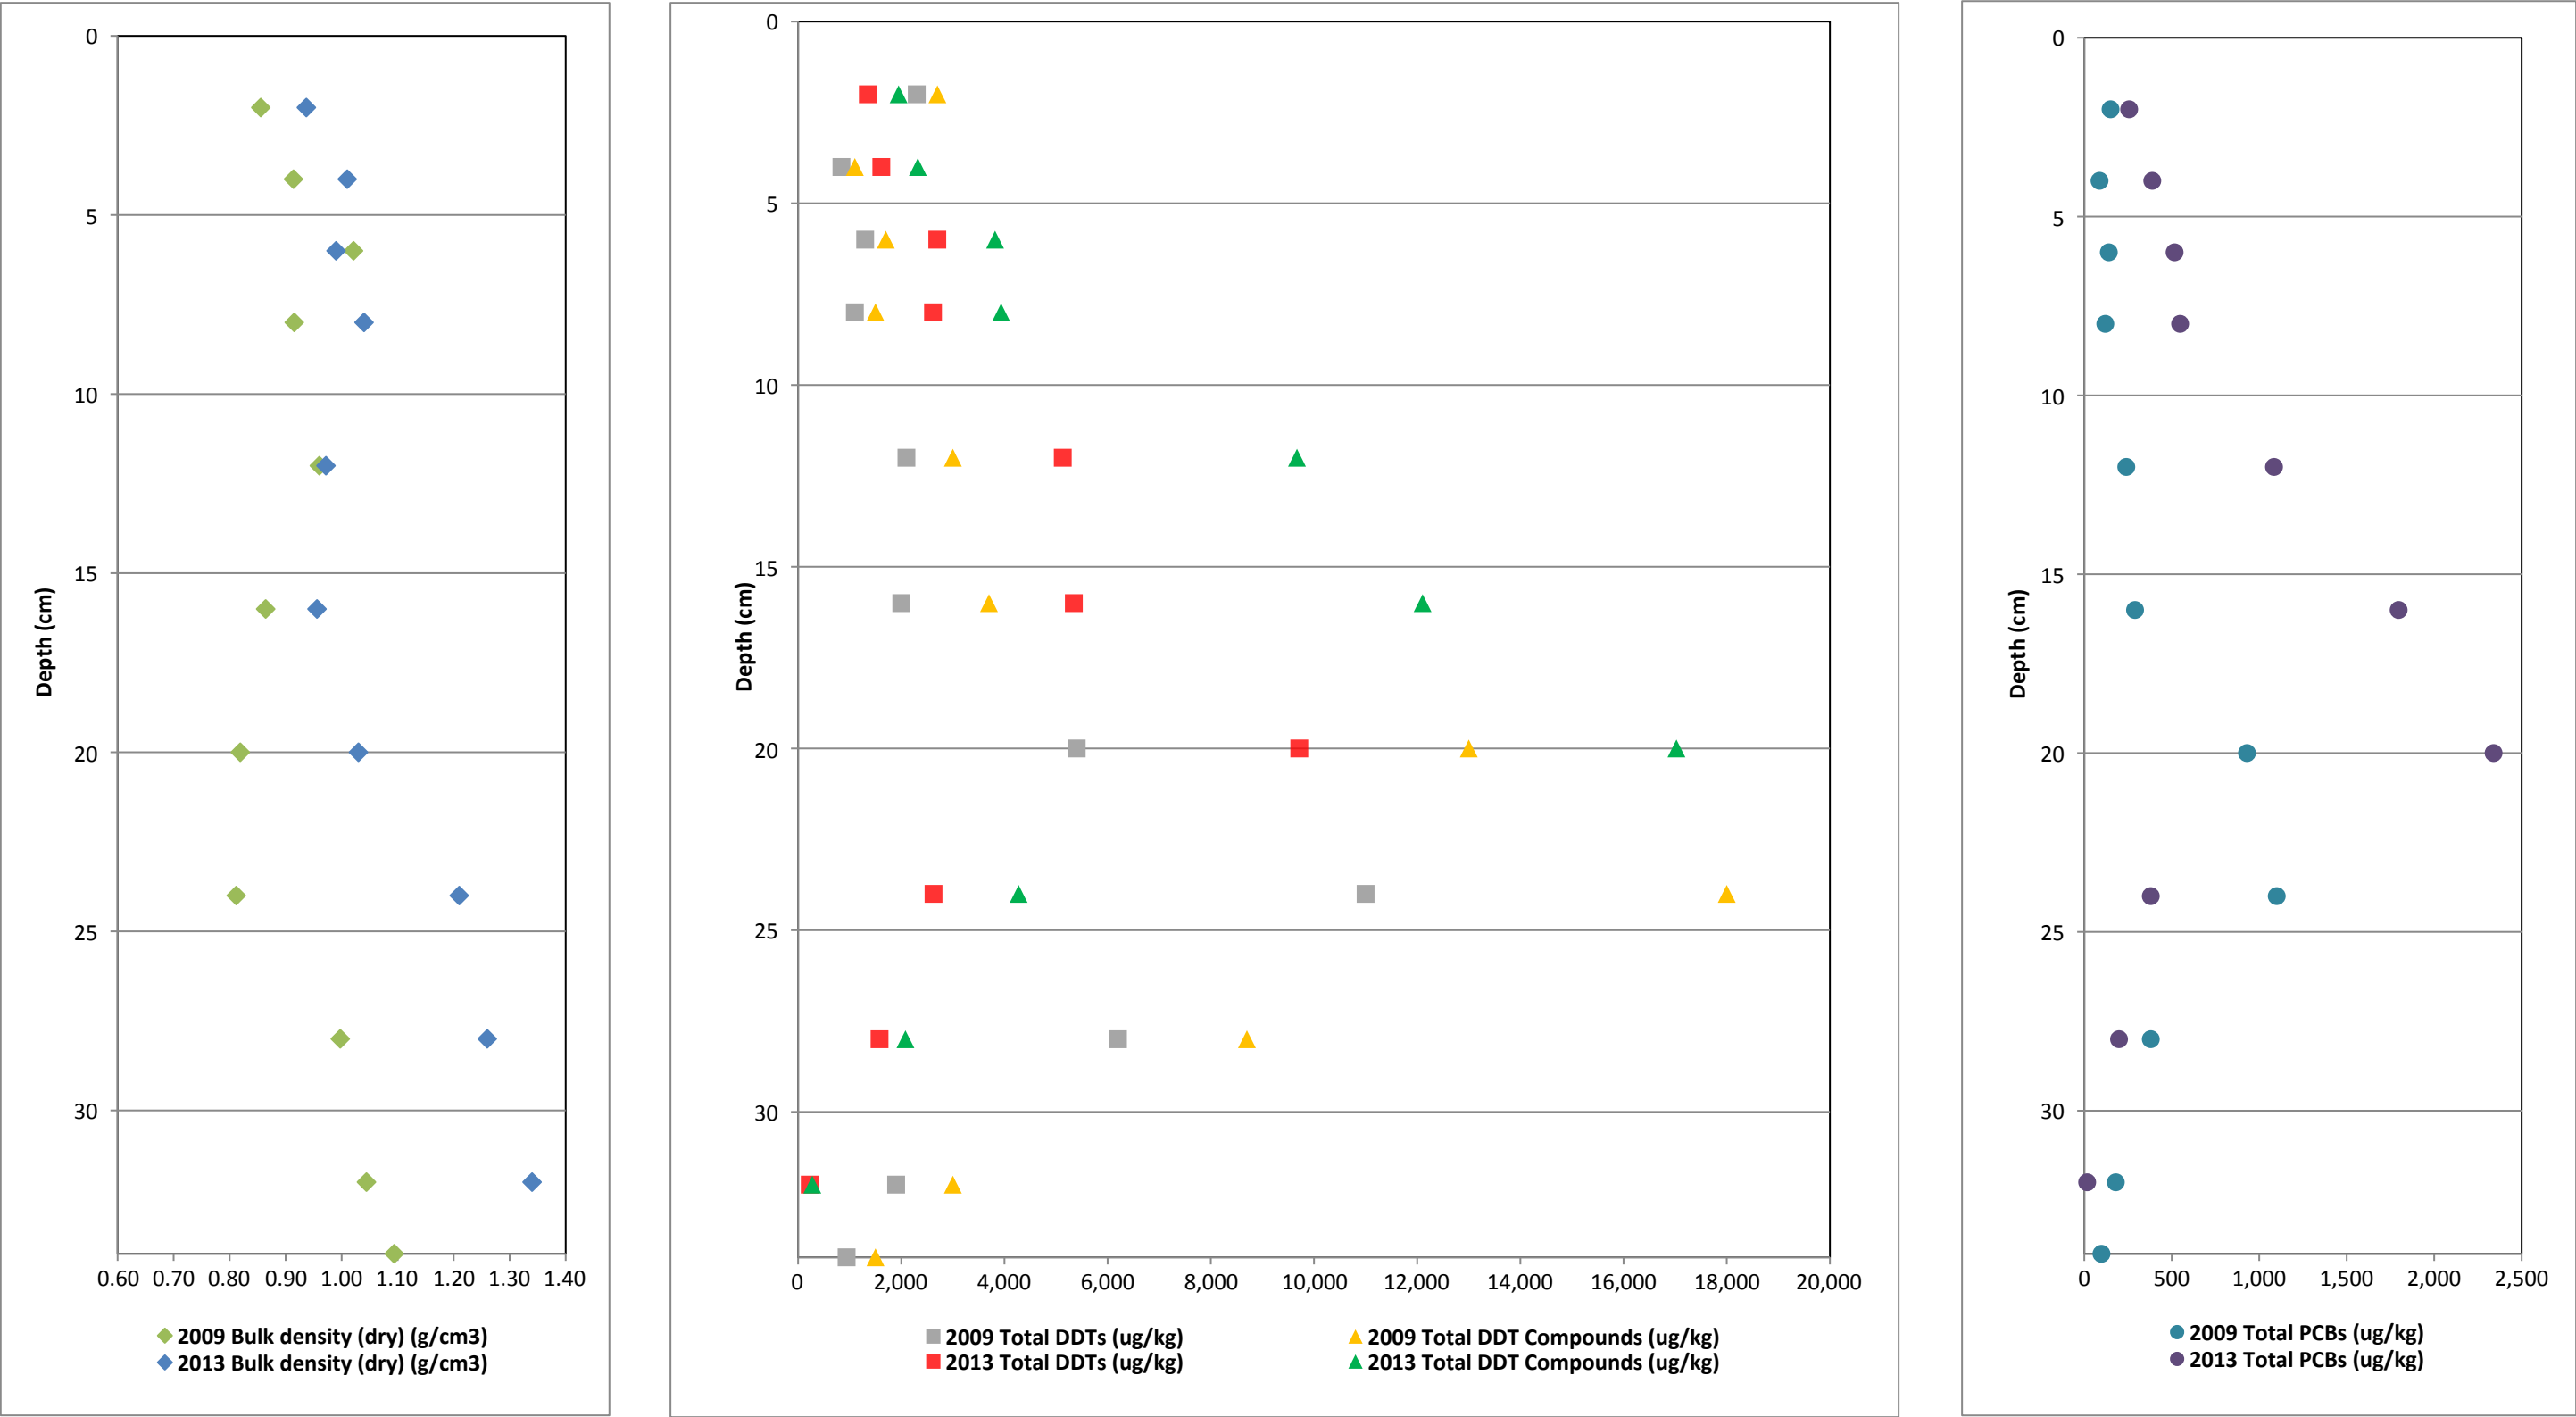
Figure 29. Vertical Profiles of Bulk Density and COCs for Core BA9BC  
First MNR Report  
Palos Verdes Shelf (OU 5 of the Montrose Chemical Corp. Superfund Site)  
Los Angeles County, California

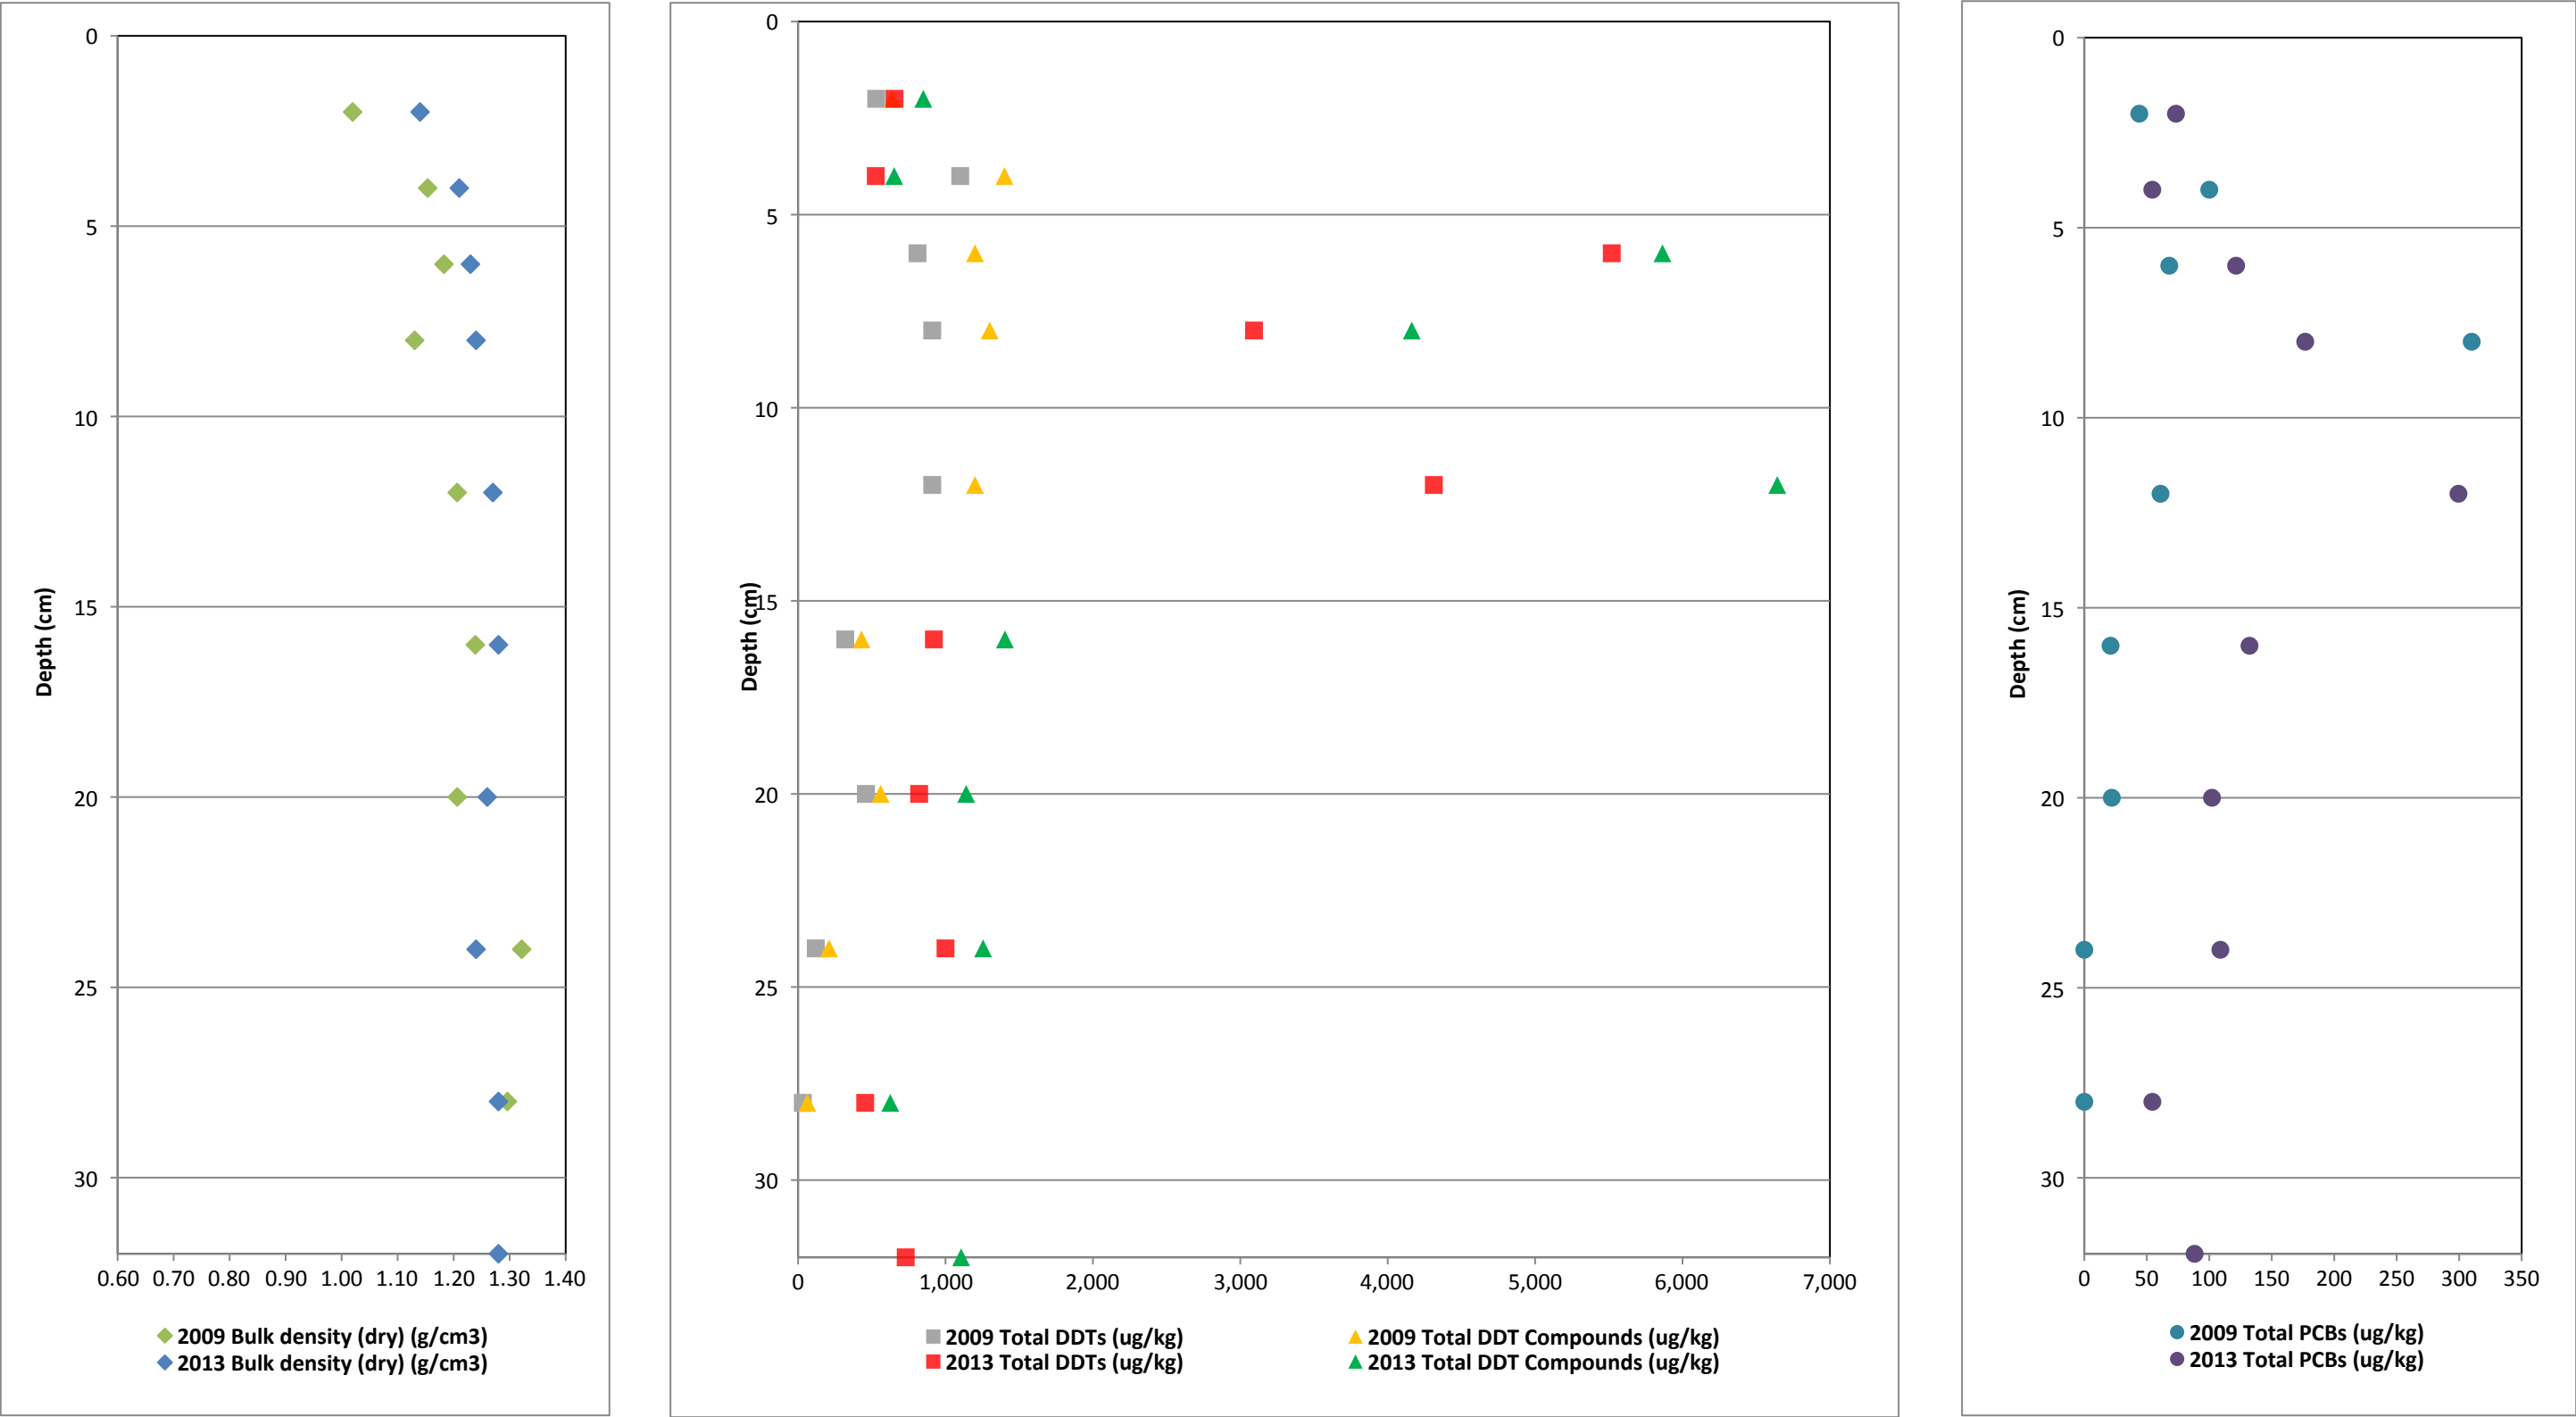
Figure 30. Vertical Profiles of Bulk Density and COCs for Core BA9C  
First MNR Report  
Palos Verdes Shelf (OU 5 of the Montrose Chemical Corp. Superfund Site)  
Los Angeles County, California

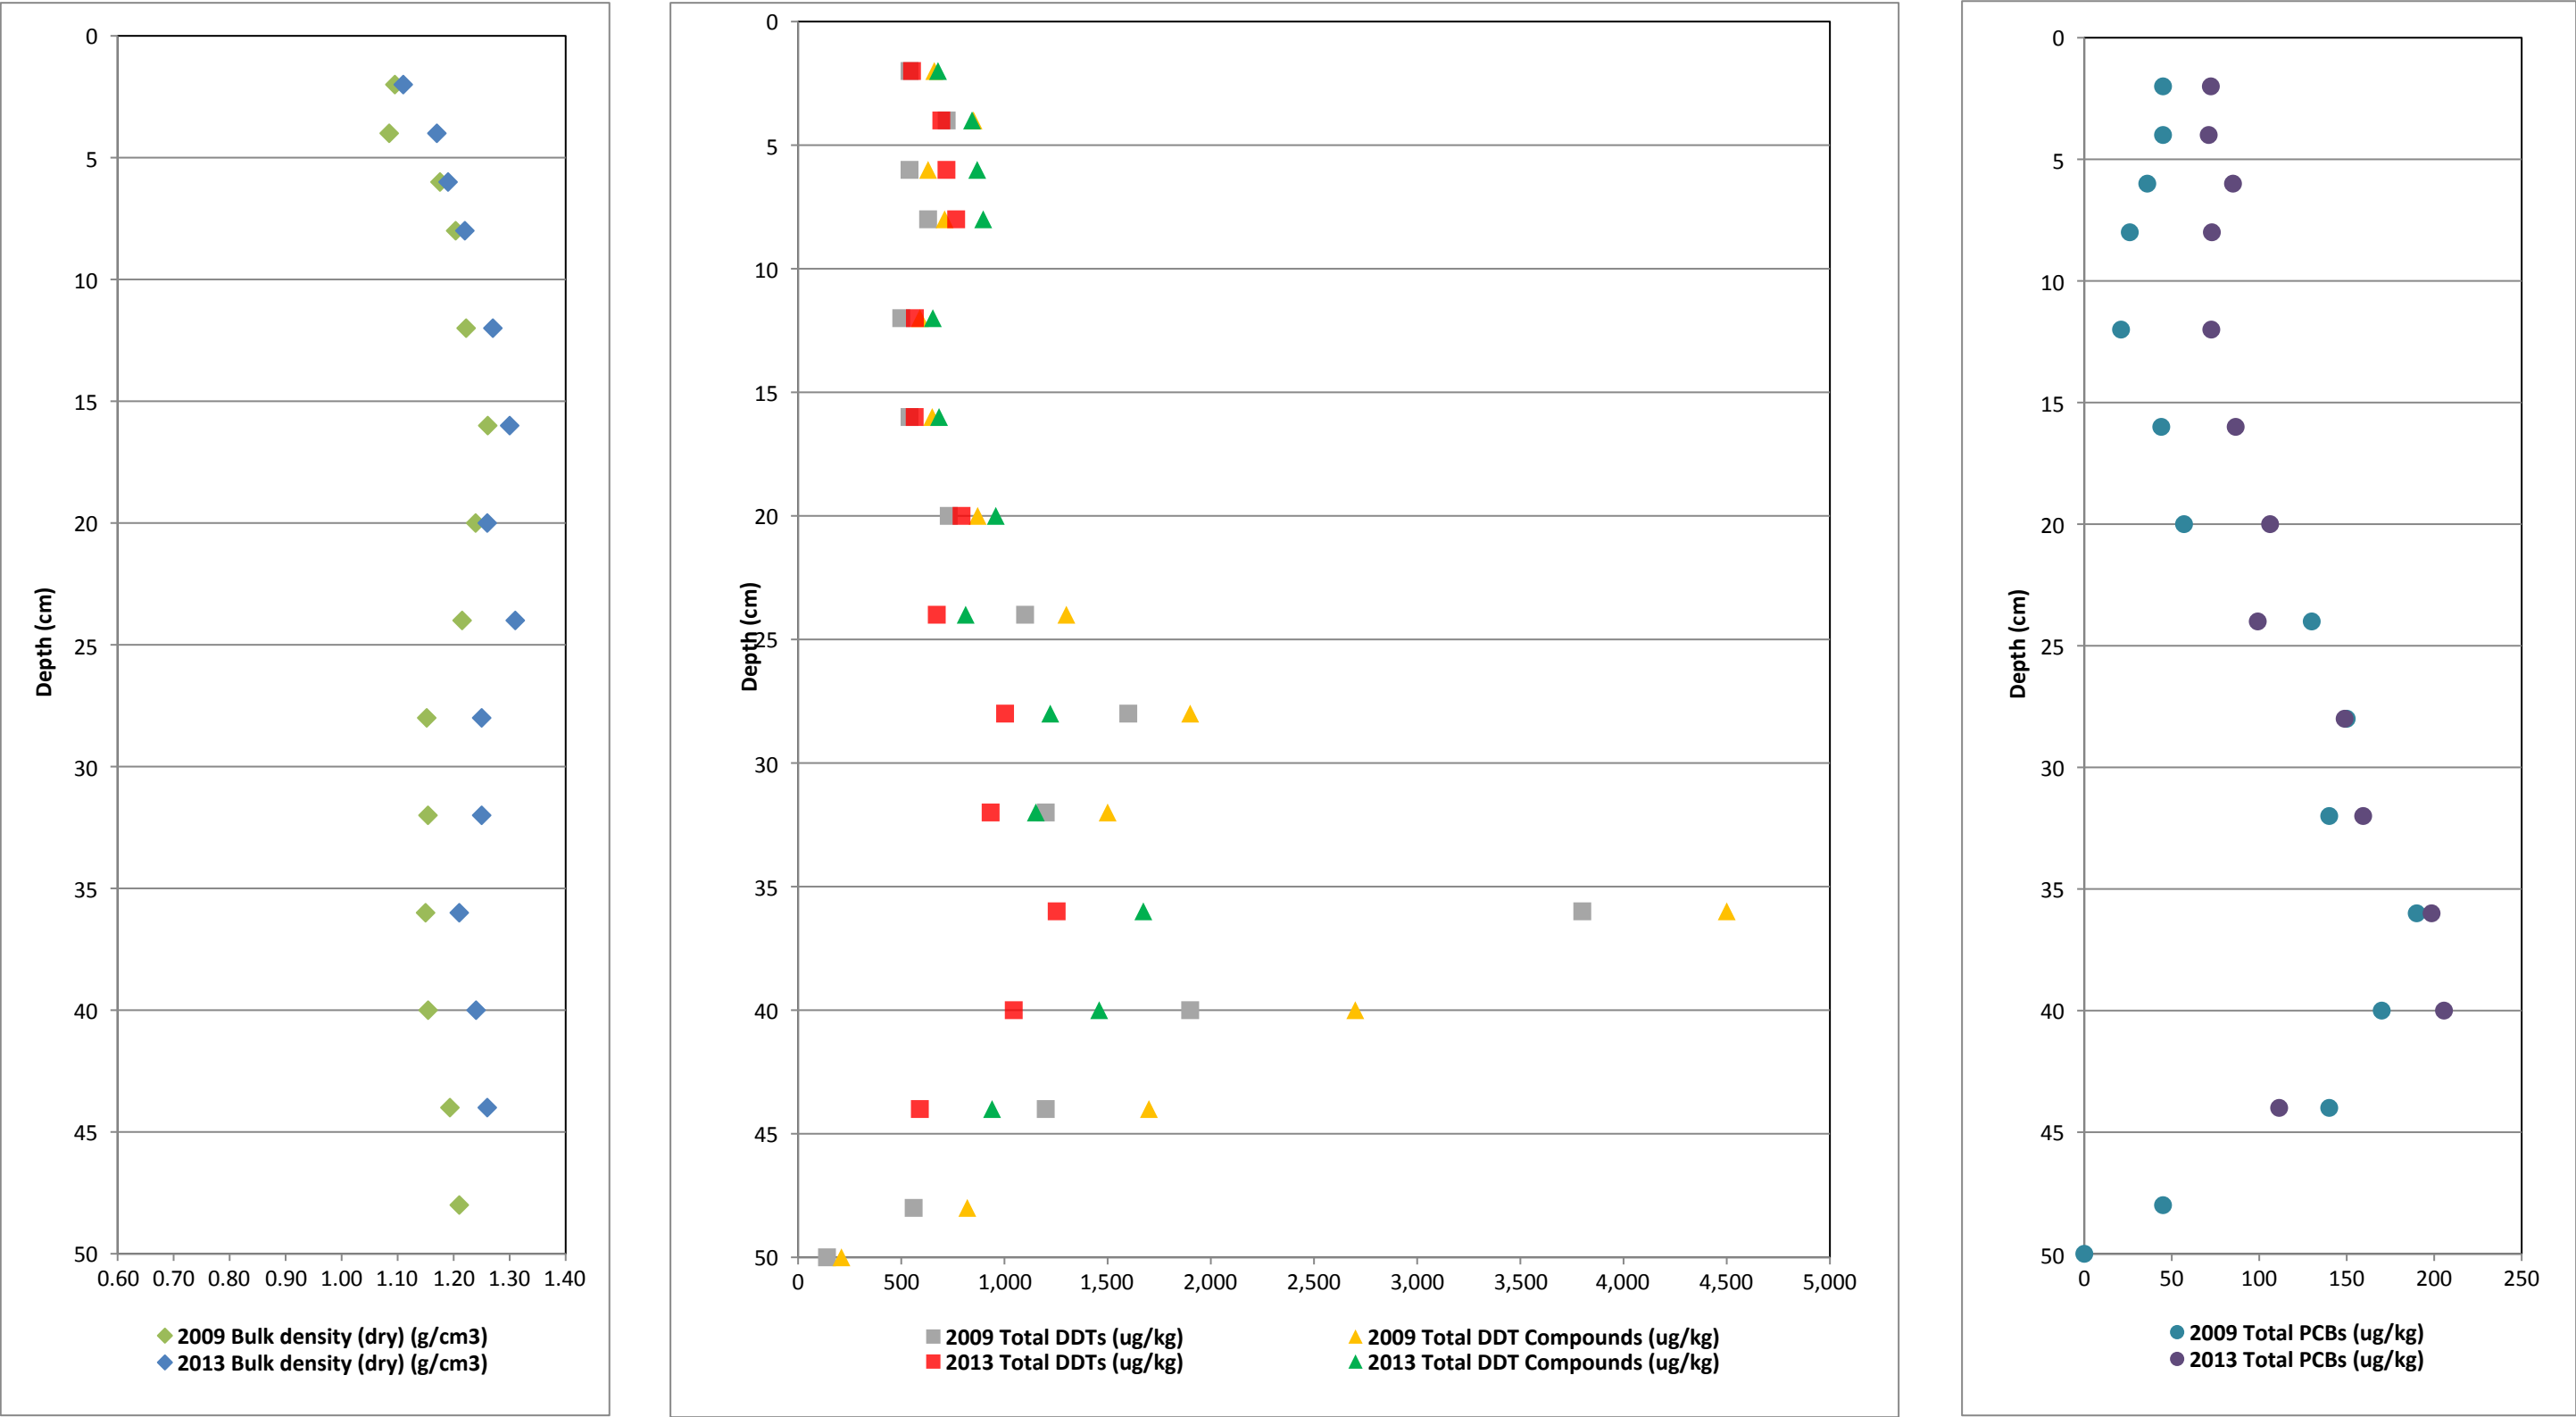
Figure 31. Vertical Profiles of Bulk Density and COCs for Core BA9DC  
First MNR Report  
Palos Verdes Shelf (OU 5 of the Montrose Chemical Corp. Superfund Site)  
Los Angeles County, California

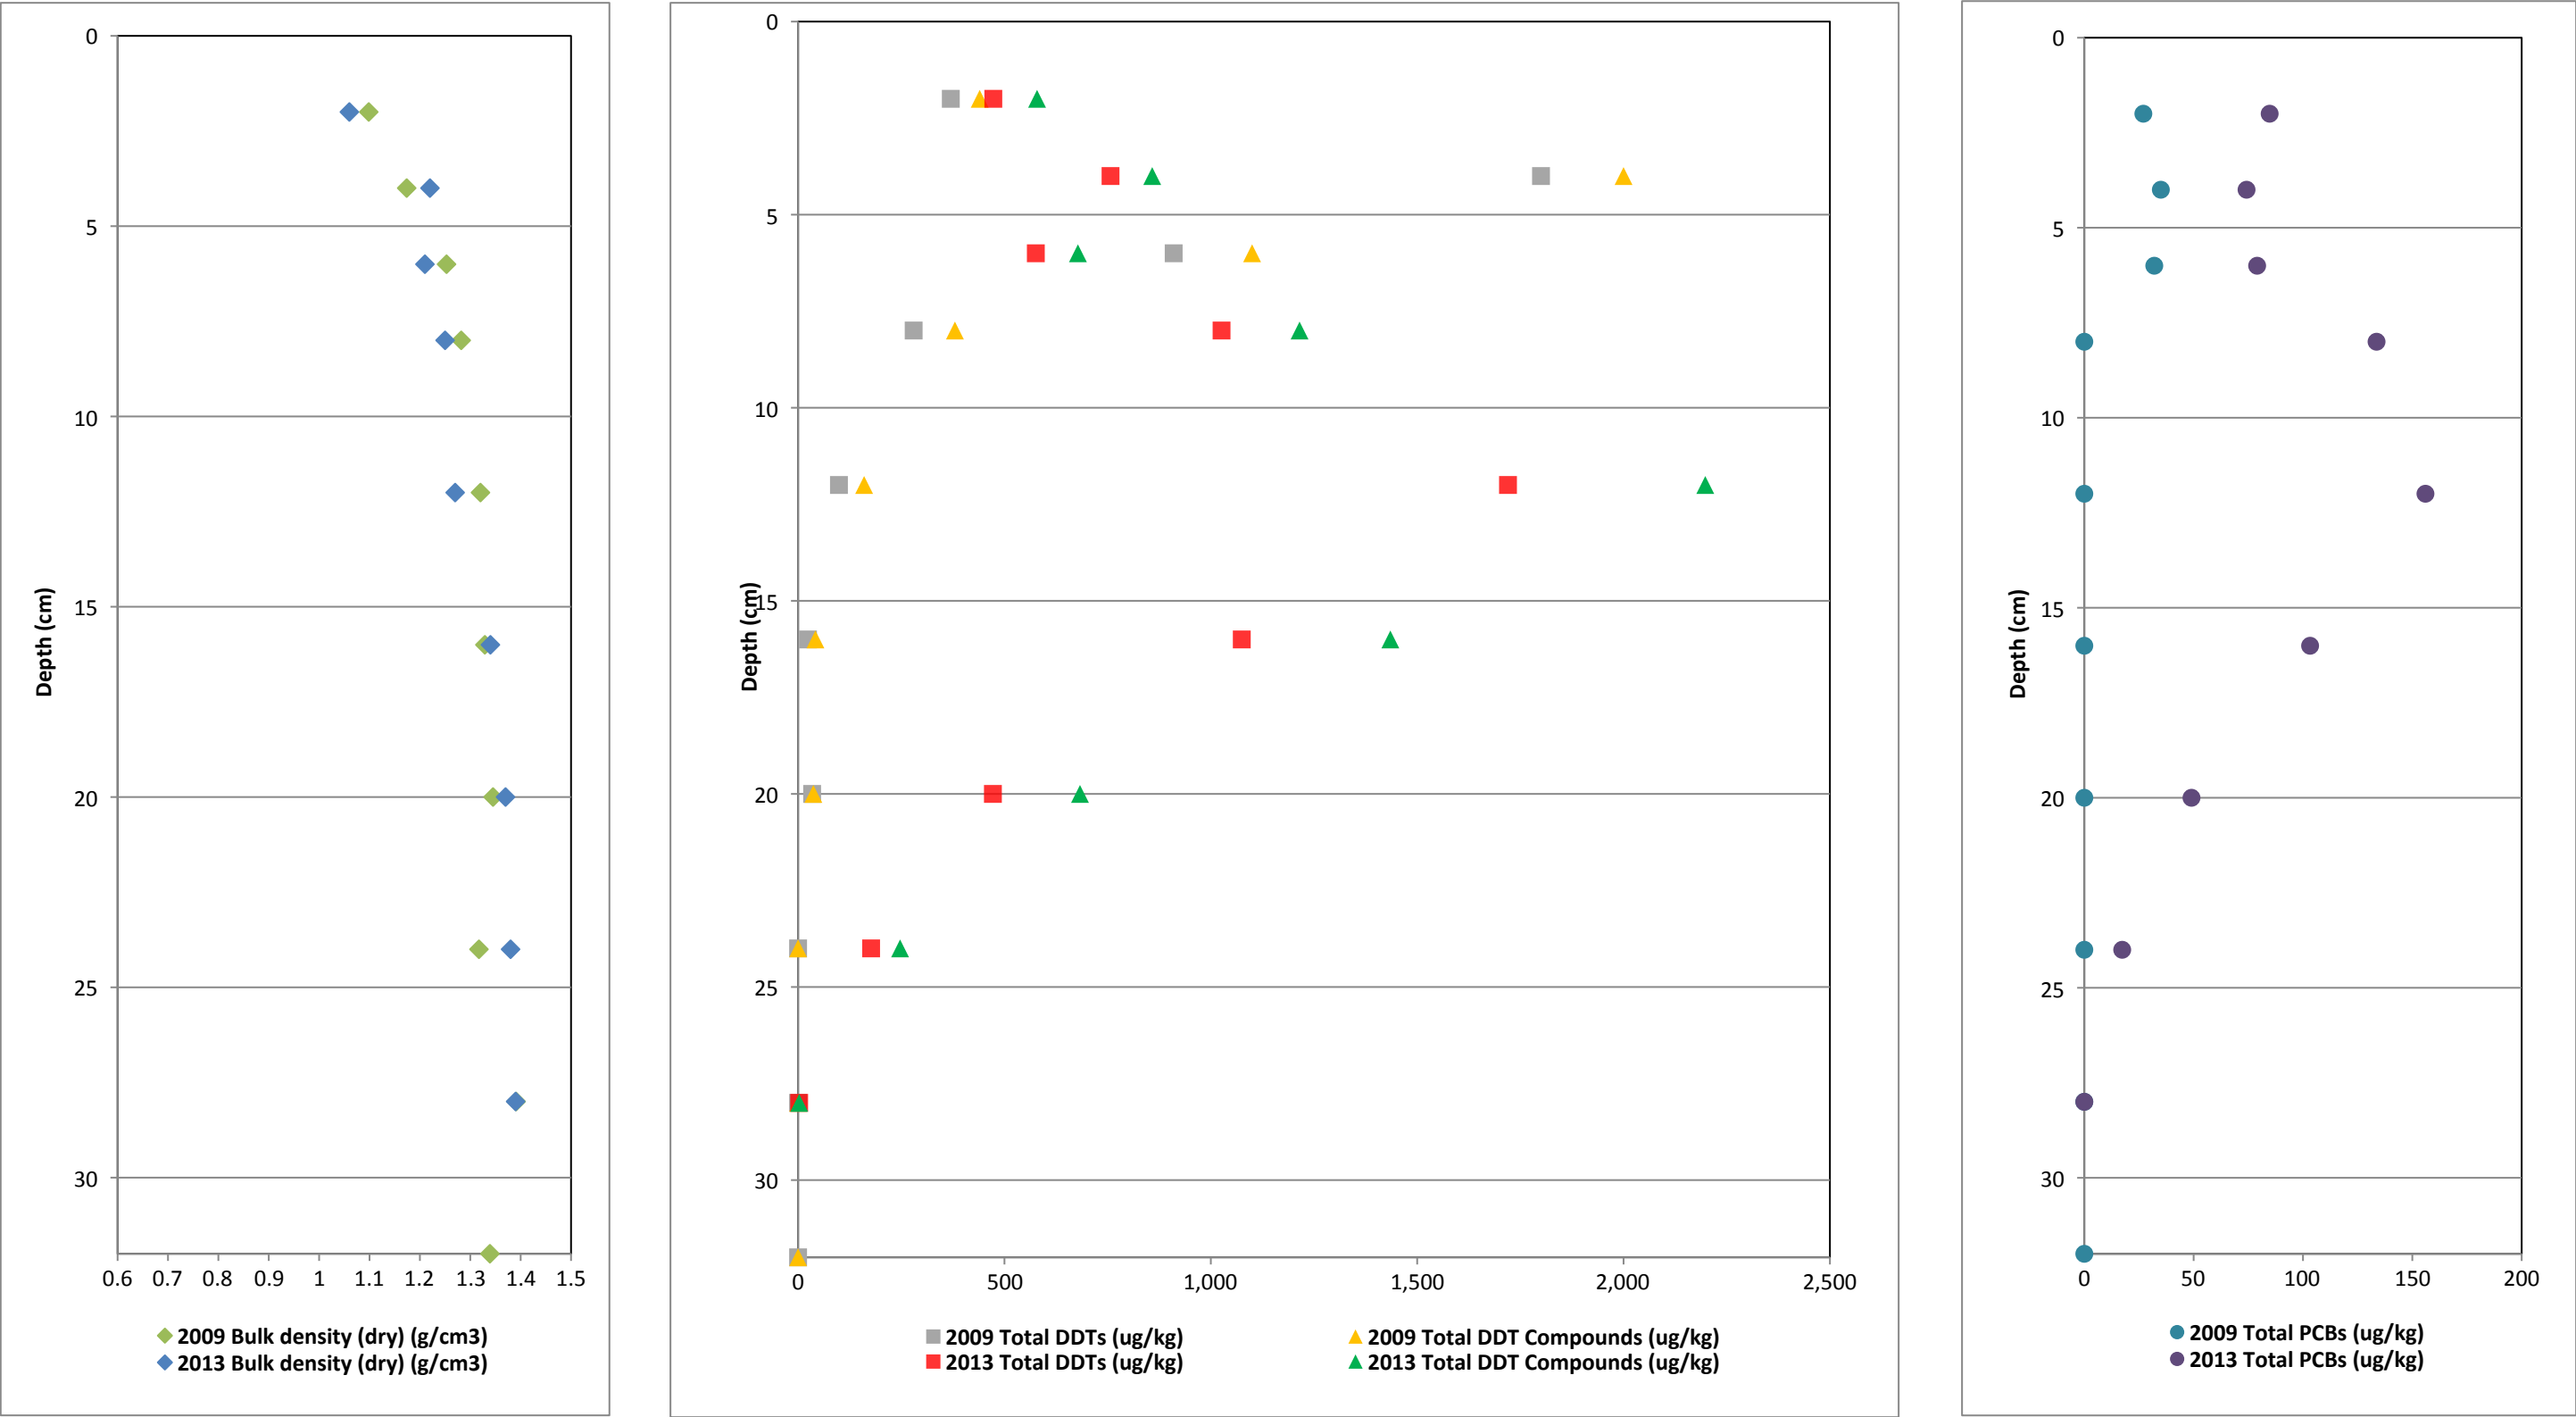
Figure 32. Vertical Profiles of Bulk Density and COCs for Core BA10B  
First MNR Report  
Palos Verdes Shelf (OU 5 of the Montrose Chemical Corp. Superfund Site)  
Los Angeles County, California

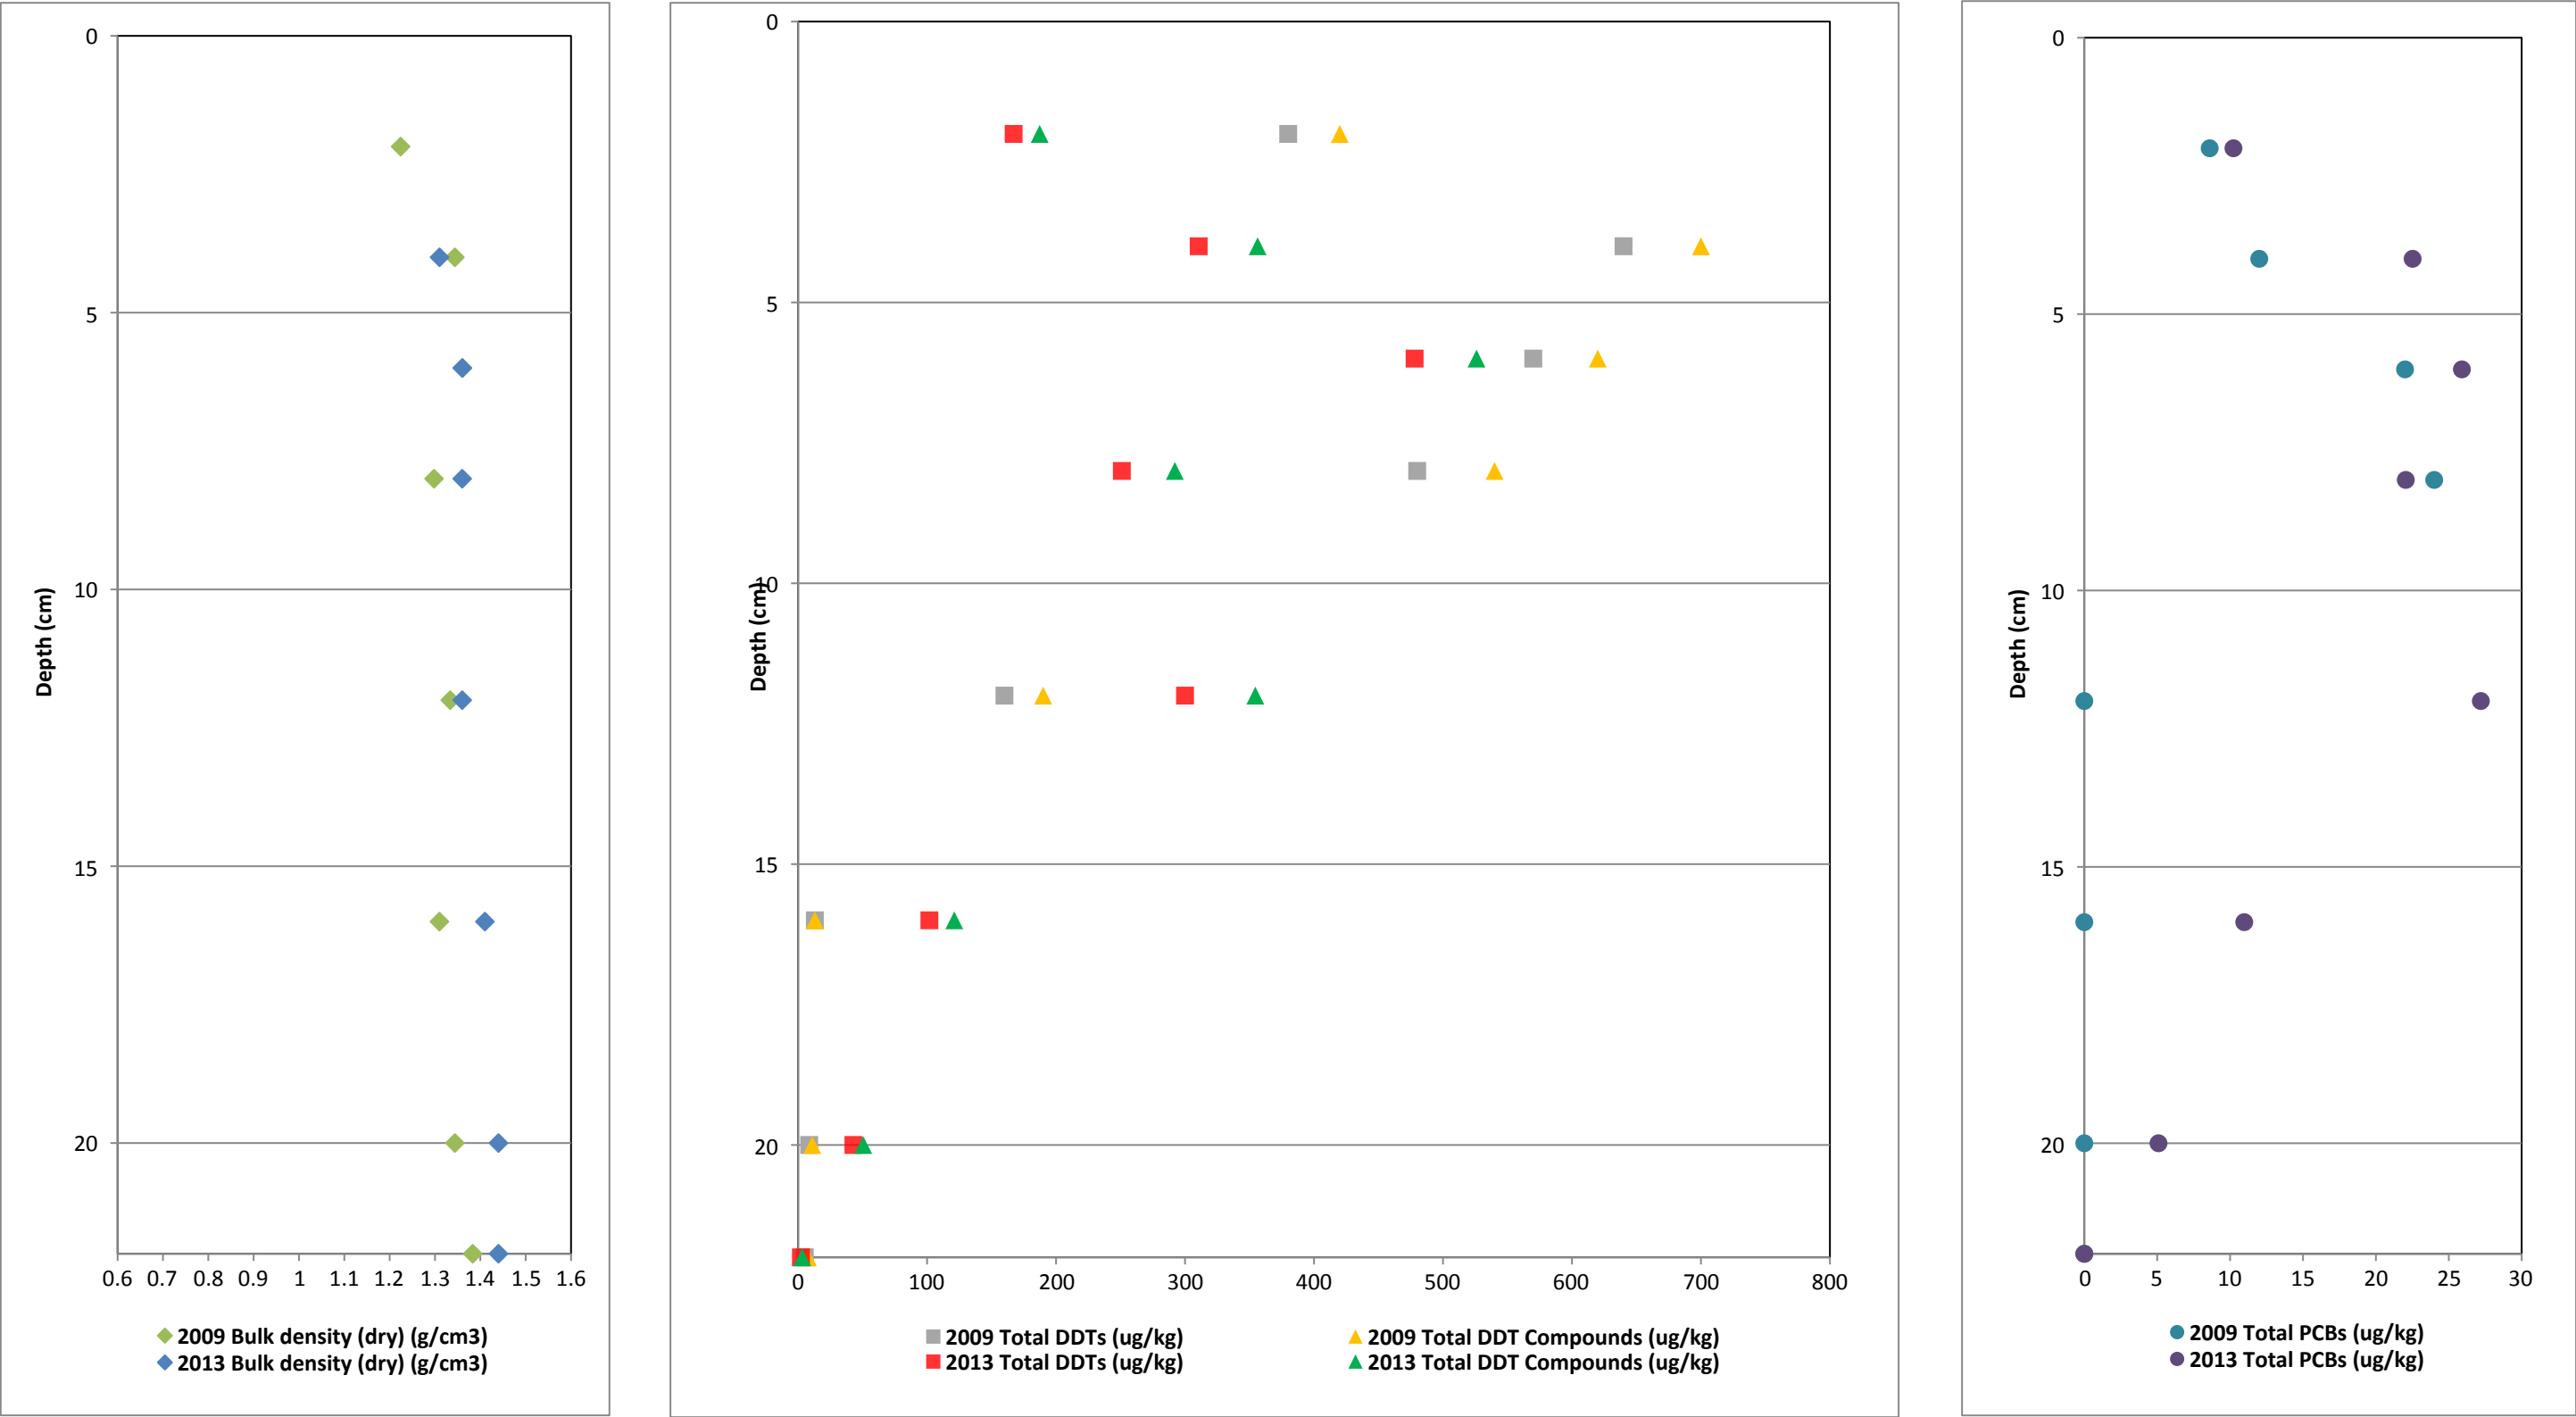
Figure 33. Vertical Profiles of Bulk Density and COCs for Core BA10C  
First MNR Report  
Palos Verdes Shelf (OU 5 of the Montrose Chemical Corp. Superfund Site)  
Los Angeles County, California

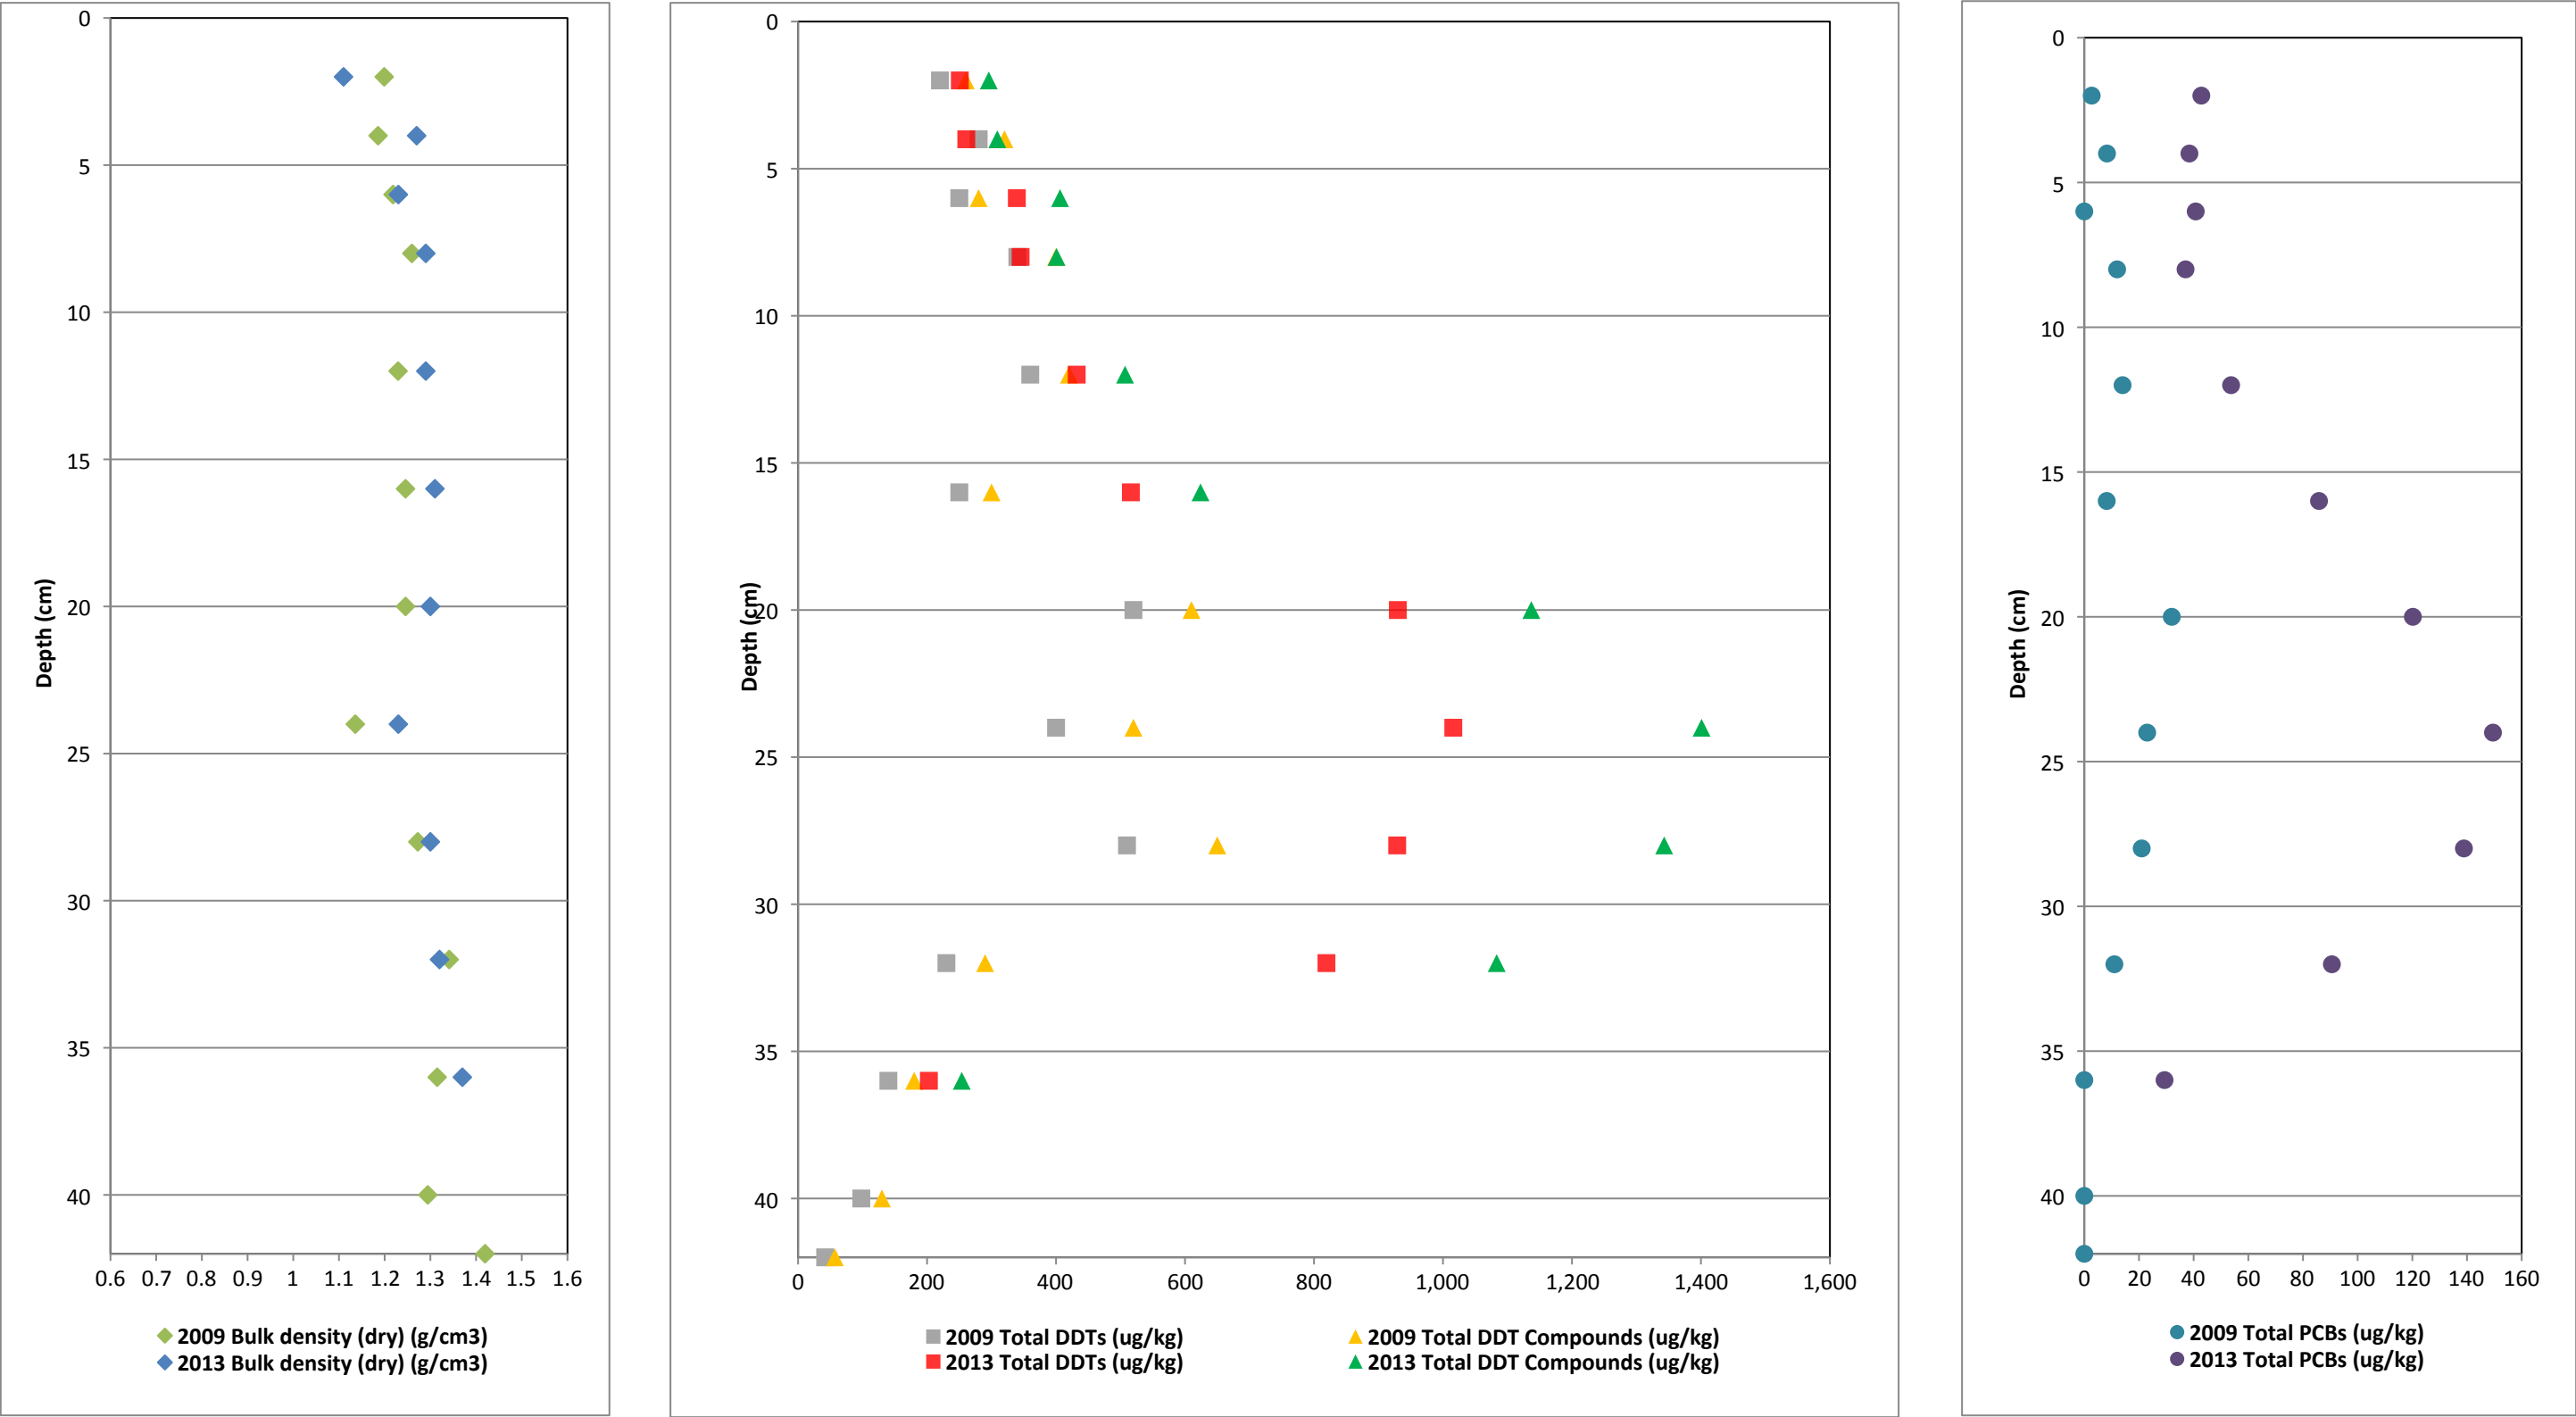
Figure 34. Vertical Profiles of Bulk Density and COCs for Core BA10DC  
First MNR Report  
Palos Verdes Shelf (OU 5 of the Montrose Chemical Corp. Superfund Site)  
Los Angeles County, California
