## **APPENDIX X.2 – VERTICAL PROFILES – OUTFALL AREA CORES**

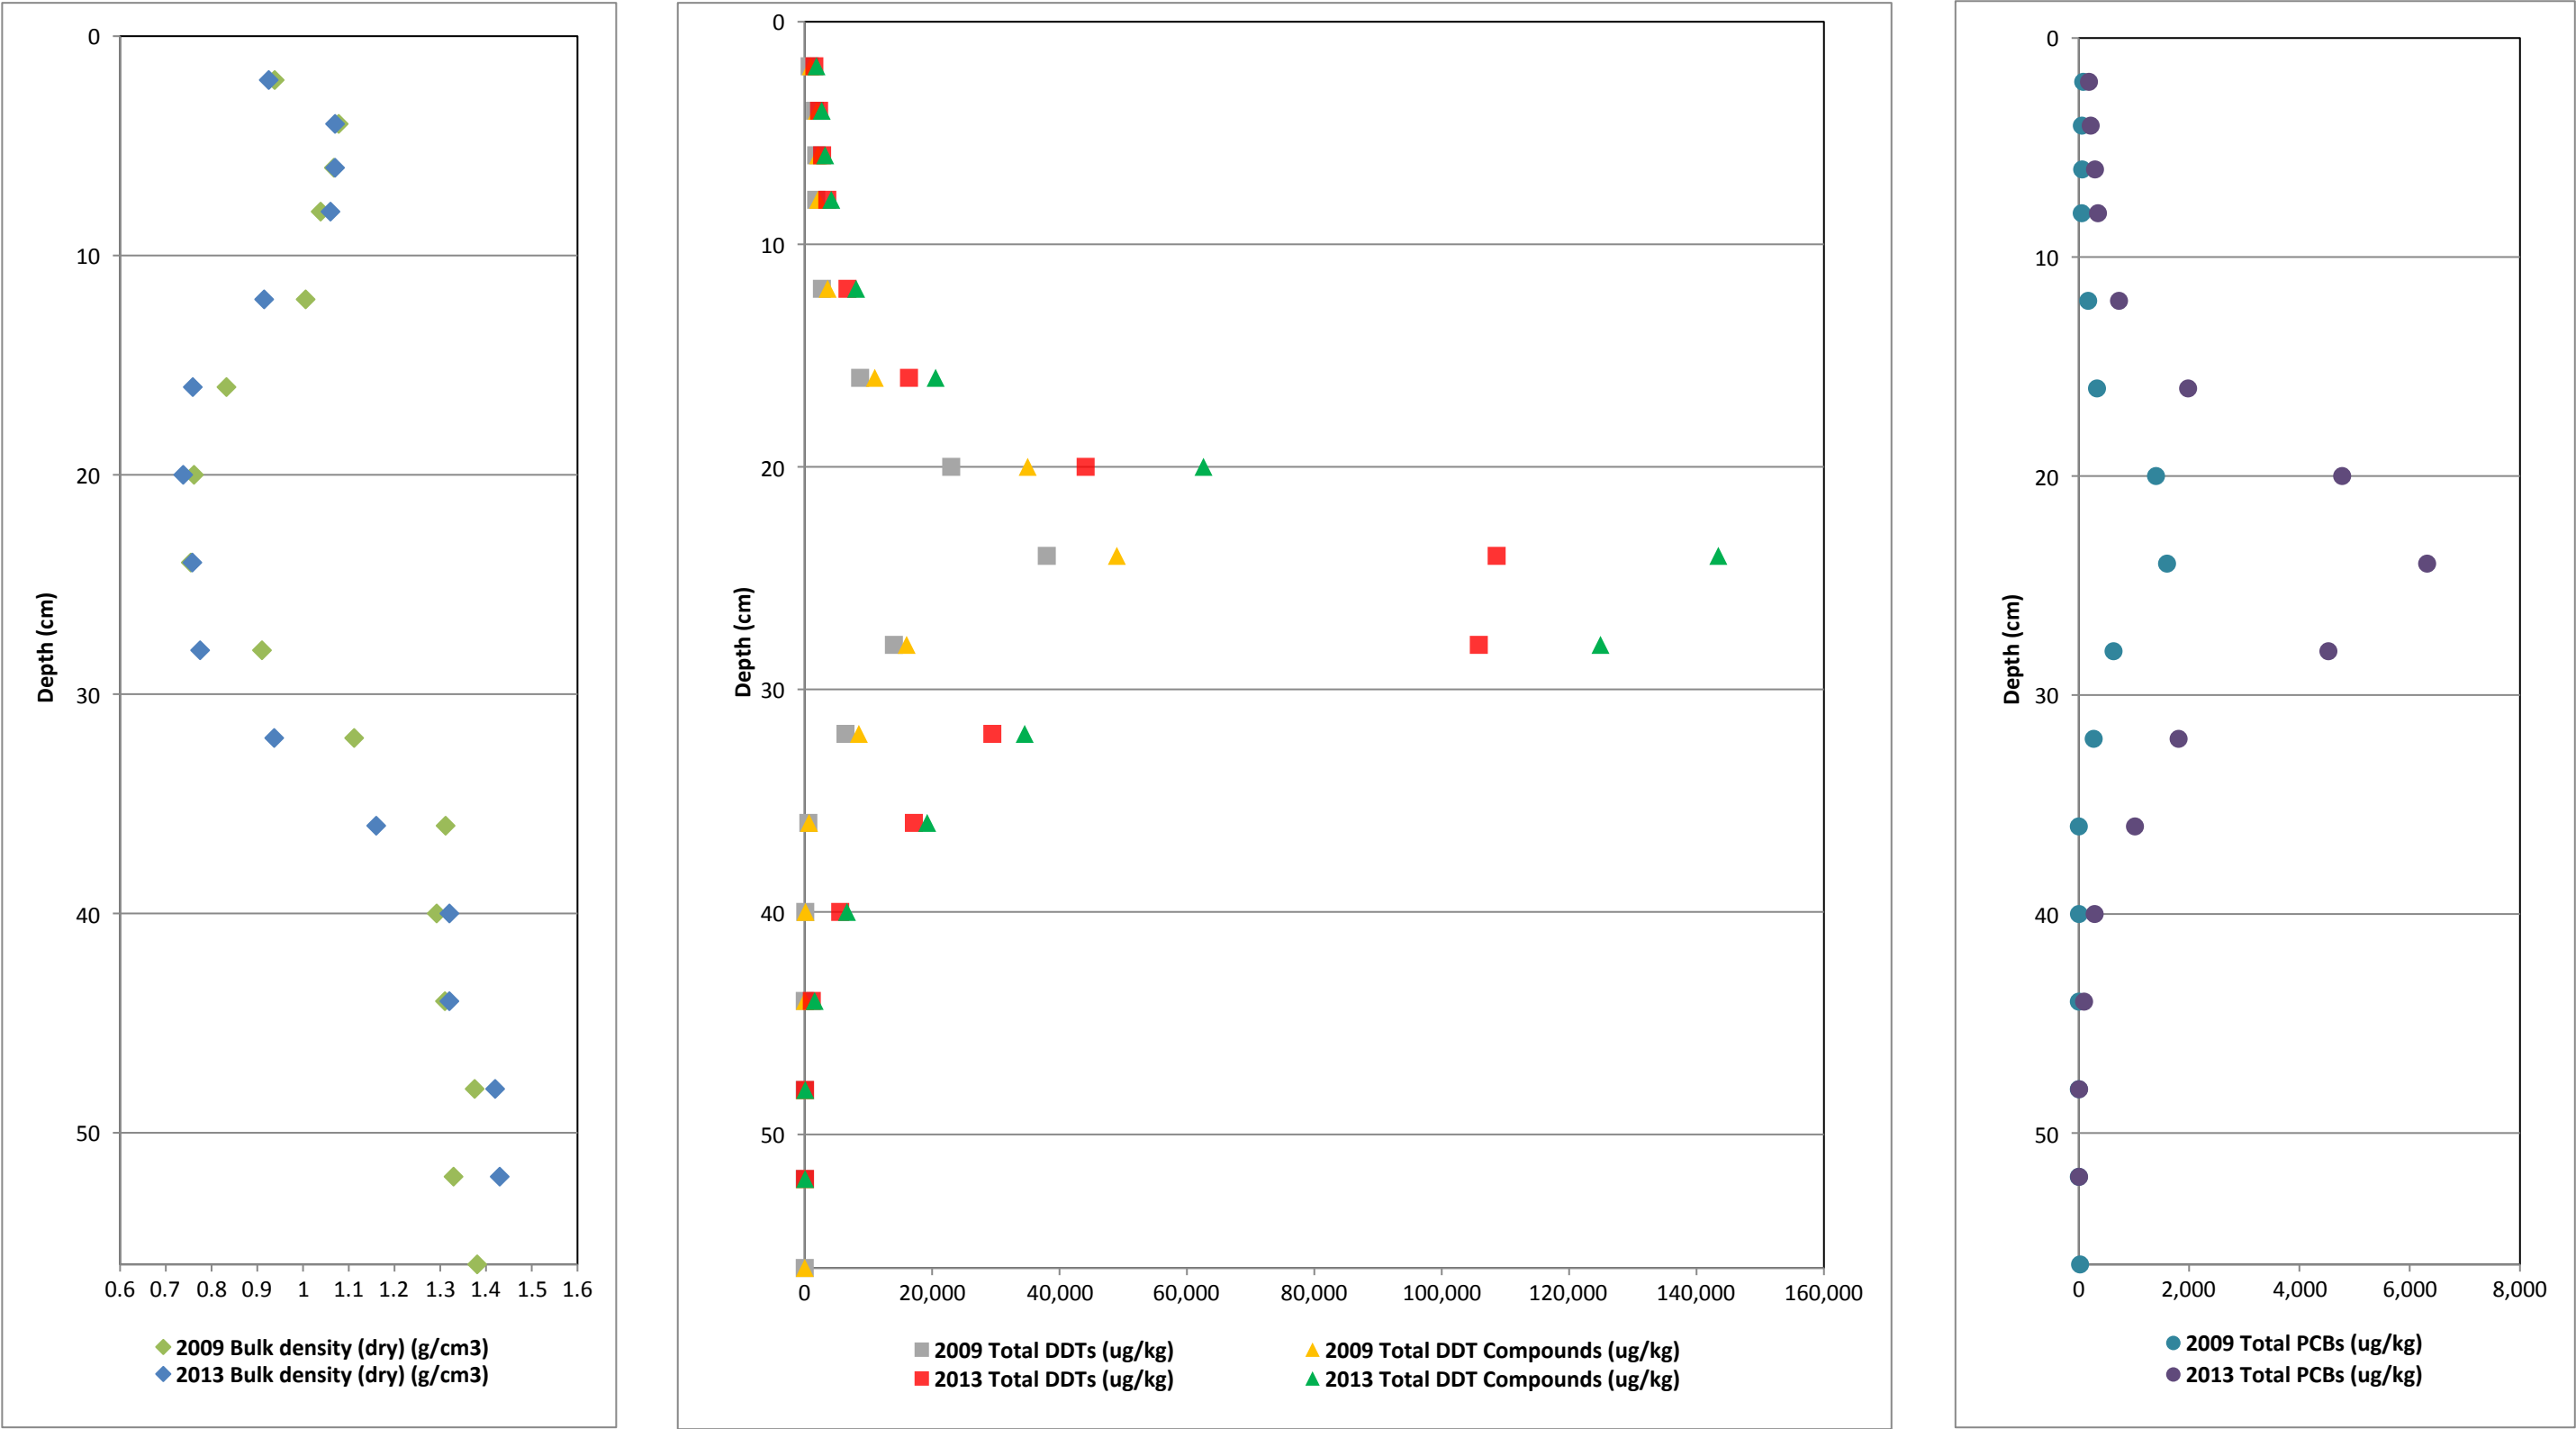
Figure 1. Vertical Profiles of Bulk Density and COCs for Core OA01  
First MNR Report  
Palos Verdes Shelf (OU 5 of the Montrose Chemical Corp. Superfund Site)  
Los Angeles County, California

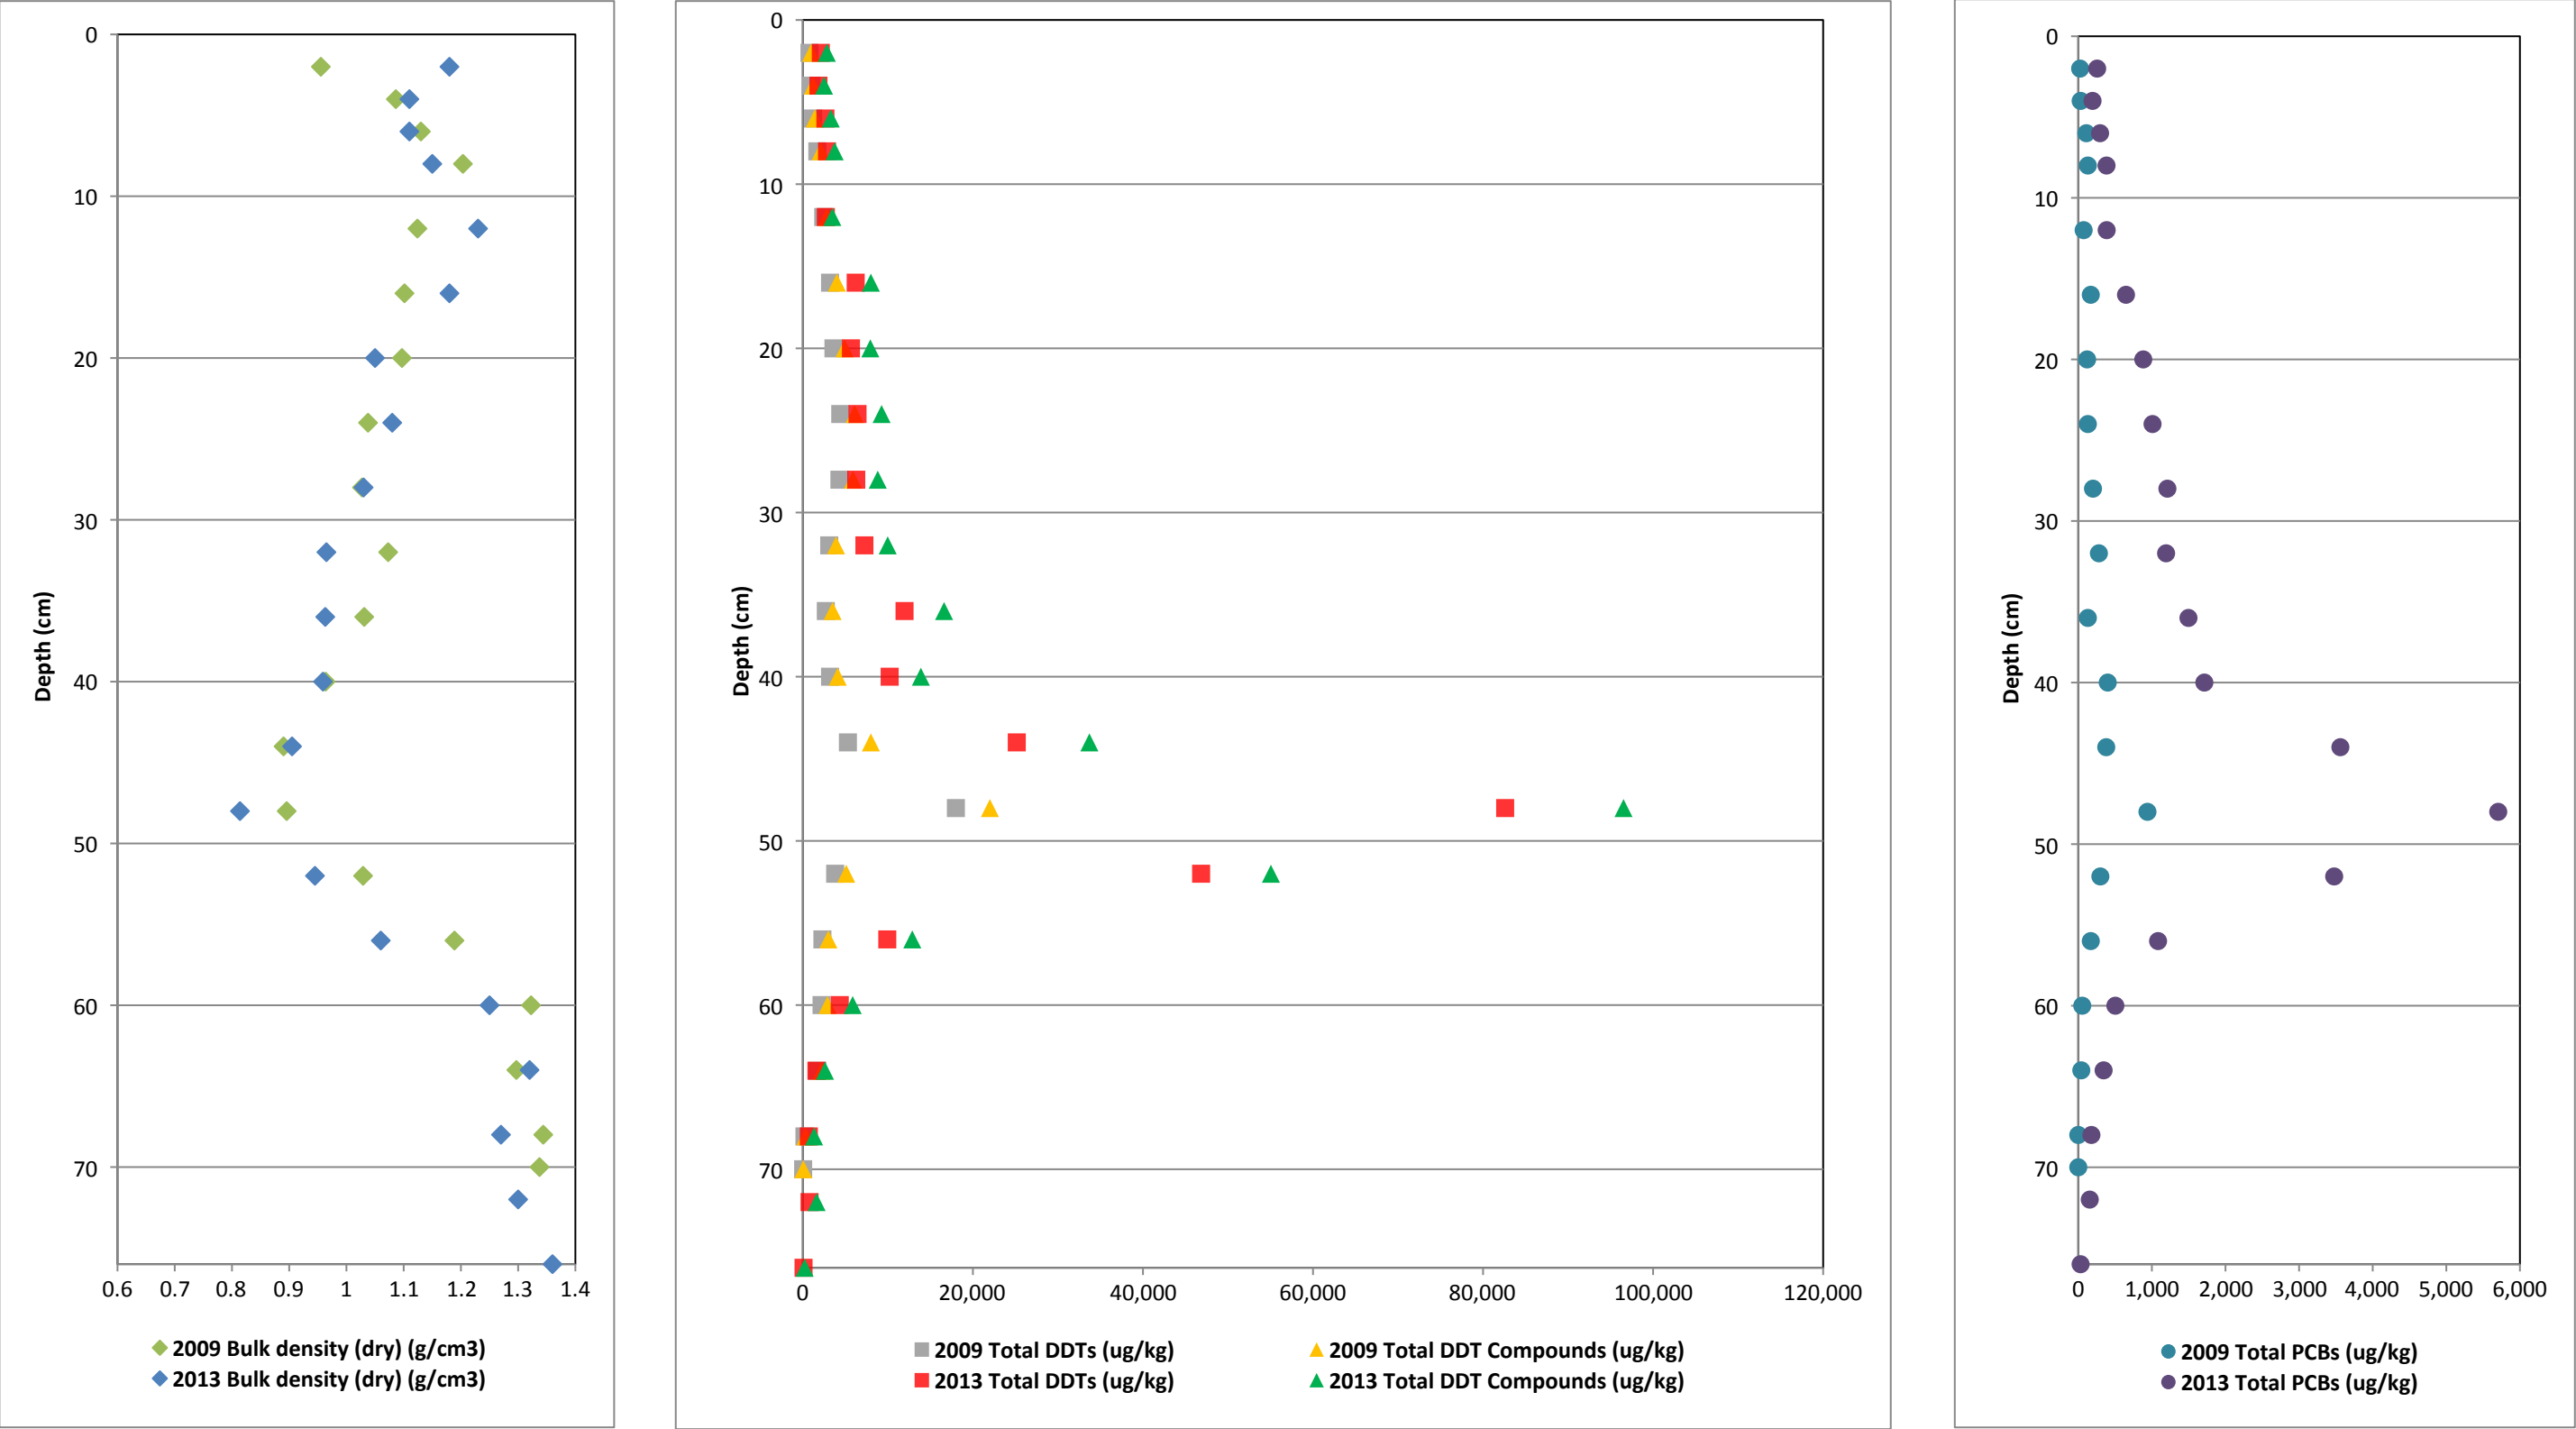
Figure 2. Vertical Profiles of Bulk Density and COCs for Core OA02  
First MNR Report  
Palos Verdes Shelf (OU 5 of the Montrose Chemical Corp. Superfund Site)  
Los Angeles County, California

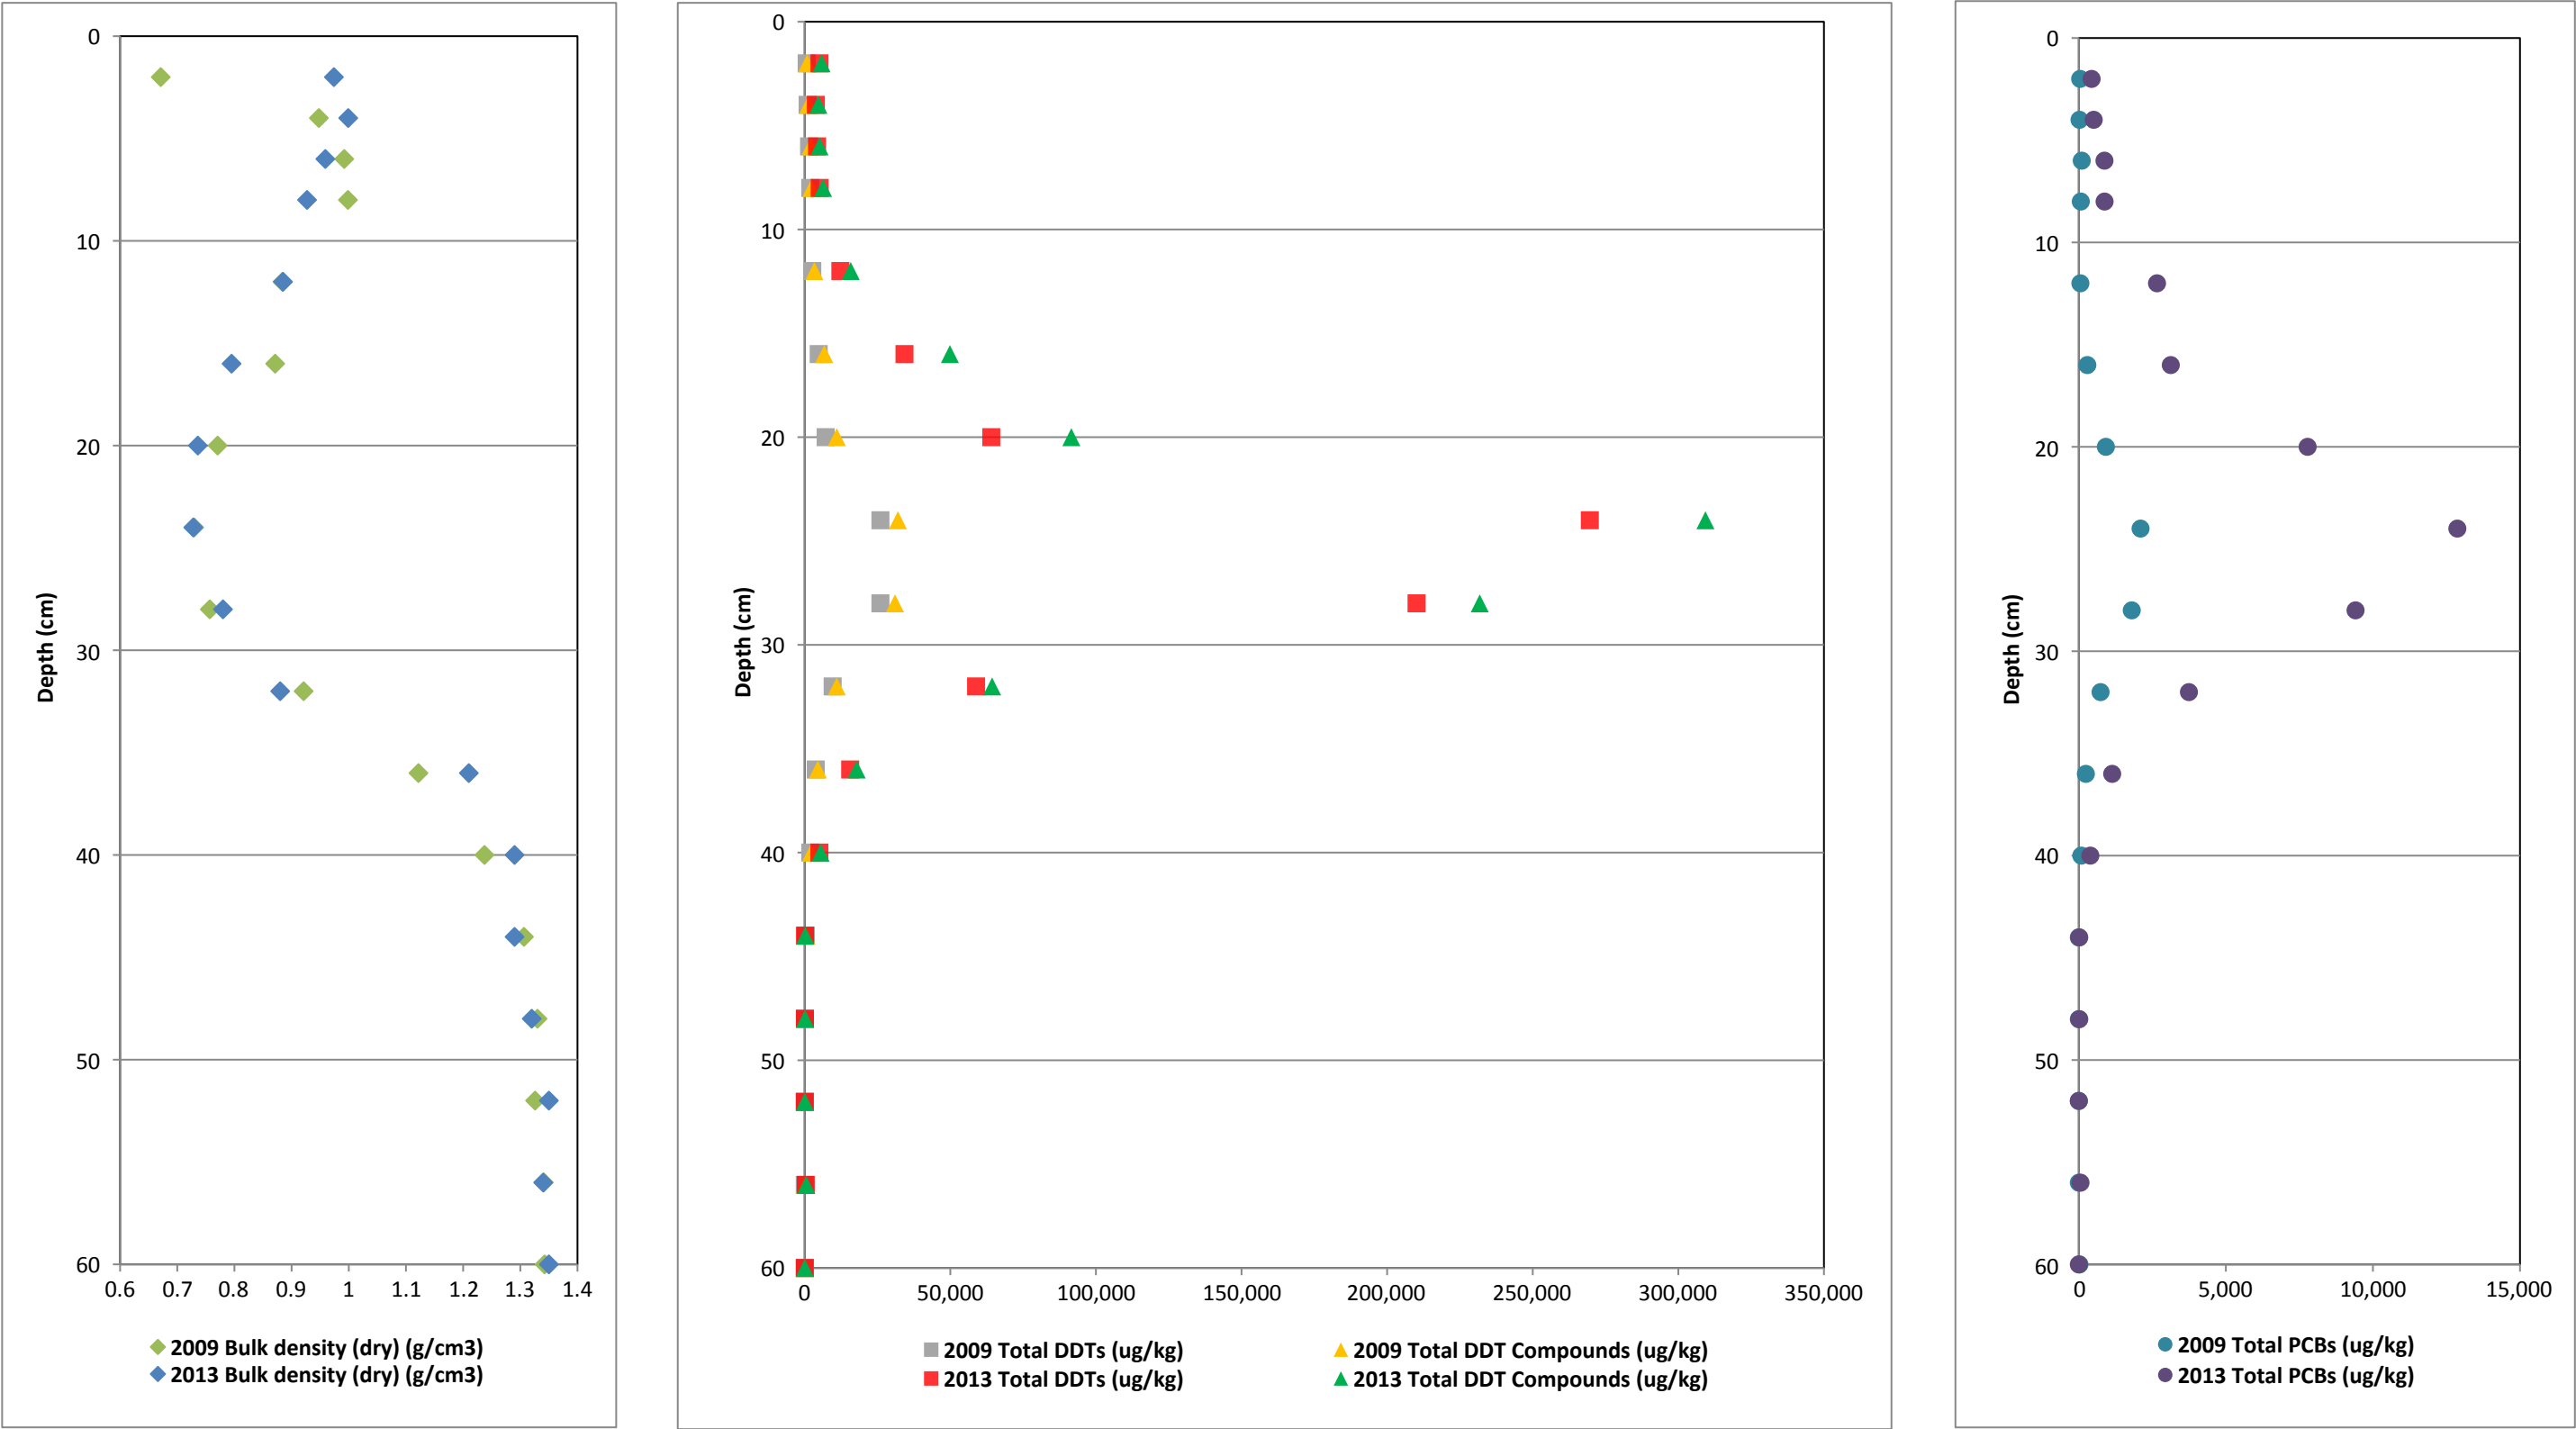
Figure 3. Vertical Profiles of Bulk Density and COCs for Core OA03  
First MNR Report  
Palos Verdes Shelf (OU 5 of the Montrose Chemical Corp. Superfund Site)  
Los Angeles County, California

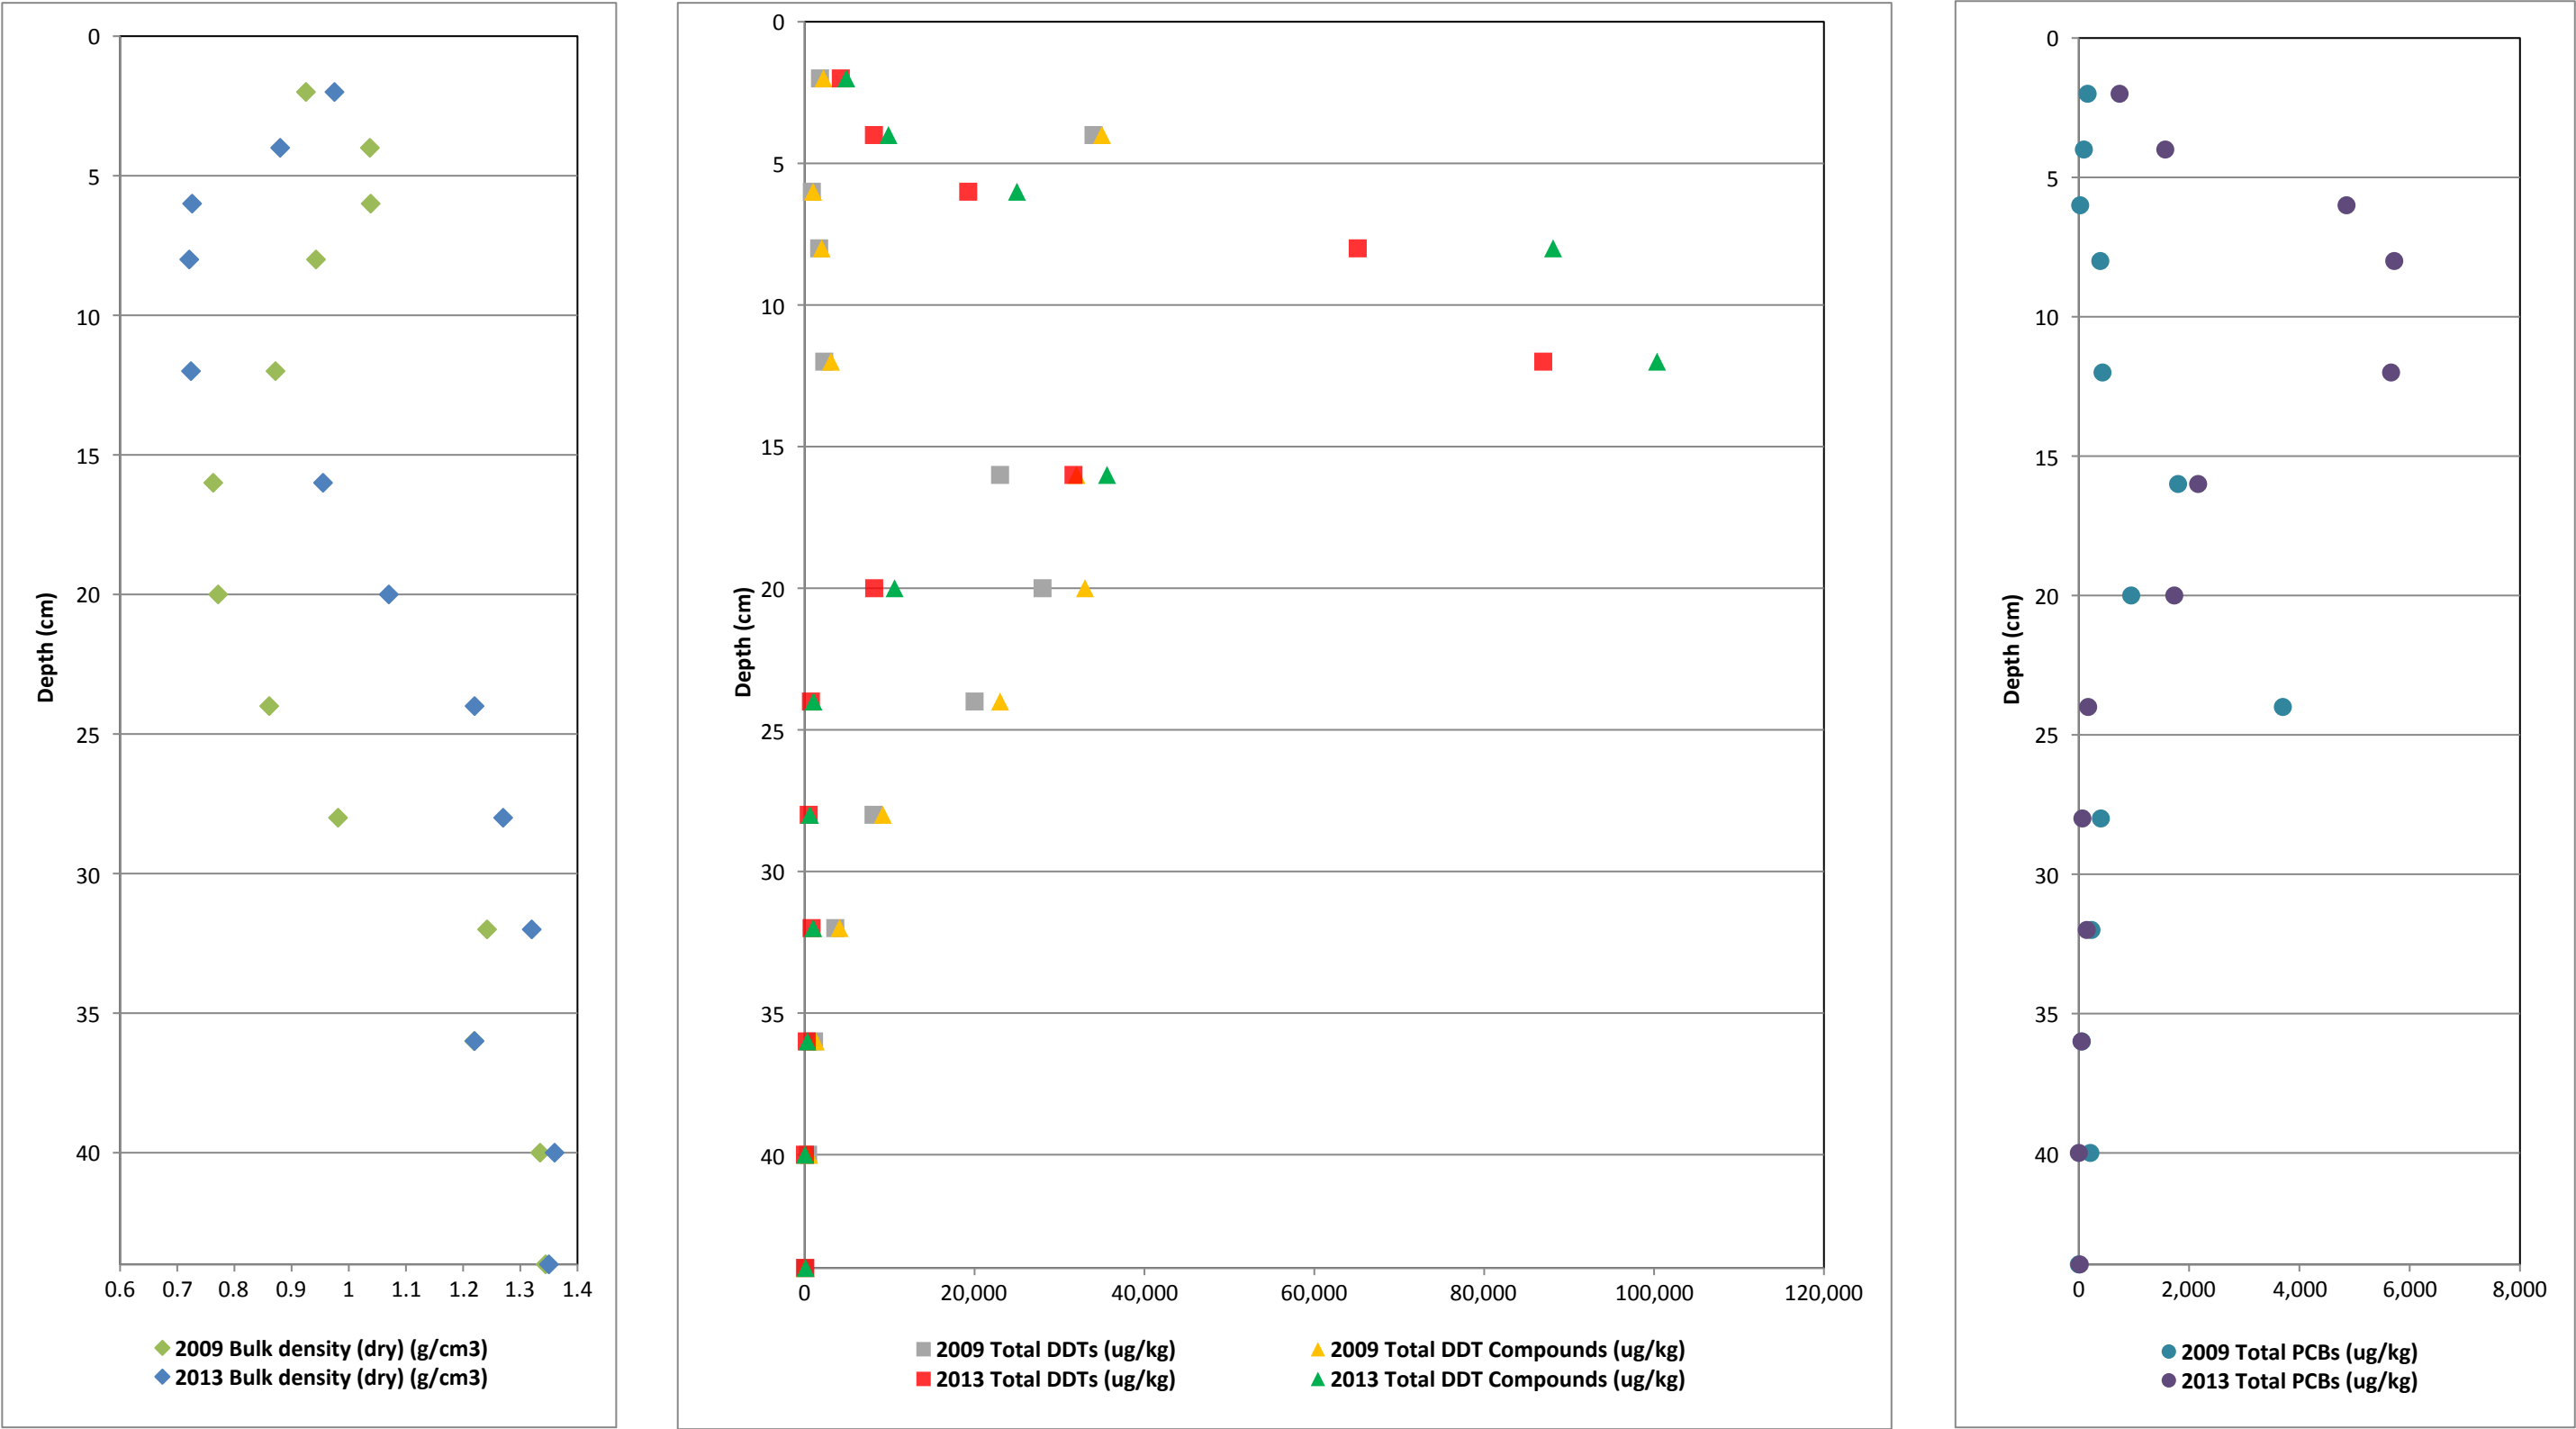
Figure 4. Vertical Profiles of Bulk Density and COCs for Core OA04  
First MNR Report  
Palos Verdes Shelf (OU 5 of the Montrose Chemical Corp. Superfund Site)  
Los Angeles County, California

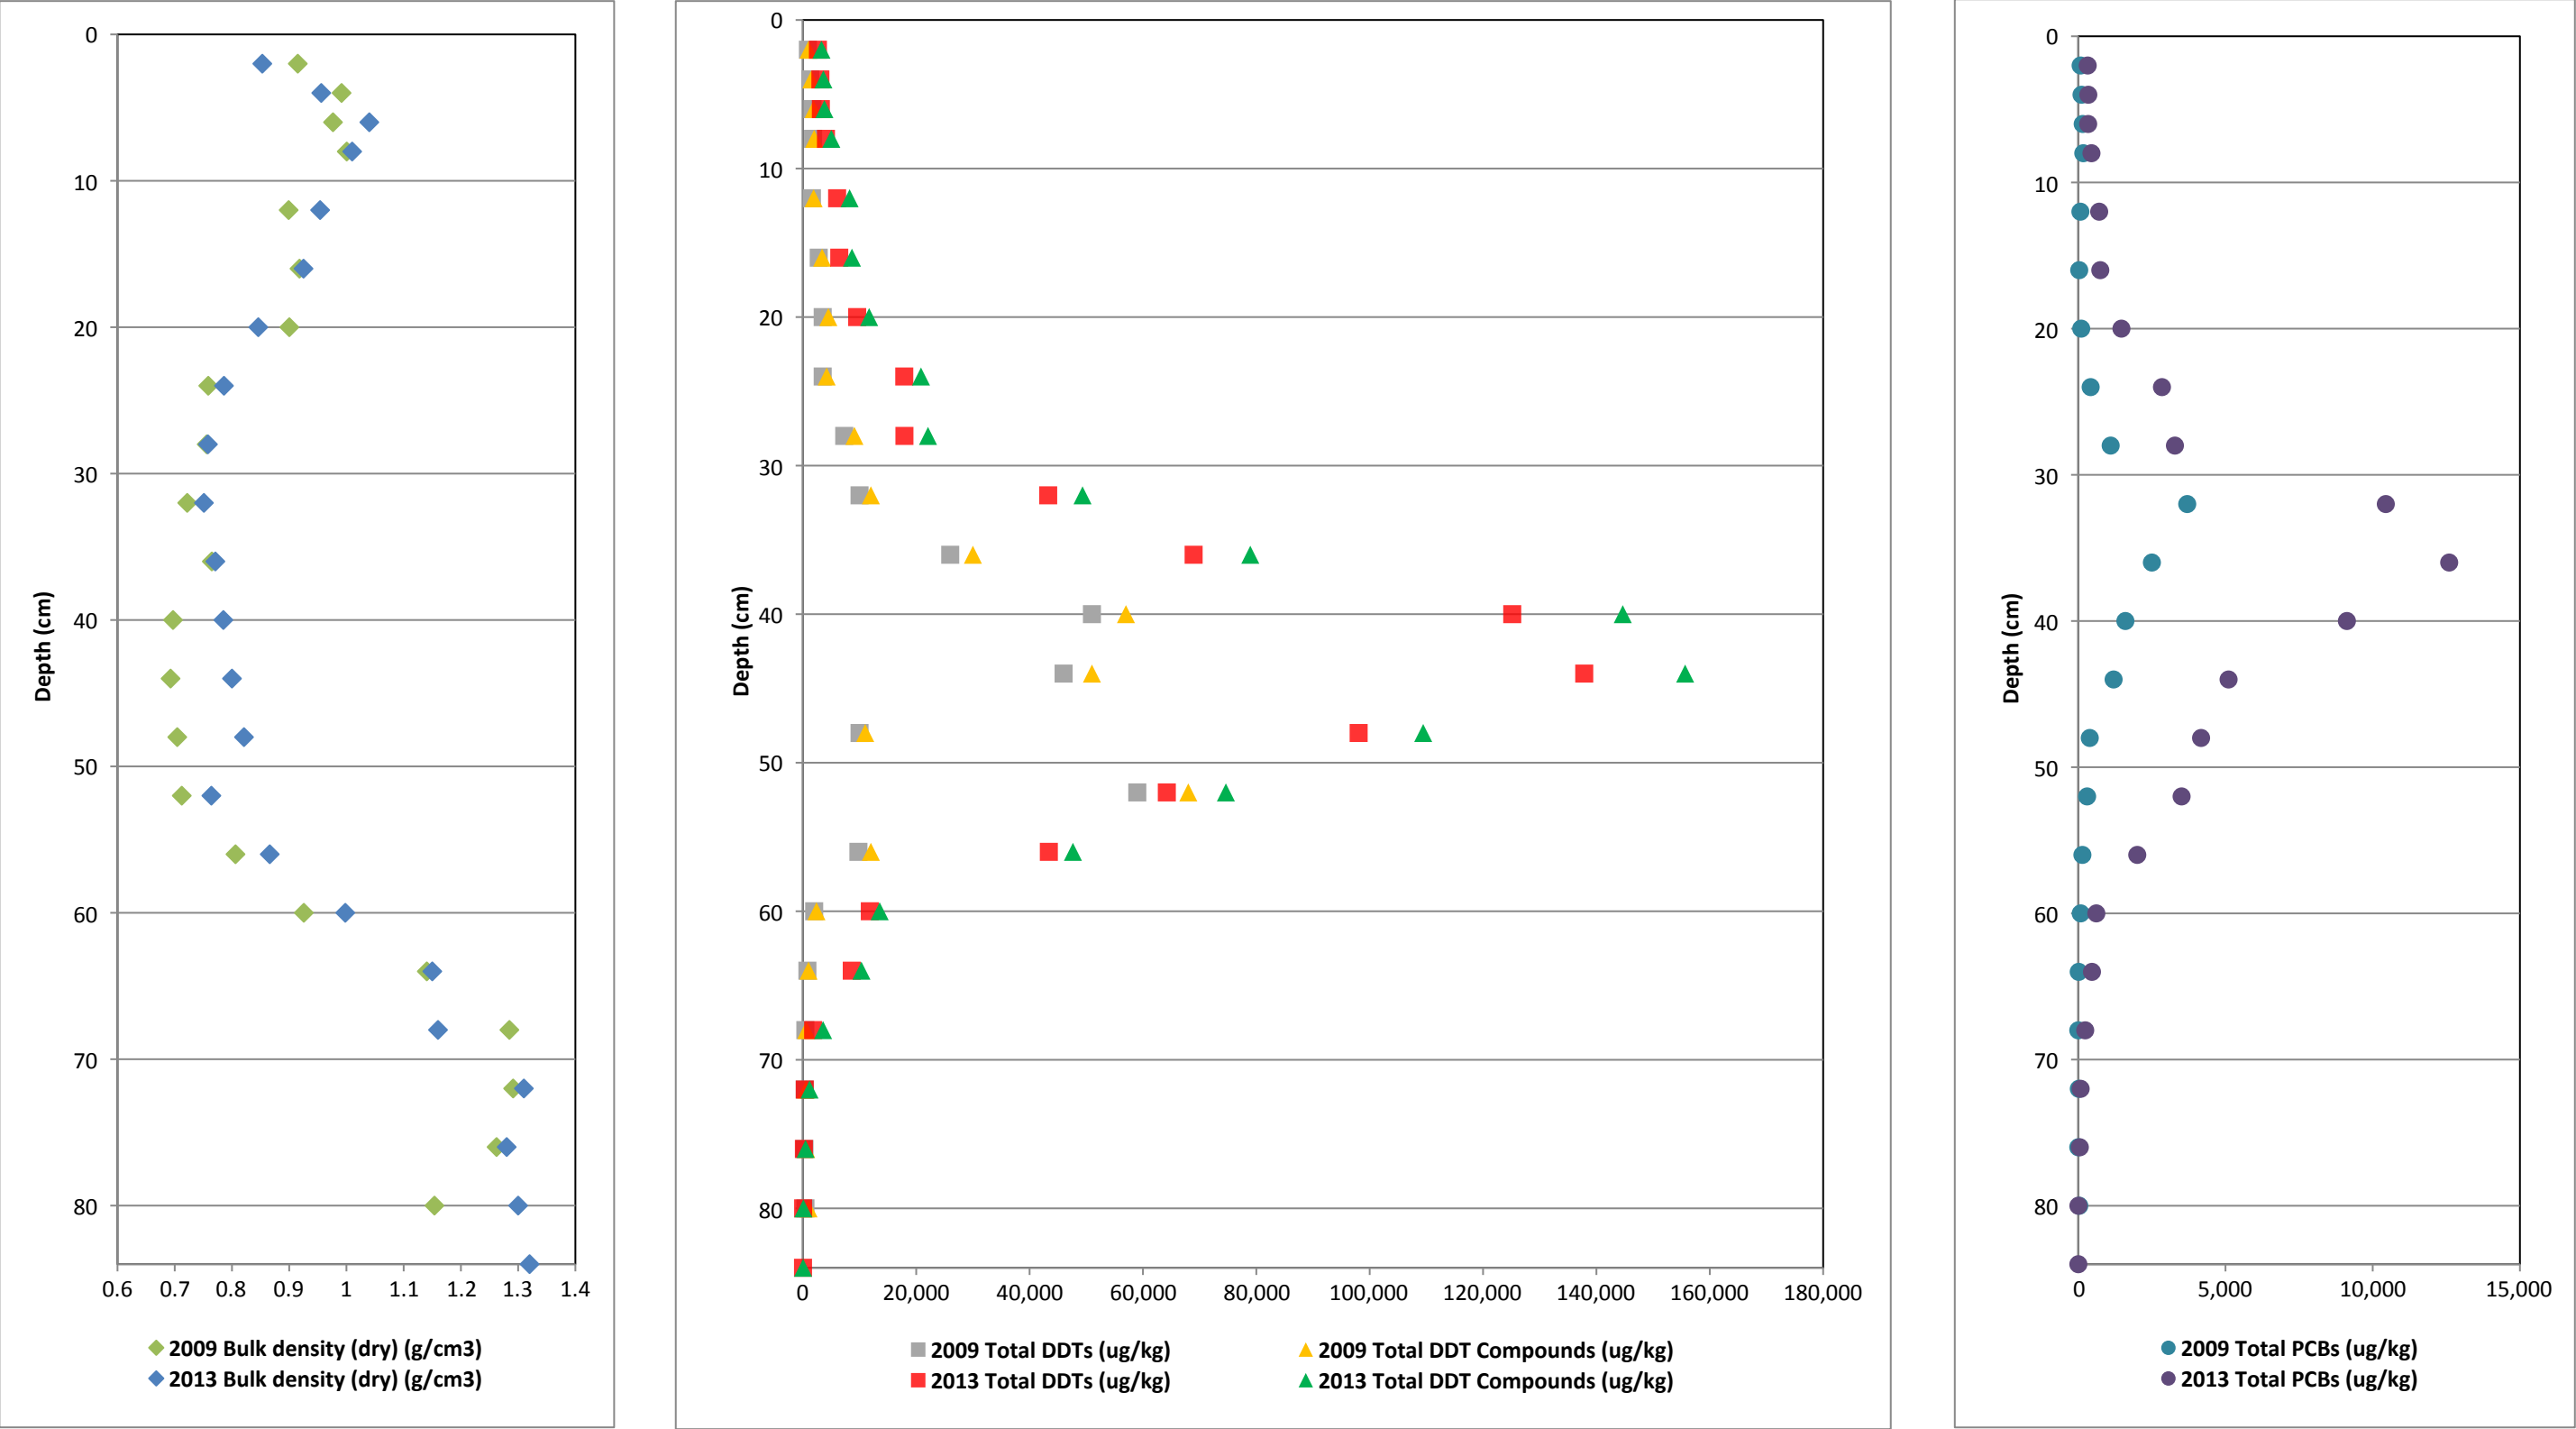
Figure 5. Vertical Profiles of Bulk Density and COCs for Core OA05  
First MNR Report  
Palos Verdes Shelf (OU 5 of the Montrose Chemical Corp. Superfund Site)  
Los Angeles County, California

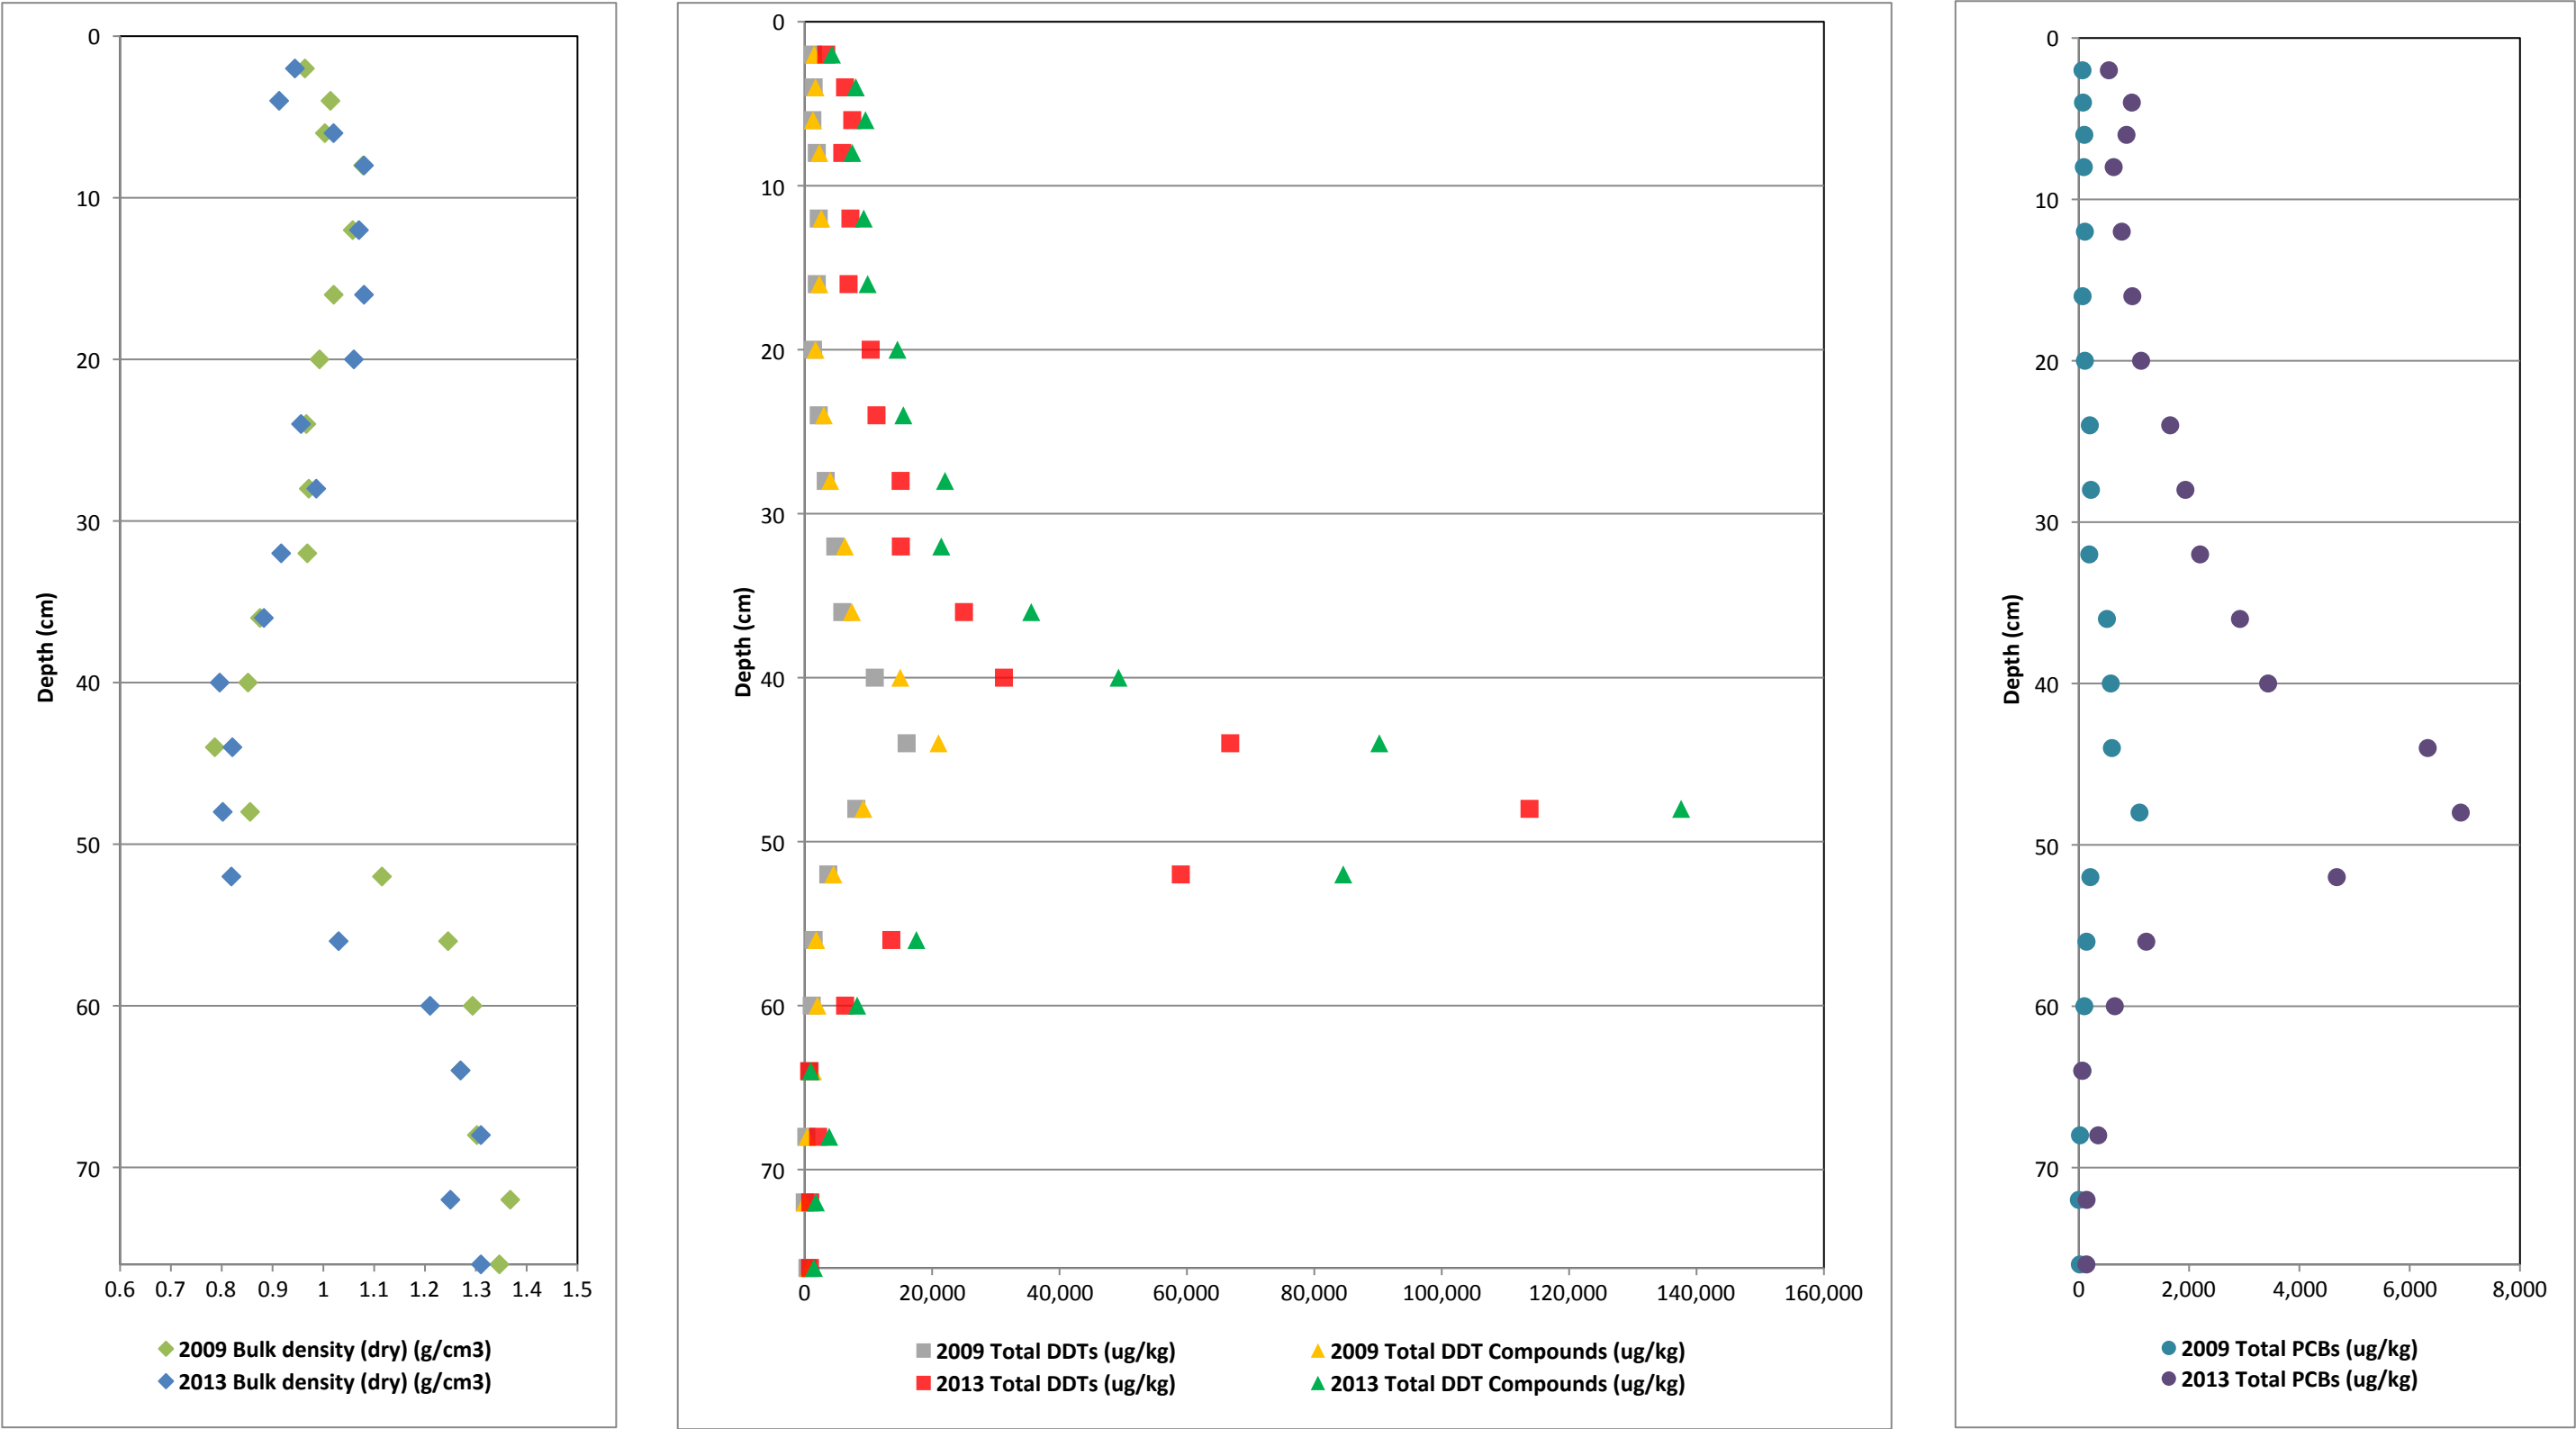
Figure 6. Vertical Profiles of Bulk Density and COCs for Core OA06  
First MNR Report  
Palos Verdes Shelf (OU 5 of the Montrose Chemical Corp. Superfund Site)  
Los Angeles County, California
