## **APPENDIX X.2 – VERTICAL PROFILES – OUTFALL AREA CORES**

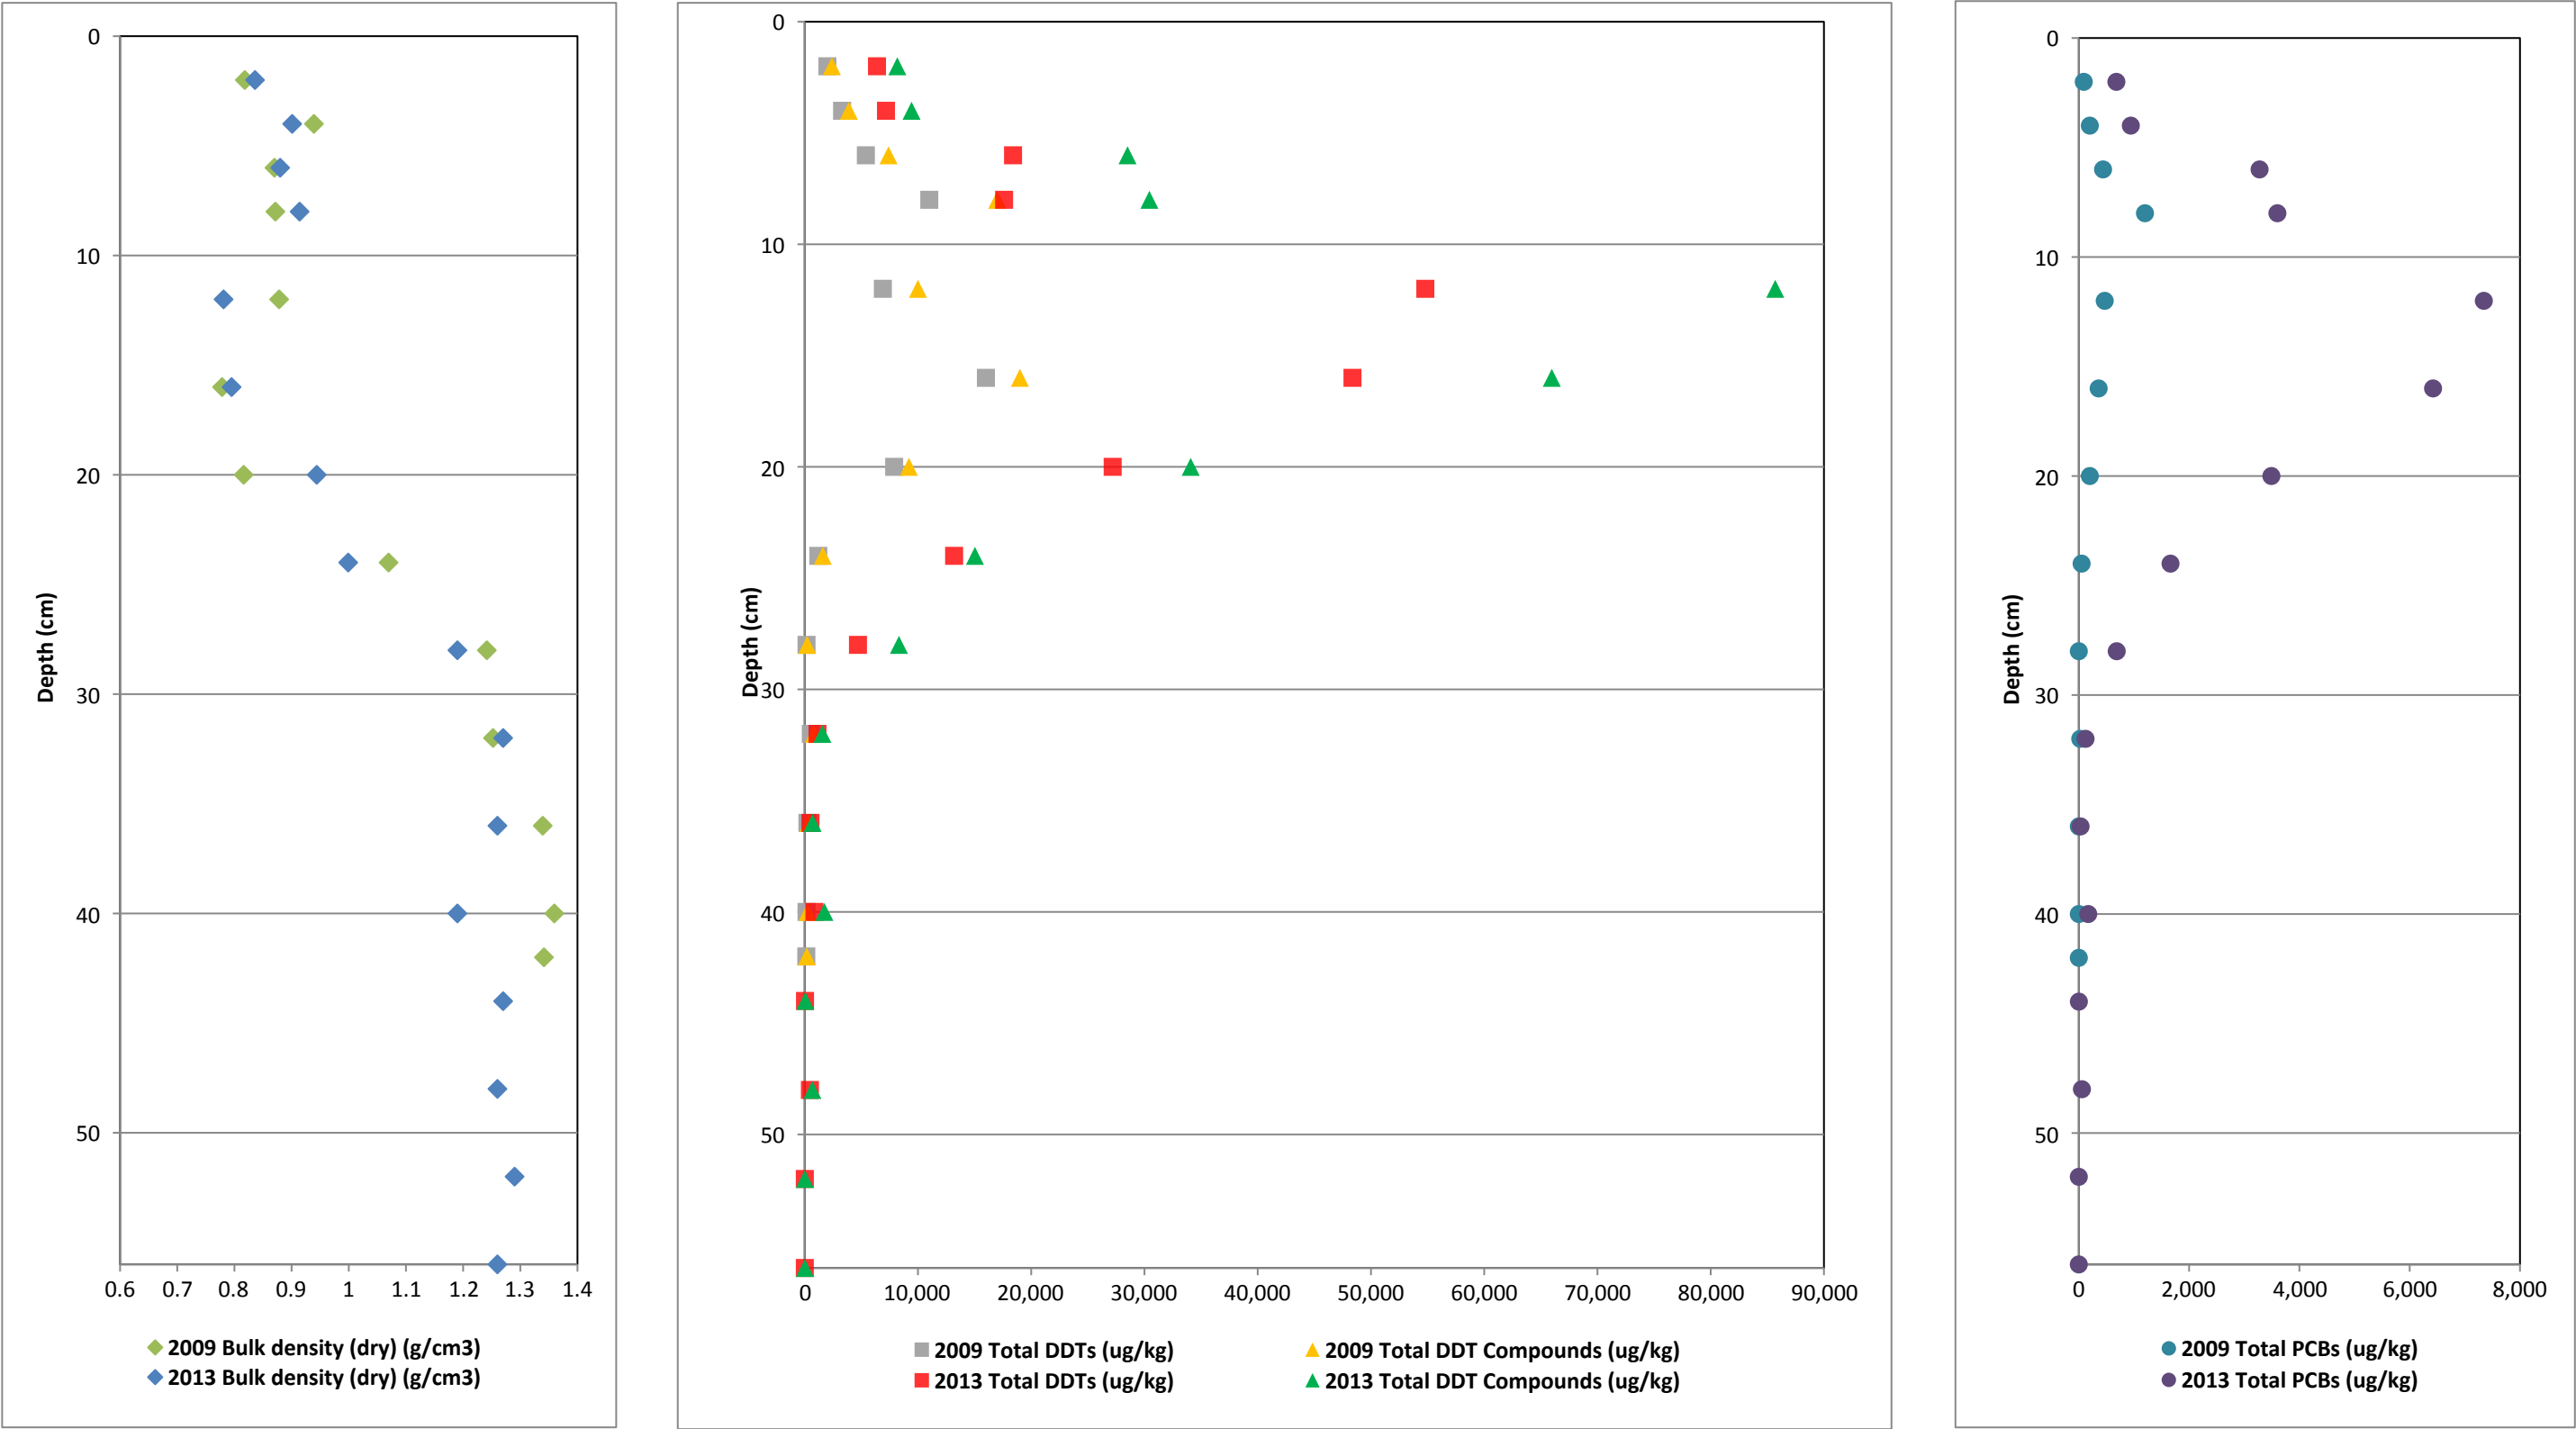
Figure 7. Vertical Profiles of Bulk Density and COCs for Core OA07  
First MNR Report  
Palos Verdes Shelf (OU 5 of the Montrose Chemical Corp. Superfund Site)  
Los Angeles County, California

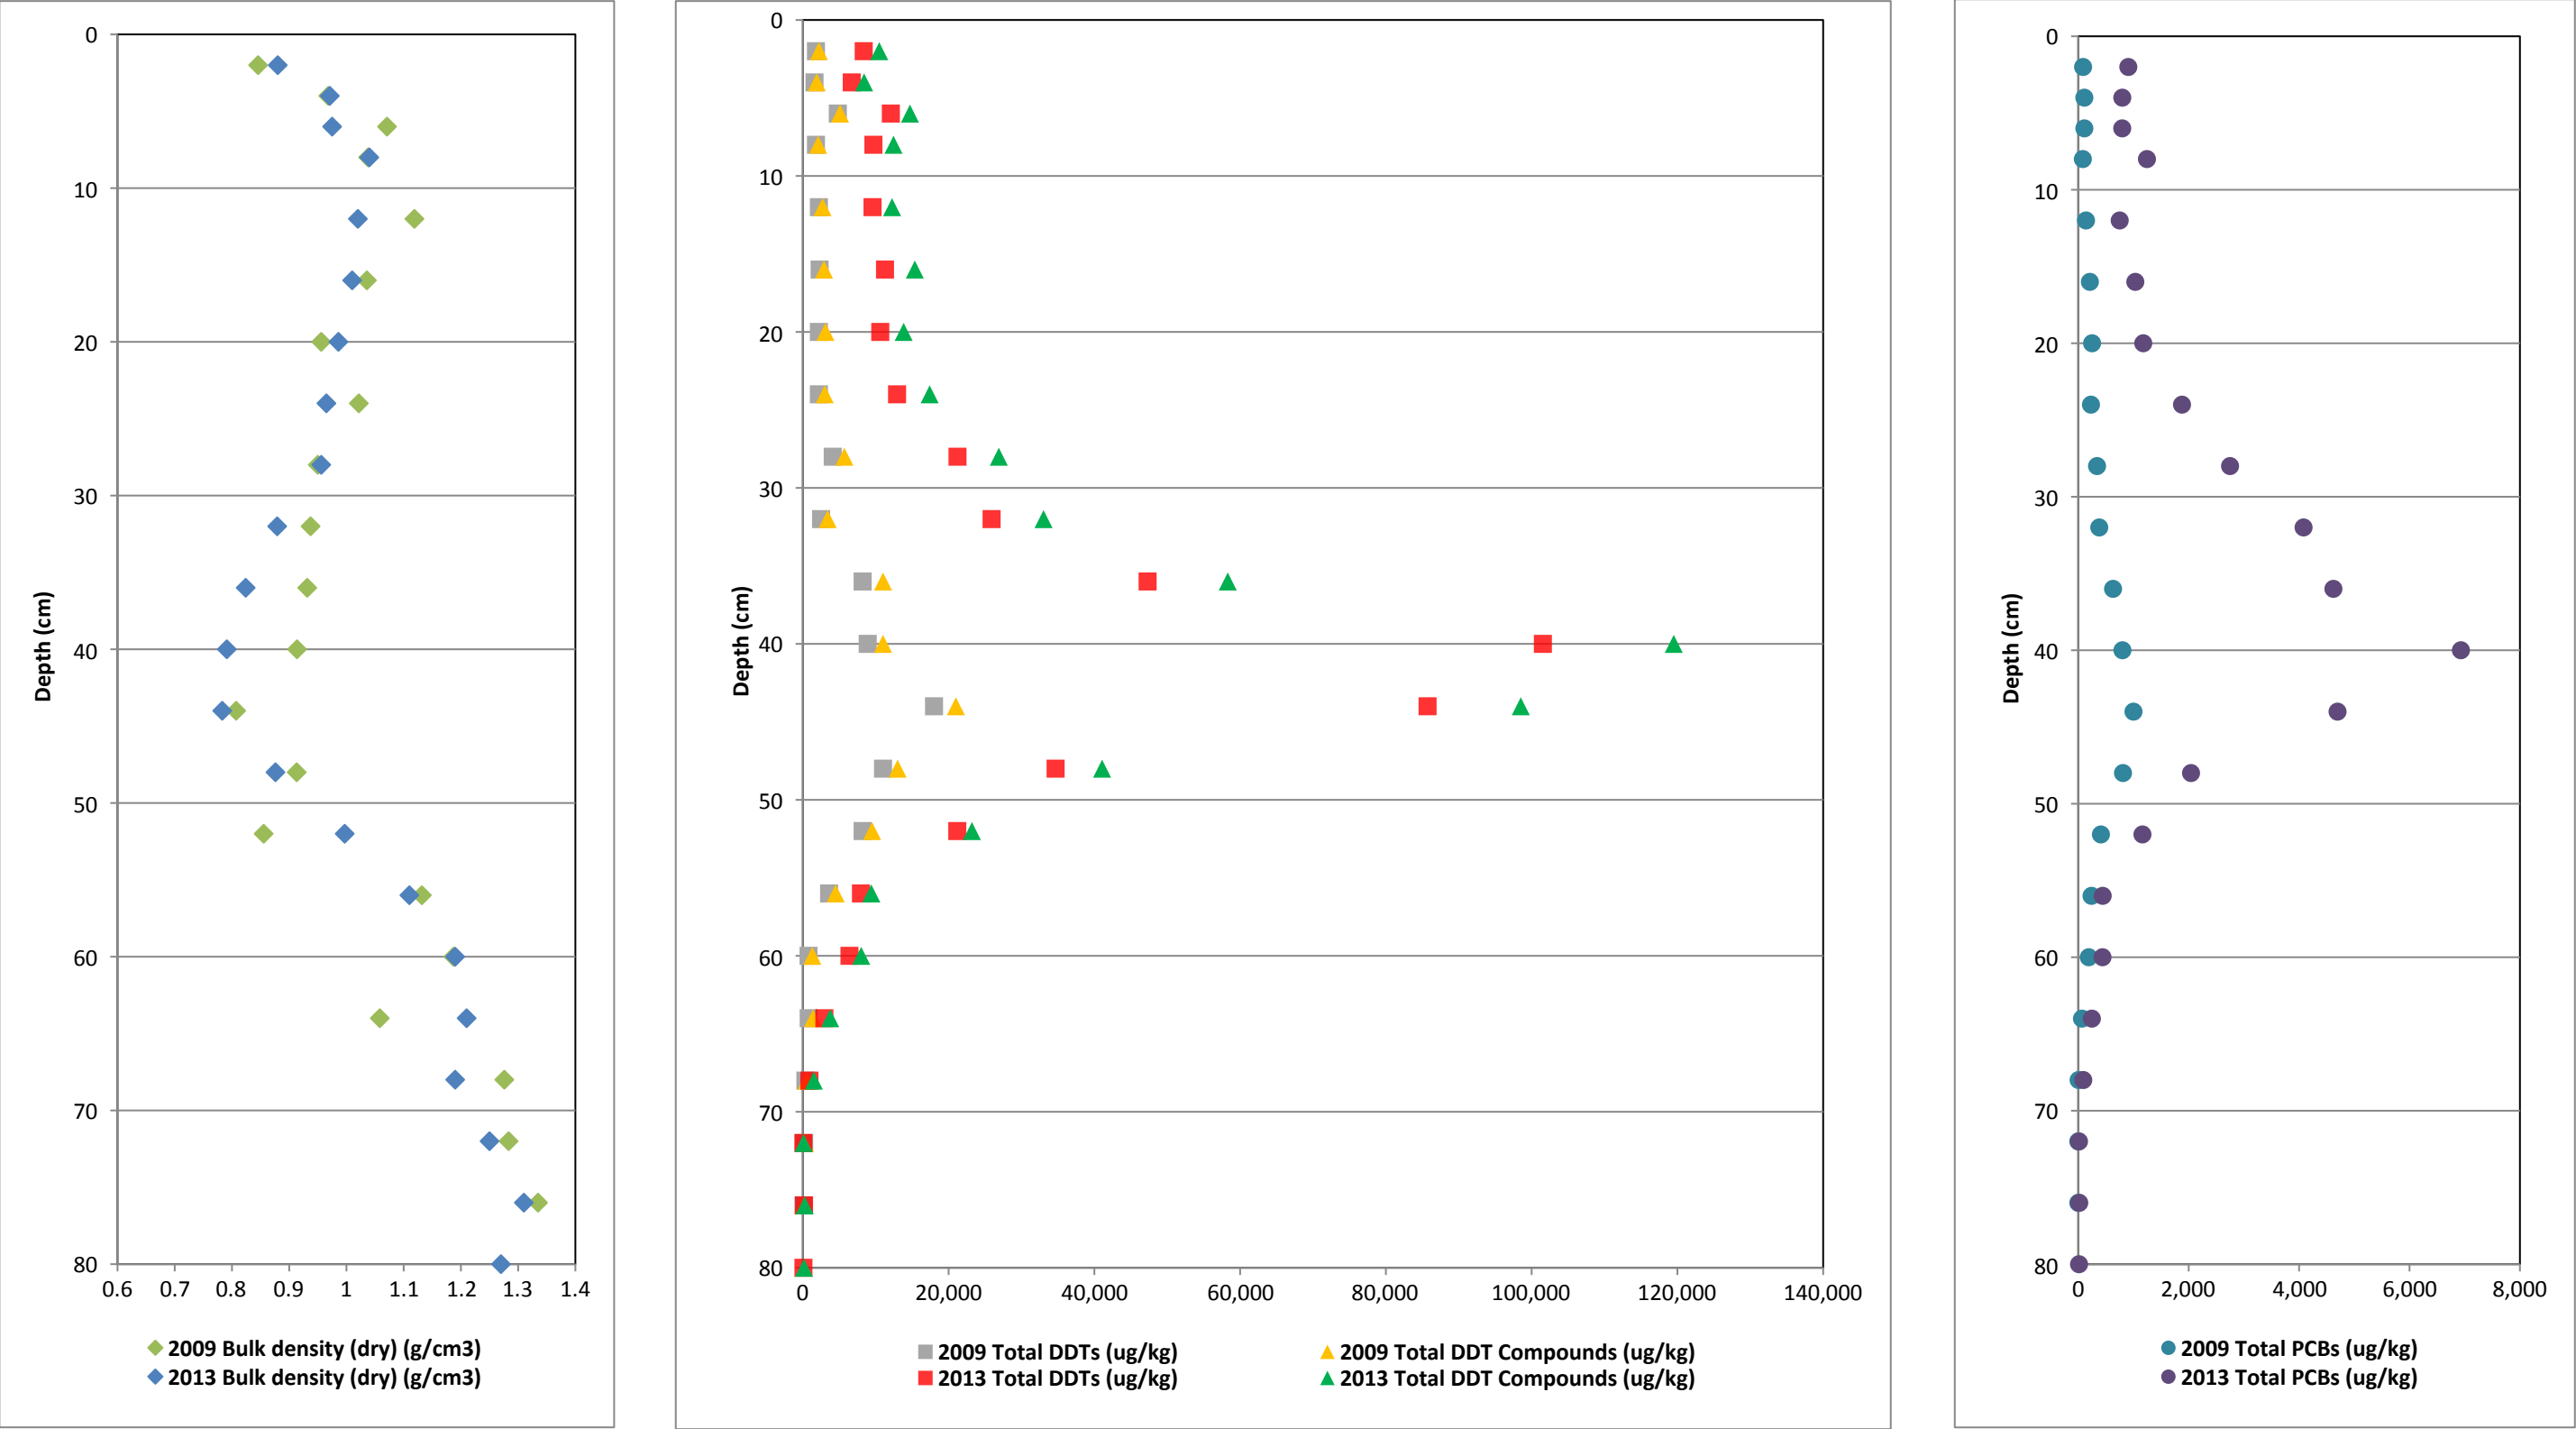
Figure 8. Vertical Profiles of Bulk Density and COCs for Core OA08  
First MNR Report  
Palos Verdes Shelf (OU 5 of the Montrose Chemical Corp. Superfund Site)  
Los Angeles County, California

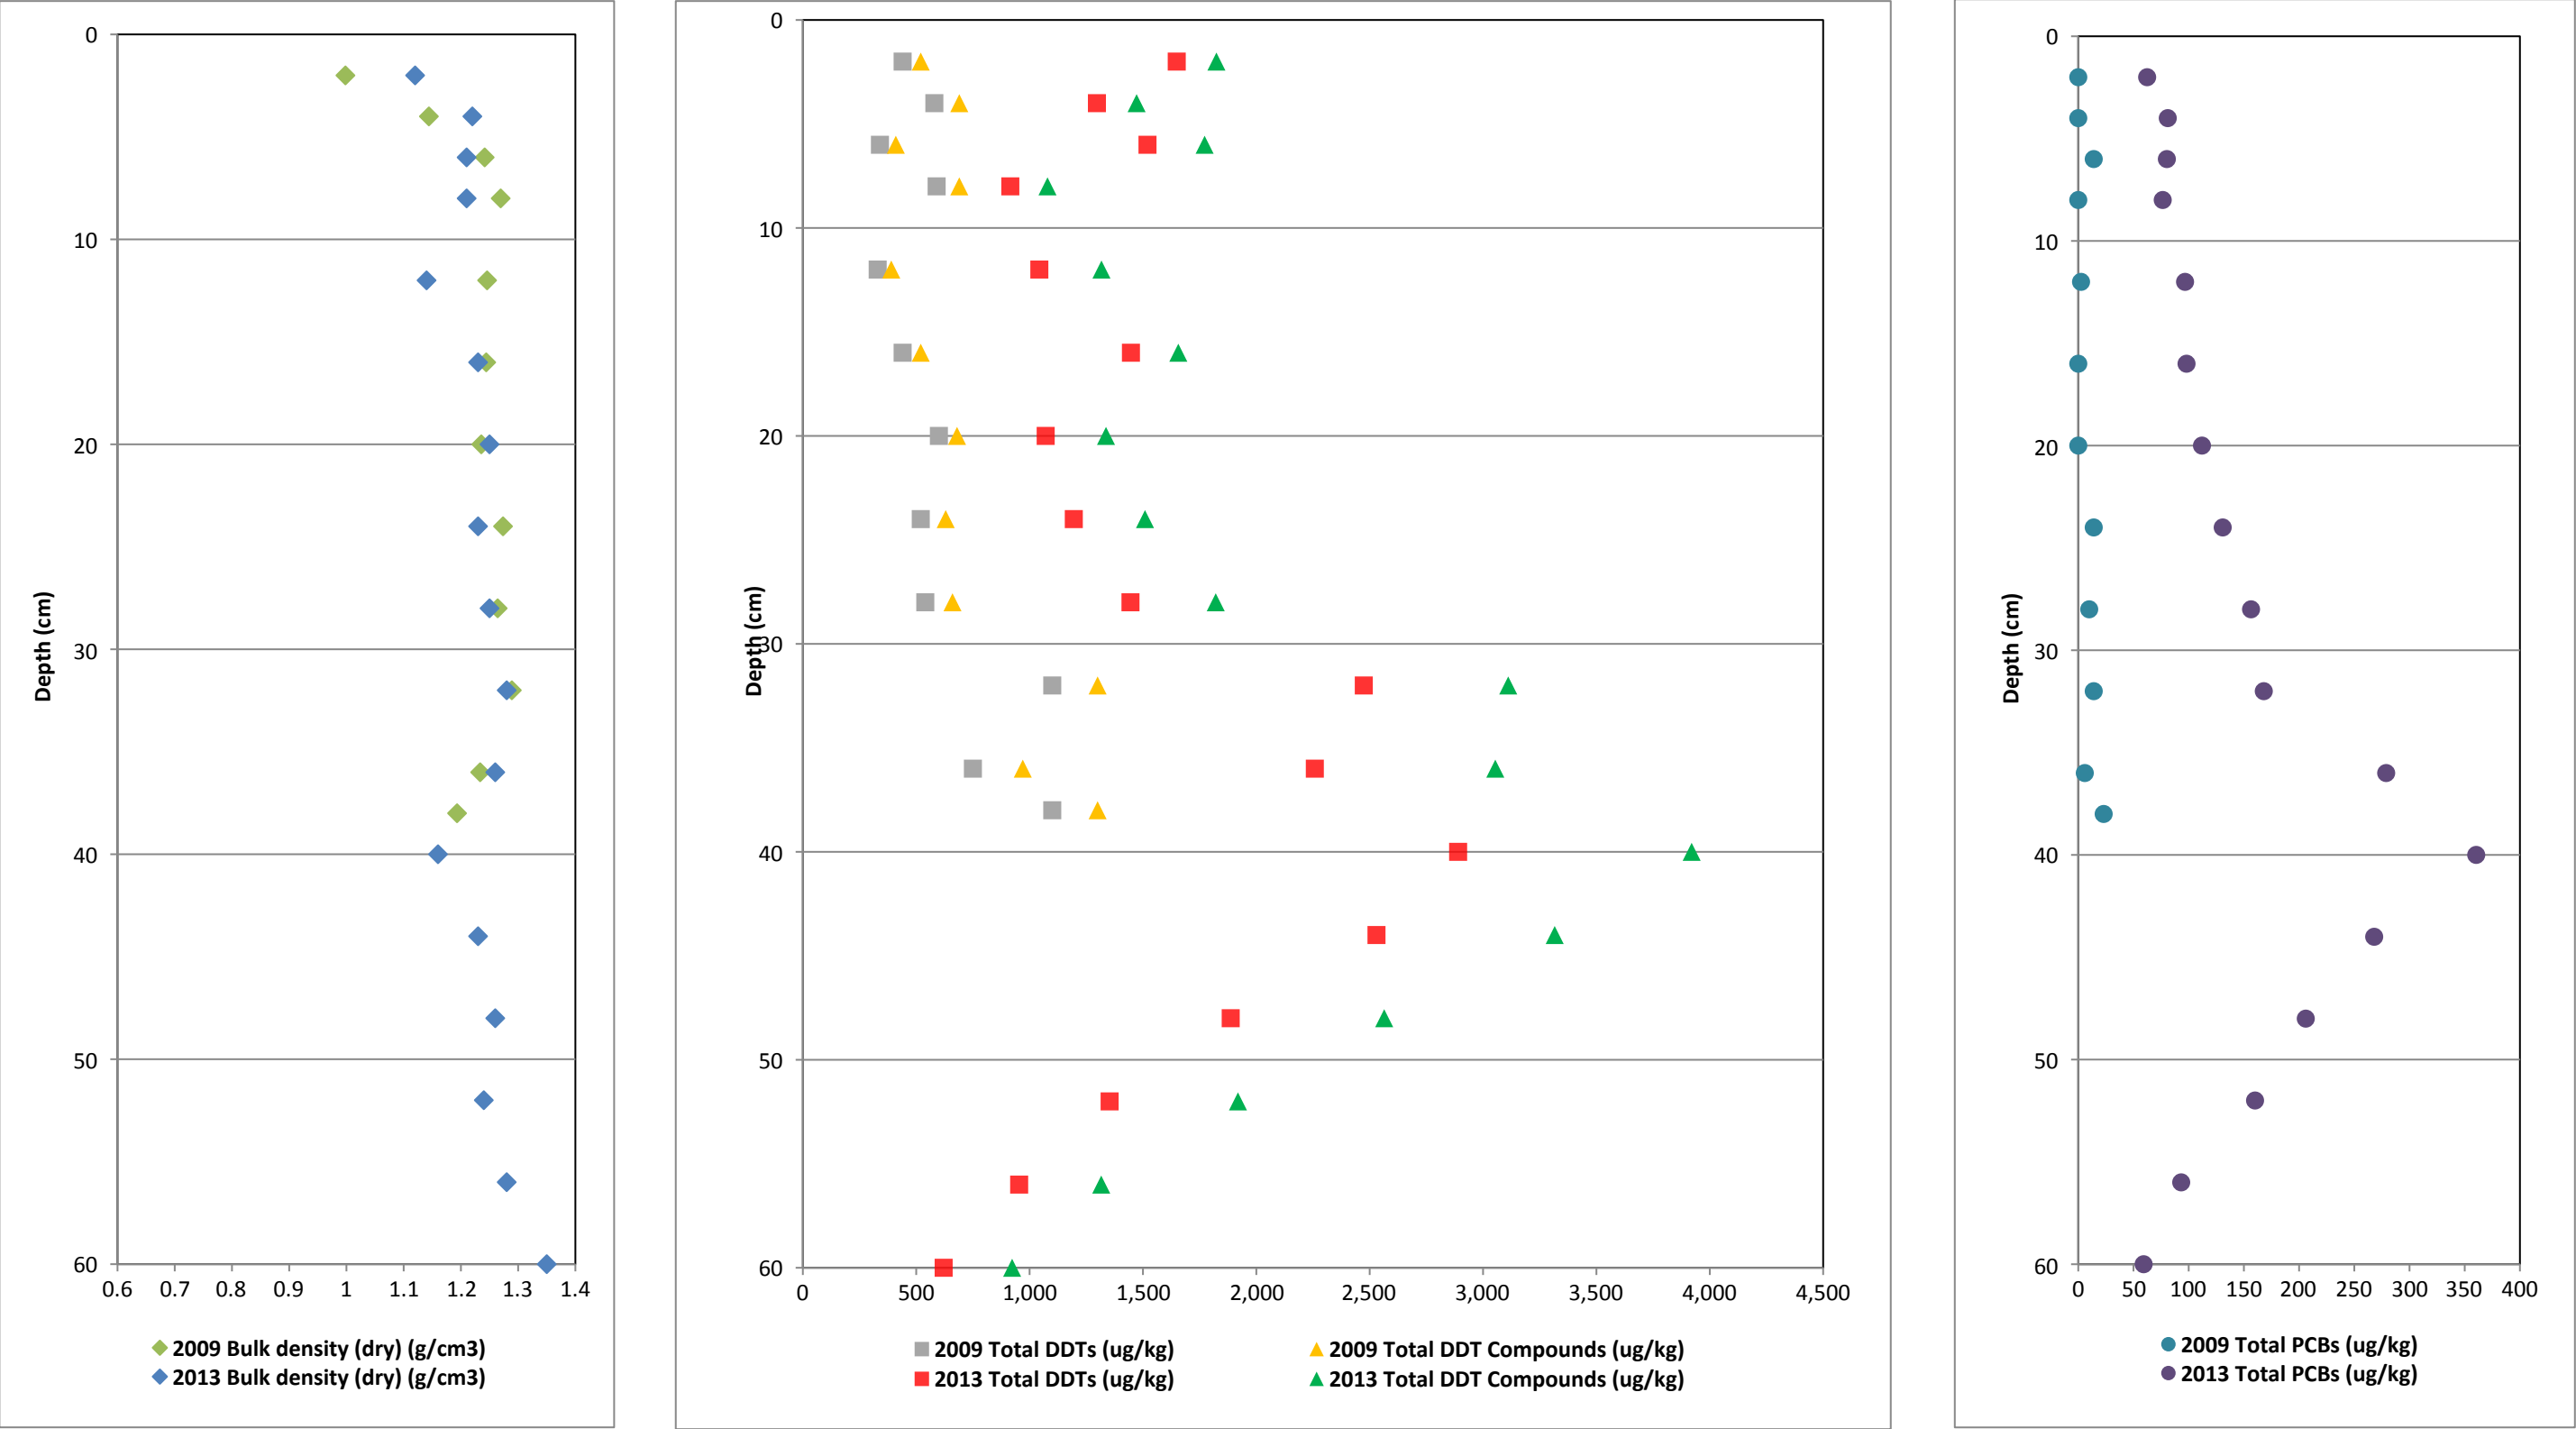
Figure 9. Vertical Profiles of Bulk Density and COCs for Core OA09  
First MNR Report  
Palos Verdes Shelf (OU 5 of the Montrose Chemical Corp. Superfund Site)  
Los Angeles County, California

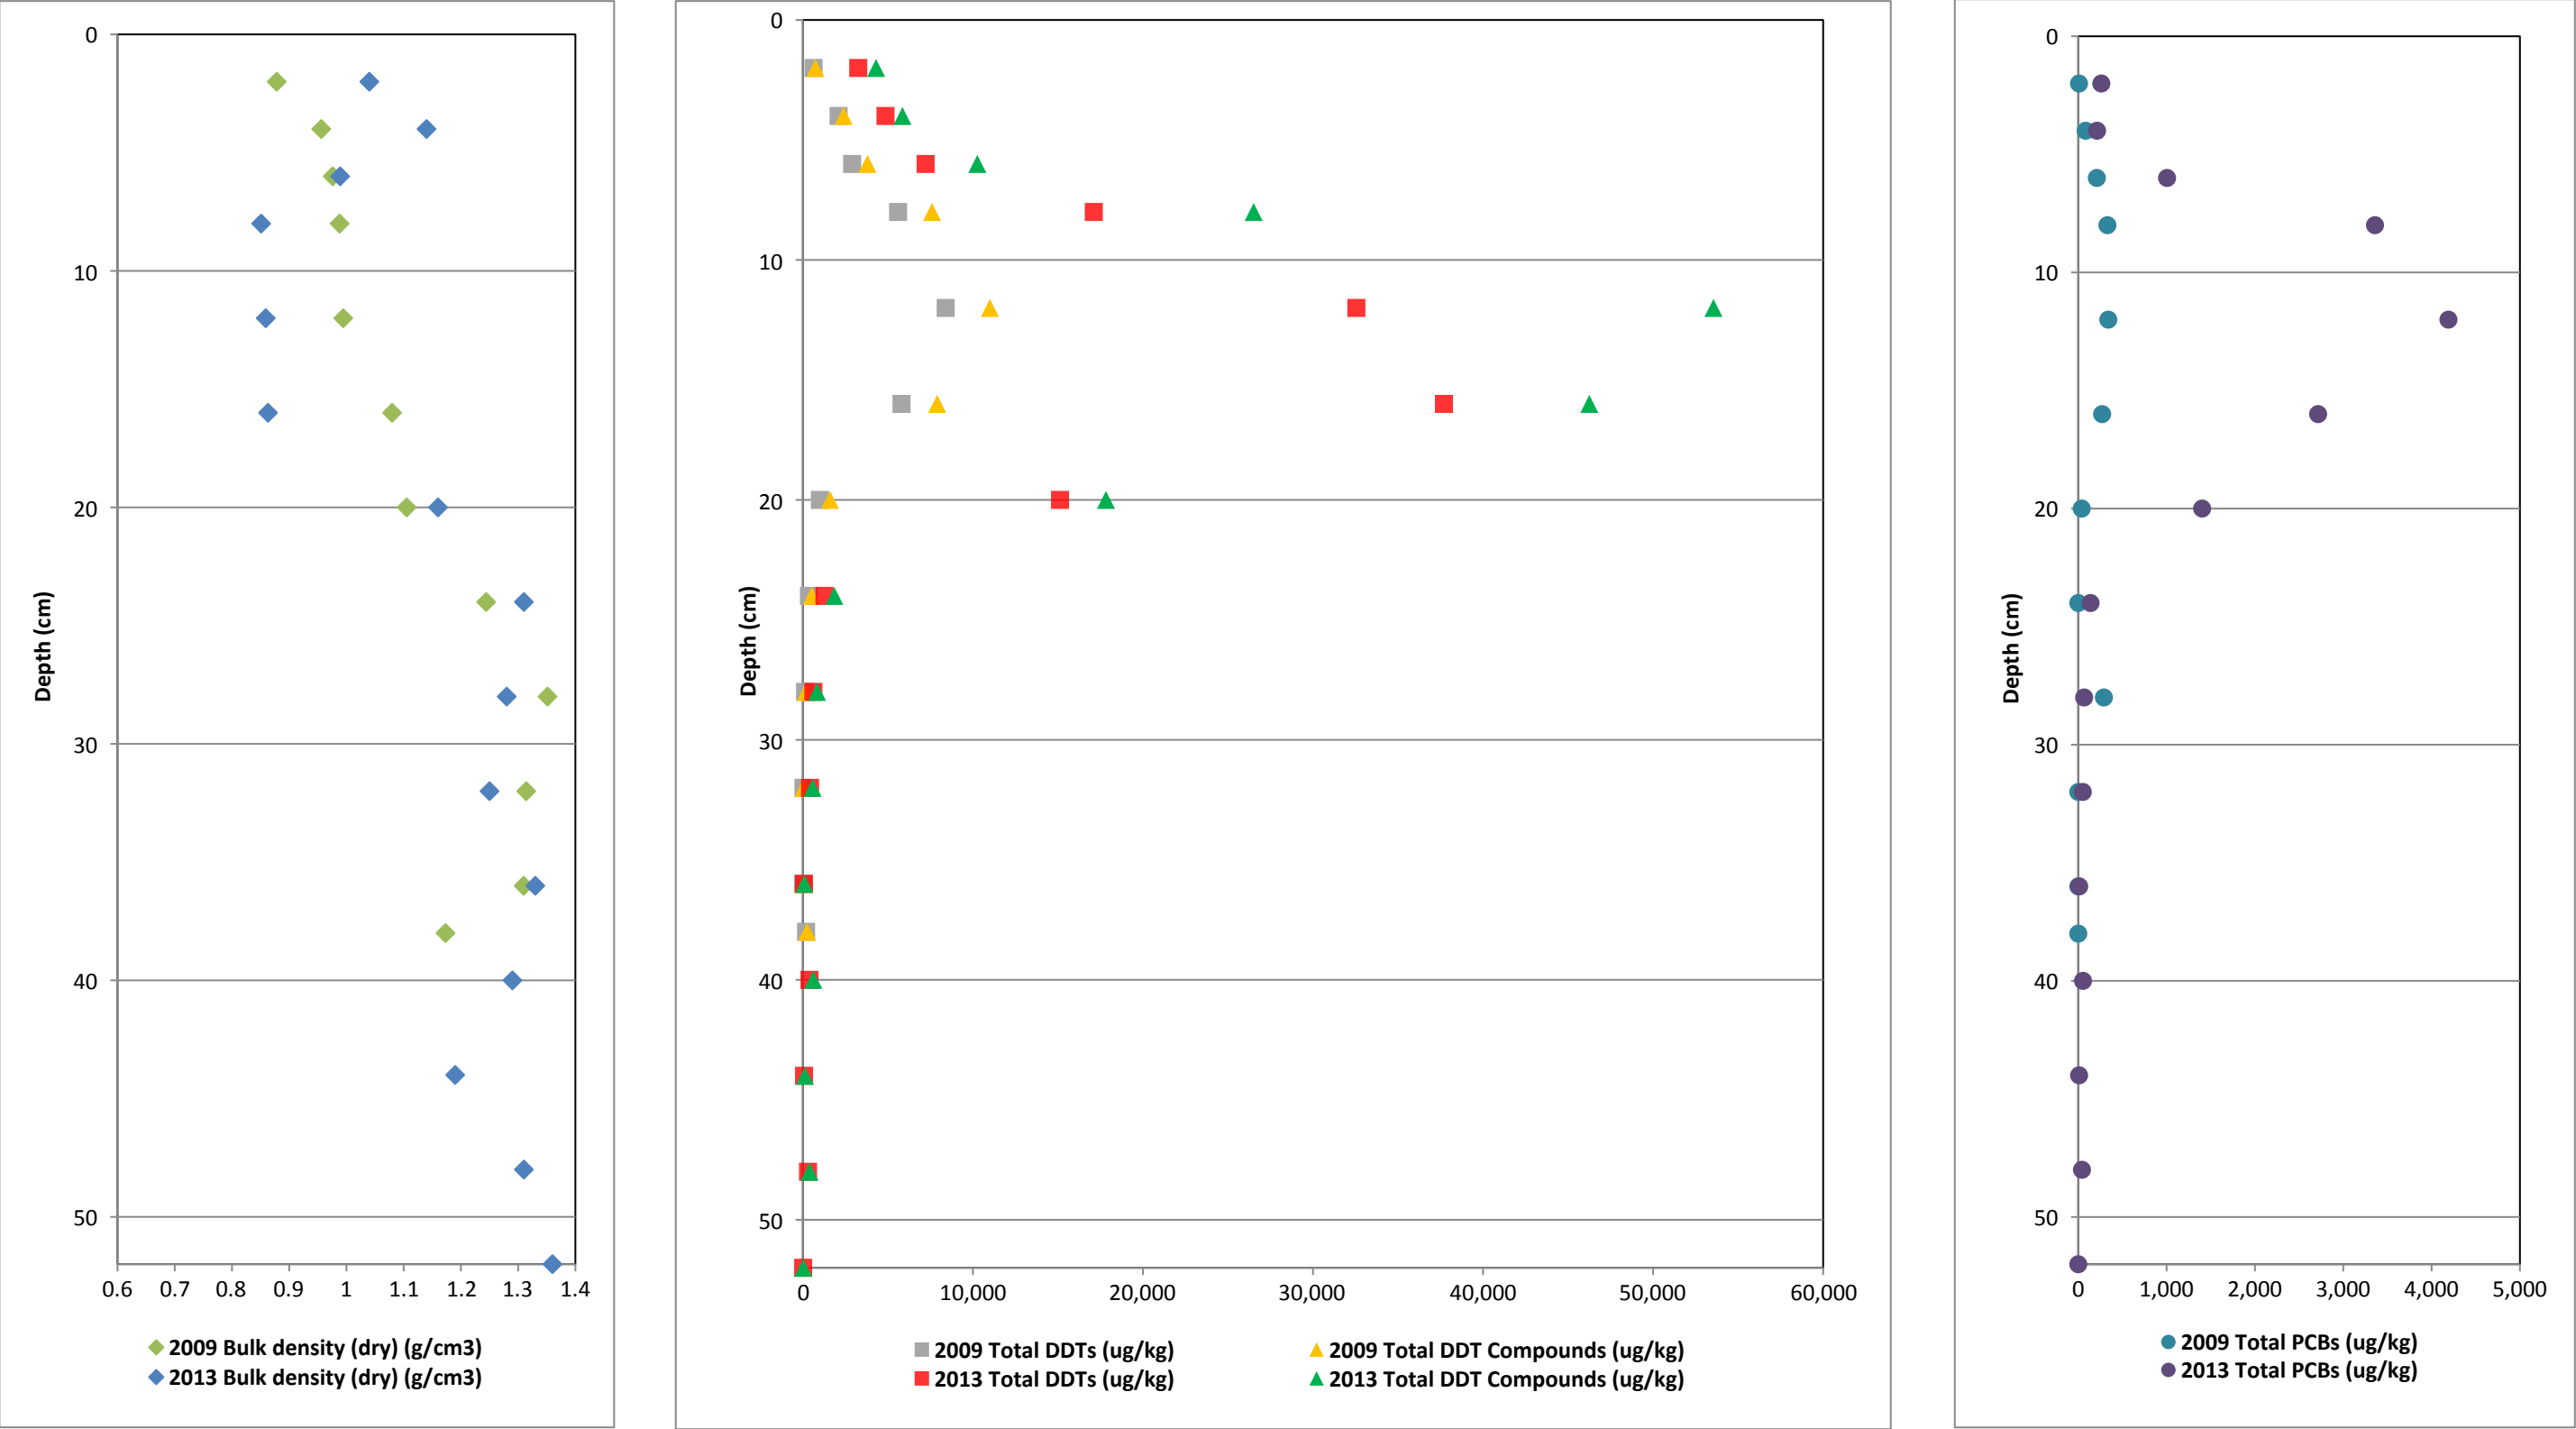
Figure 10. Vertical Profiles of Bulk Density and COCs for Core OA10  
First MNR Report  
Palos Verdes Shelf (OU 5 of the Montrose Chemical Corp. Superfund Site)  
Los Angeles County, California

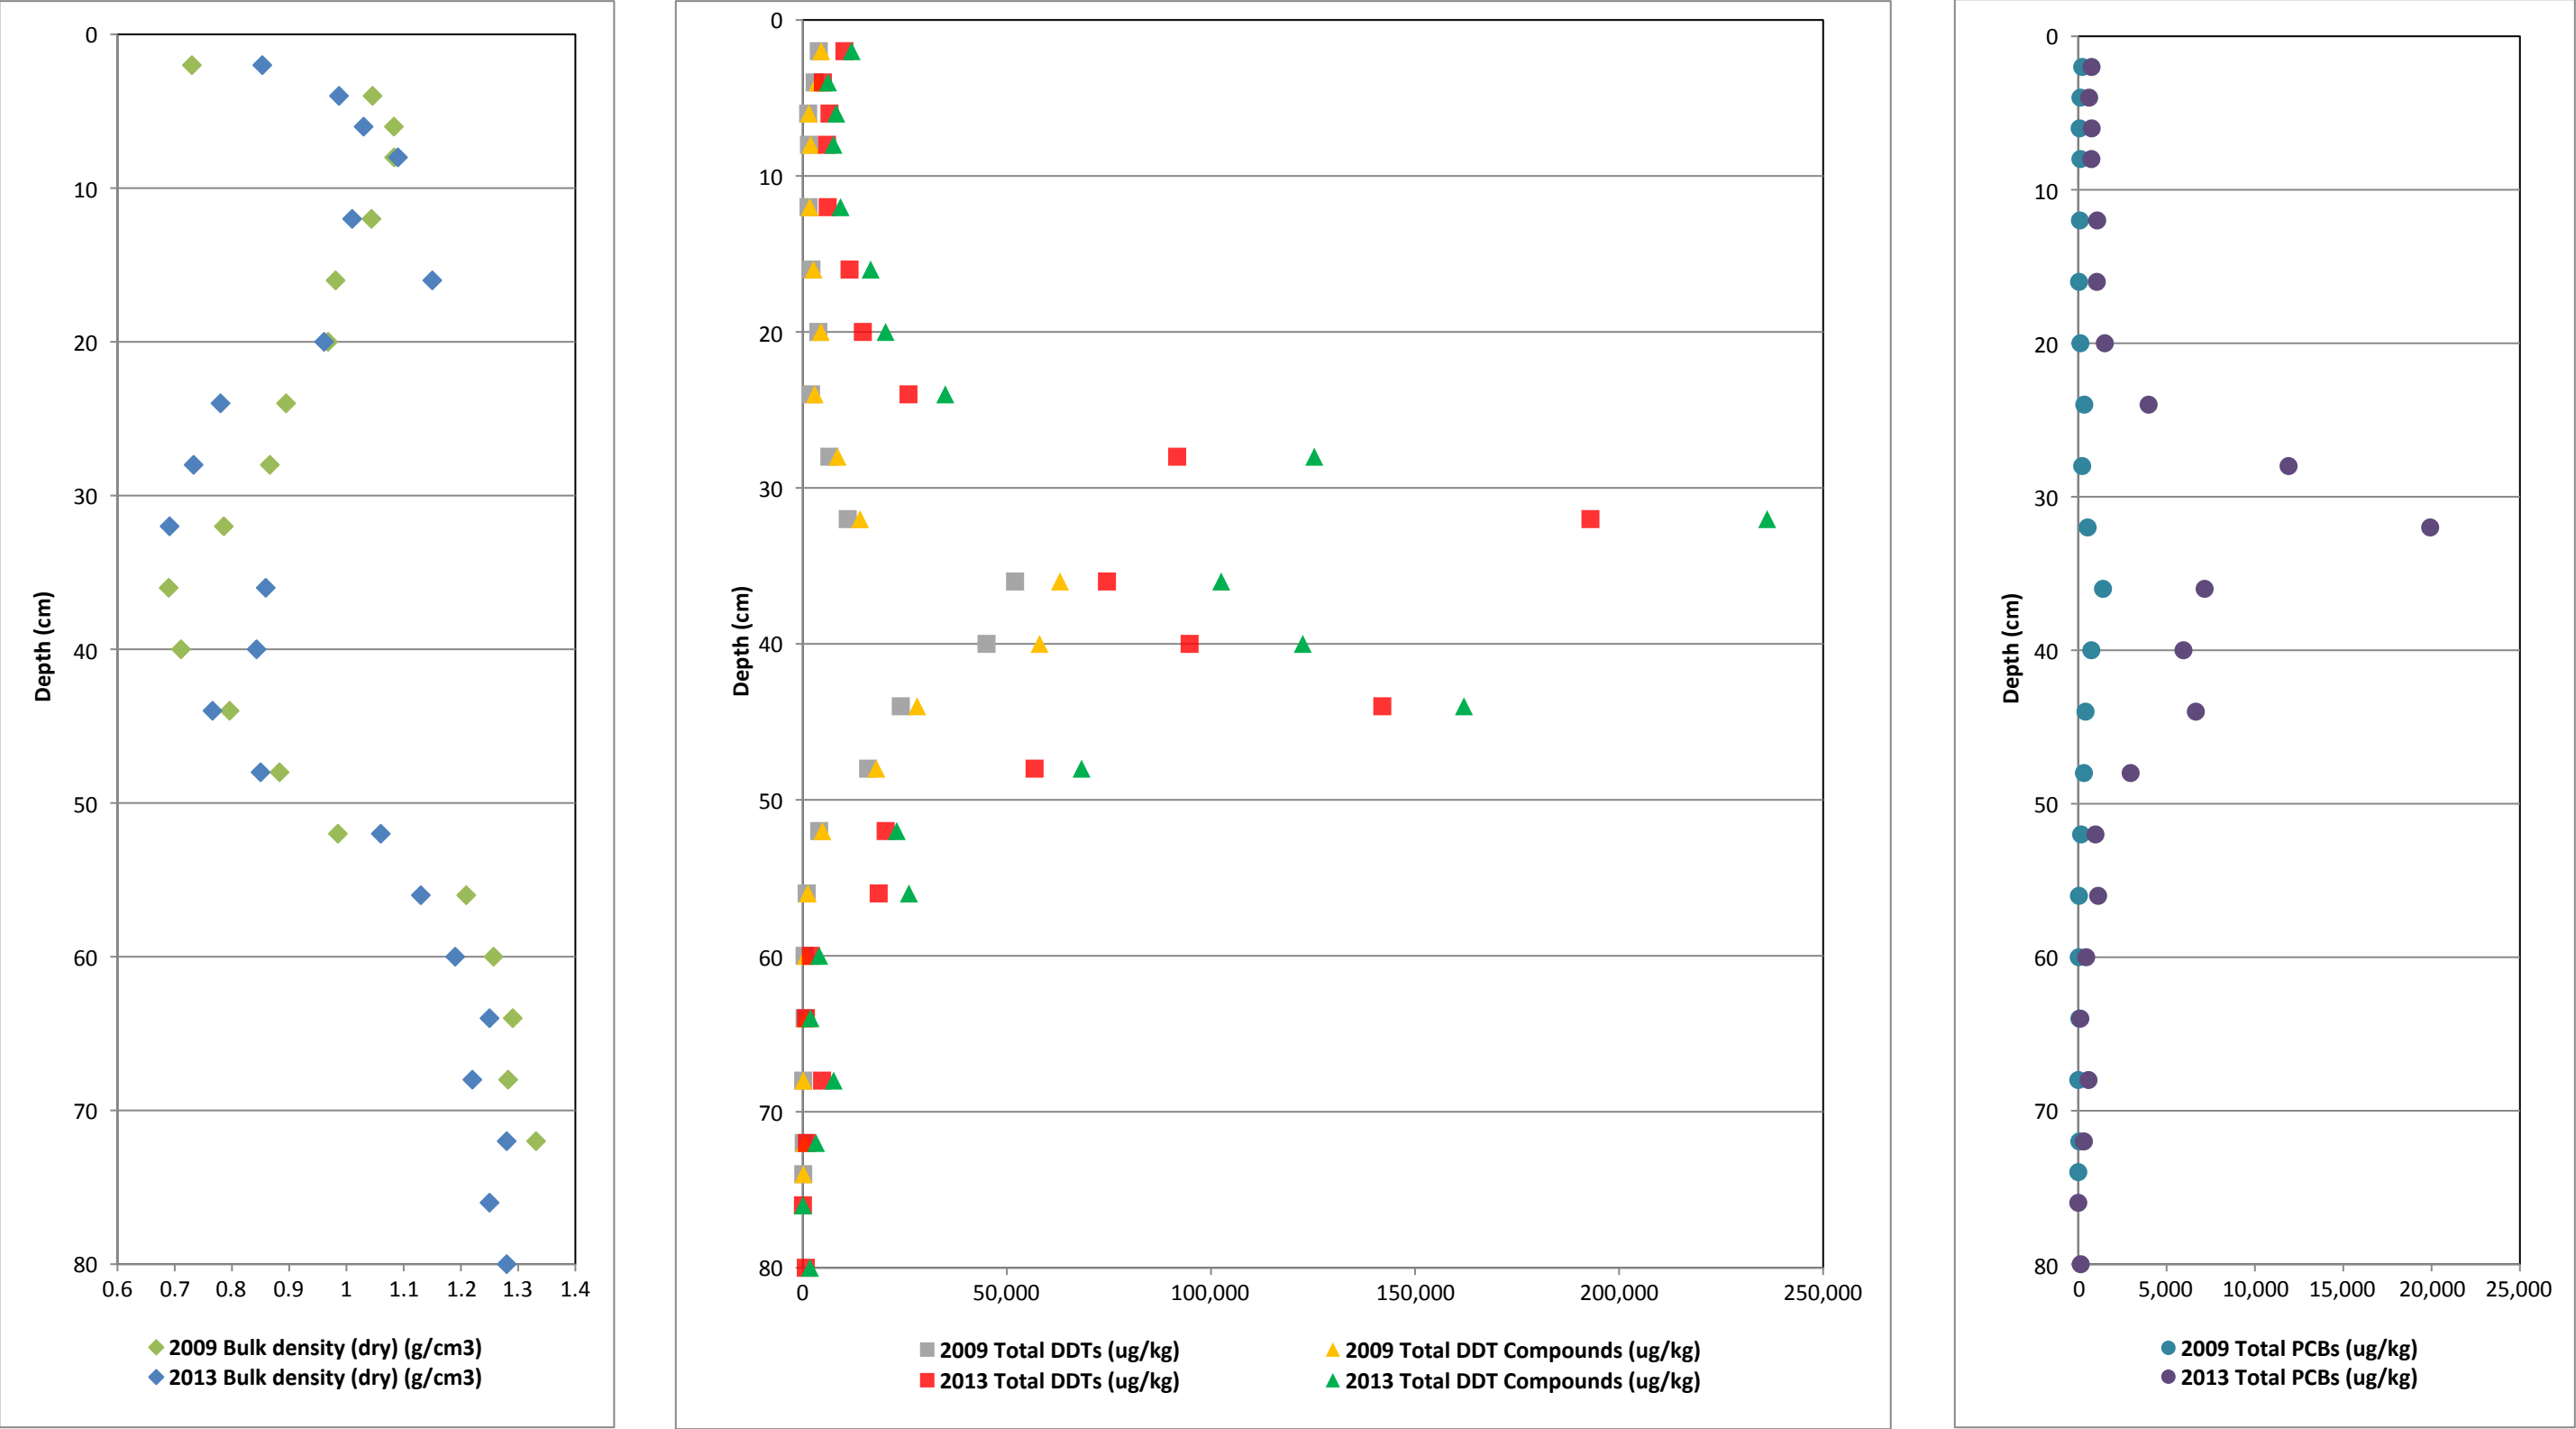
Figure 11. Vertical Profiles of Bulk Density and COCs for Core OA11  
First MNR Report  
Palos Verdes Shelf (OU 5 of the Montrose Chemical Corp. Superfund Site)  
Los Angeles County, California

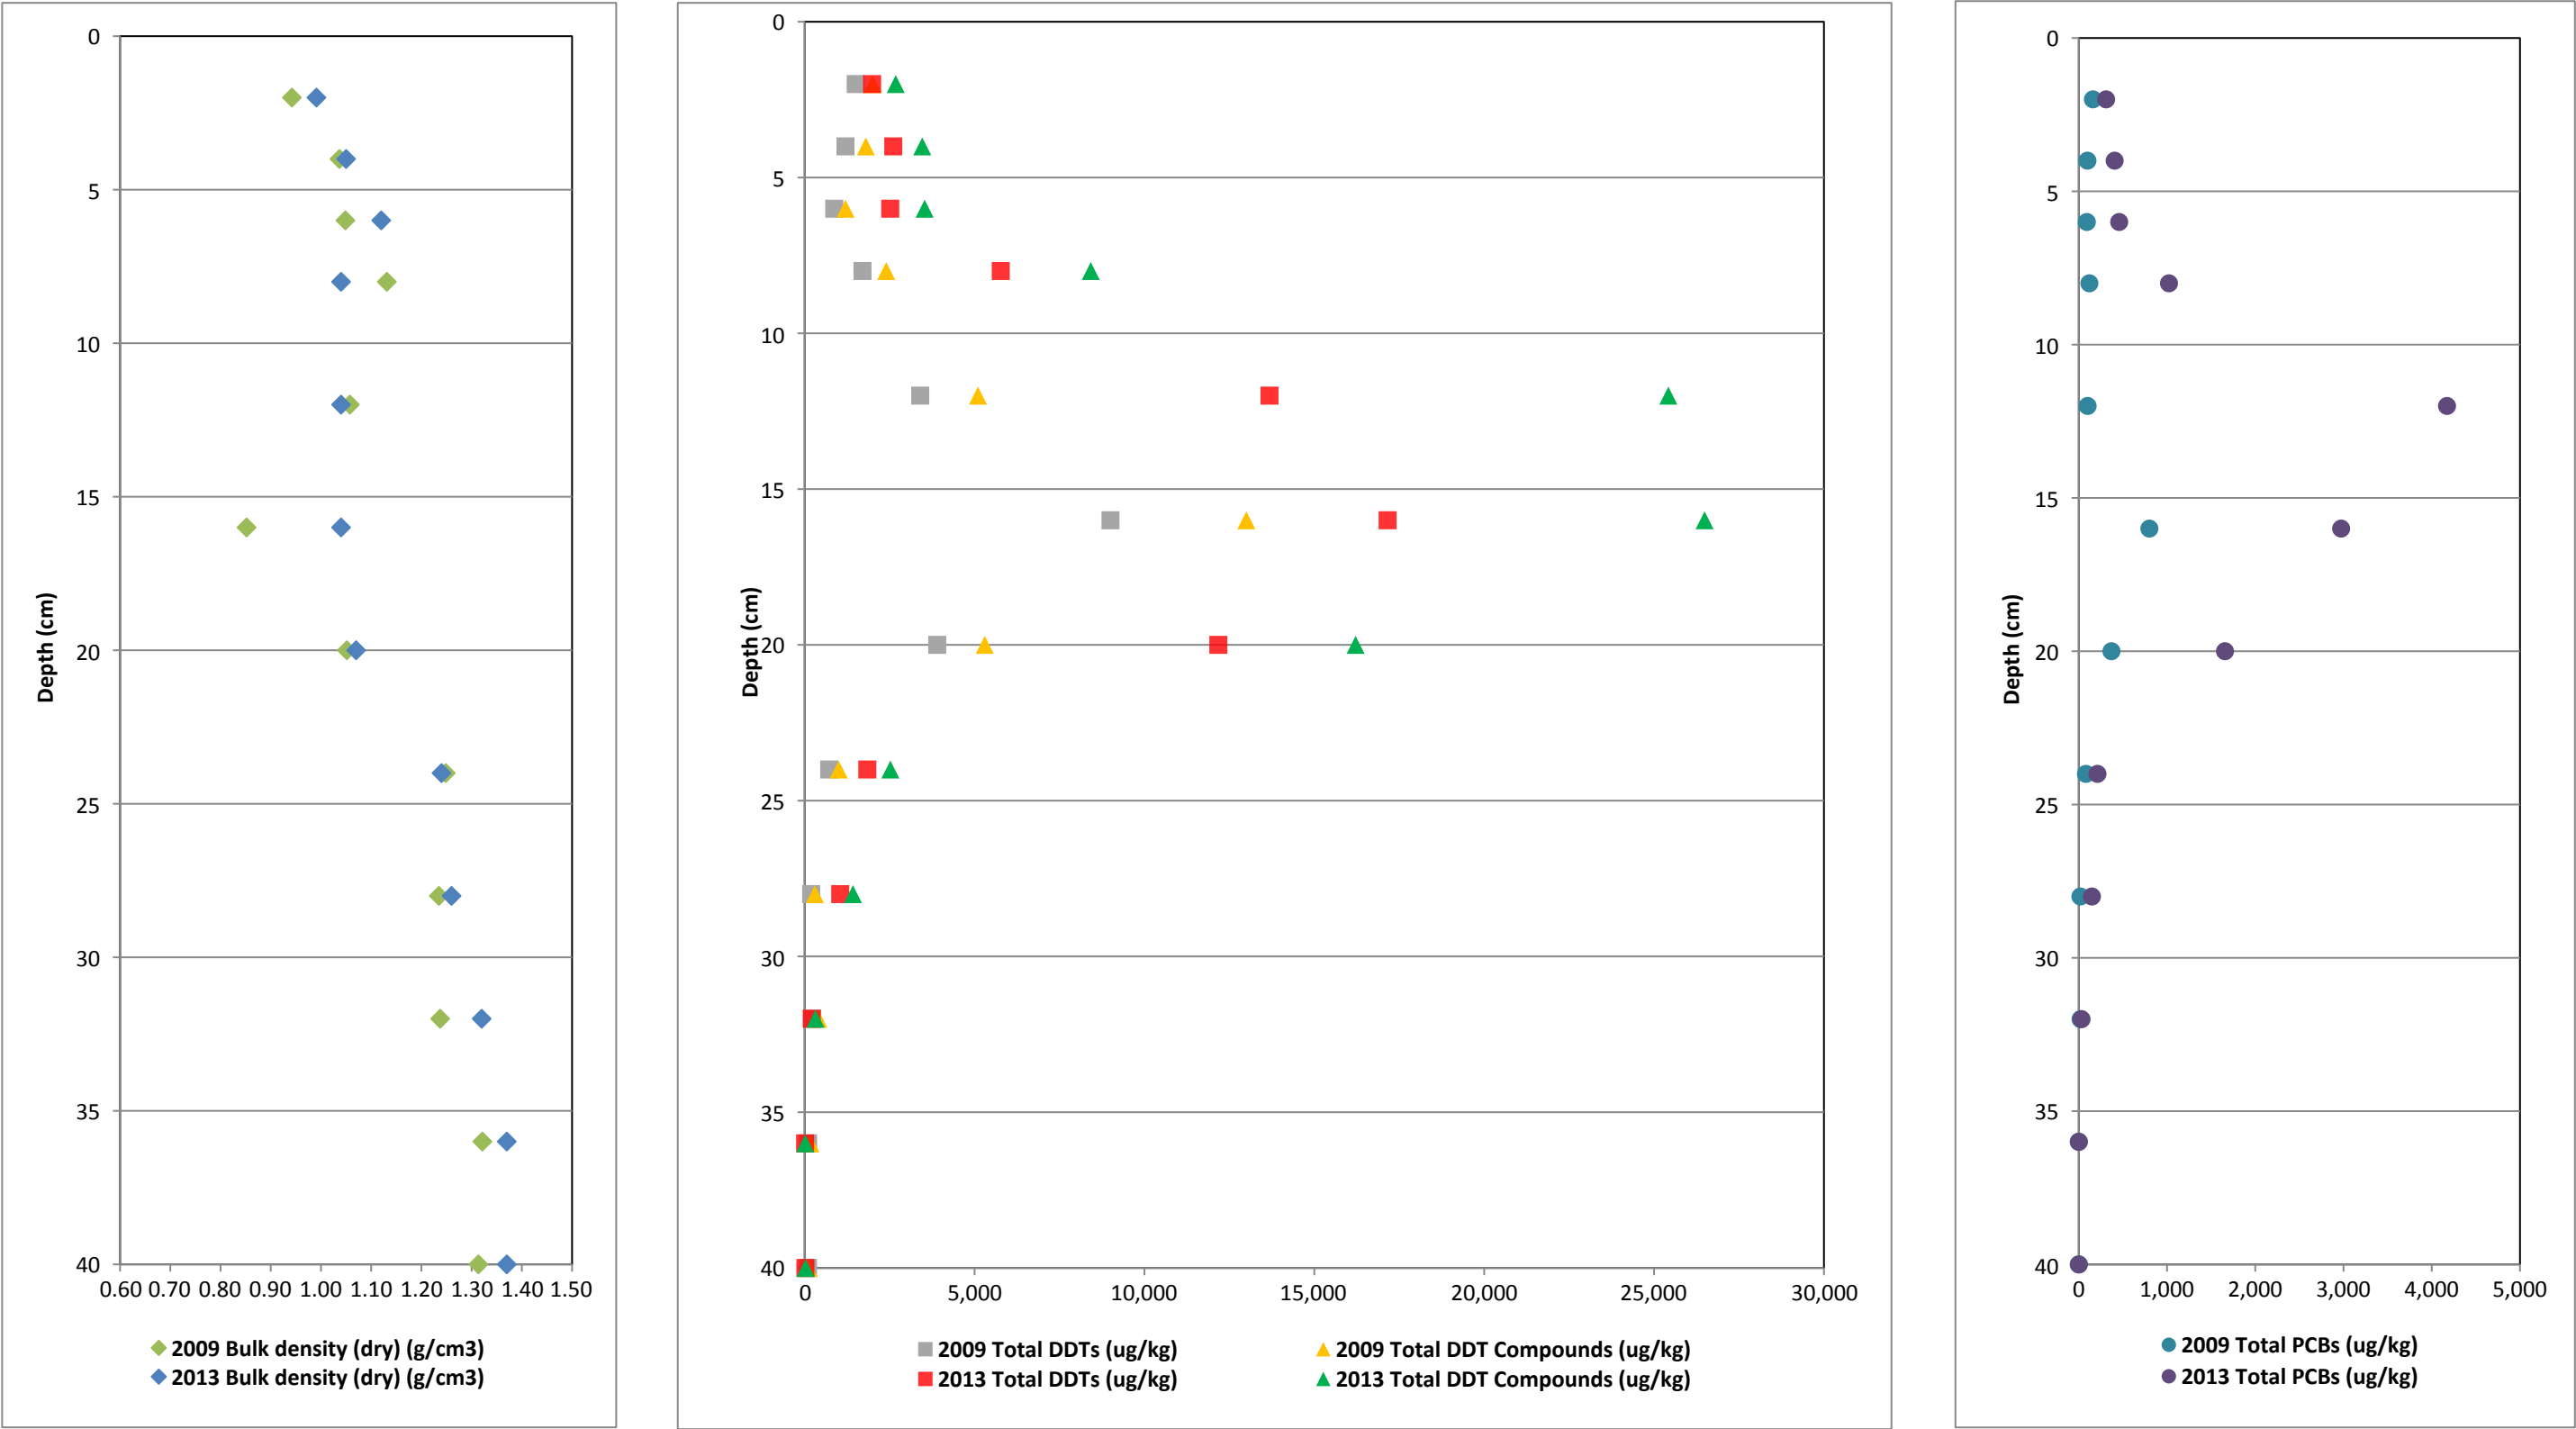
Figure 12. Vertical Profiles of Bulk Density and COCs for Core OA12  
First MNR Report  
Palos Verdes Shelf (OU 5 of the Montrose Chemical Corp. Superfund Site)  
Los Angeles County, California
