## **APPENDIX X.2 – VERTICAL PROFILES – OUTFALL AREA CORES**

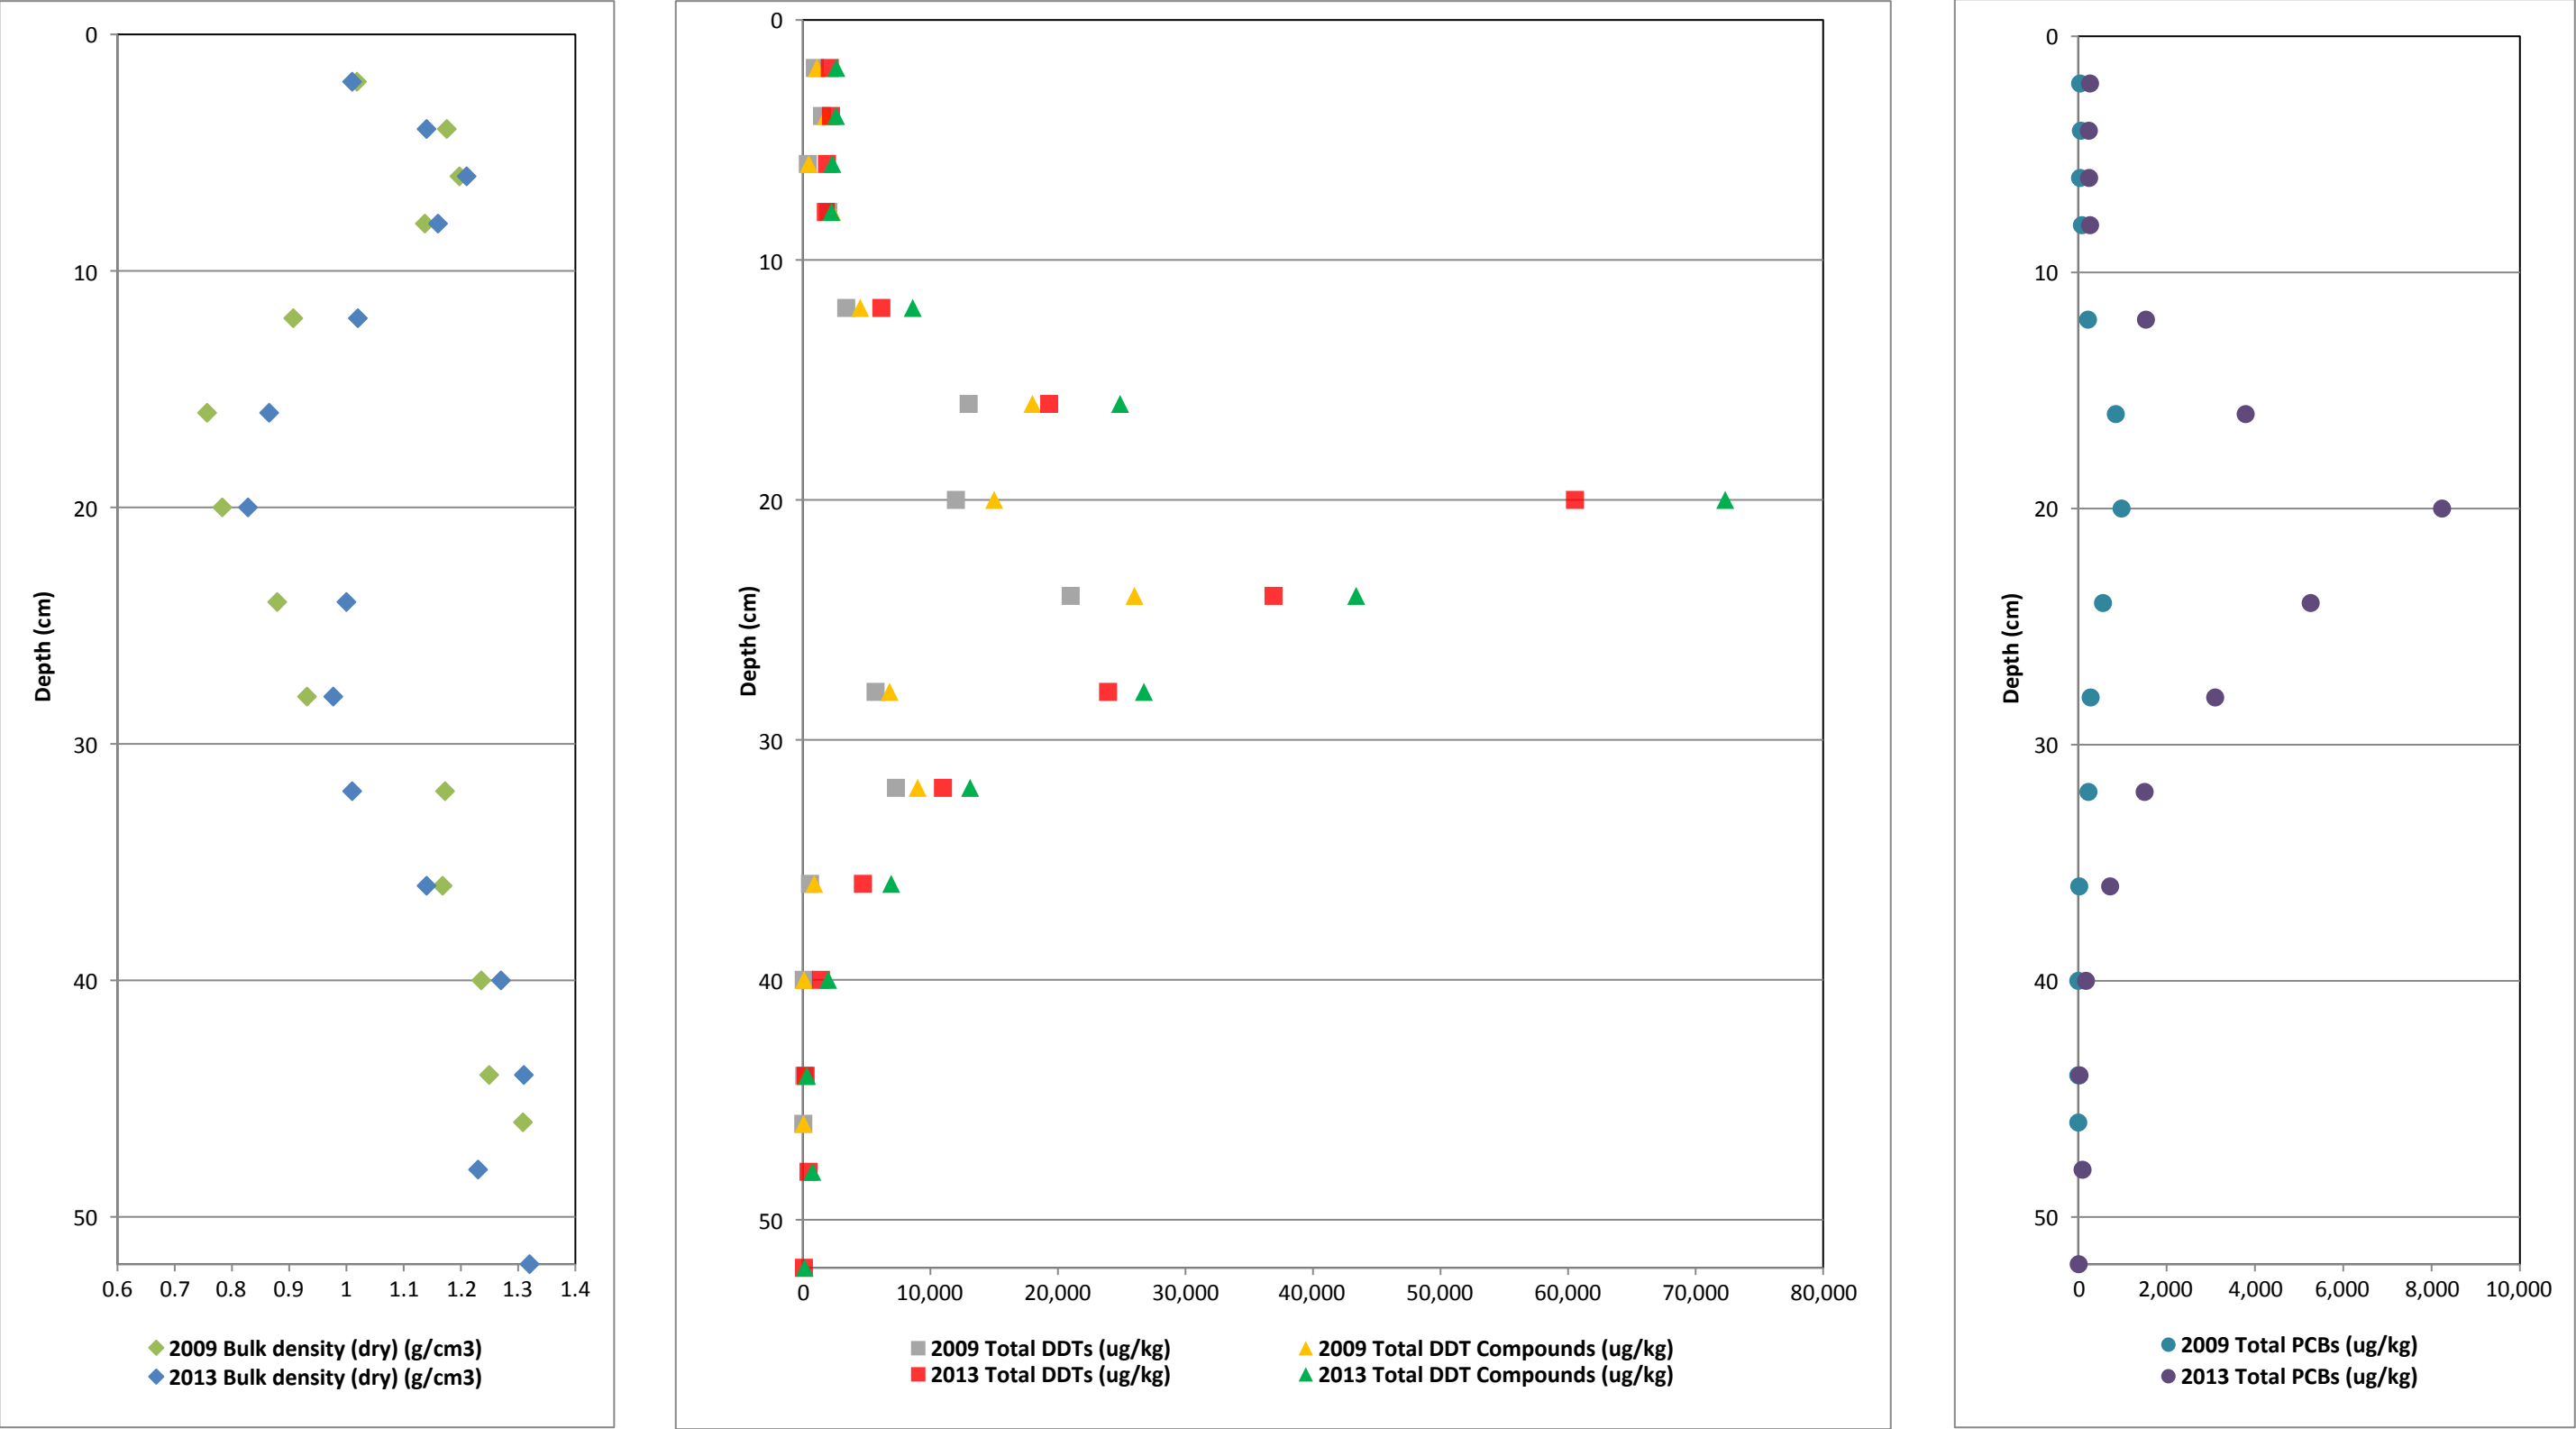
Figure 13. Vertical Profiles of Bulk Density and COCs for Core OA13  
First MNR Report  
Palos Verdes Shelf (OU 5 of the Montrose Chemical Corp. Superfund Site)  
Los Angeles County, California

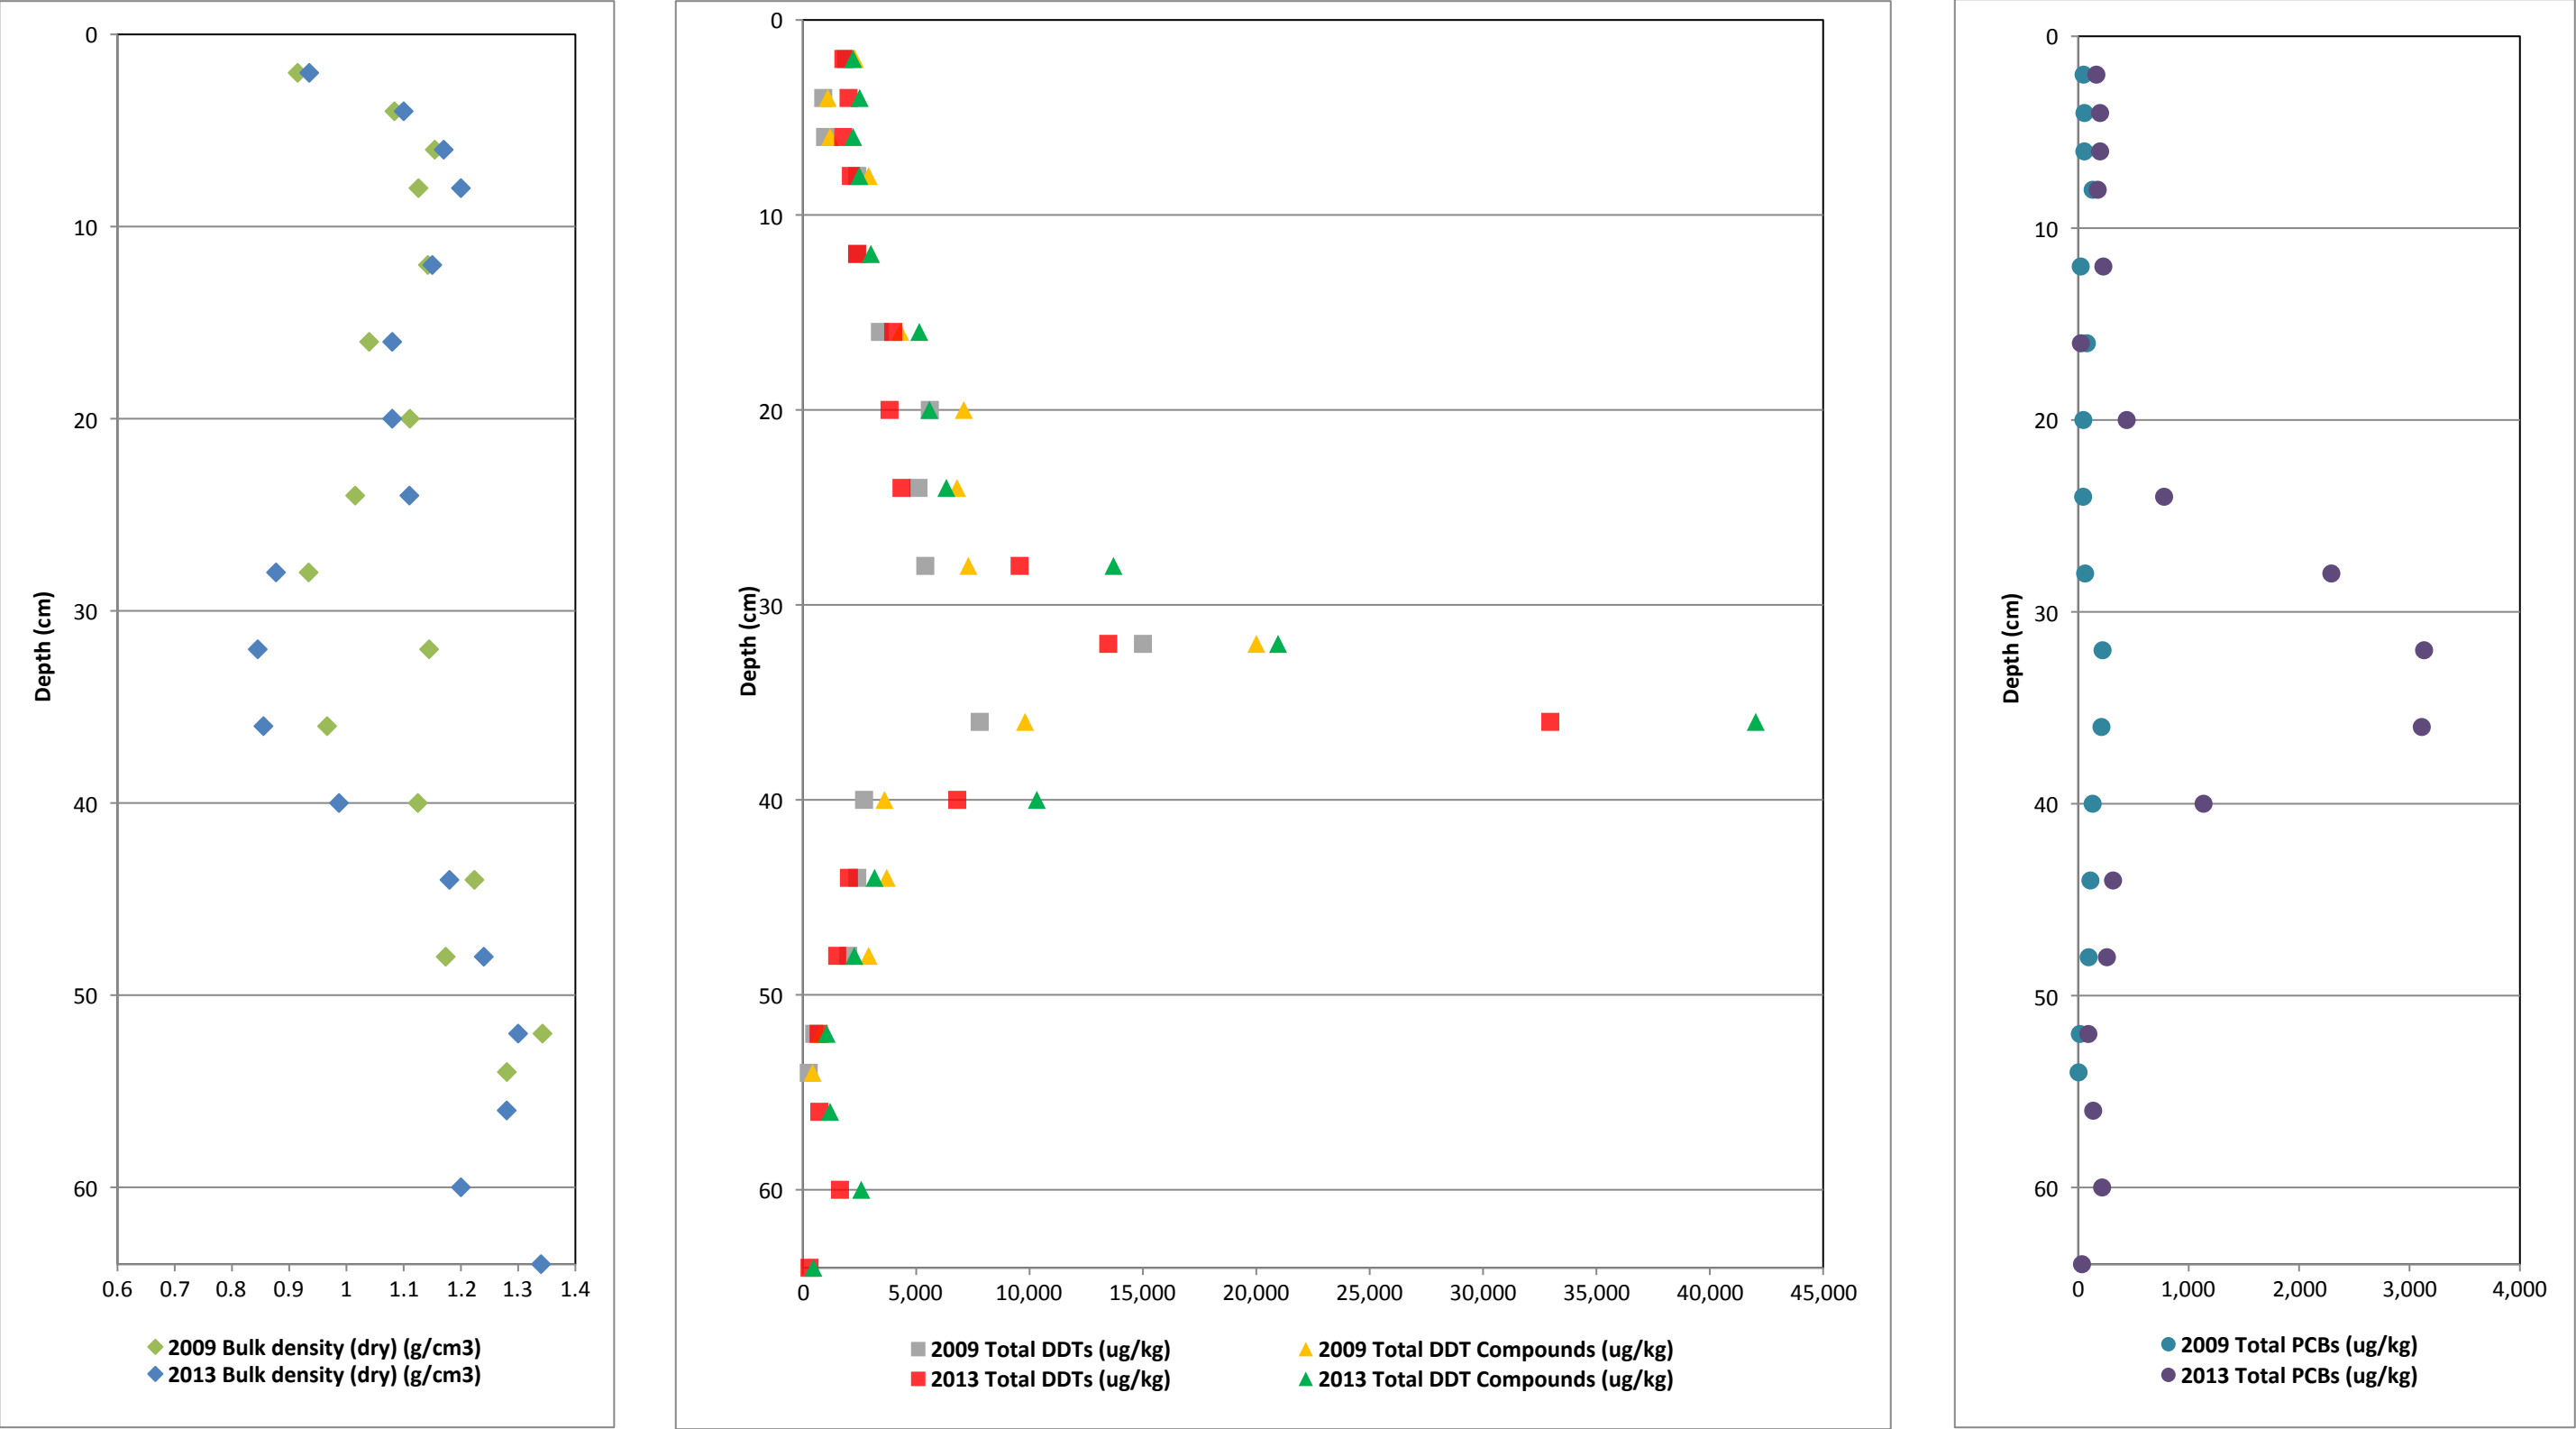
Figure 14. Vertical Profiles of Bulk Density and COCs for Core OA14  
First MNR Report  
Palos Verdes Shelf (OU 5 of the Montrose Chemical Corp. Superfund Site)  
Los Angeles County, California

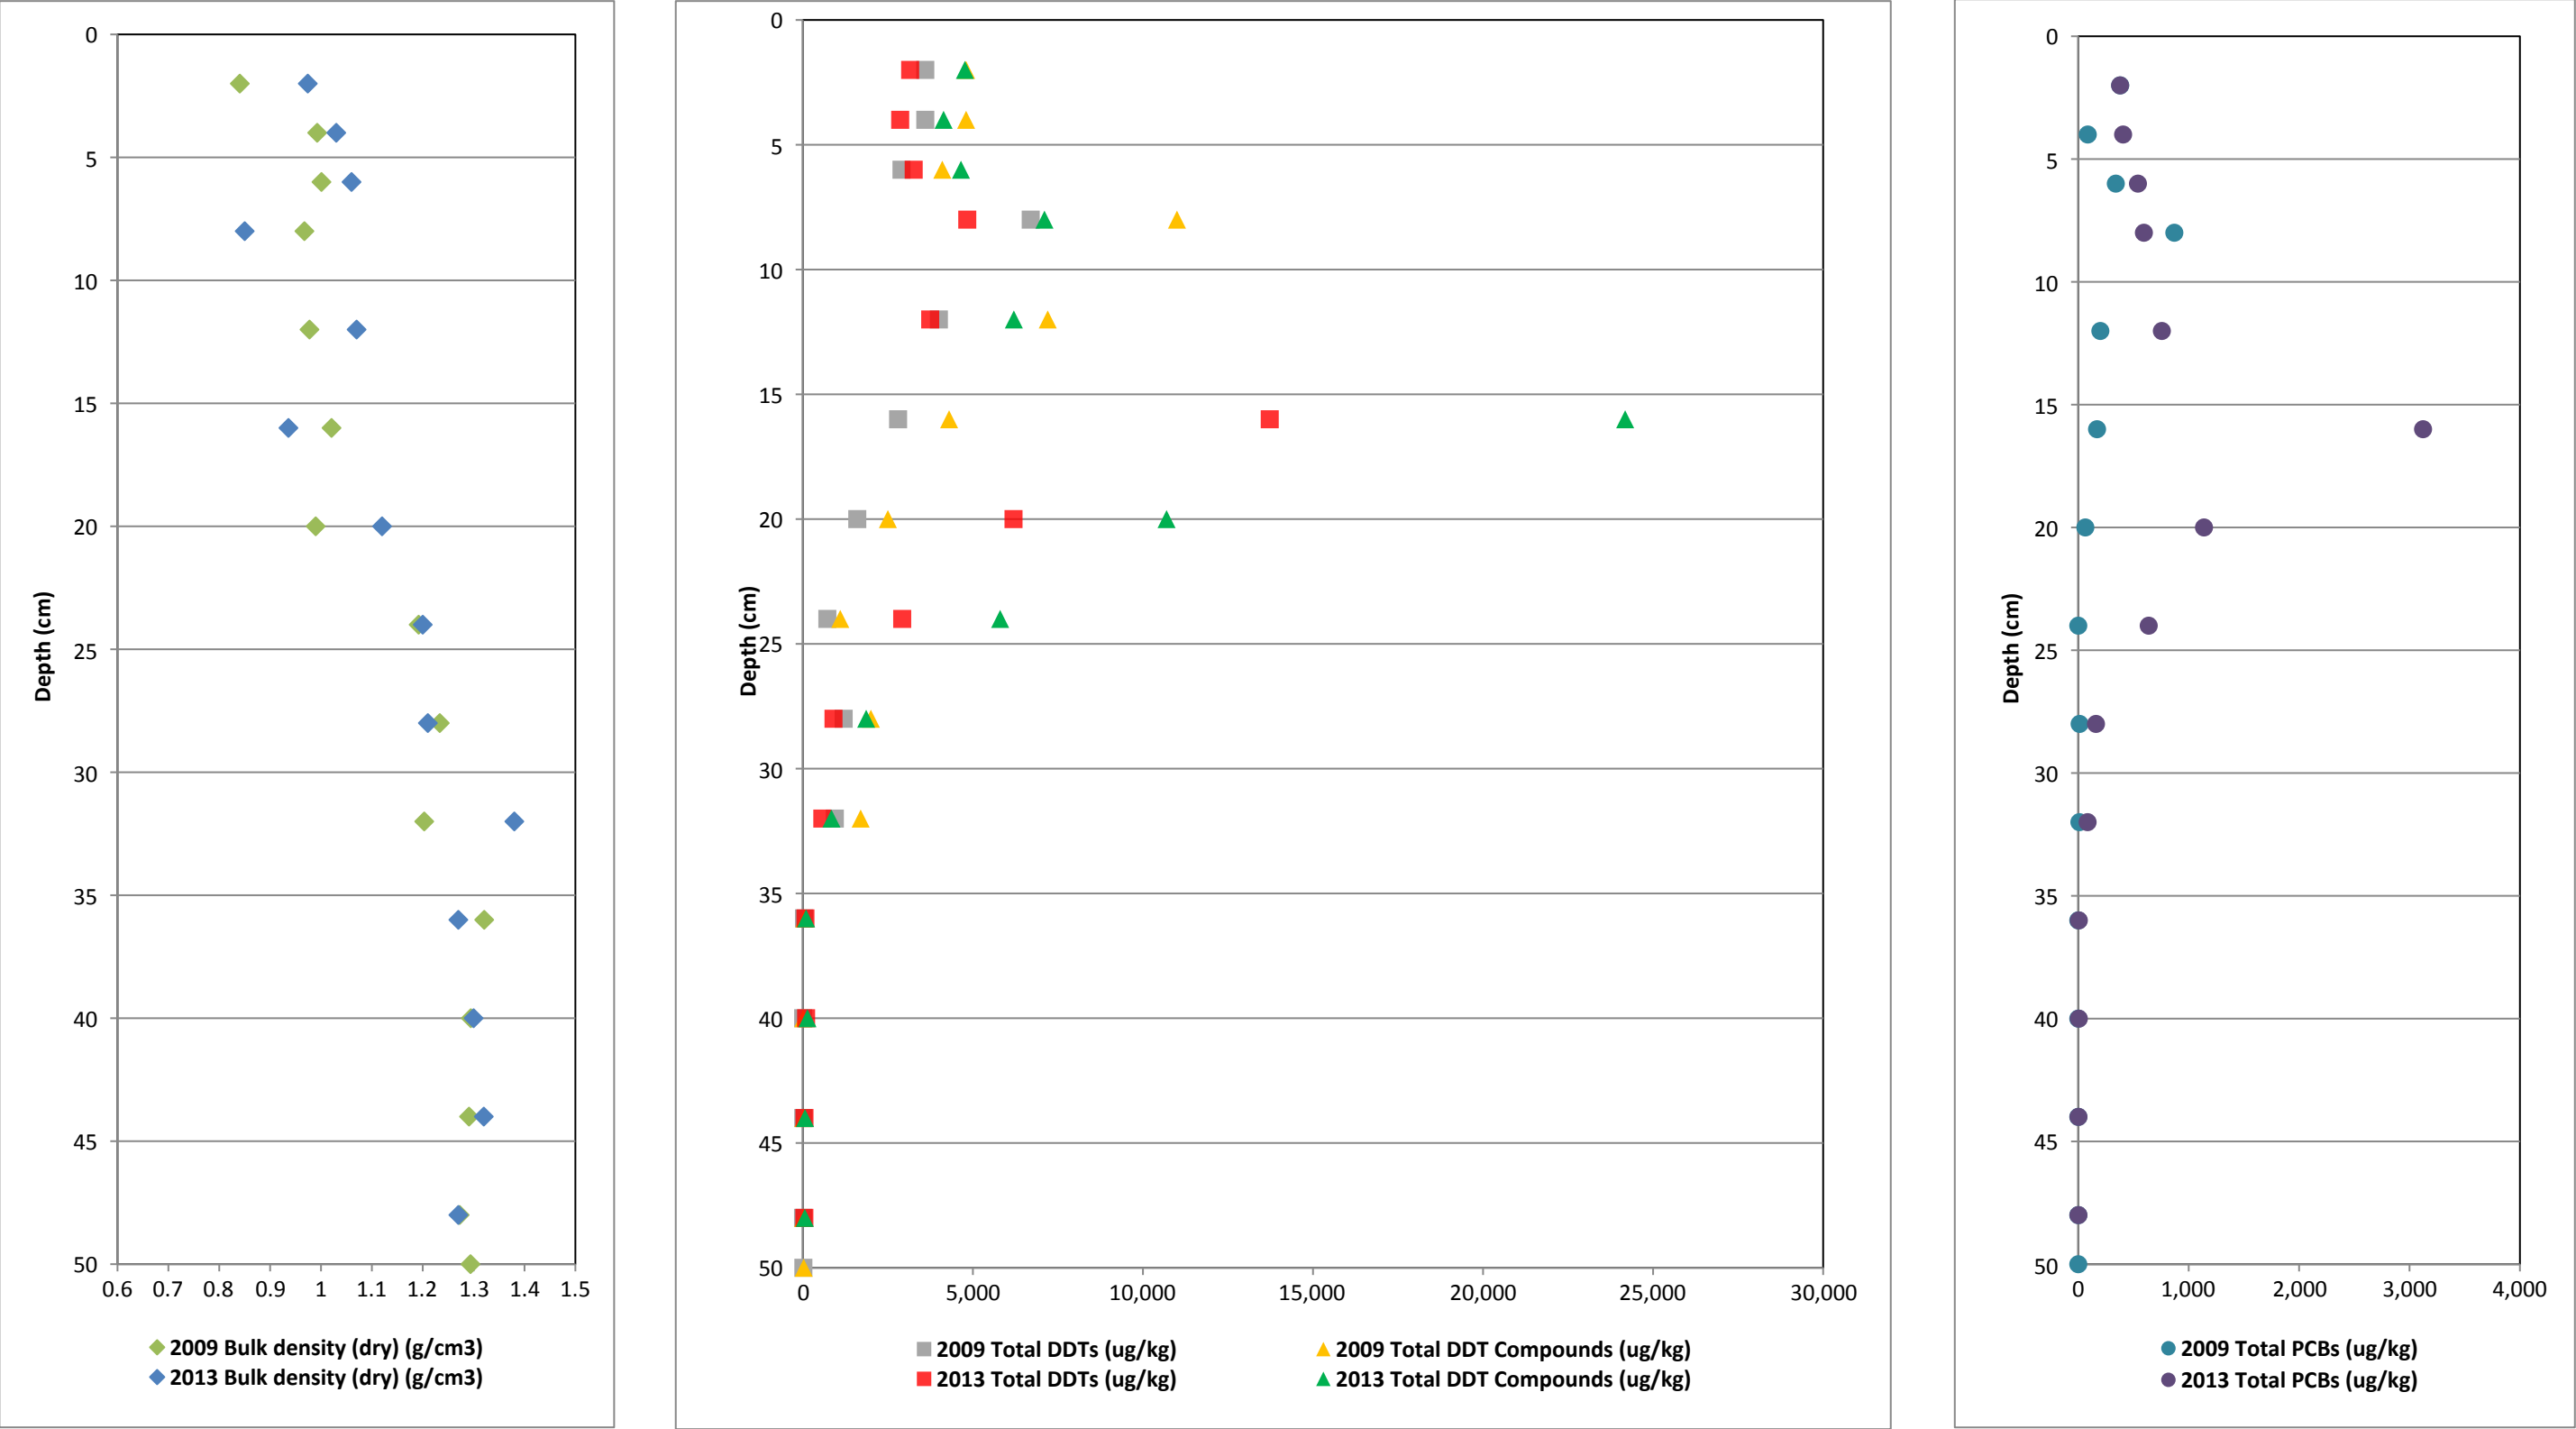
Figure 15. Vertical Profiles of Bulk Density and COCs for Core OA15  
First MNR Report  
Palos Verdes Shelf (OU 5 of the Montrose Chemical Corp. Superfund Site)  
Los Angeles County, California

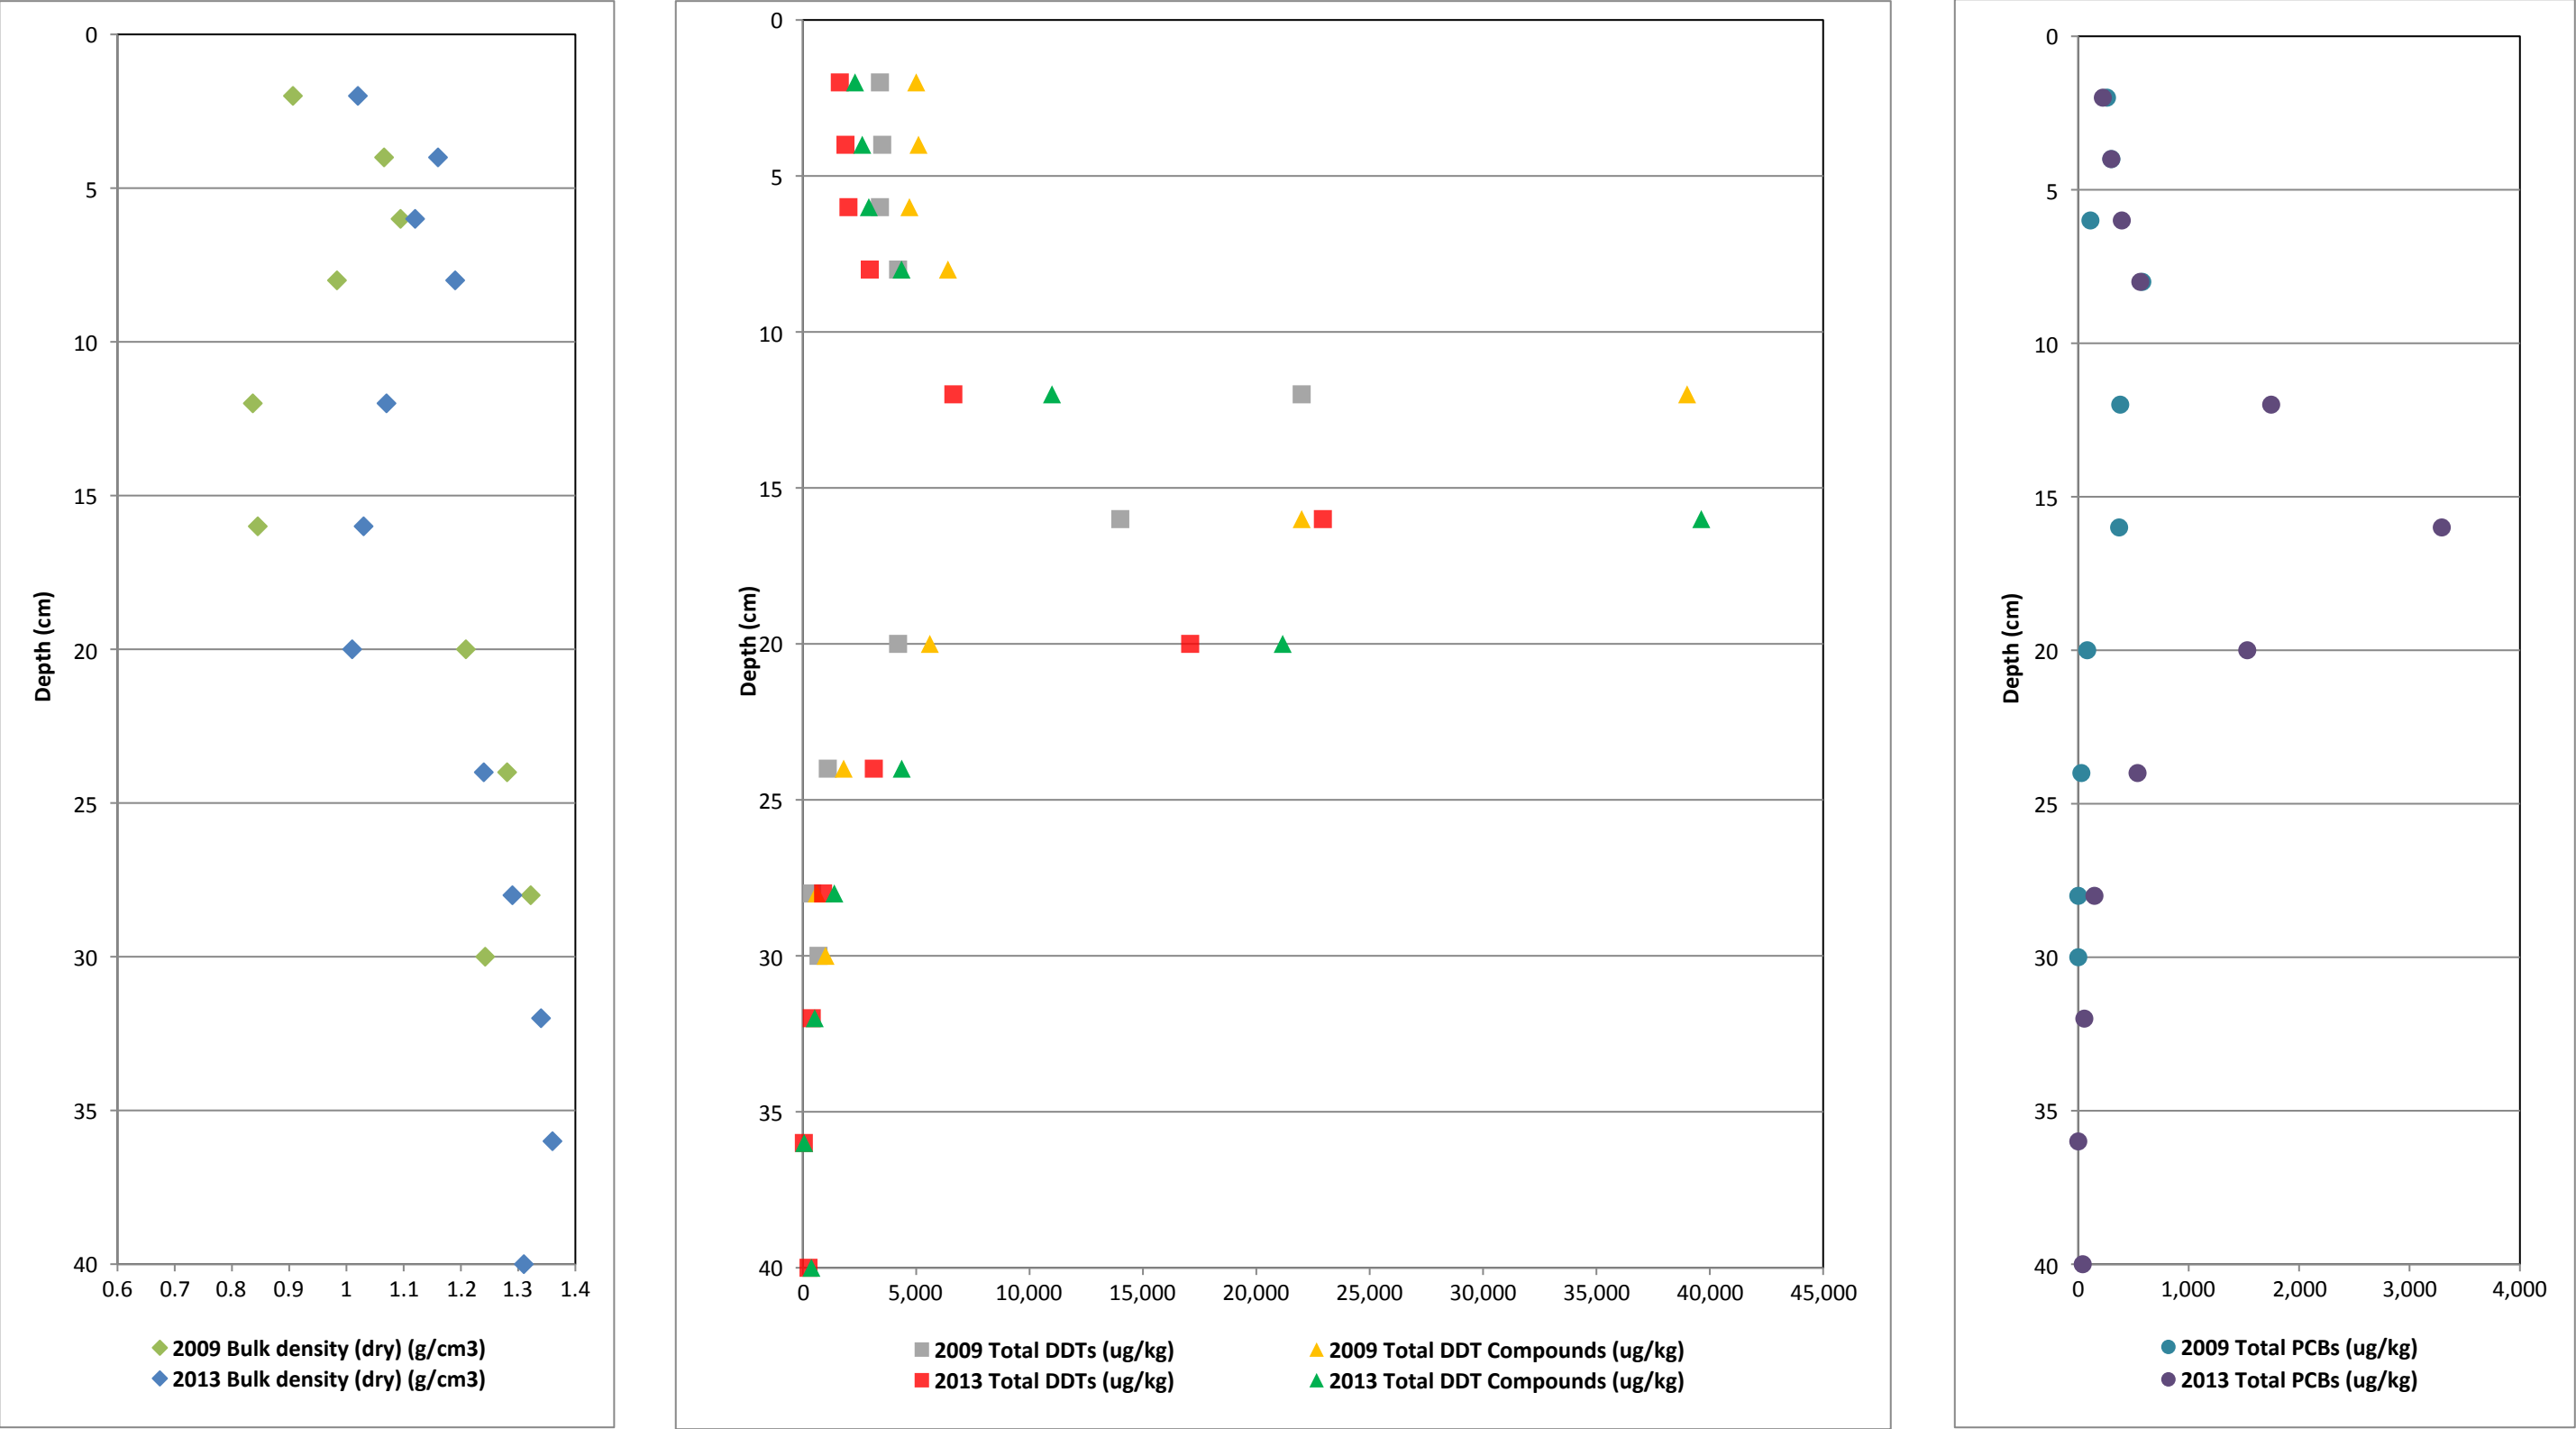
Figure 16. Vertical Profiles of Bulk Density and COCs for Core OA16  
First MNR Report  
Palos Verdes Shelf (OU 5 of the Montrose Chemical Corp. Superfund Site)  
Los Angeles County, California

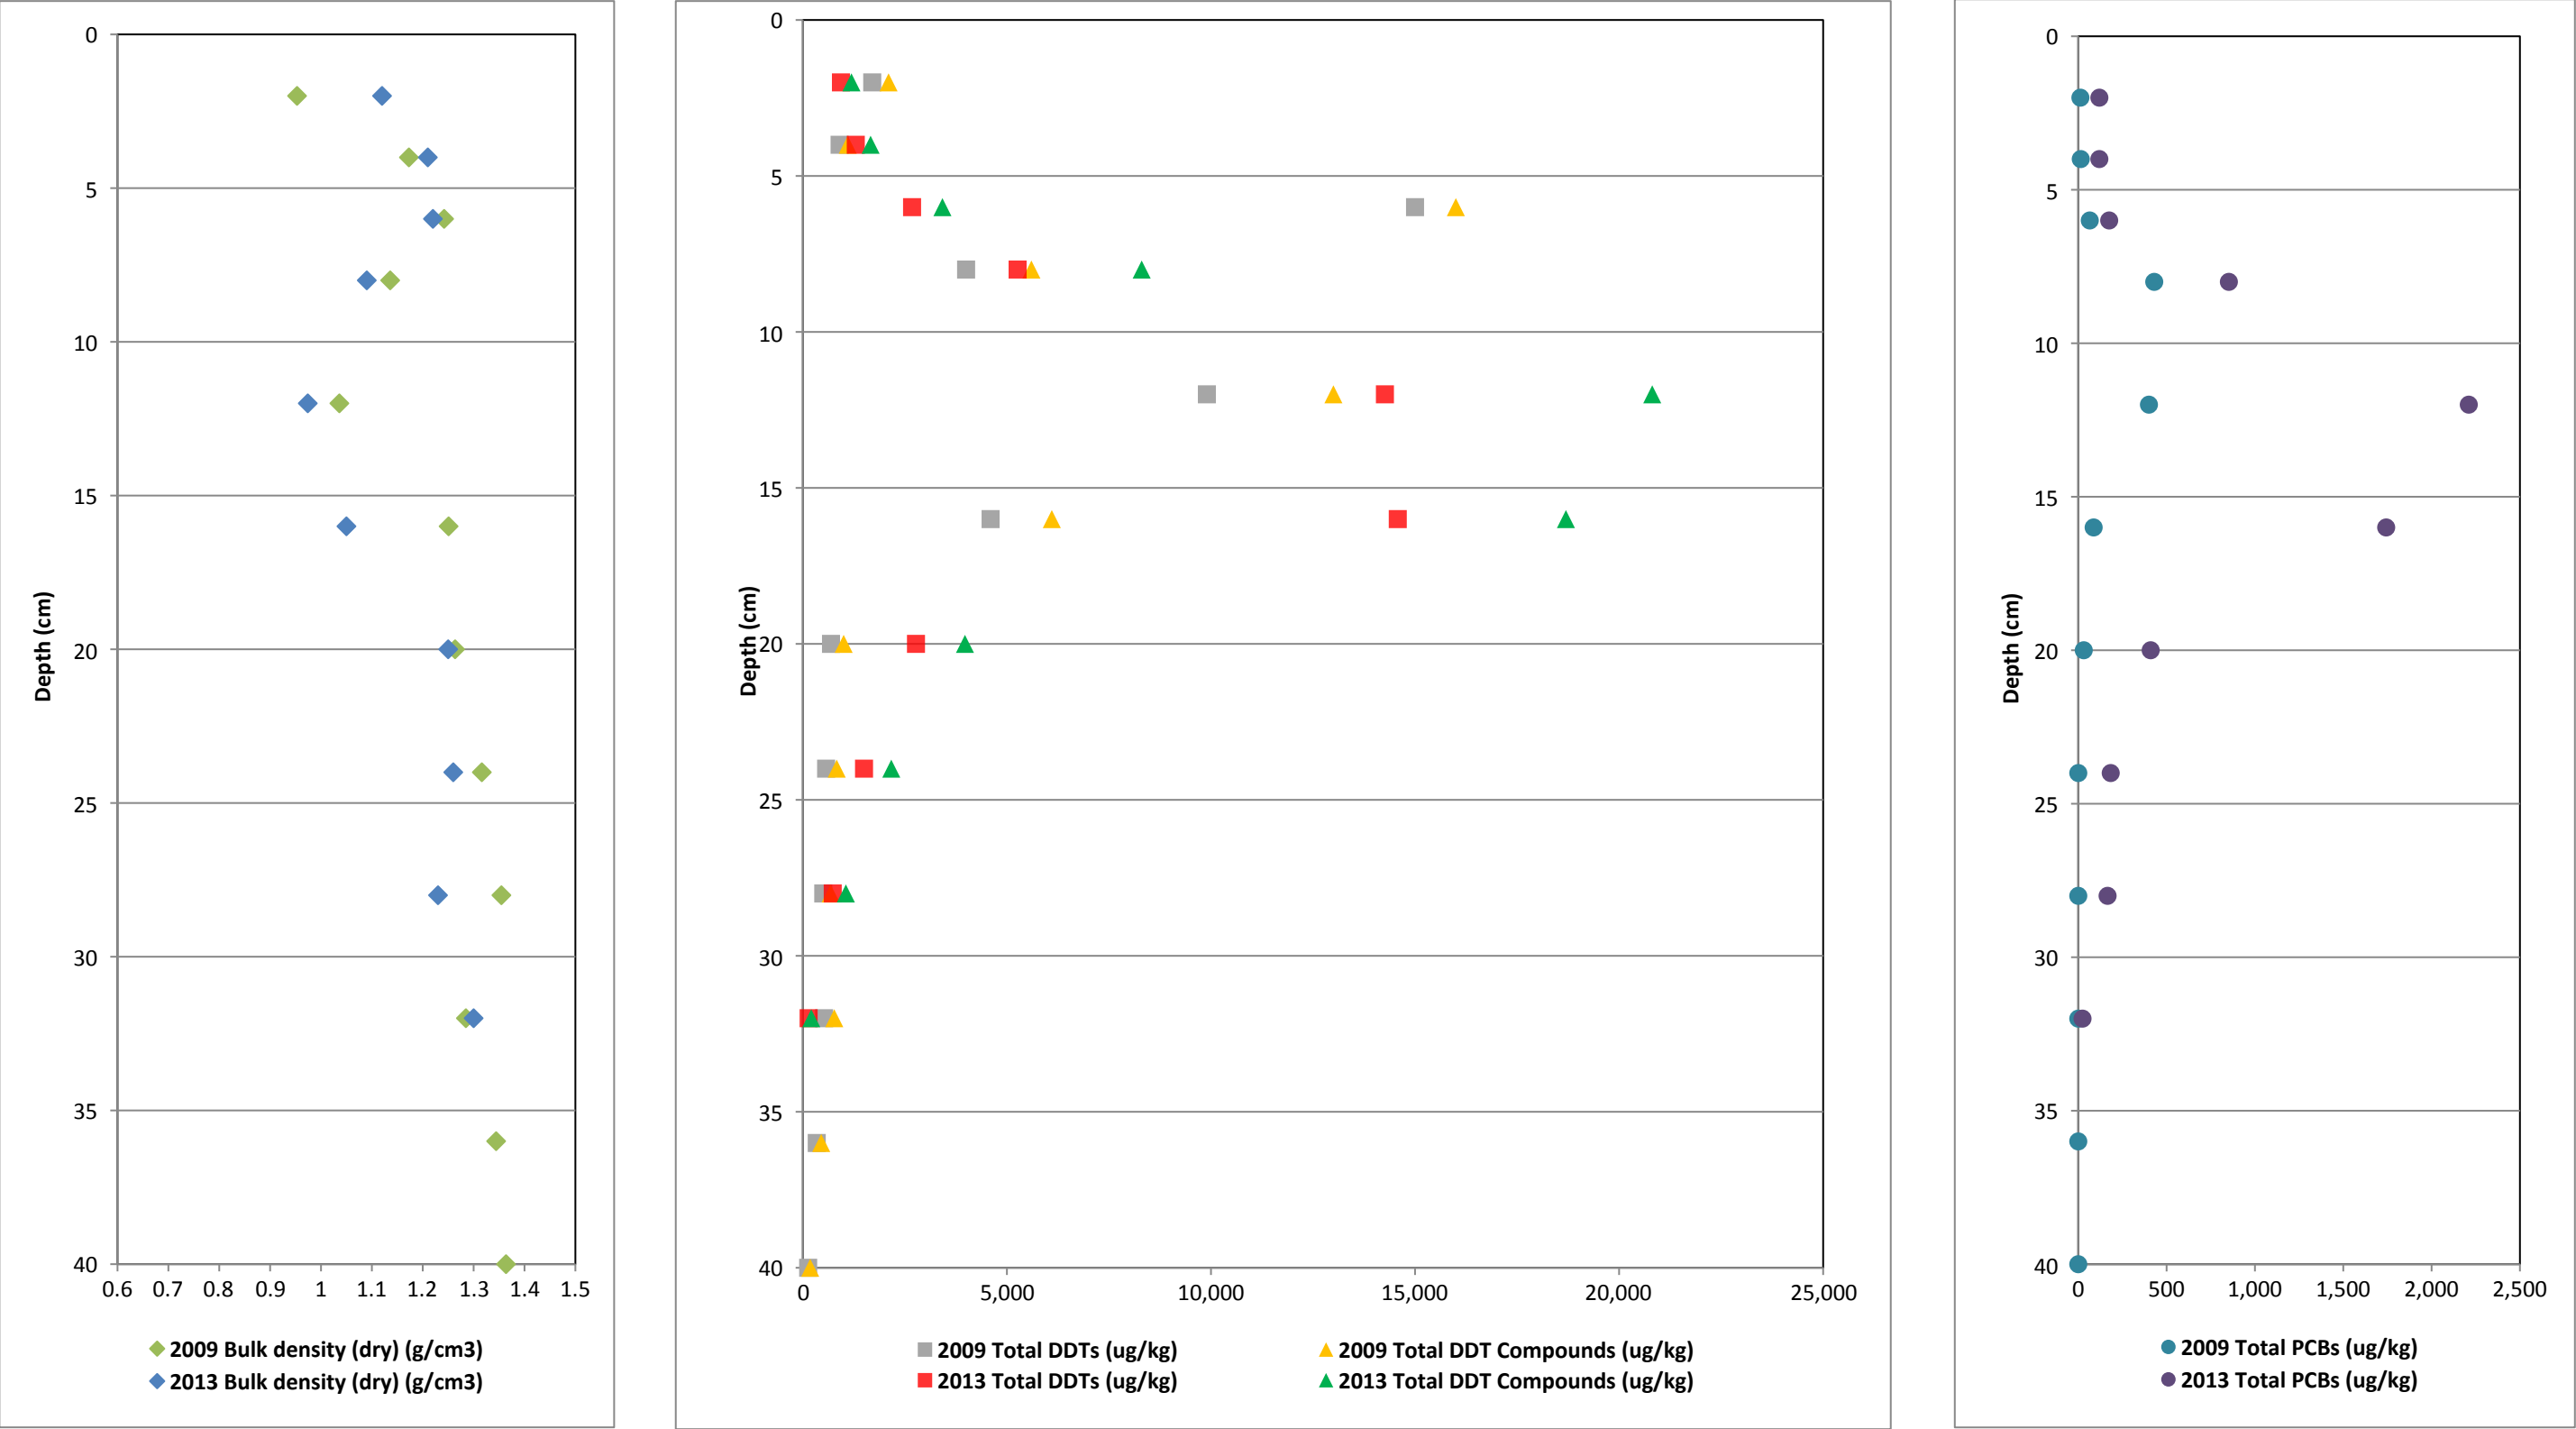
Figure 17. Vertical Profiles of Bulk Density and COCs for Core OA17  
First MNR Report  
Palos Verdes Shelf (OU 5 of the Montrose Chemical Corp. Superfund Site)  
Los Angeles County, California

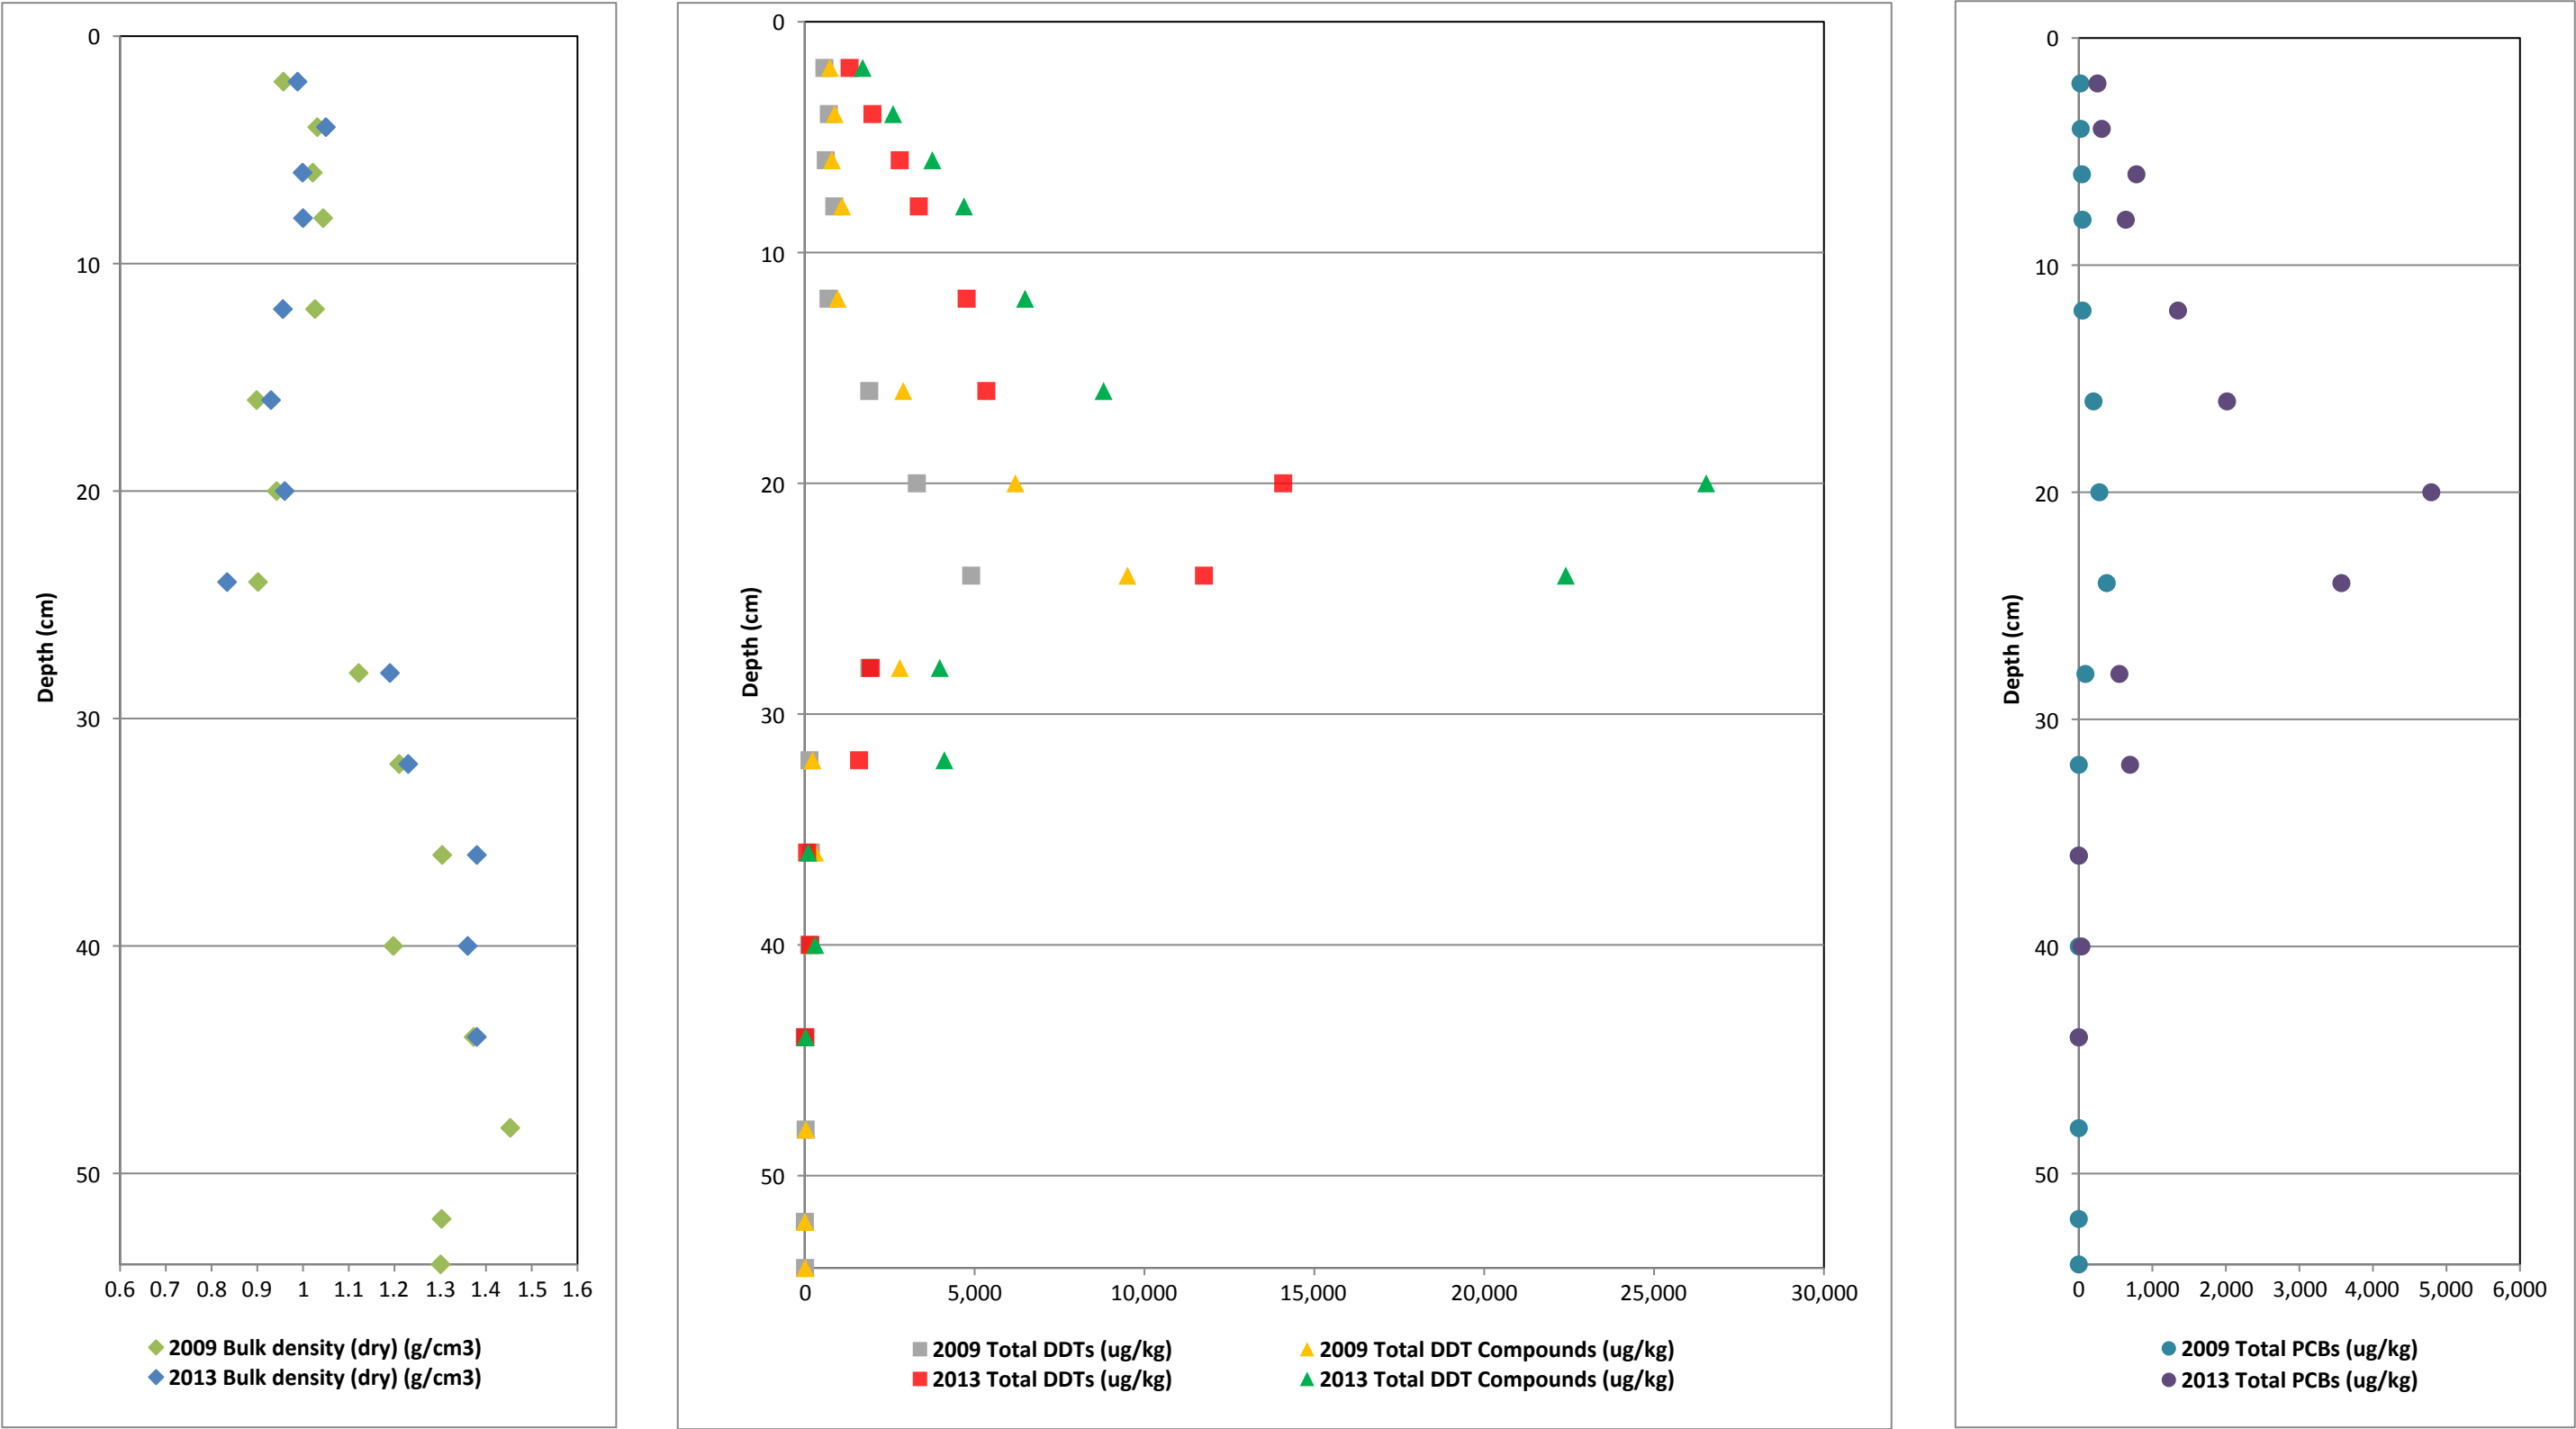
Figure 18. Vertical Profiles of Bulk Density and COCs for Core OA18  
First MNR Report  
Palos Verdes Shelf (OU 5 of the Montrose Chemical Corp. Superfund Site)  
Los Angeles County, California
