## **APPENDIX X.2 – VERTICAL PROFILES – OUTFALL AREA CORES**

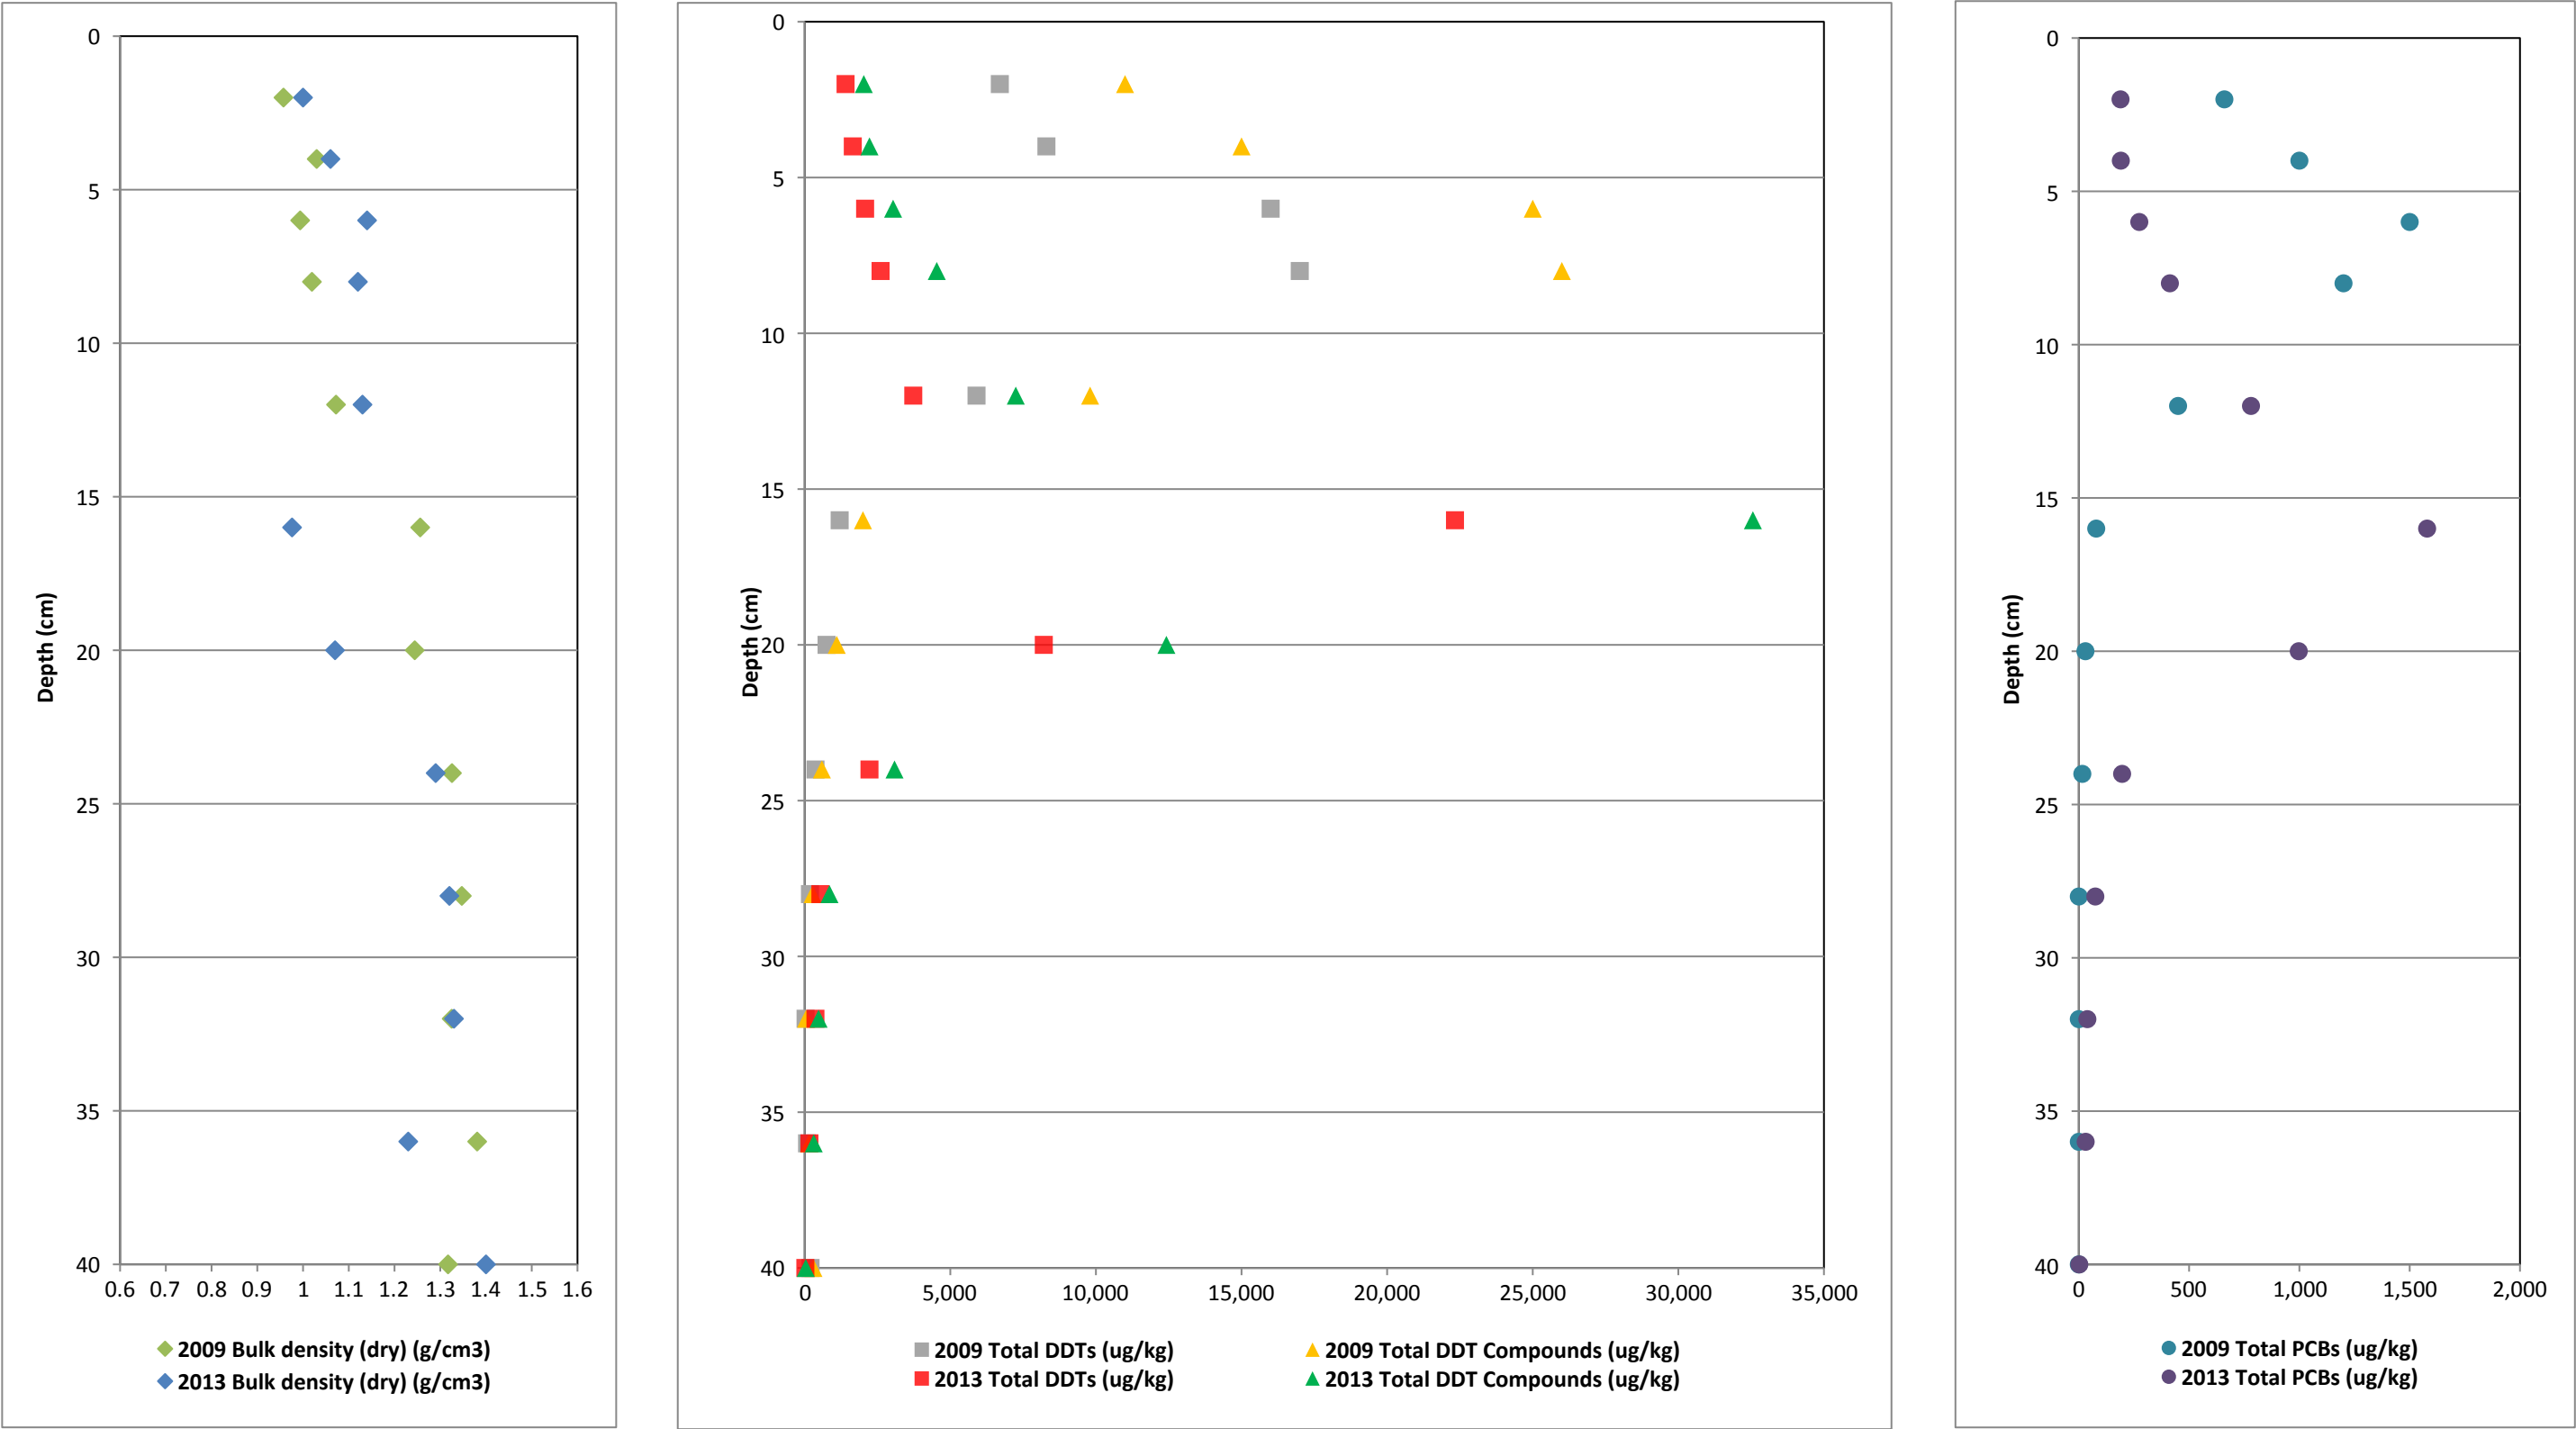
Figure 19. Vertical Profiles of Bulk Density and COCs for Core OA19  
First MNR Report  
Palos Verdes Shelf (OU 5 of the Montrose Chemical Corp. Superfund Site)  
Los Angeles County, California

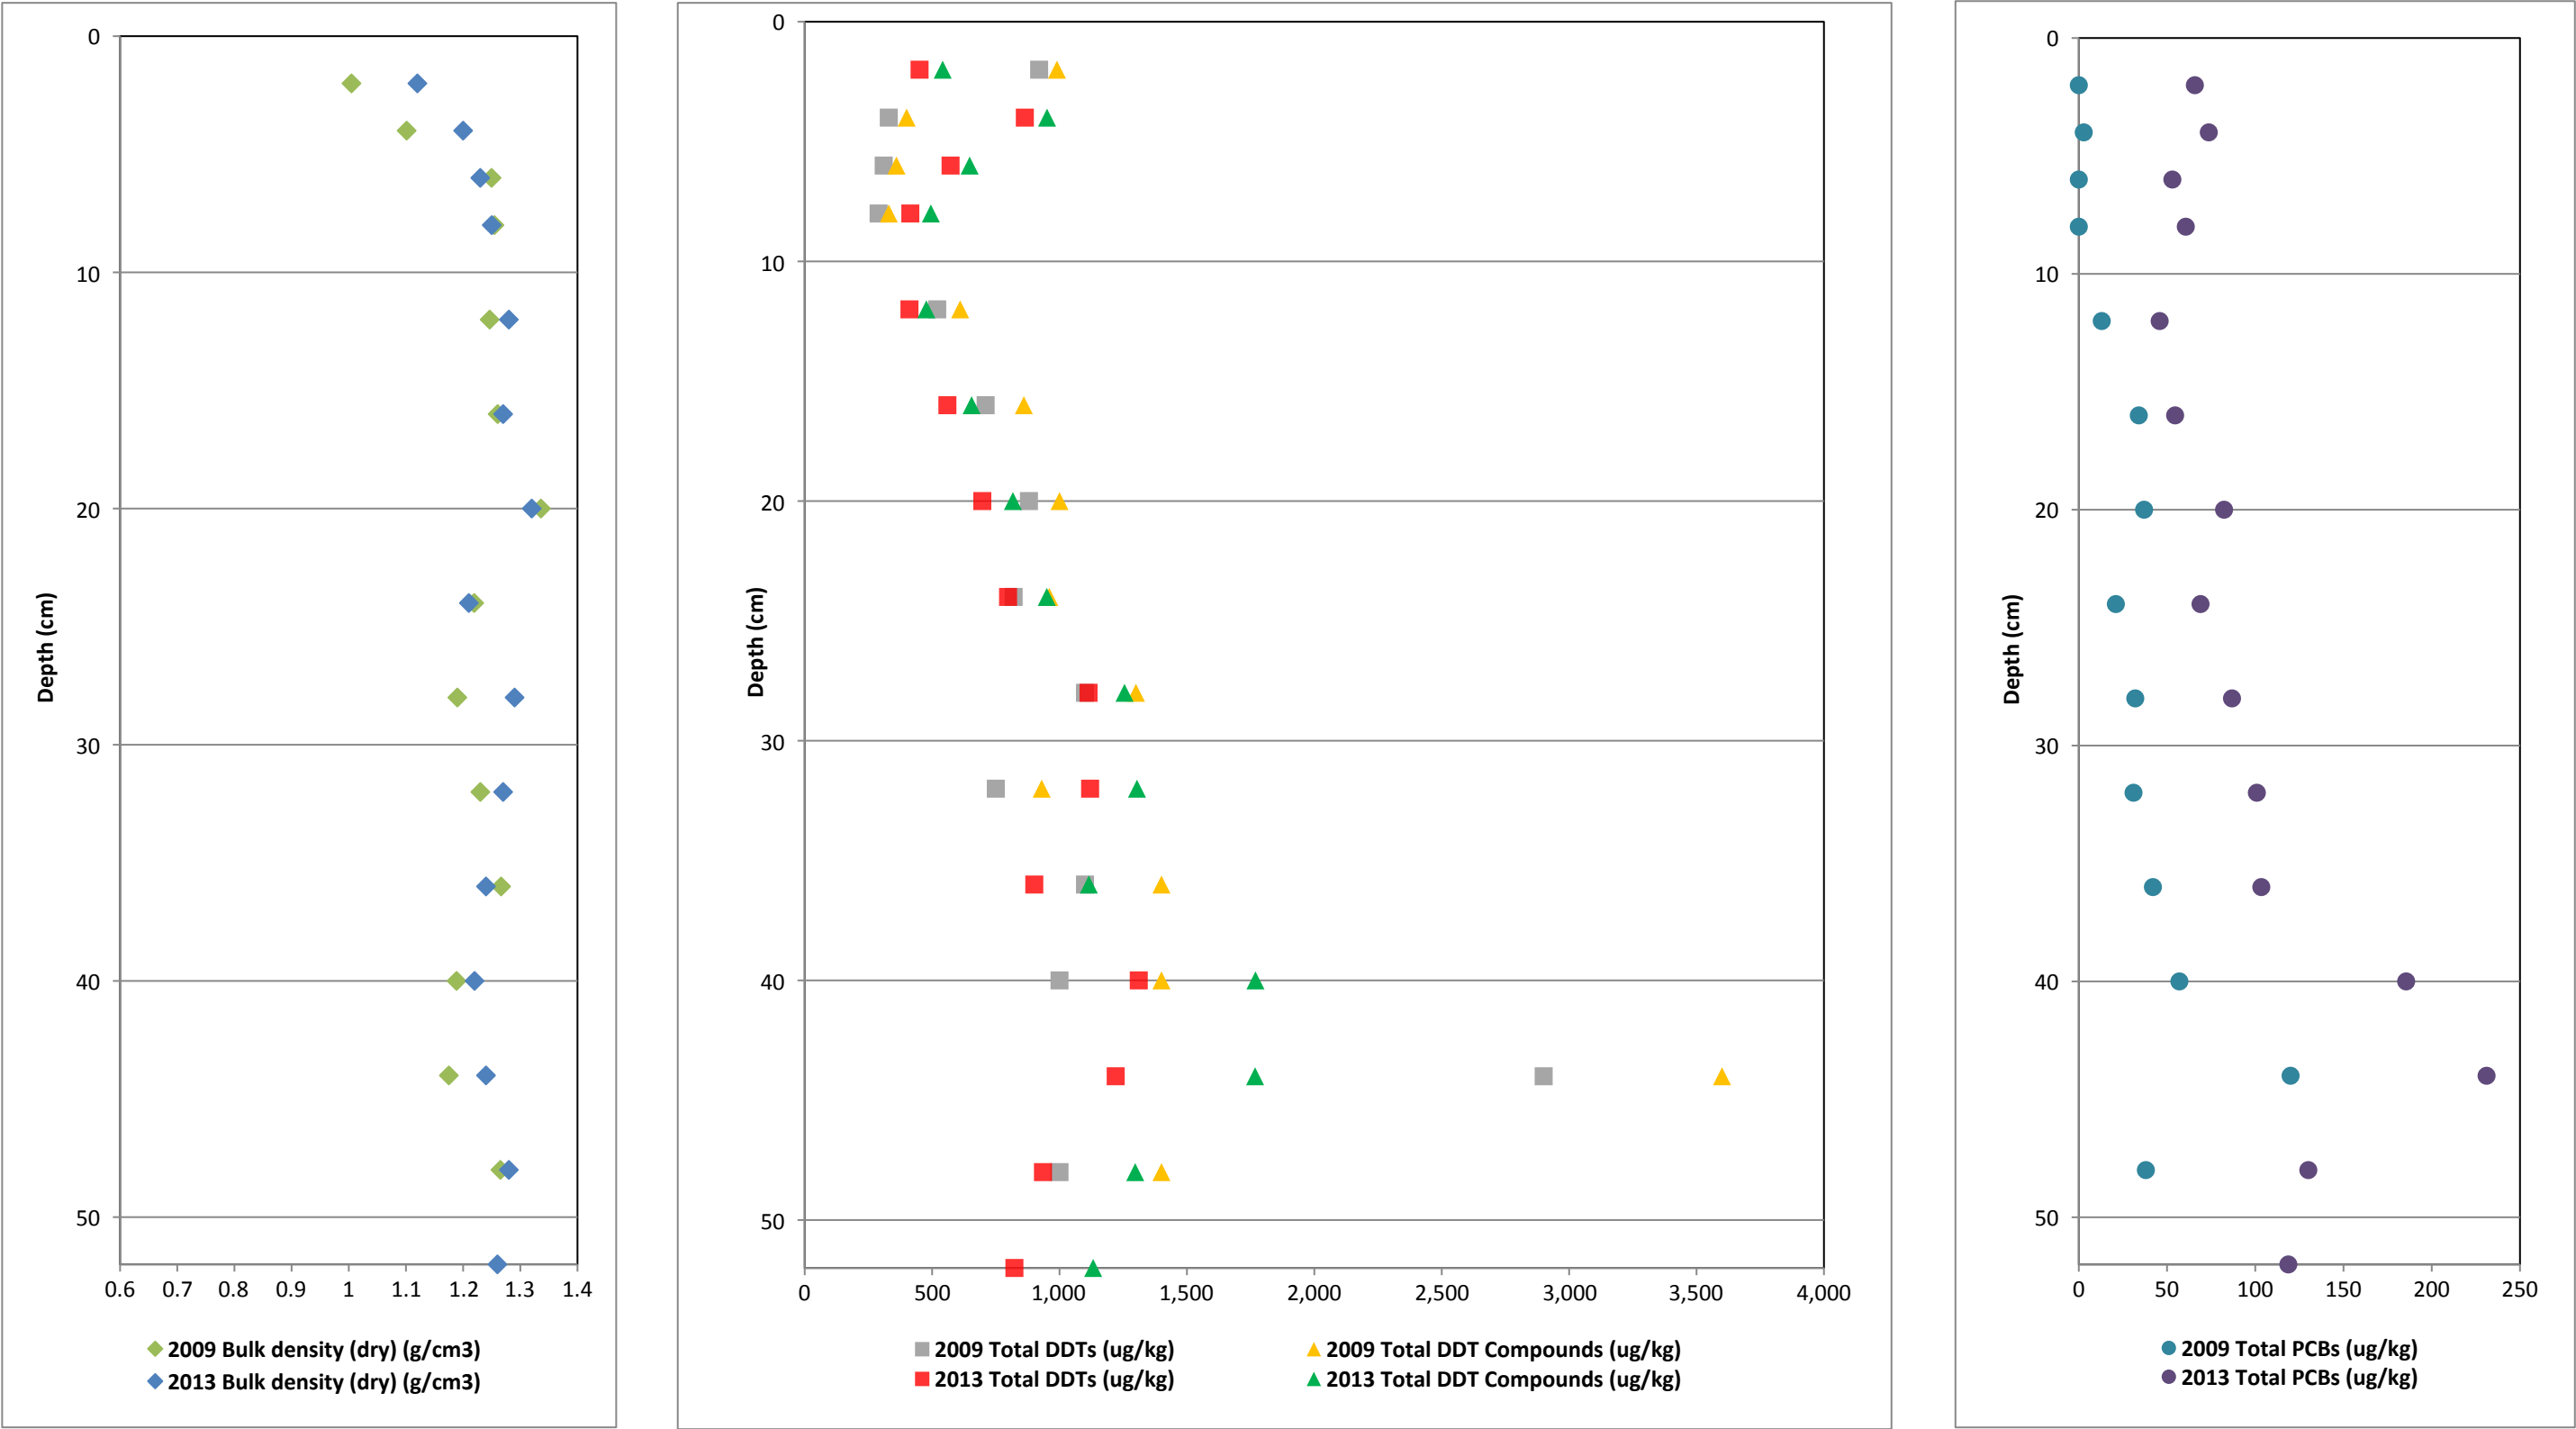
Figure 20. Vertical Profiles of Bulk Density and COCs for Core OA20  
First MNR Report  
Palos Verdes Shelf (OU 5 of the Montrose Chemical Corp. Superfund Site)  
Los Angeles County, California

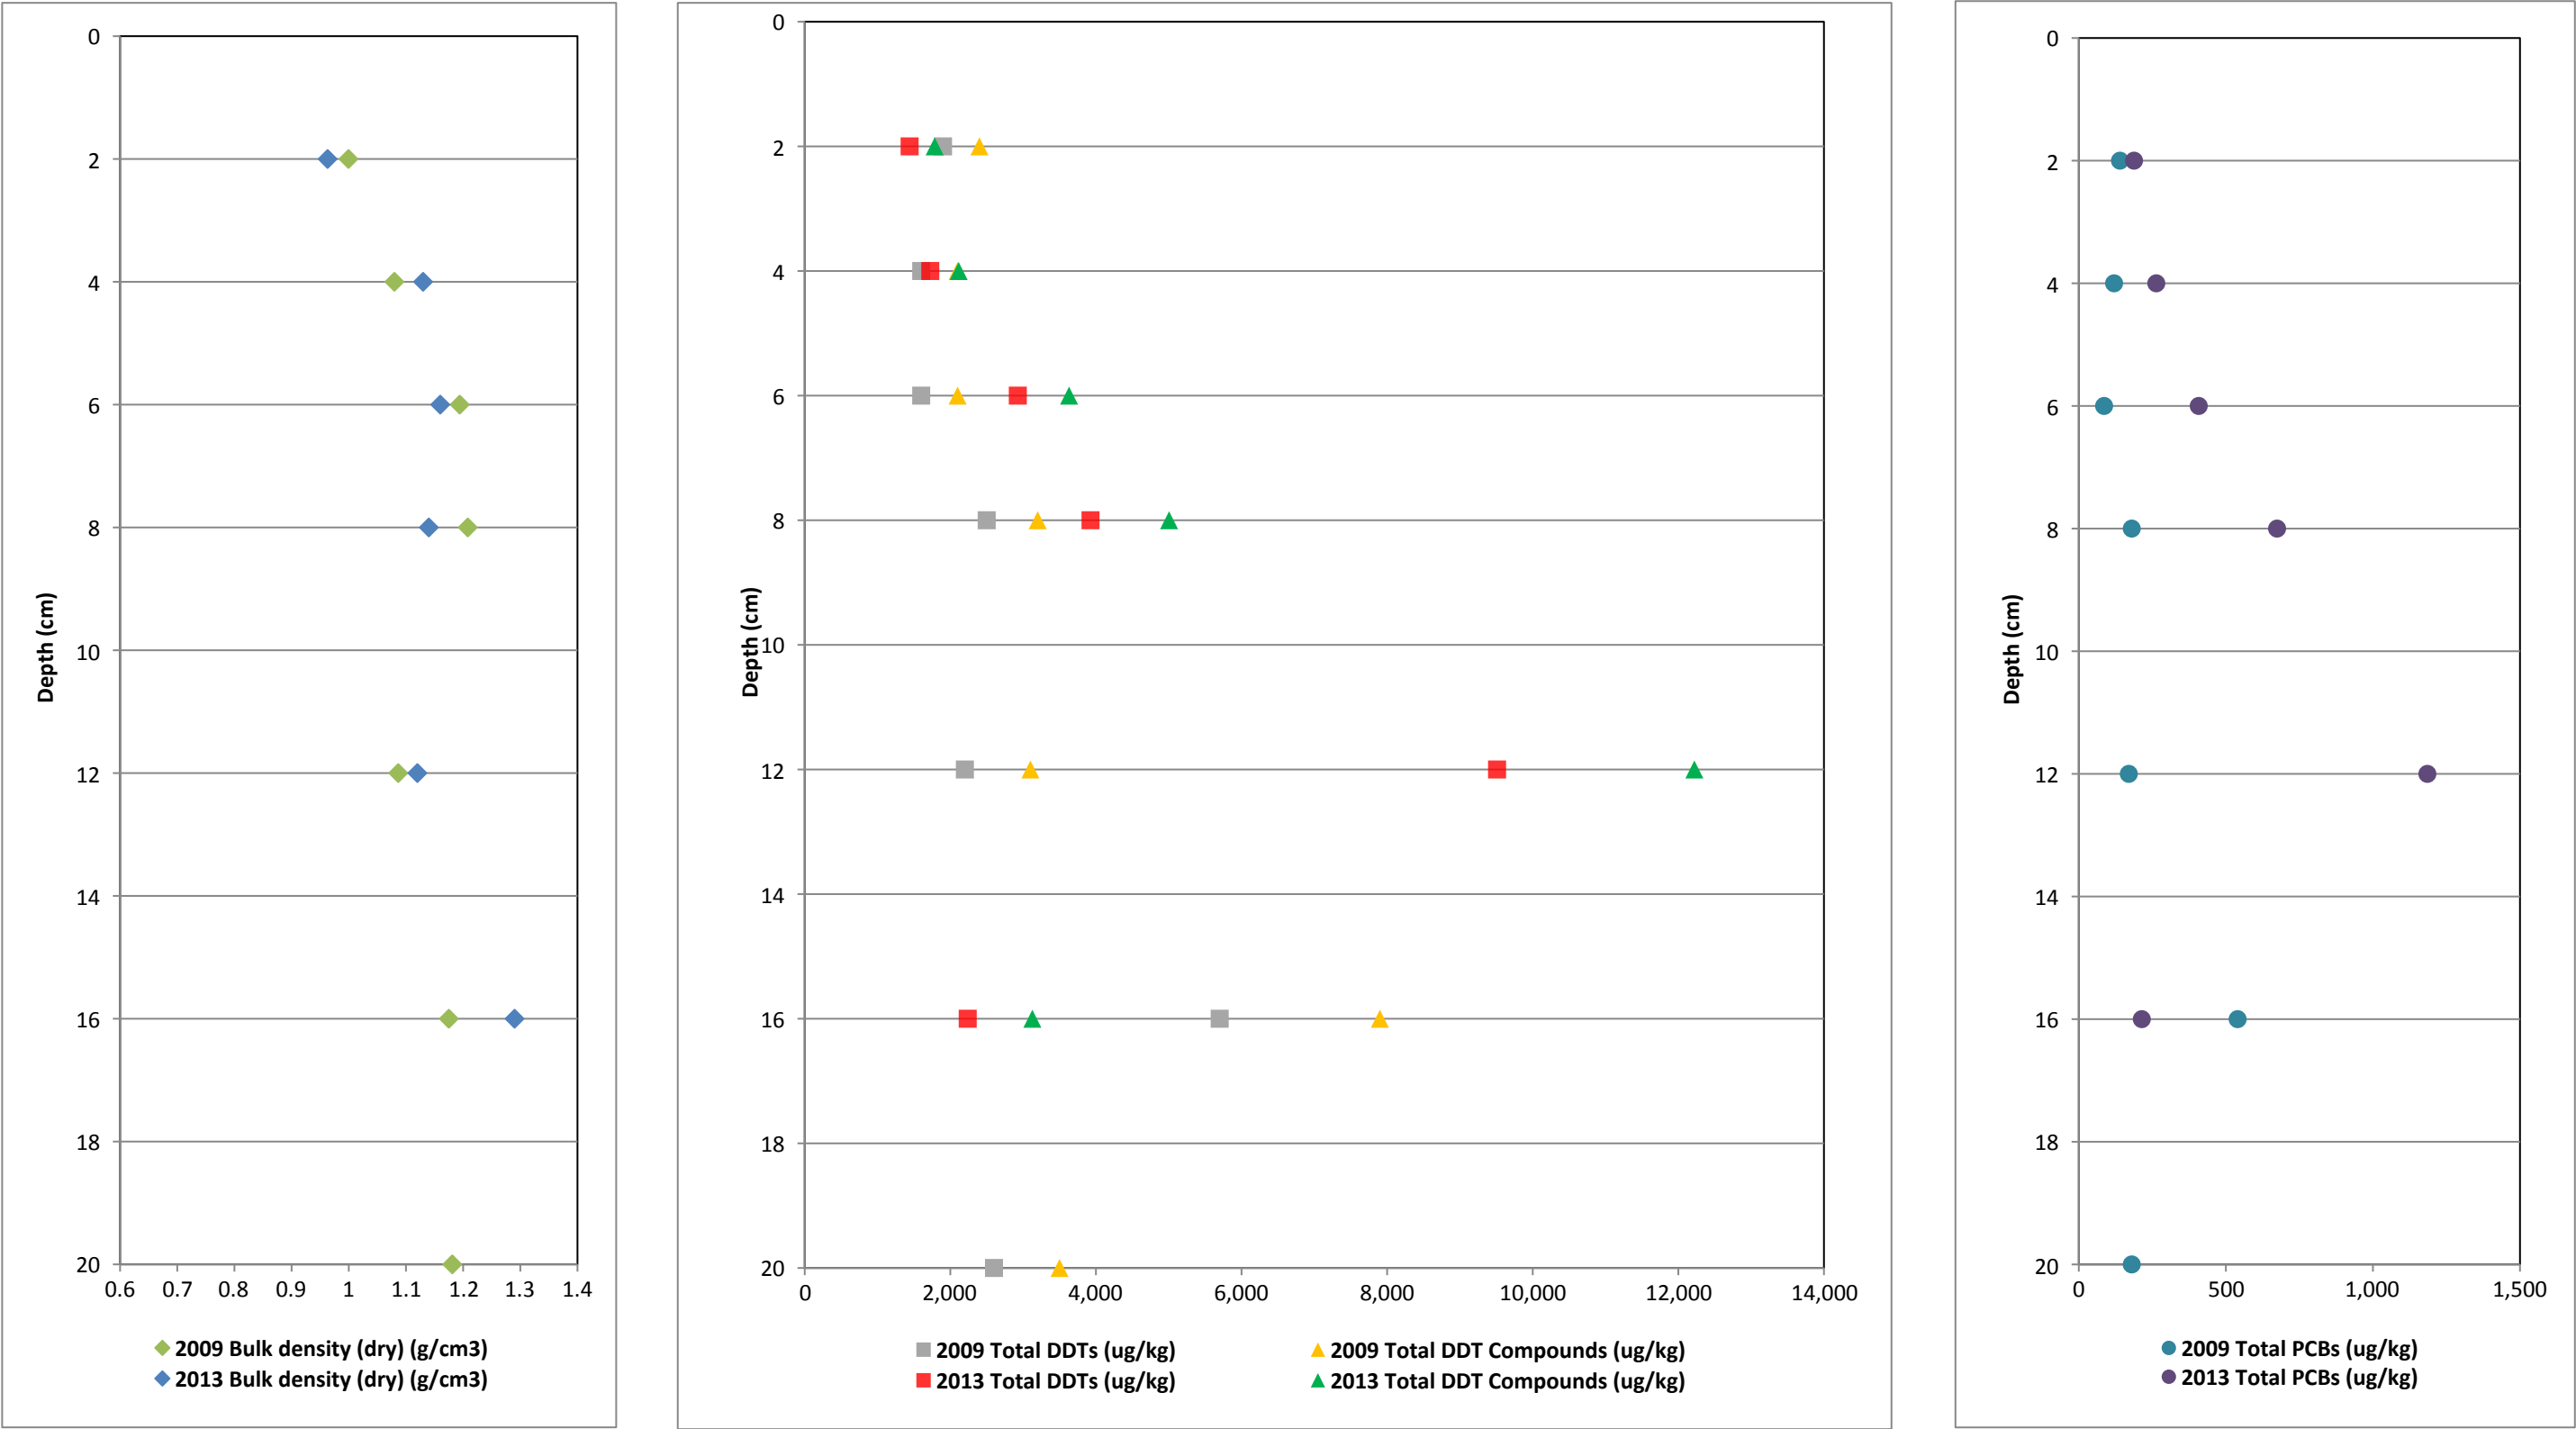
Figure 21. Vertical Profiles of Bulk Density and COCs for Core OA21  
First MNR Report  
Palos Verdes Shelf (OU 5 of the Montrose Chemical Corp. Superfund Site)  
Los Angeles County, California

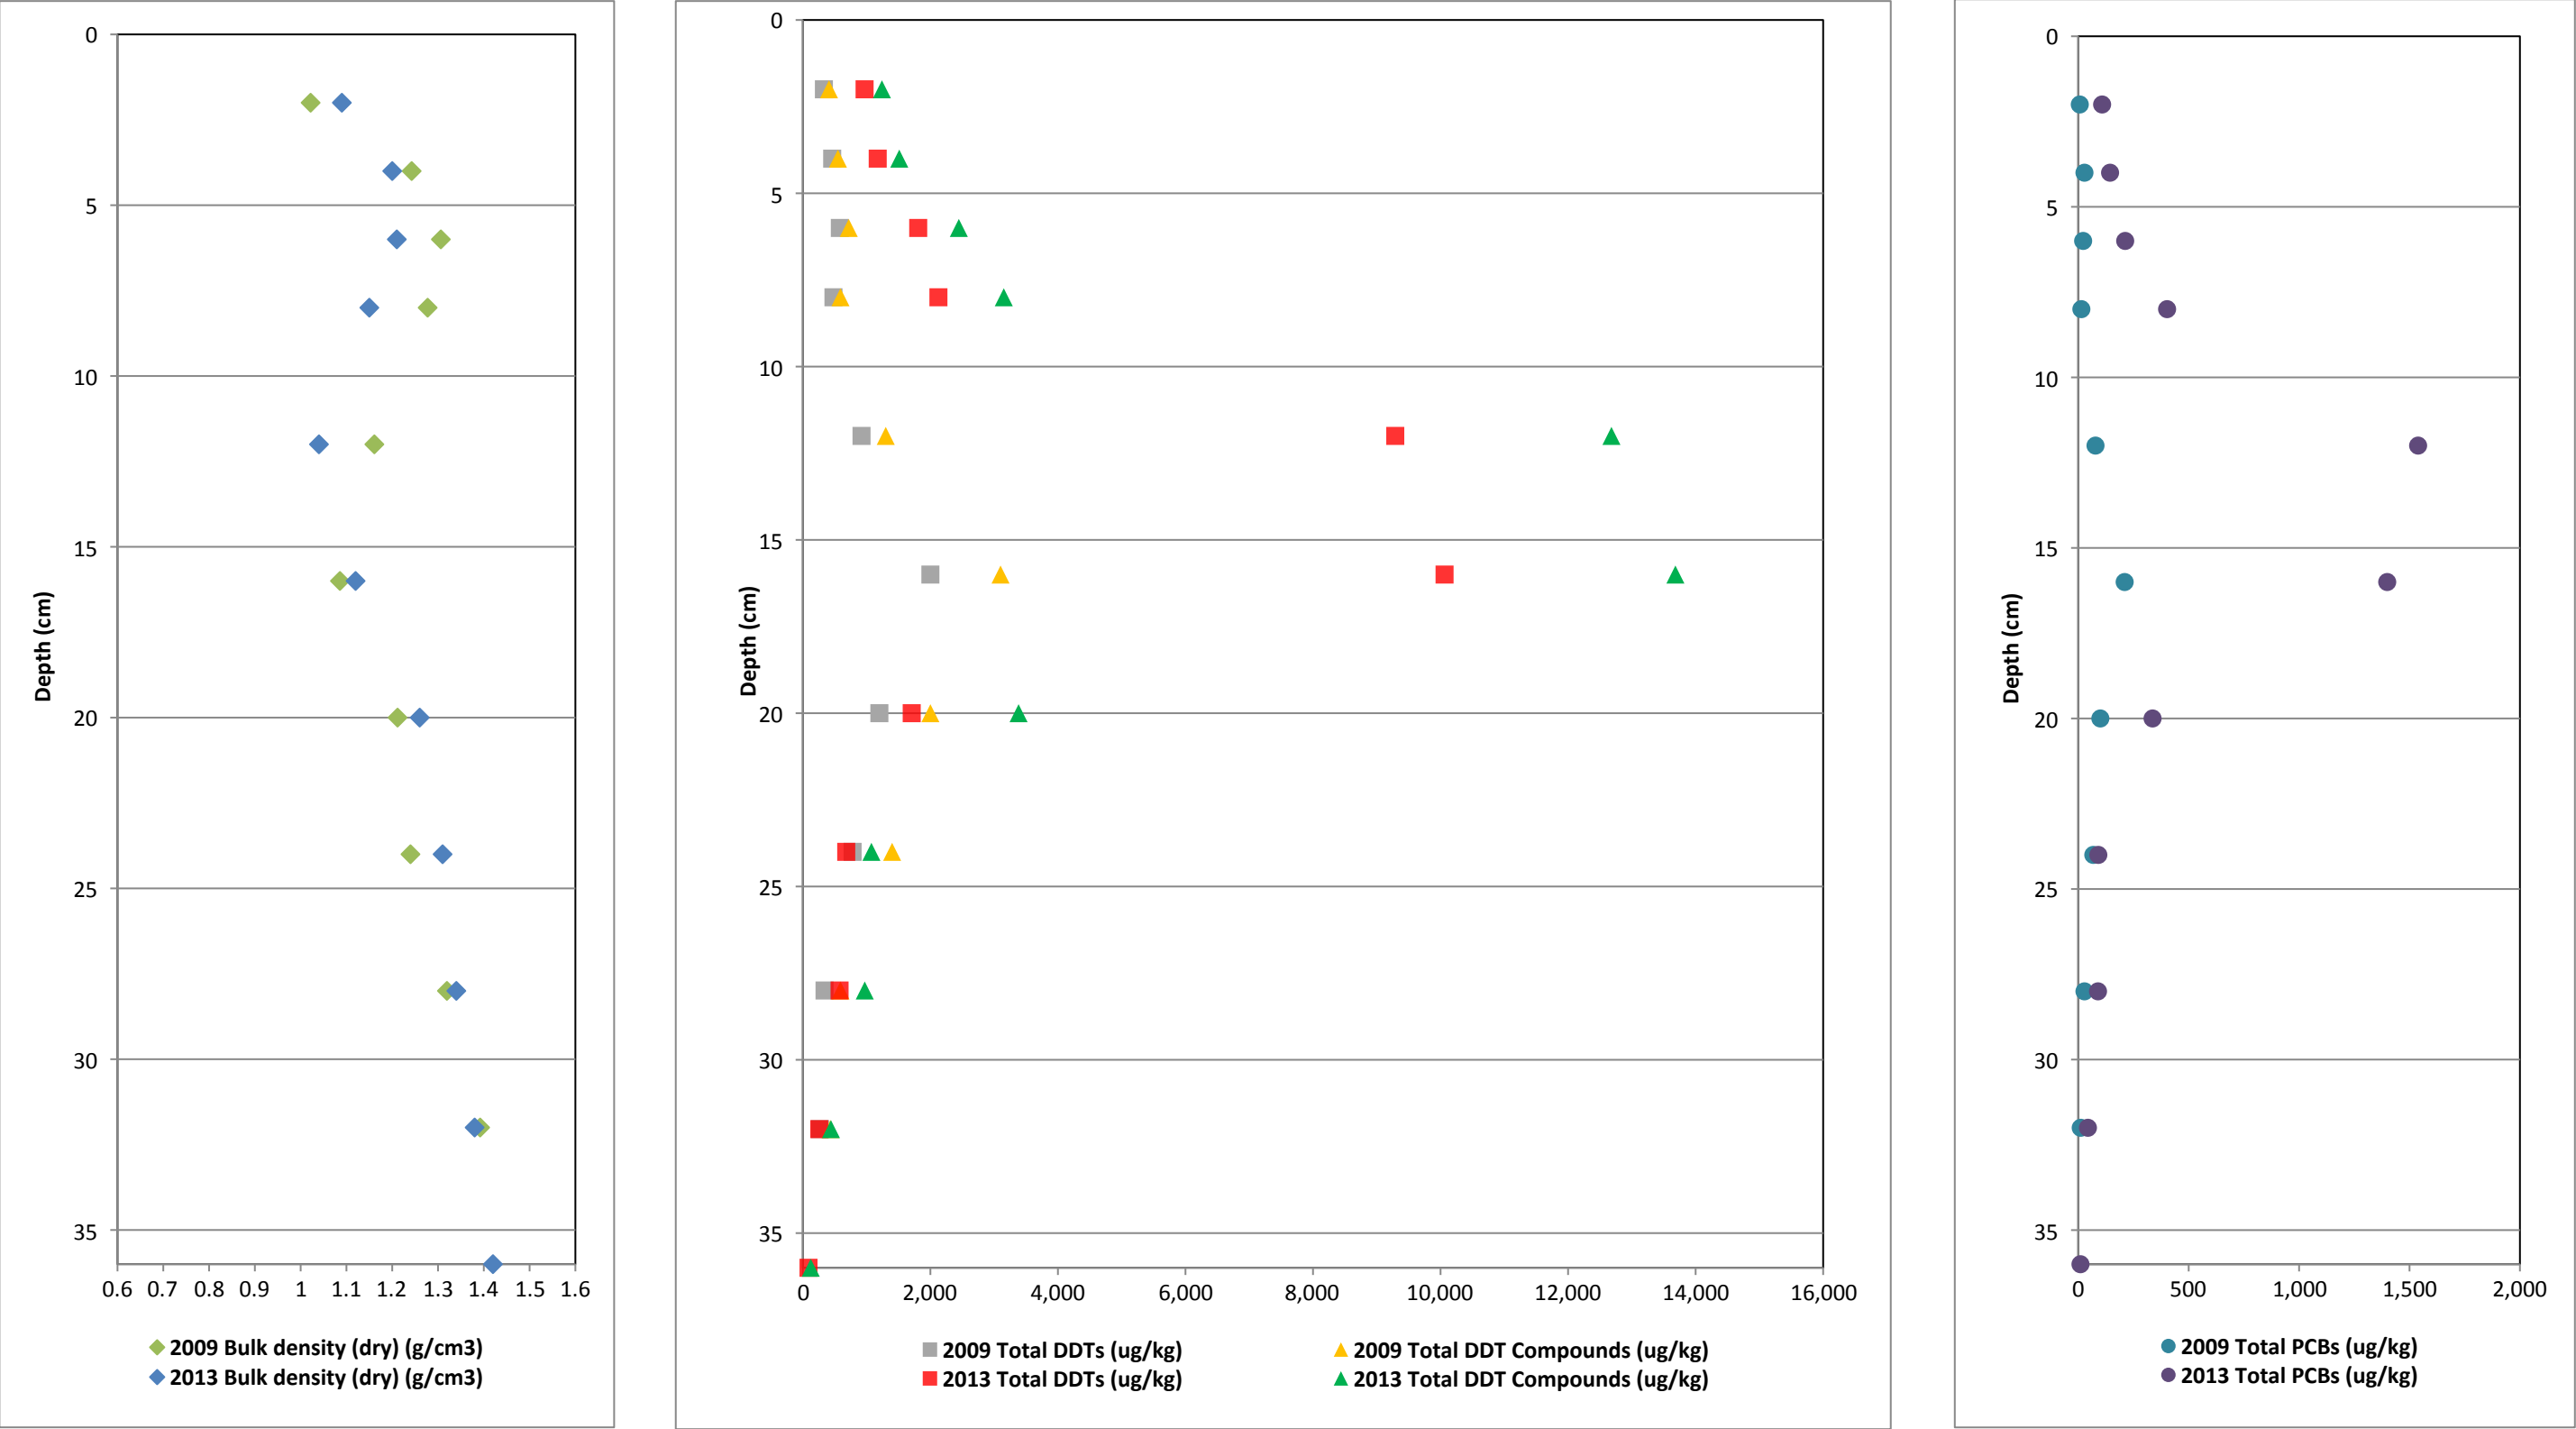
Figure 22. Vertical Profiles of Bulk Density and COCs for Core OA22  
First MNR Report  
Palos Verdes Shelf (OU 5 of the Montrose Chemical Corp. Superfund Site)  
Los Angeles County, California

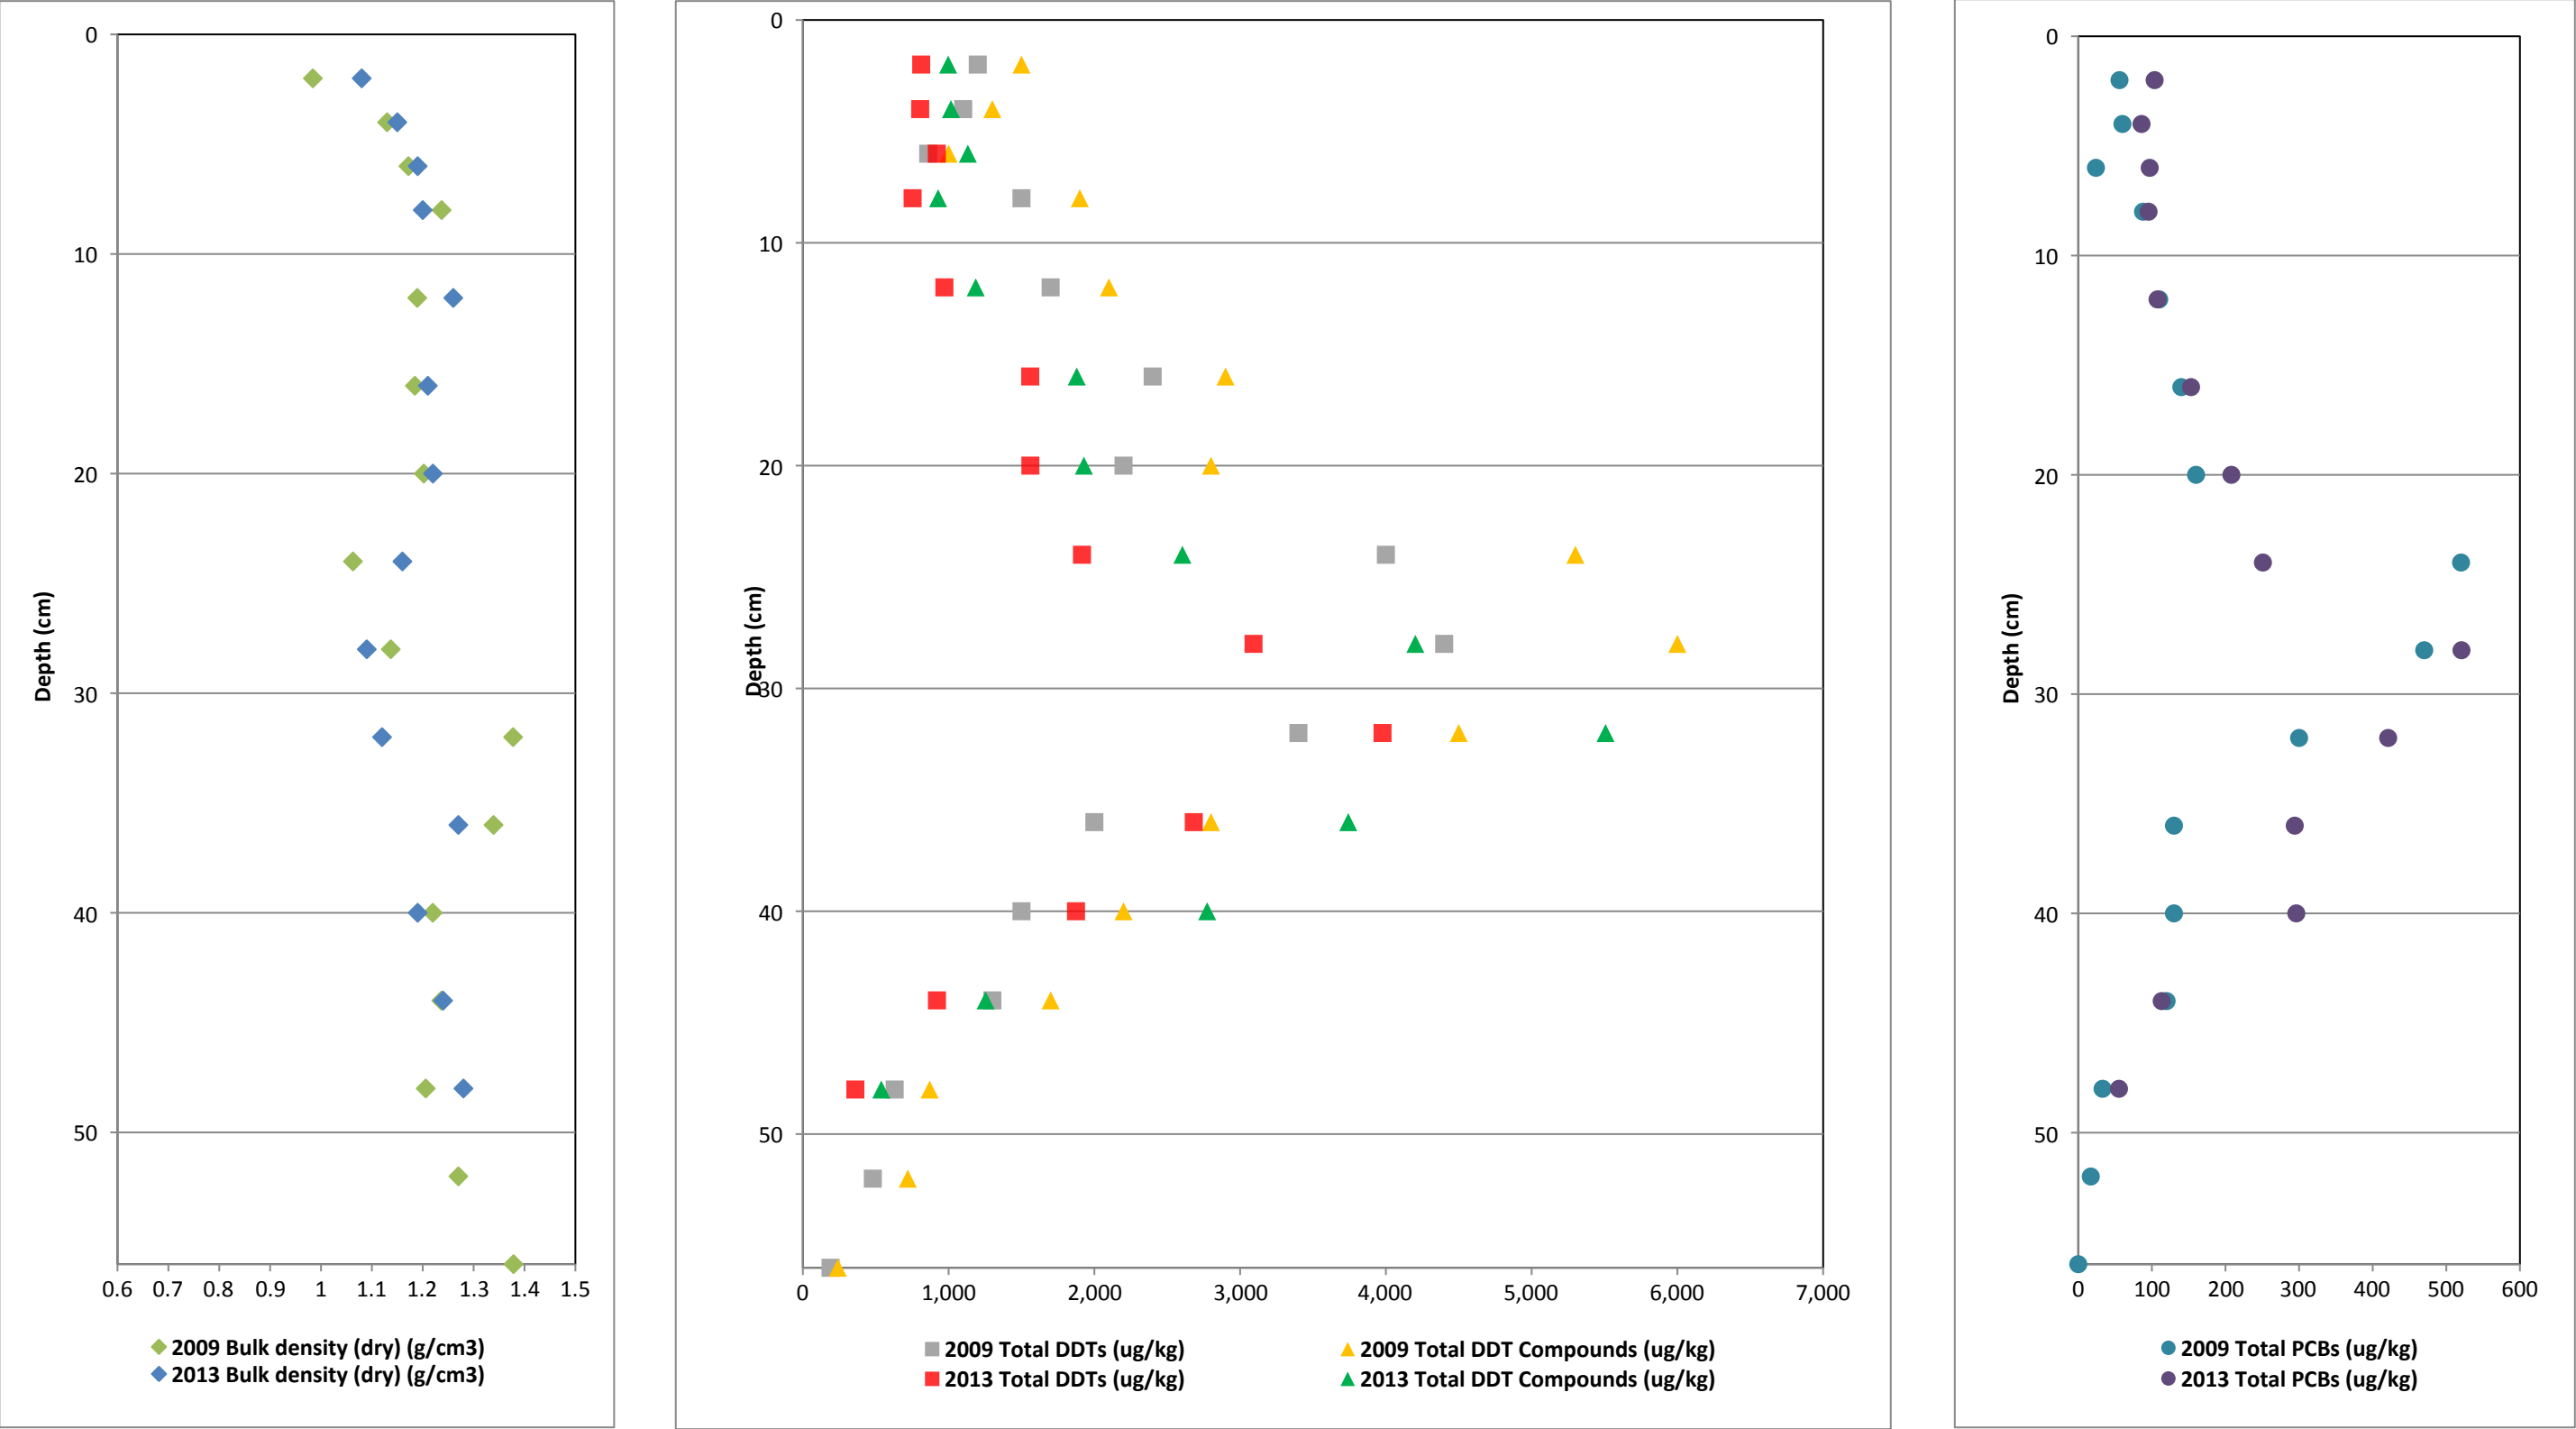
Figure 23. Vertical Profiles of Bulk Density and COCs for Core OA23  
First MNR Report  
Palos Verdes Shelf (OU 5 of the Montrose Chemical Corp. Superfund Site)  
Los Angeles County, California

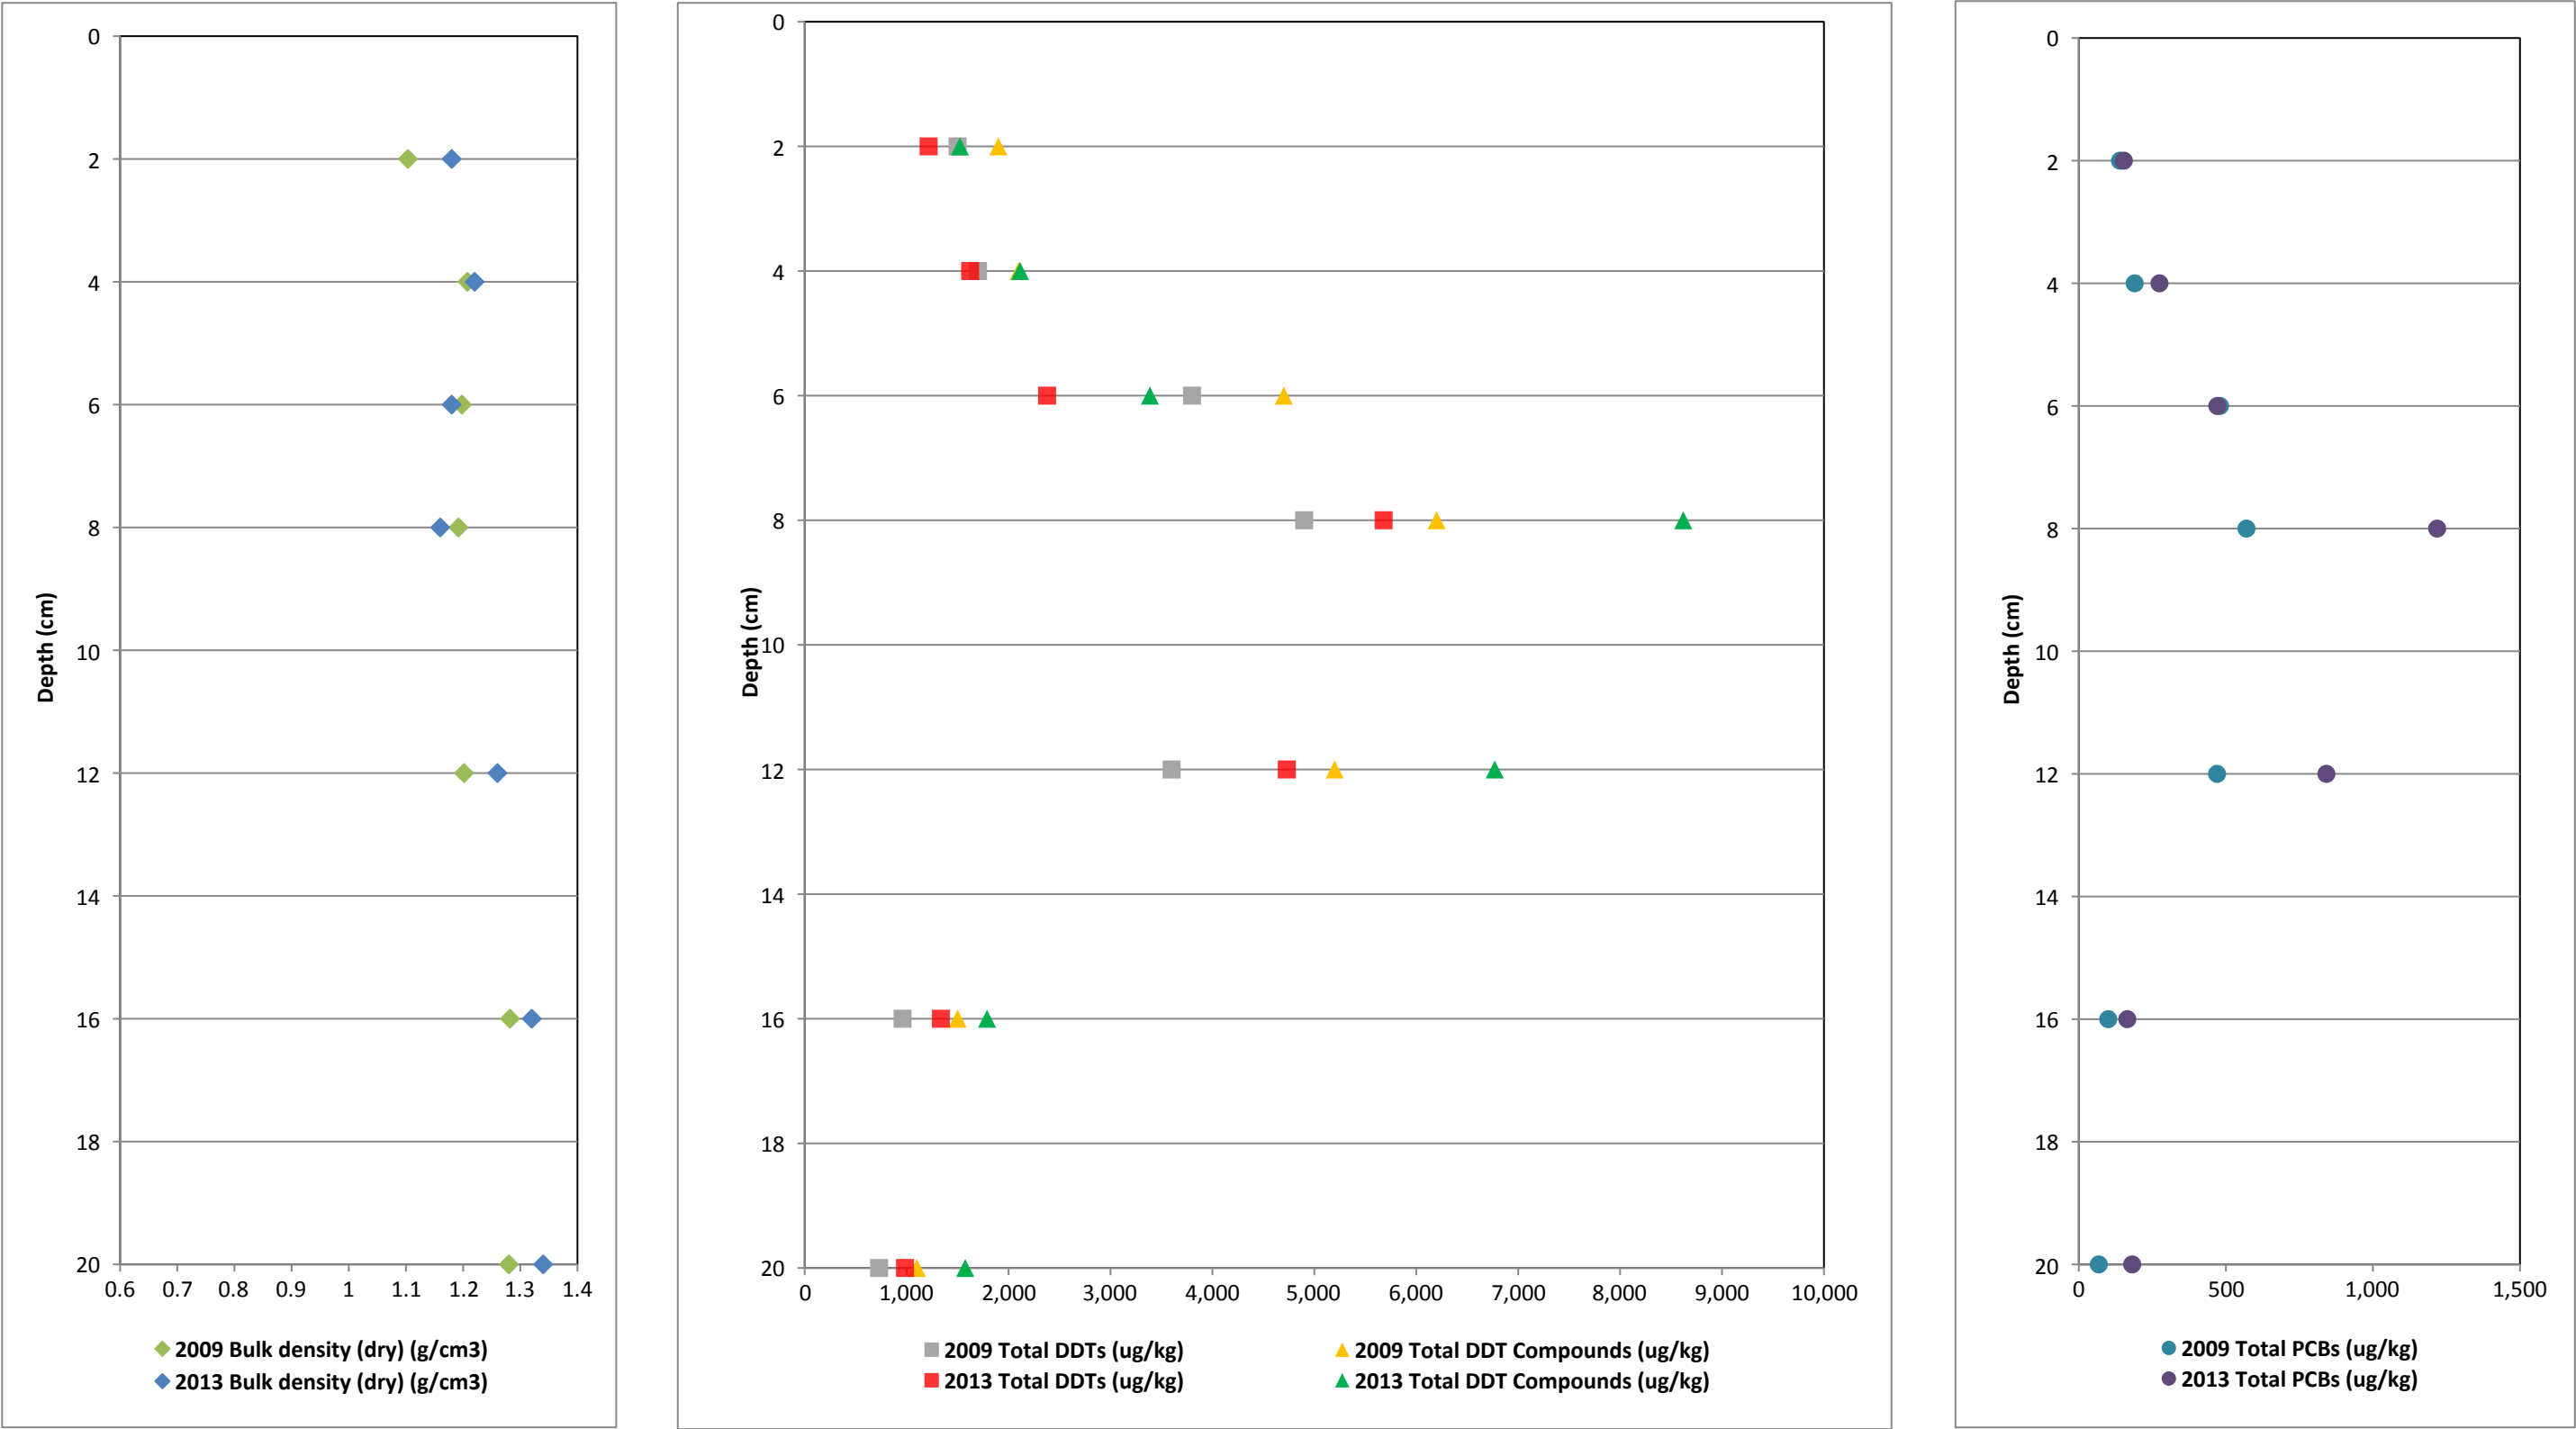
Figure 24. Vertical Profiles of Bulk Density and COCs for Core OA24  
First MNR Report  
Palos Verdes Shelf (OU 5 of the Montrose Chemical Corp. Superfund Site)  
Los Angeles County, California
