## **APPENDIX X.2 – VERTICAL PROFILES – OUTFALL AREA CORES**

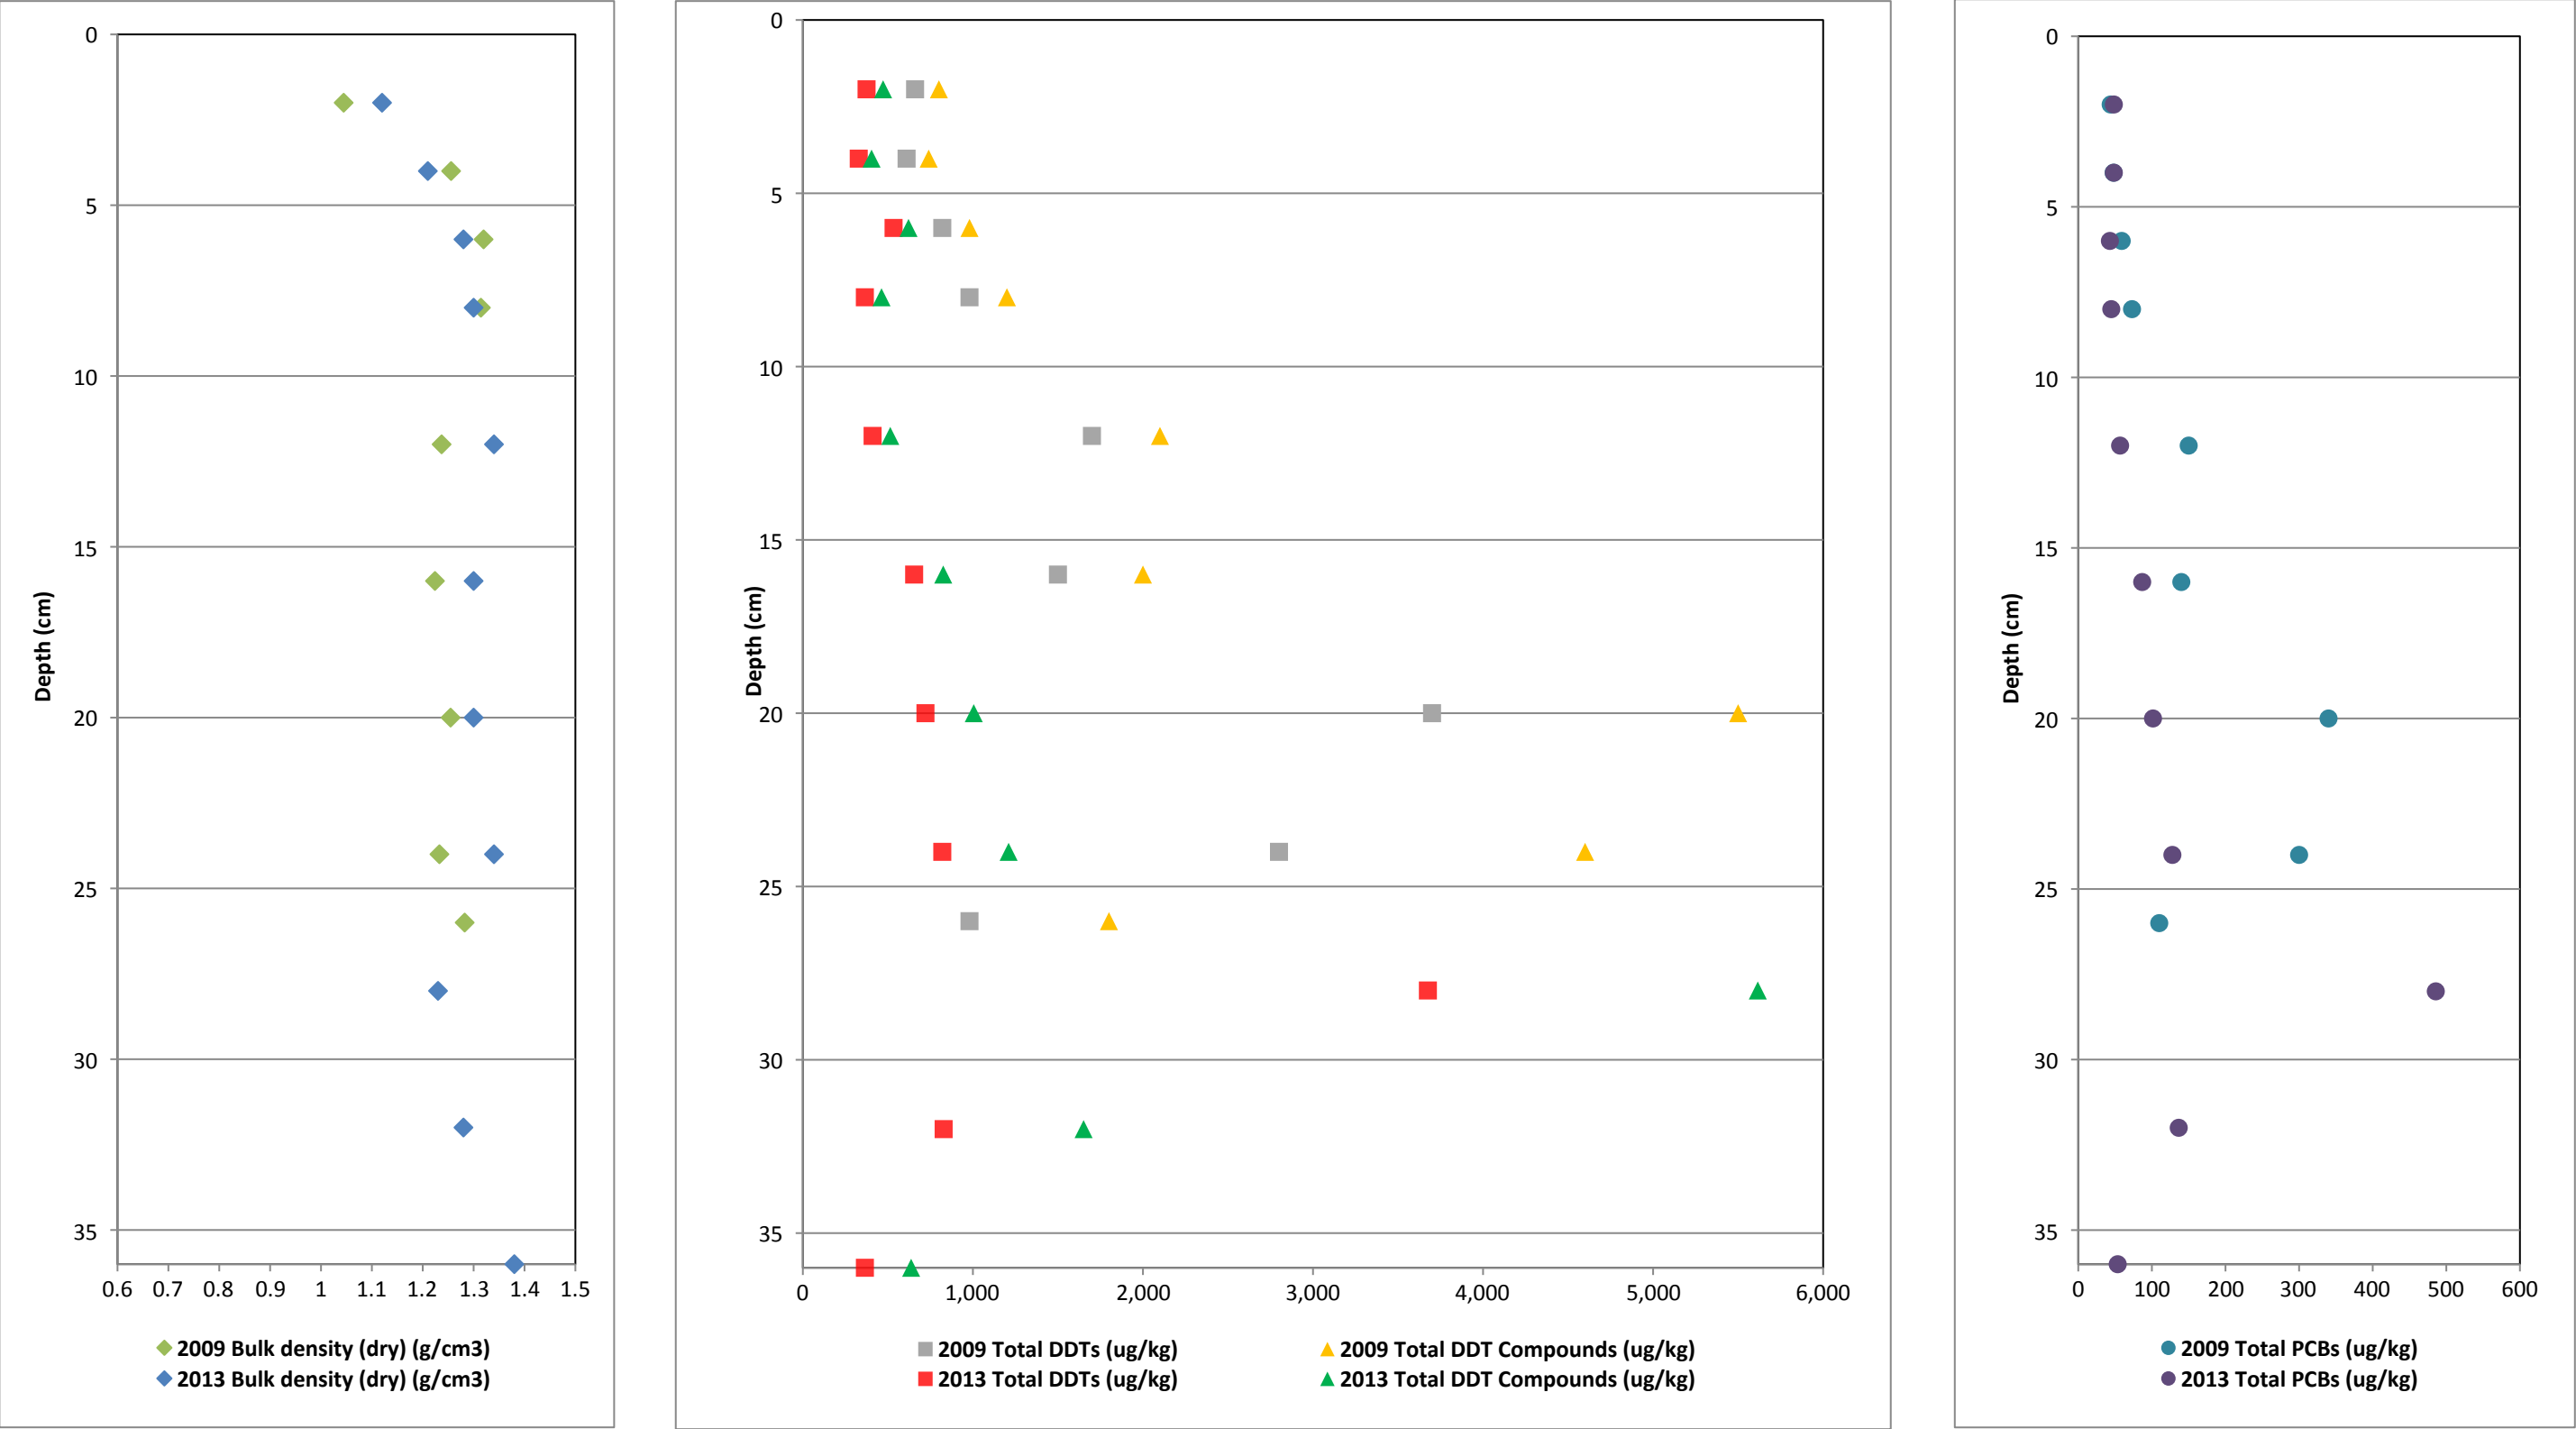
Figure 25. Vertical Profiles of Bulk Density and COCs for Core OA25  
First MNR Report  
Palos Verdes Shelf (OU 5 of the Montrose Chemical Corp. Superfund Site)  
Los Angeles County, California

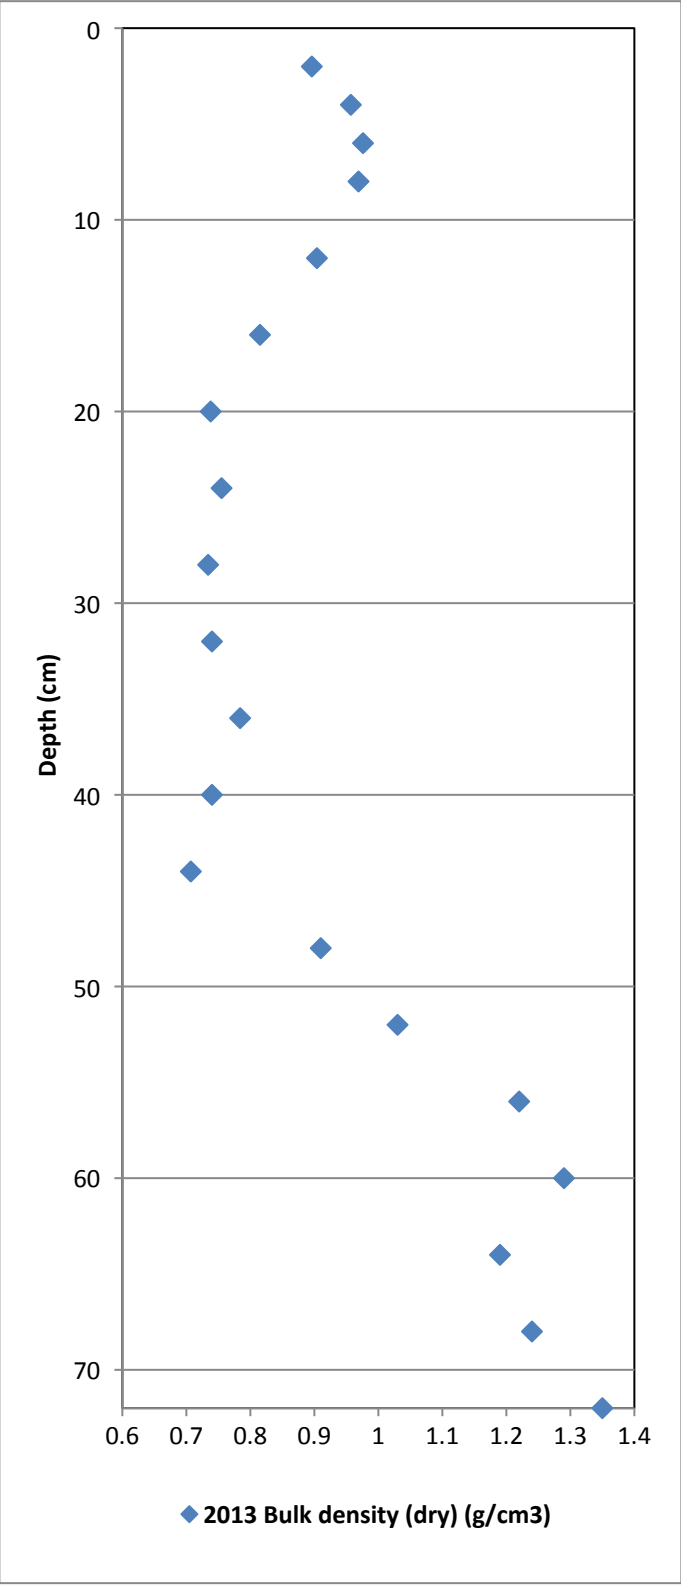
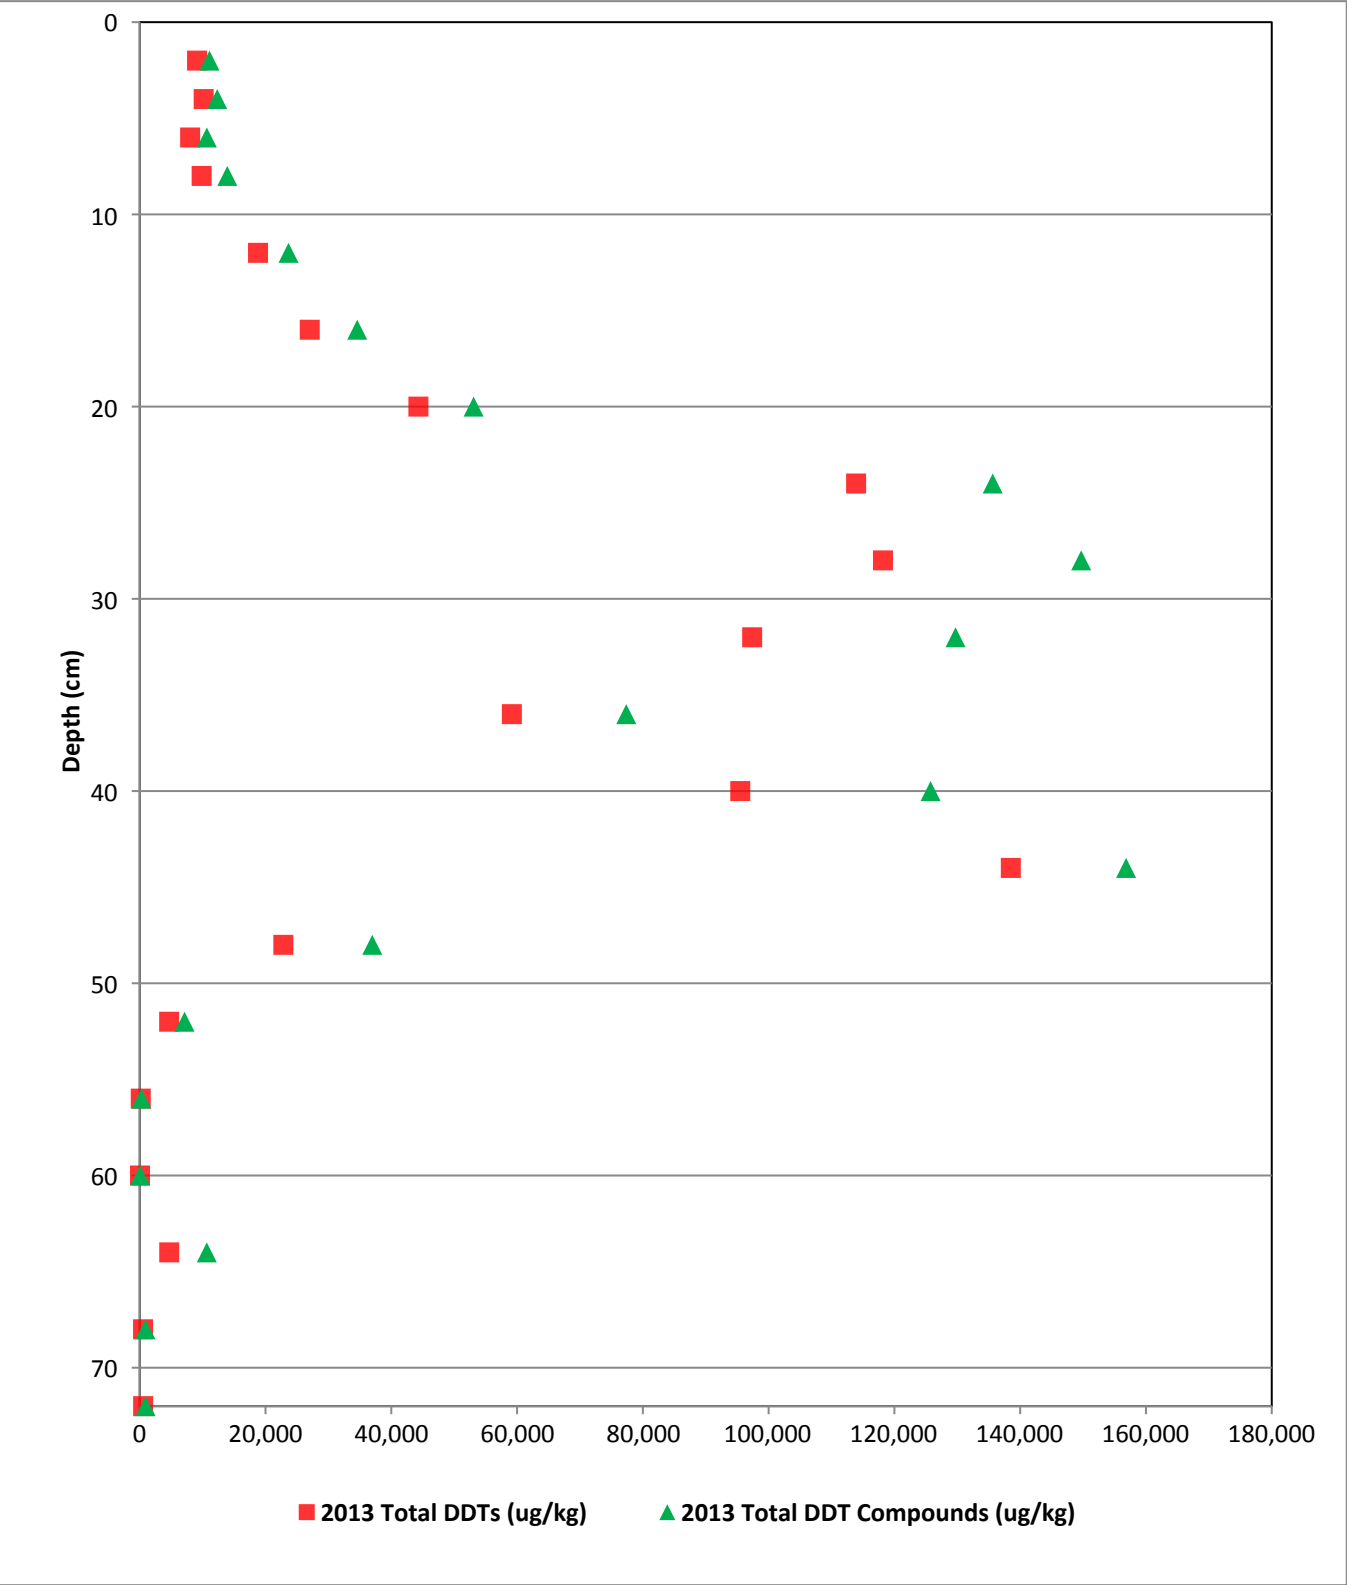
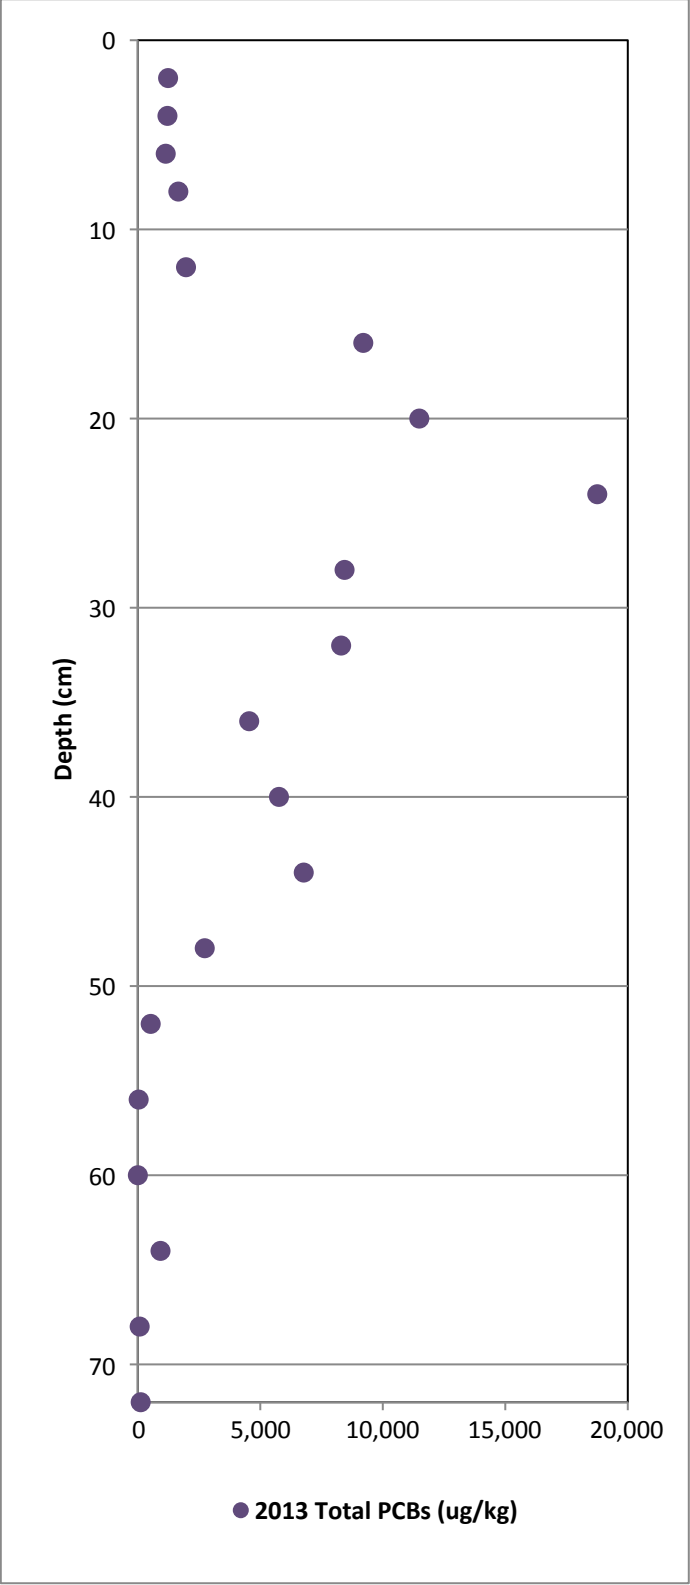
Figure 26. Vertical Profiles of Bulk Density and COCs for Core OA26  
First MNR Report  
Palos Verdes Shelf (OU 5 of the Montrose Chemical Corp. Superfund Site)  
Los Angeles County, California

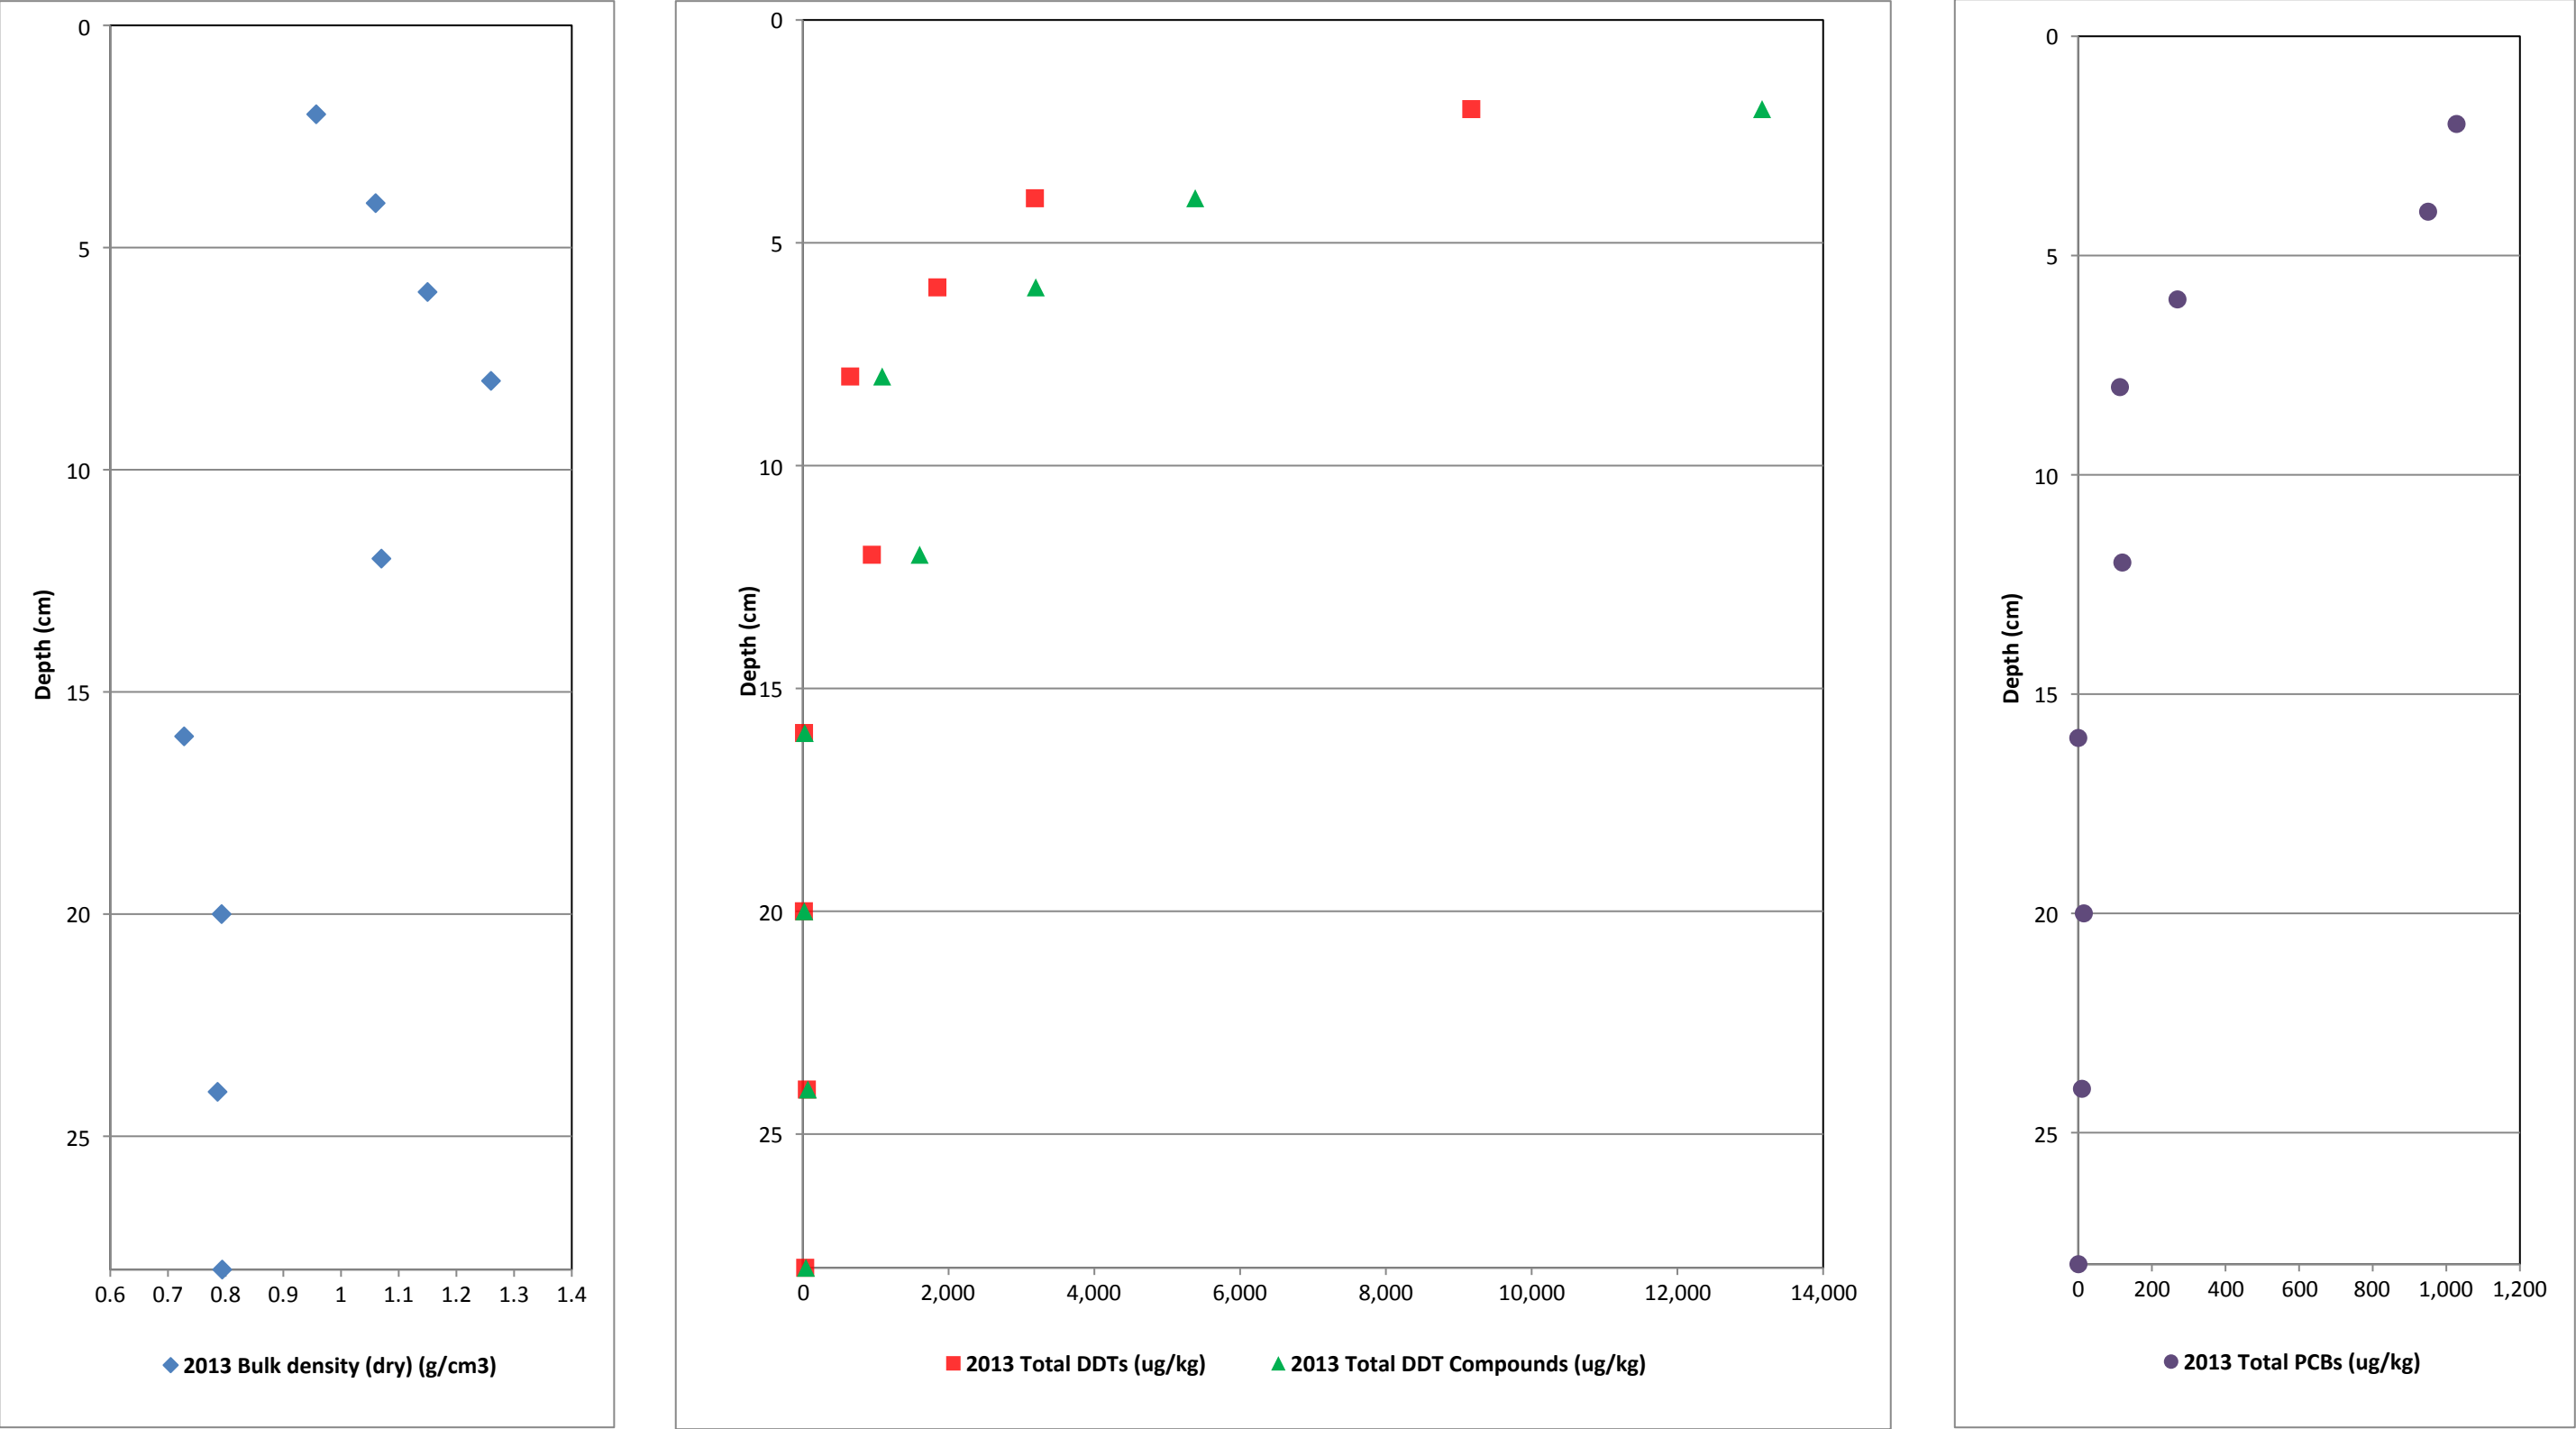
Figure 27. Vertical Profiles of Bulk Density and COCs for Core OA27  
First MNR Report  
Palos Verdes Shelf (OU 5 of the Montrose Chemical Corp. Superfund Site)  
Los Angeles County, California

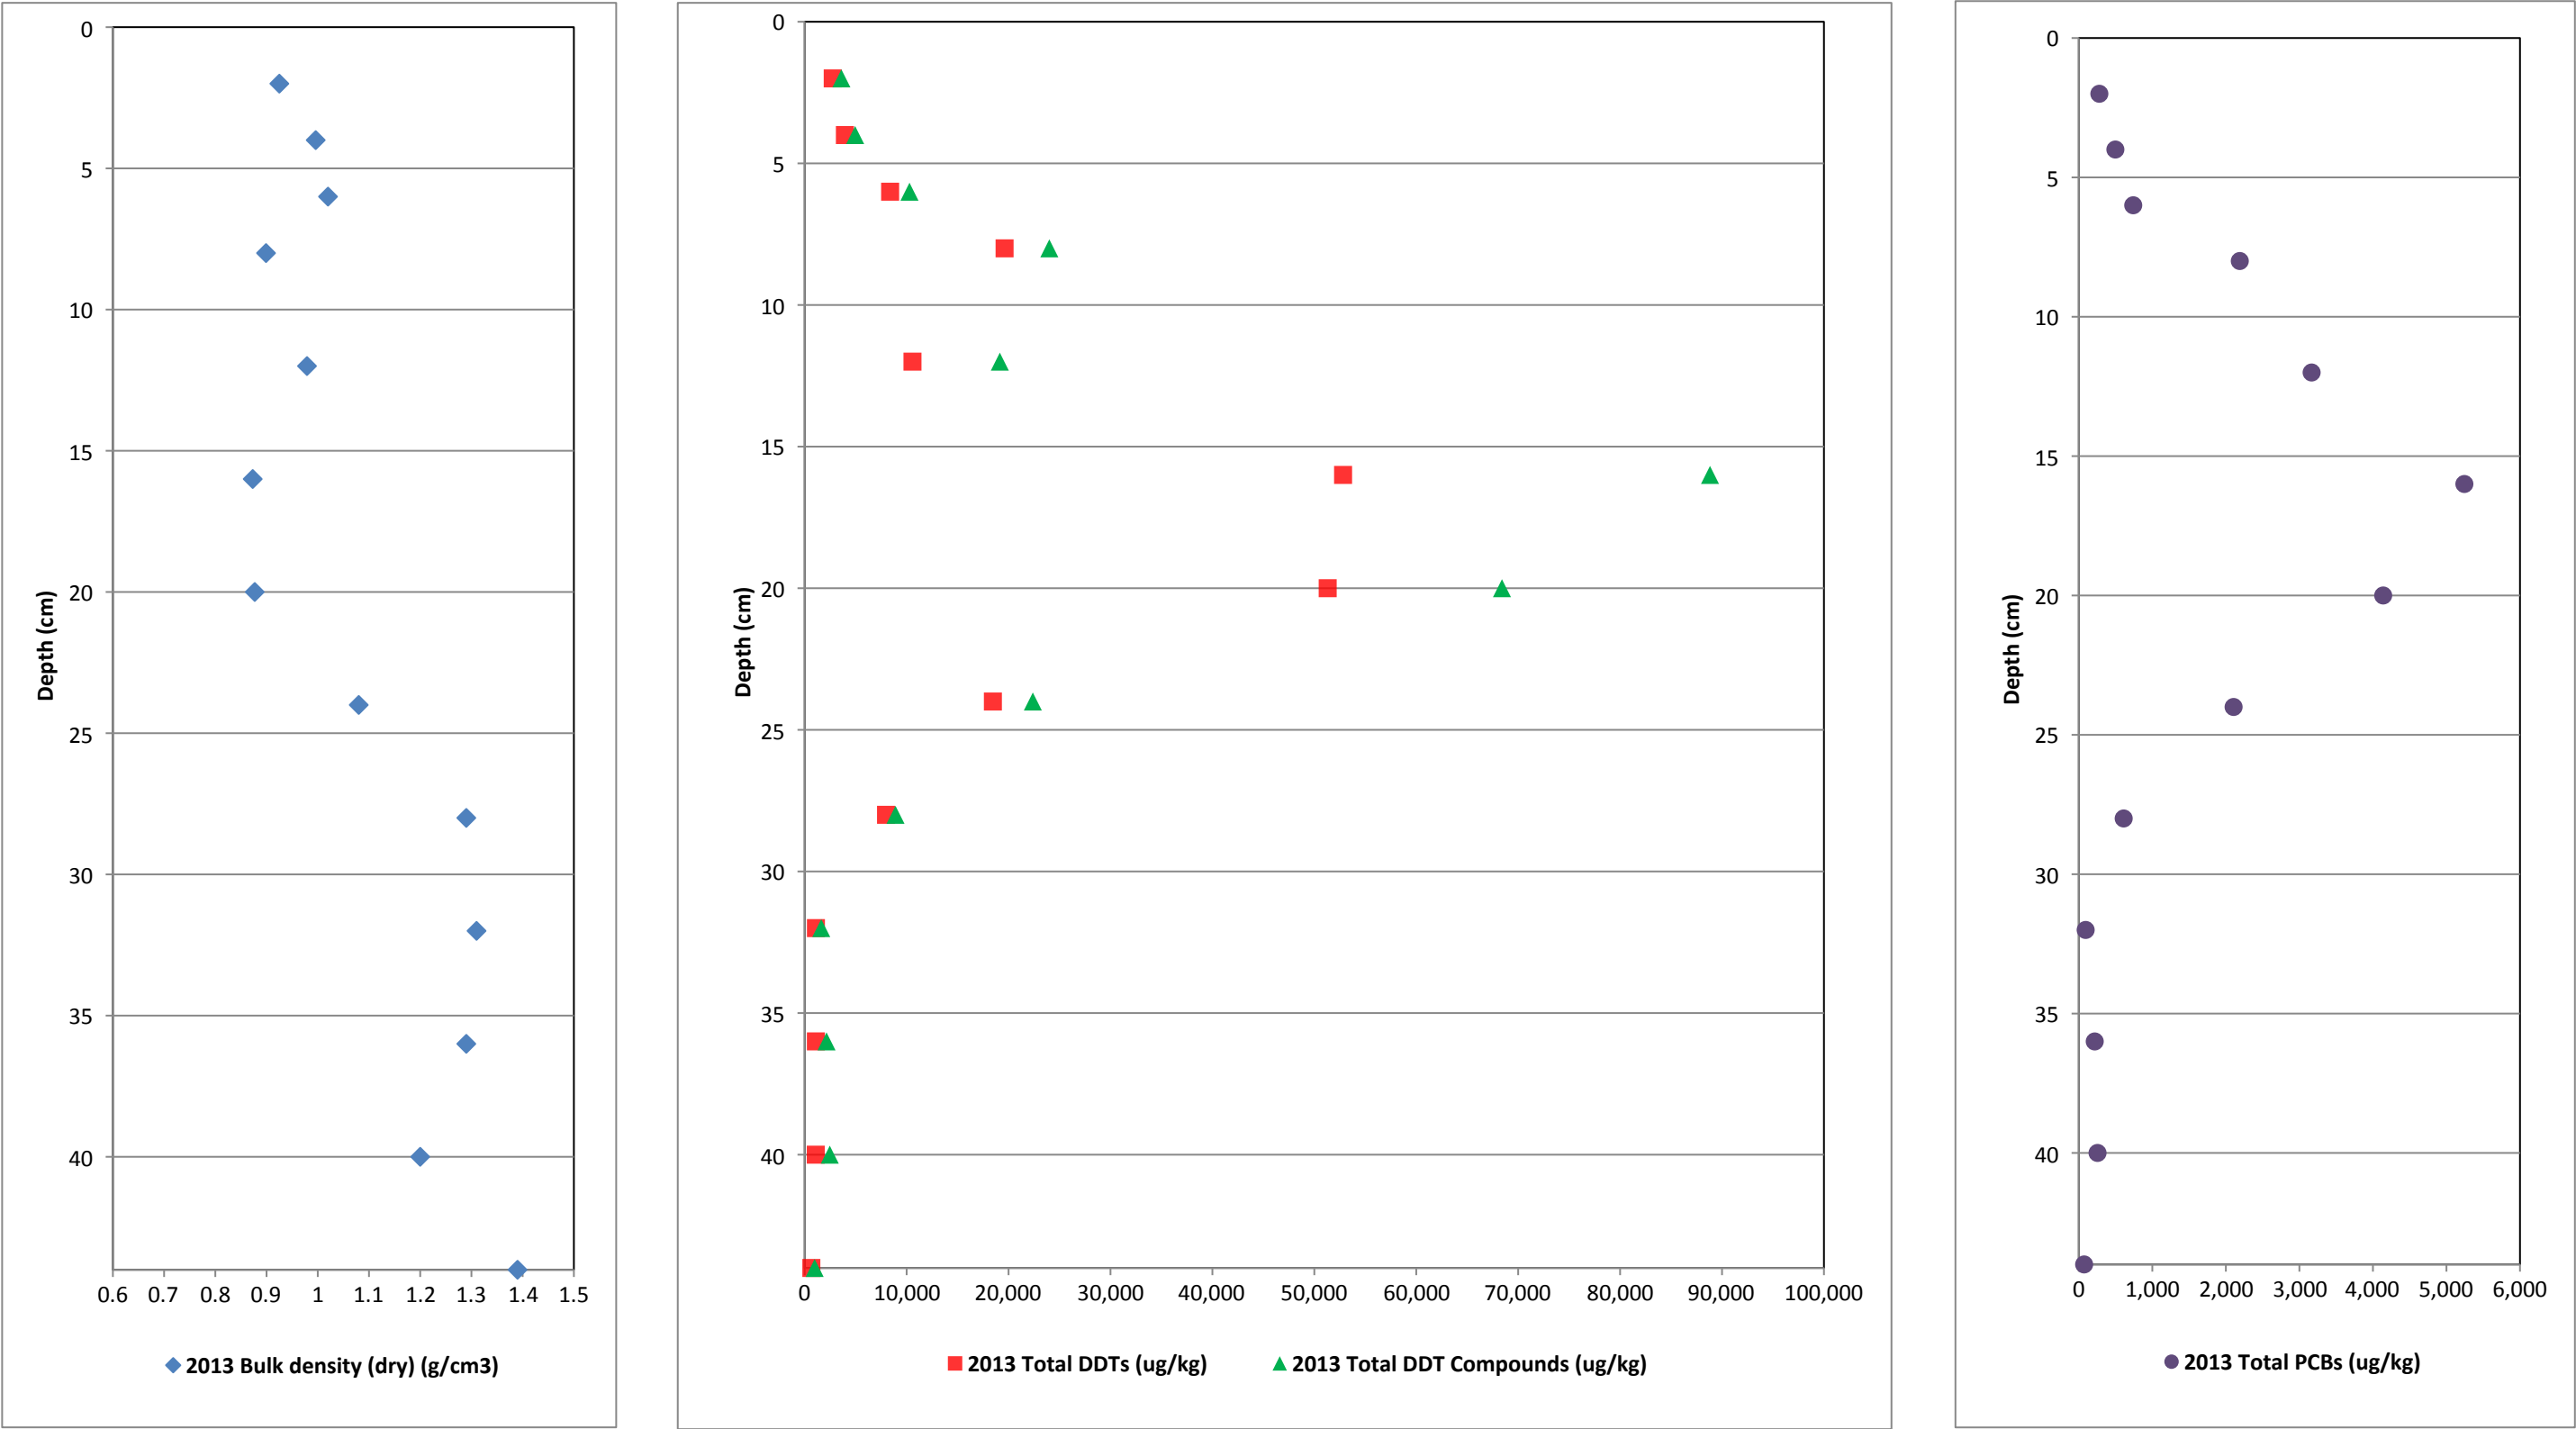
Figure 28. Vertical Profiles of Bulk Density and COCs for Core OA28  
First MNR Report  
Palos Verdes Shelf (OU 5 of the Montrose Chemical Corp. Superfund Site)  
Los Angeles County, California

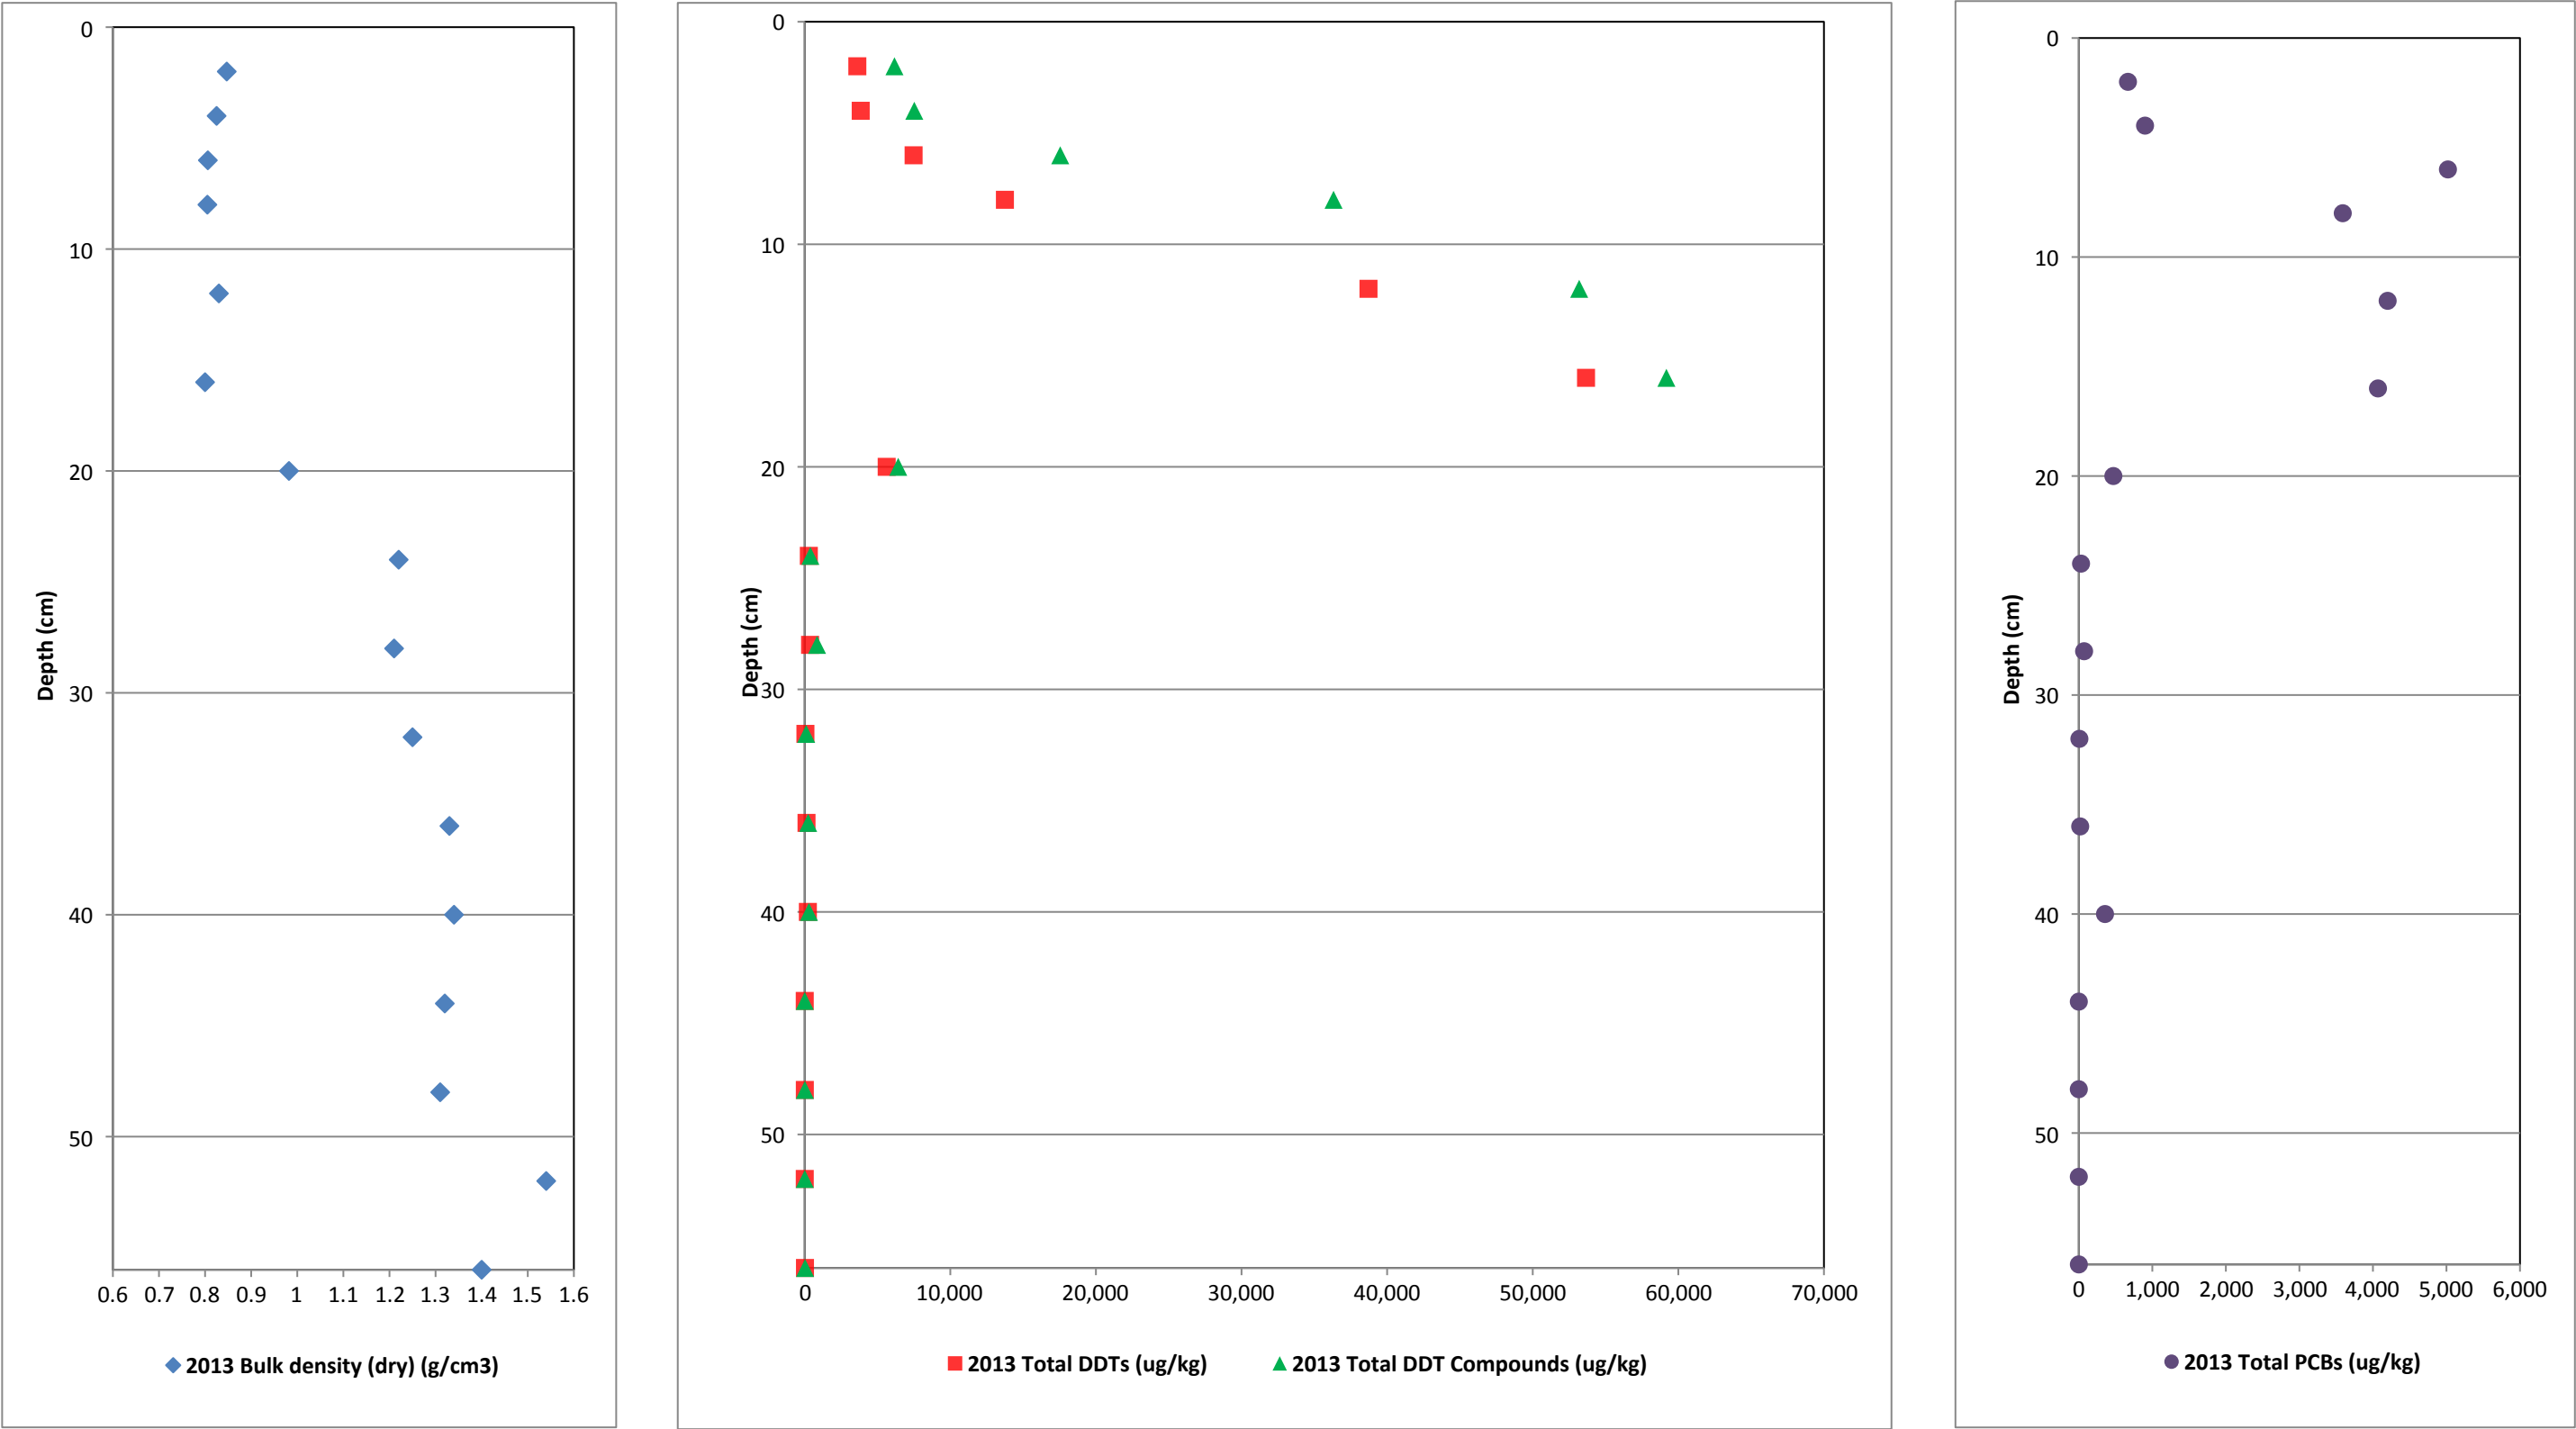
Figure 29. Vertical Profiles of Bulk Density and COCs for Core OA29  
First MNR Report  
Palos Verdes Shelf (OU 5 of the Montrose Chemical Corp. Superfund Site)  
Los Angeles County, California

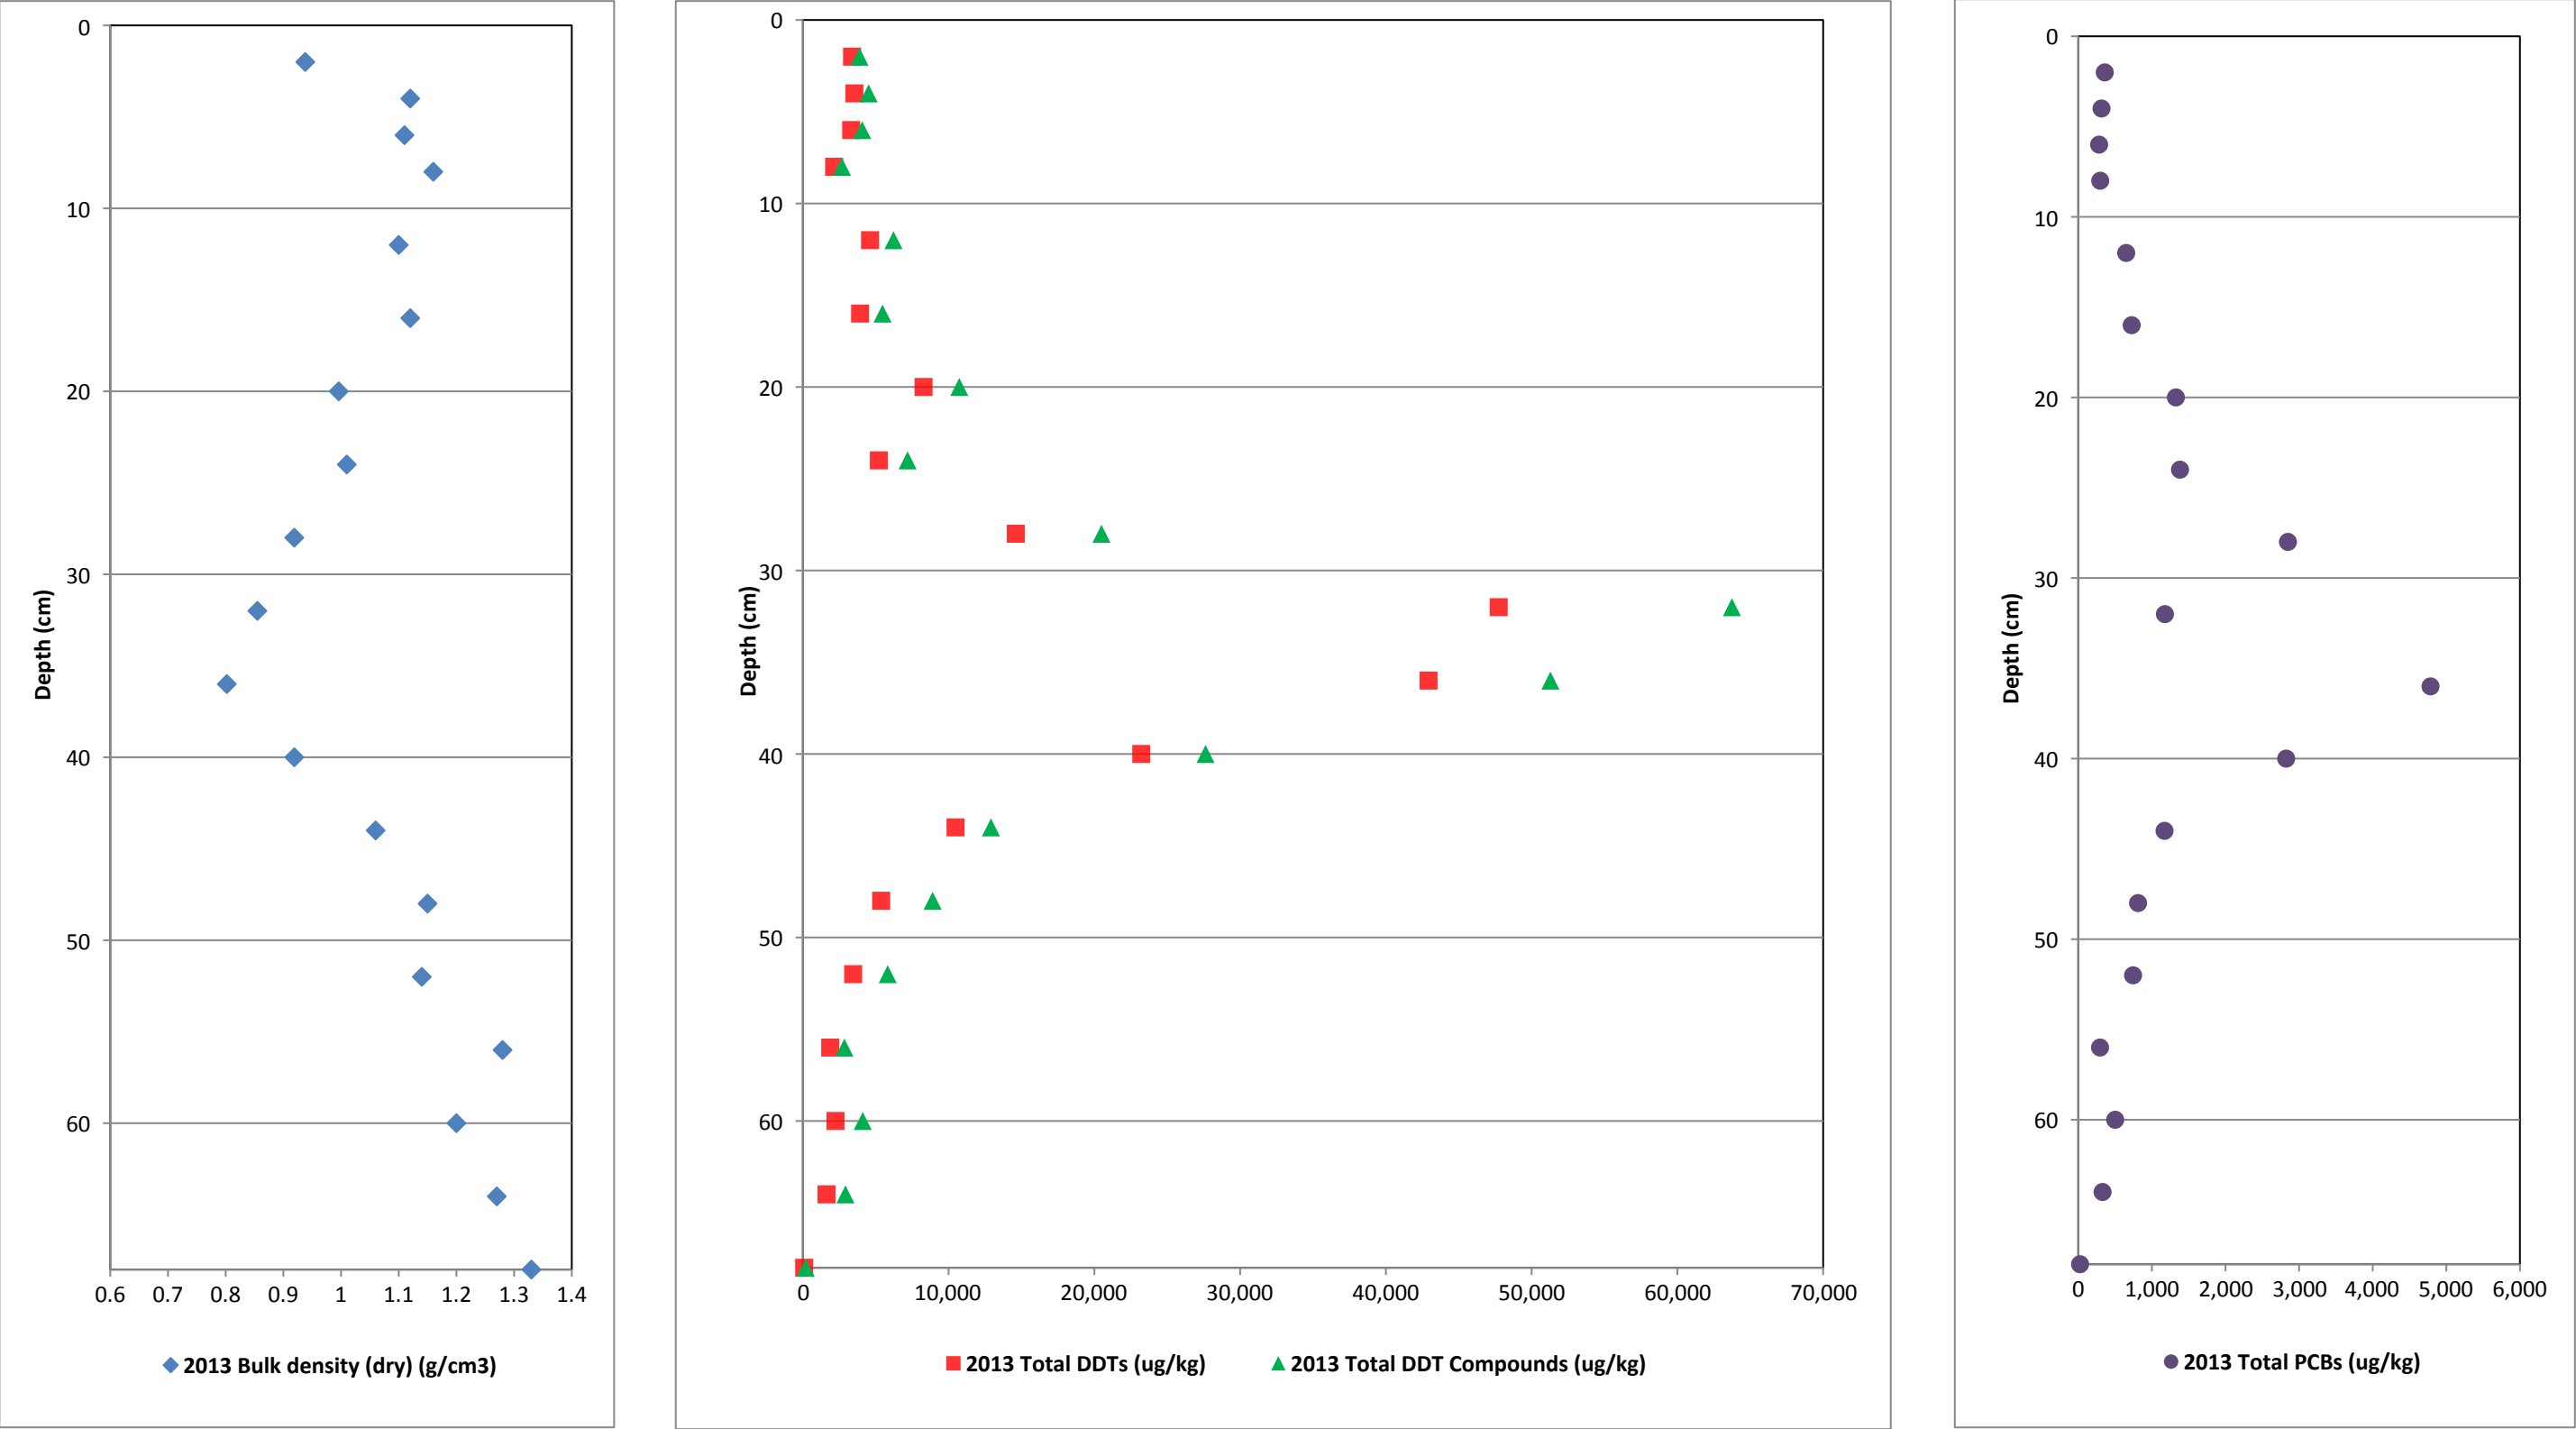
Figure 30. Vertical Profiles of Bulk Density and COCs for Core OA30  
First MNR Report  
Palos Verdes Shelf (OU 5 of the Montrose Chemical Corp. Superfund Site)  
Los Angeles County, California
