## **APPENDIX X.2 – VERTICAL PROFILES – OUTFALL AREA CORES**

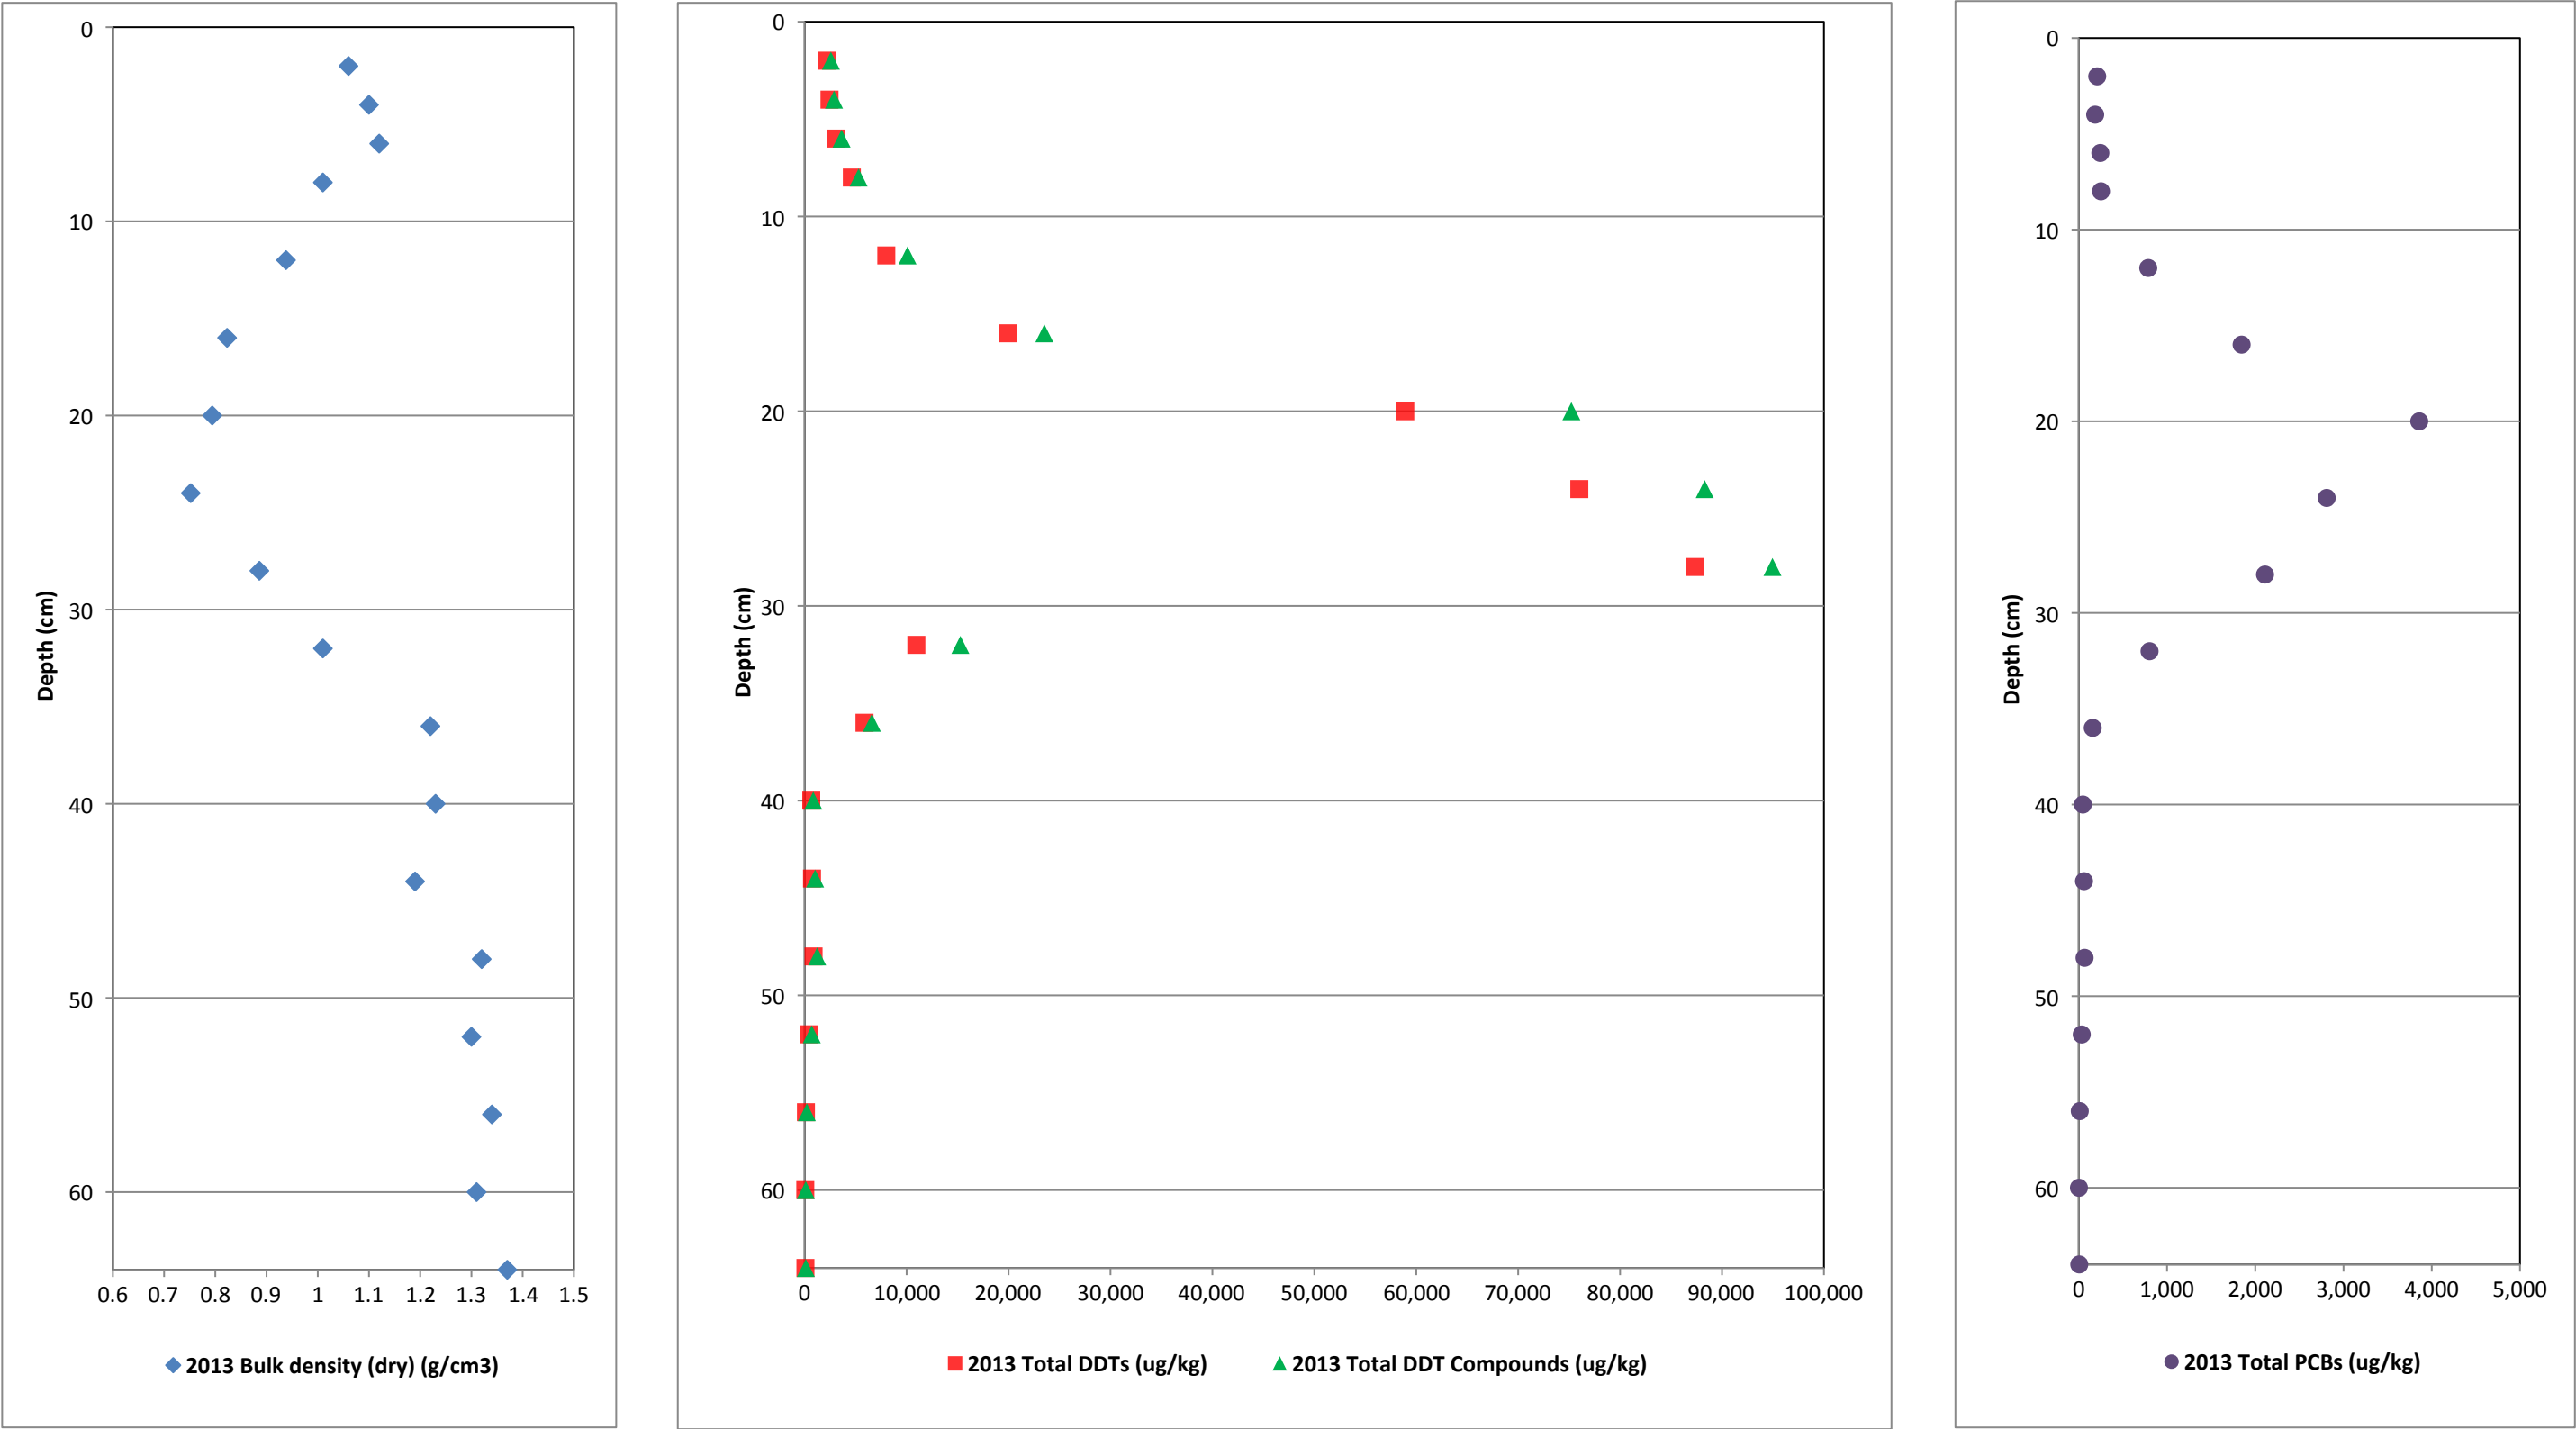
Figure 31. Vertical Profiles of Bulk Density and COCs for Core OA31  
First MNR Report  
Palos Verdes Shelf (OU 5 of the Montrose Chemical Corp. Superfund Site)  
Los Angeles County, California

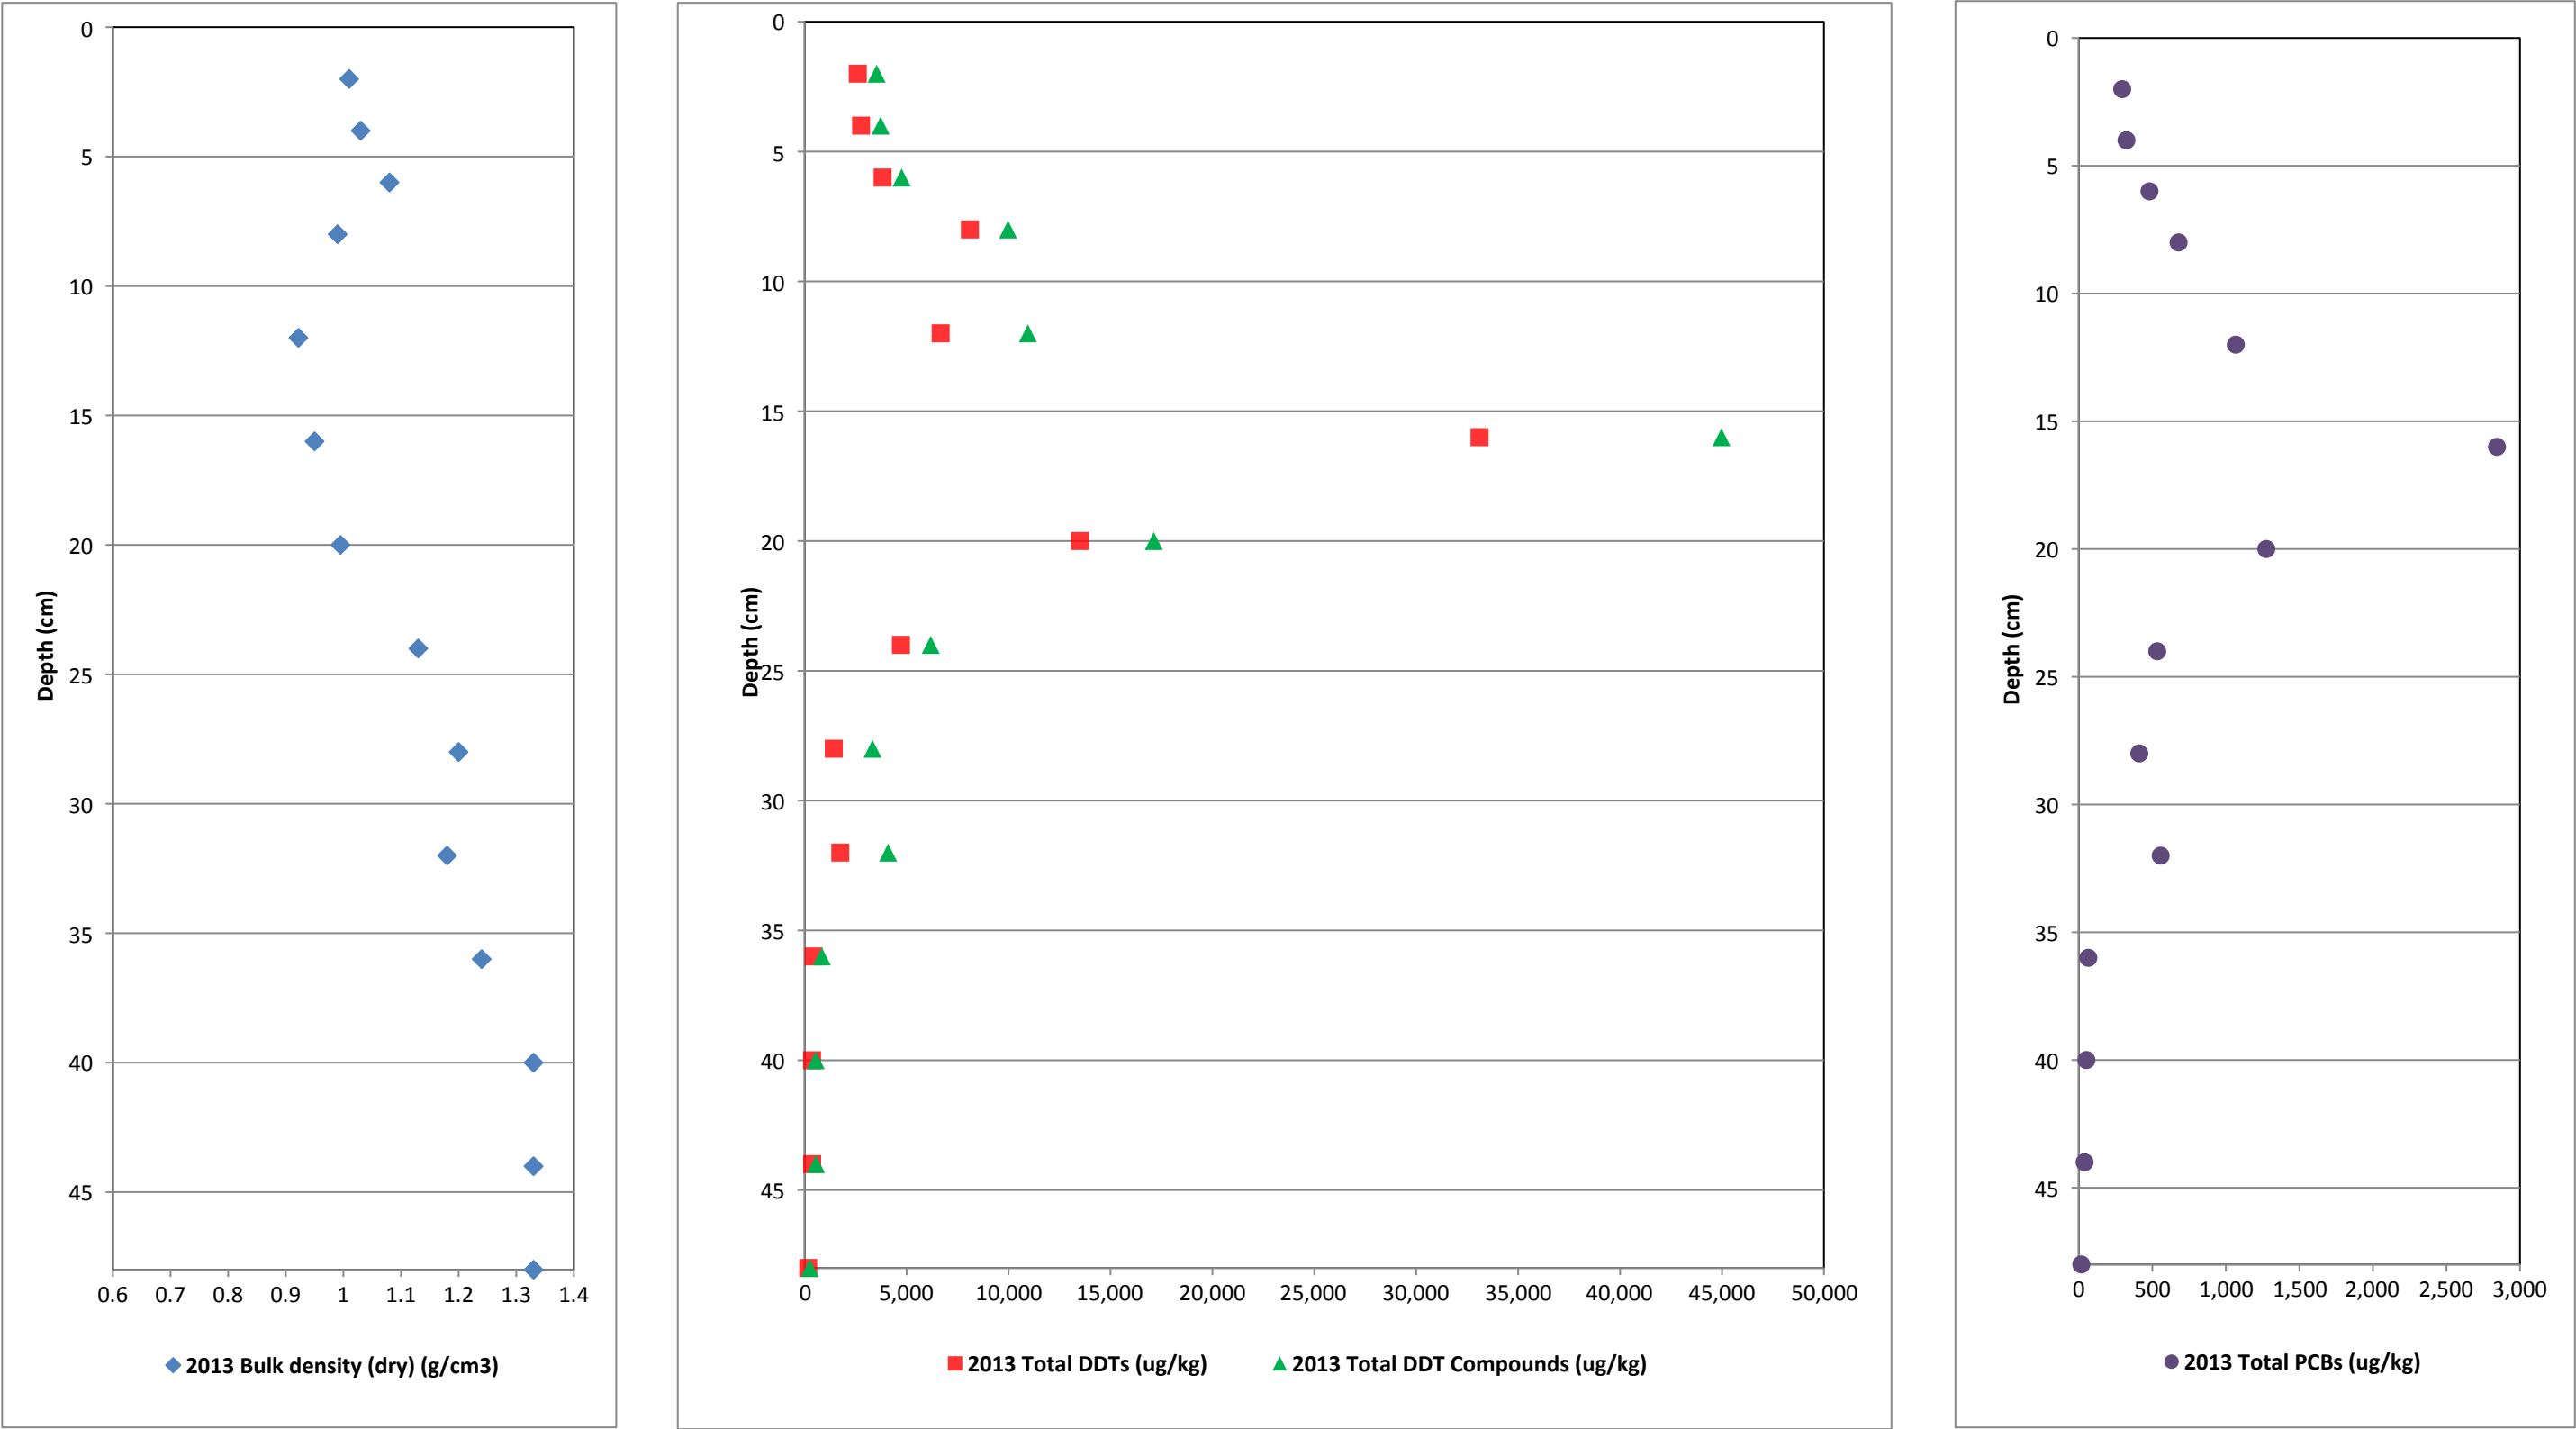
Figure 32. Vertical Profiles of Bulk Density and COCs for Core OA32  
First MNR Report  
Palos Verdes Shelf (OU 5 of the Montrose Chemical Corp. Superfund Site)  
Los Angeles County, California

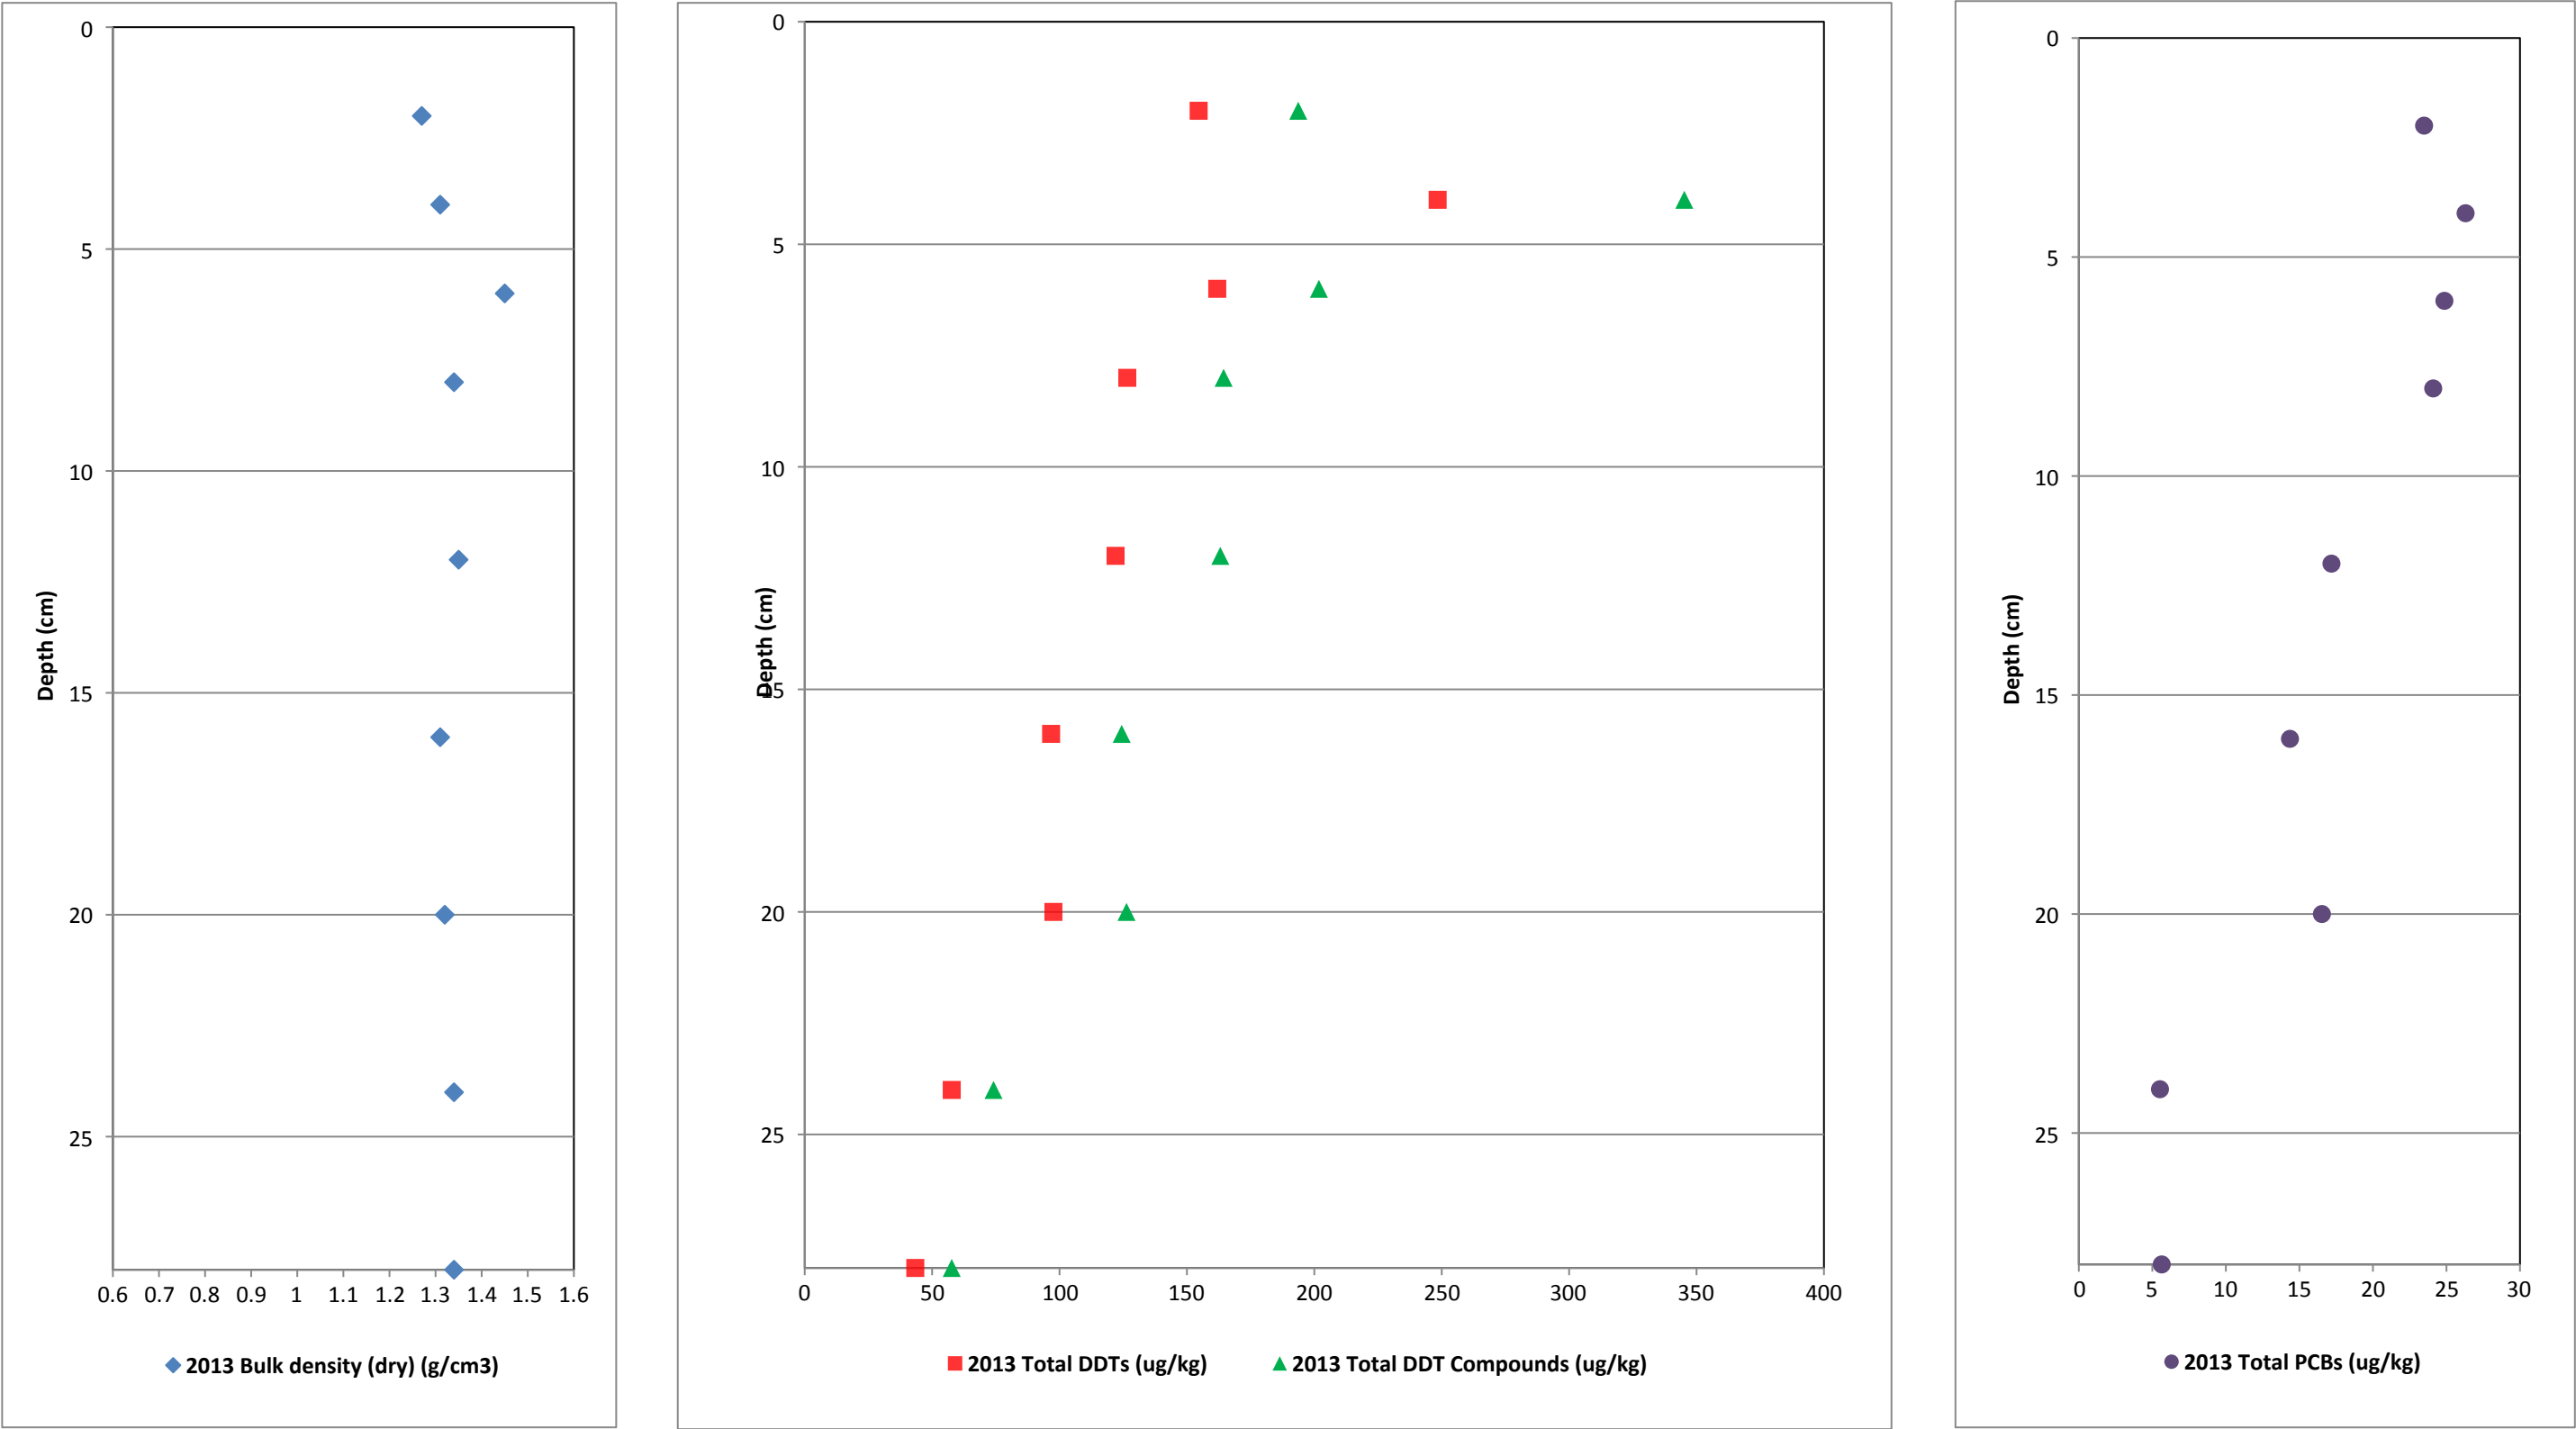
Figure 33. Vertical Profiles of Bulk Density and COCs for Core OA33  
First MNR Report  
Palos Verdes Shelf (OU 5 of the Montrose Chemical Corp. Superfund Site)  
Los Angeles County, California

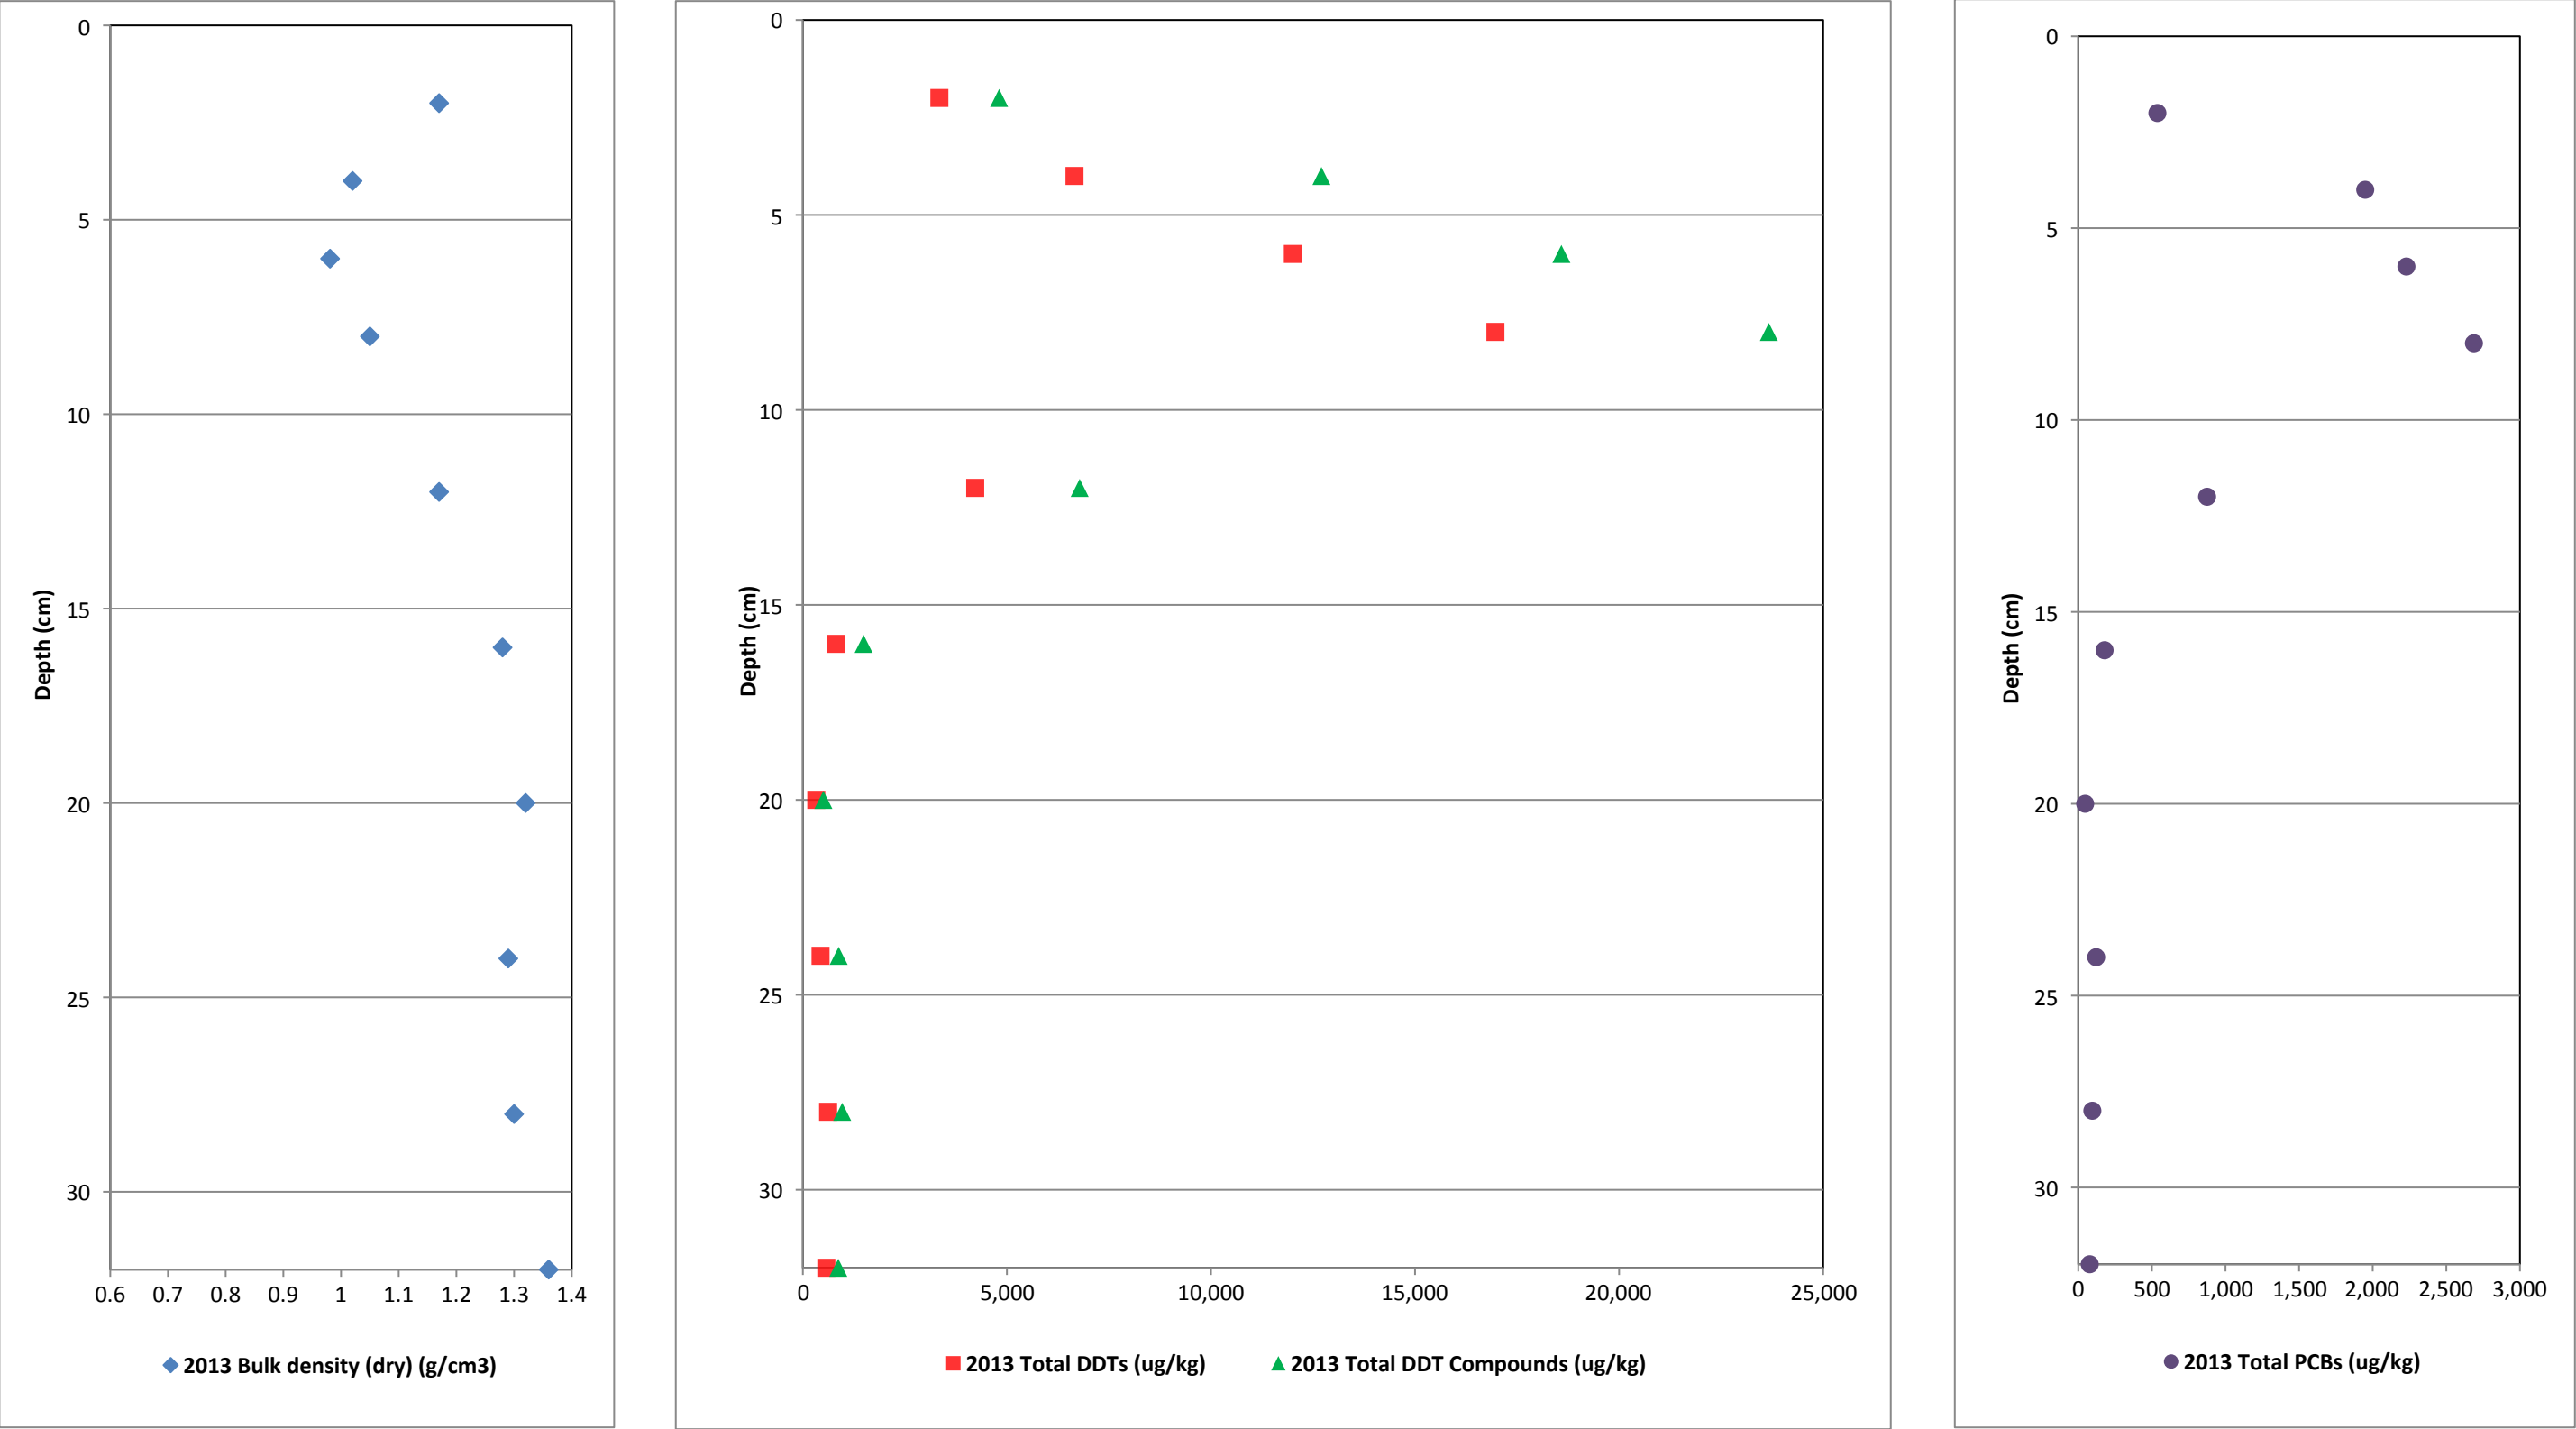
Figure 34. Vertical Profiles of Bulk Density and COCs for Core OA34  
First MNR Report  
Palos Verdes Shelf (OU 5 of the Montrose Chemical Corp. Superfund Site)  
Los Angeles County, California

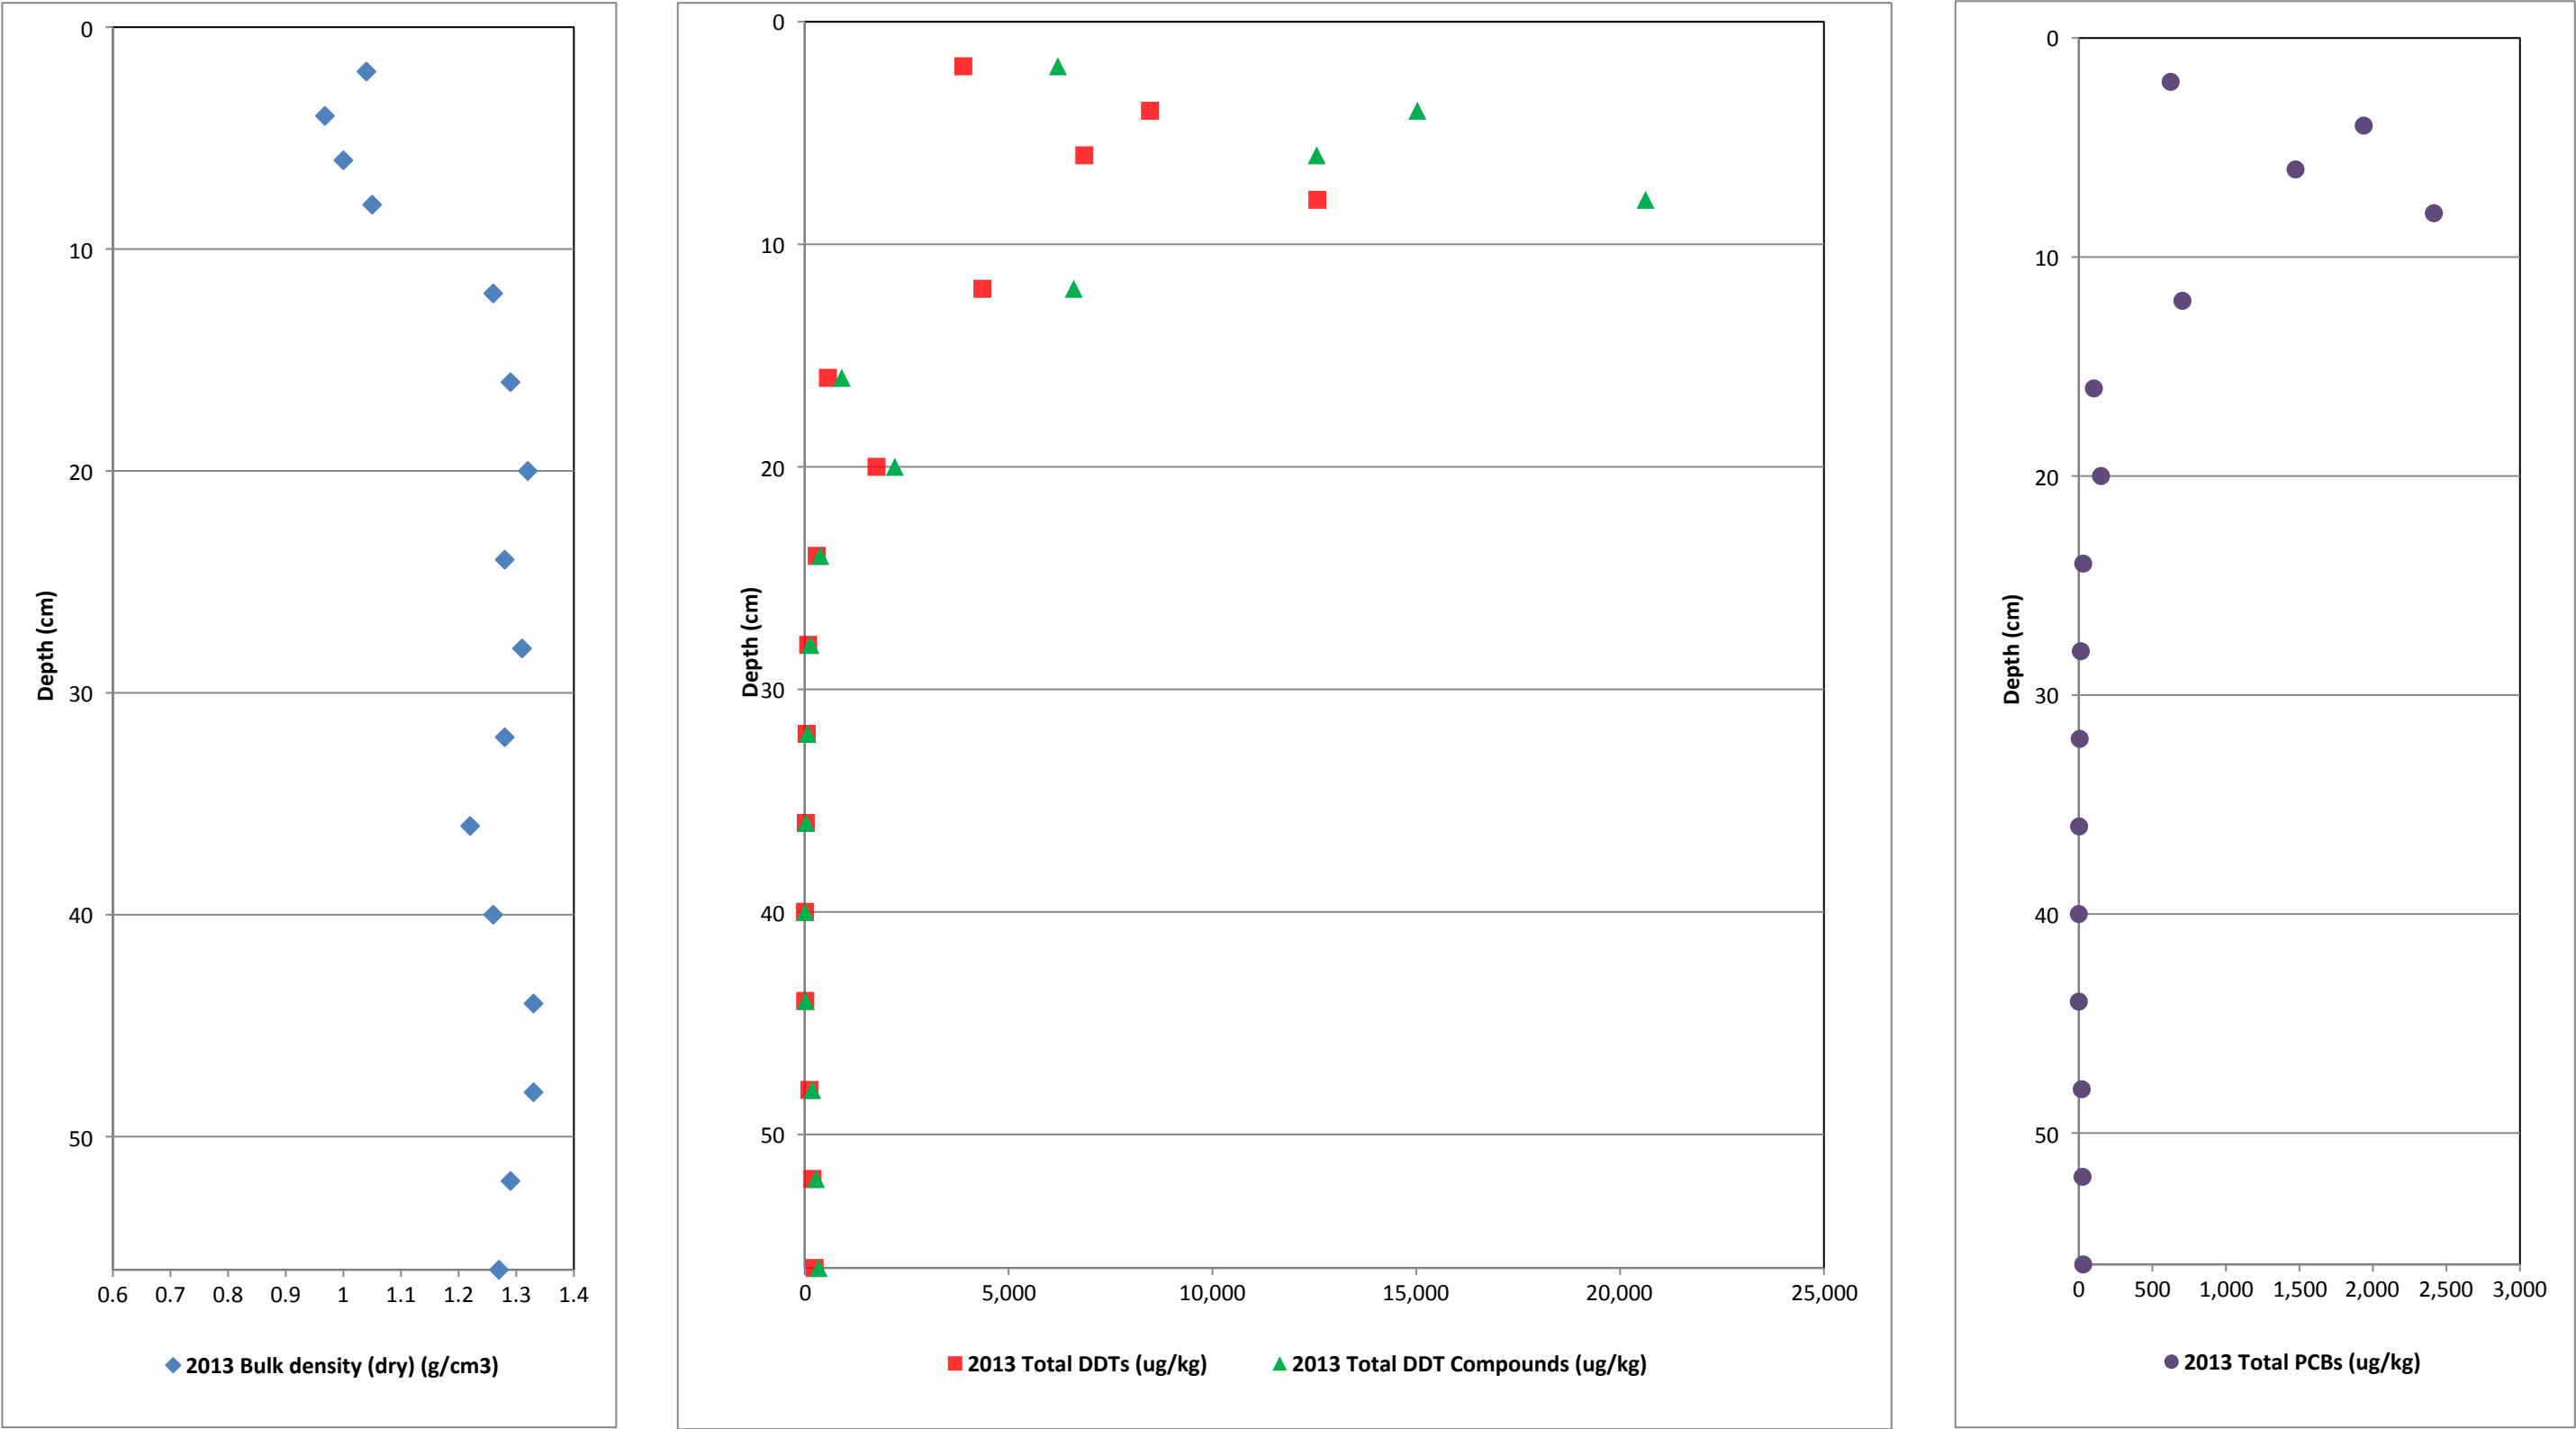
Figure 35. Vertical Profiles of Bulk Density and COCs for Core OA35  
First MNR Report  
Palos Verdes Shelf (OU 5 of the Montrose Chemical Corp. Superfund Site)  
Los Angeles County, California
